Cow Tag 137	Function Code S 17.1	
Brief Description: [timber element, p/s, condition, fragments] TRUNCATED PLANK - FORE SCARP MISSING, WOOD SURFACES VERY SOFT		
Notable Features: [tool marks, scribed lines, decoration, repairs] POINTS TO LOOK OUT FOR WHEN RECORDING ufos INBOARD: - TYPE 1 LINES ON AFT SCARP TYPE 1 LINES FORE OF COWTAG Outboard: degraded INBOARD: type 1 lines; additional nail angle not with 15 cm rod outboard: 3RD complete upper nail

137 S17_1 Yardeni Vorst 17 July 2006

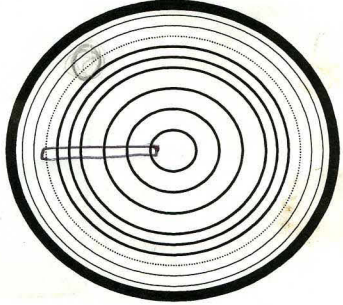
does have nail head but no clear boundaries of this nail head. Same goes for 10th nail hole (next to 6th treenail) Forward end cut in antiquity.		
Wood Science: [rings, ARW, knots, sapwood, conversion] Radial - 120HT 2S. Pith beyond upper edge. ARW = 205/122

- cut in antiquity

Recommended action: [samples, additional photos, moulding, queries and problems] photo: possible clamp mark, inboard, forward end between 2nd & 3rd treenail		
Cleaned: 13/7/06 BS VT	Recorded: 17/07/06 D.V.	Photos:
