DB 11/2/8

Cow Tag 159	Function Code P6.6	
Brief Description: [timber element, p/s, condition, fragments] Plank		
Notable Features: [tool marks, scribed lines, decoration, repairs] POINTS TO LOOK OUT FOR WHEN RECORDING ufos <ul style="list-style-type: none"> - SEVERAL ADDITIONAL NAILS AT EDGE OF SCARF INBD. - 1 BLIND NAIL HOLE ON LAND RIGHT NEXT TO SCARF INBD. - 1 PLUGGED HOLE LAND - DOUBLE TREE NAILS - at every station. 		
Wood Science: [rings, ARW, knots, sapwood, conversion] <p>Not clear c 80H Near radial. ARW: 200/80 Centre beyond upper edge. Timber has some heavy grain esp aft scarf. Also a number of minor knots.</p>

159.P6_6 Monika Maleszka-Ritchie 25.10.2005

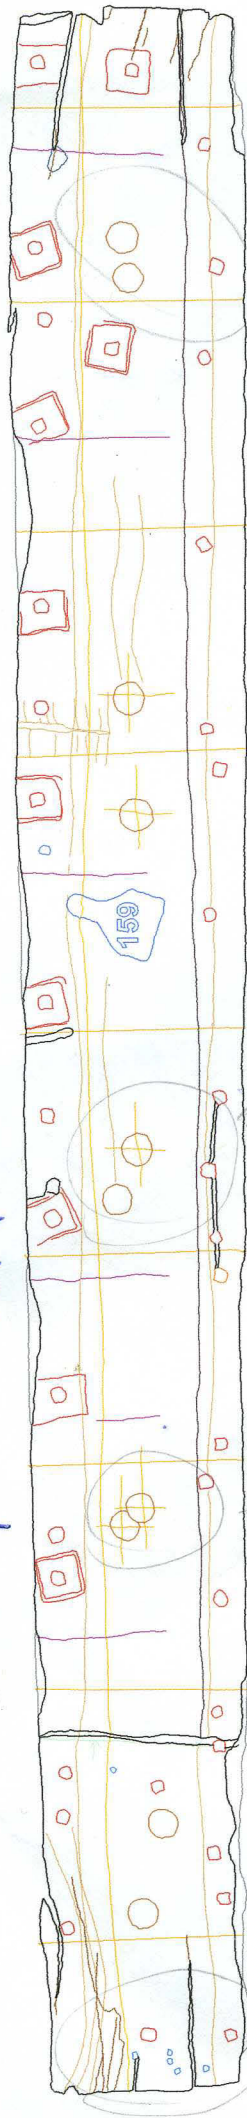
need to check these breaks in framing lines. F37?

photo
ex 3

photo
ex 2

ex 1
blind averaged photo
size ~ 8mm diam
20mm deep
rounded bottom
photo
