DB 11/2/8

Cow Tag <i>165</i>		Function Code <i>P 7.8</i>
Brief Description: [timber element, p/s, condition, fragments] <i>PORTSIDE PLANK, FRAGILE MIDDLE AS DAMAGED BY PILES, FAIRLY KNOTTY PLANK, PARTICULARLY AFT END.</i> → Almost Broken		
Notable Features: [tool marks, scribed lines, decoration, repairs] POINTS TO LOOK OUT FOR WHEN RECORDING ufos <i>IB: ADD NAIL CLOSE TO TREENAIL 1.30M AFT OF FORWARD EDGE. (GOES THROUGH) SAWMARKS (MODERN) 1.20M AFT OF FORWARD EDGE. ADD NAIL ALSO AT 1.90 M AFT OF FORWARD EDGE</i> <i>Possible toolmarks/intentional lines → centre of plank, inboard face</i> <i>↳ Now separated with aft section renumbered 1708</i> <i>Nice tool signatures on aft scarf.</i>		
Wood Science: [rings, ARW, knots, sapwood, conversion] <i>Slightly better. Picked up aft scarf. Pith beyond lower edge on growth trail. c 85 H ARW c 203/85</i>		
Recommended action: [samples, additional photos, moulding, queries and problems] <i>Mould impression & mark as indicated on plan.</i>

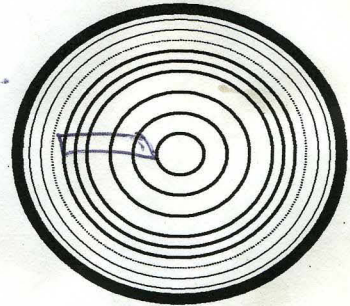
modern marks
Thin section was detached and numbered 1708.
of impression
