| Cow Tag 178 | | Function Code P8-3 |
| Brief Description: [timber element, p/s, condition, fragments] <i>Complete plank. Split damage at aft scarf</i> | | |

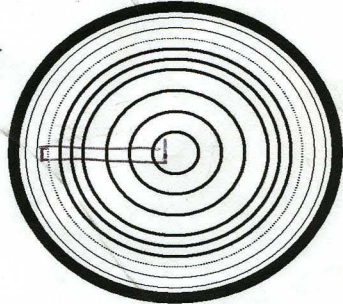
| Notable Features: [tool marks, scribed lines, decoration, repairs] POINTS TO LOOK OUT FOR WHEN RECORDING ufos <i>Has repair along lower edge</i> <i>Type 1 Inscribed line?</i> <i>Old control points recorded and removed.</i> <i>Need to add wood fastener centres layer</i> | | |
| Wood Science: [rings, ARW, knots, sapwood, conversion] <i>Radial at aft scarf. Pith beyond lower edge. c70HP⁵. Distinct growth band later. ARW = 230/75</i> | | |

| Recommended action: [samples, additional photos, moulding, queries and problems] <i>Plus repair</i> | | |
