Cow Tag 195	Function Code P7.3	
Brief Description: [timber element, p/s, condition, fragments] GOOD CONDITION PLANK, NEXT SIDE		
Notable Features: [tool marks, scribed lines, decoration, repairs] POINTS TO LOOK OUT FOR WHEN RECORDING ufos INBOARD: - TREENAIL DRILLING HOLE/IMPRESSION ABOVE 3rd TREENAIL FROM AFT SCARF

195 P7_3 Deni Vorst 30 April 2006

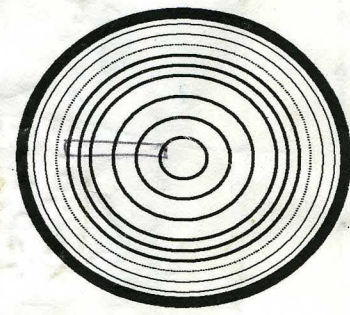
POSSIBLE 'PRE SCARF' ADJUSTMENT, C. 20cm FROM OF AFT SCARF. OUTBOARD: - / This is modern - changed to limit or original edge on Rhino file.		
Wood Science: [rings, ARW, knots, sapwood, conversion] Radial. c80H at aft scarf. ARW = 4.85/80. Some shifting many grains. Growth trend suggests pitch beyond lower edge.

Recommended action: [samples, additional photos, moulding, queries and problems] problems with calibrating (see other side) photo: inboard, MIDDLE SECTION HALF-DRILLED treenail hole		
Cleaned: 28/09/06 BT VT	Recorded: Dani 3-5-06	Photos:
Checked: [corrections needed]		Initials & Date: NN 12/5/6

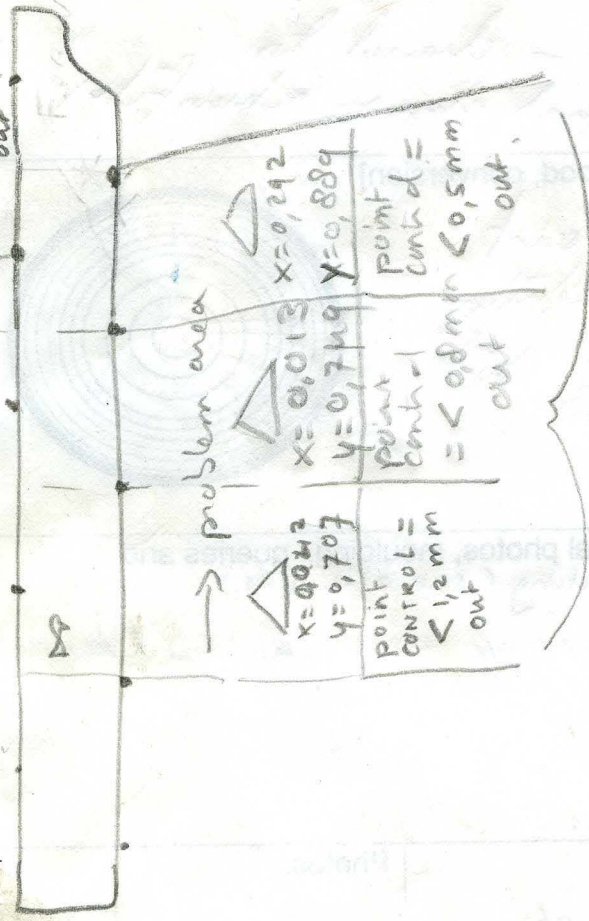
outboard with control point

- inboard & half of outboard aft end drawn on 1 day.
- outboard forward (minus last leap frog-section) drawn next day see problems

- last leap frog section drawn day after (calibration over the whole outboard length got worse!)
