Cow Tag 196	Function Code P11-4 P11-5	
Brief Description: [timber element, p/s, condition, fragments] DAMAGED		
Notable Features: [tool marks, scribed lines, decoration, repairs] POINTS TO LOOK OUT FOR WHEN RECORDING ufos REPAIRS MANY REPAIRS + ADDITIONAL NAILS → AFT END INBOARD: INSCRIBED MARKS * 1 TOWARDS BOW SIDE. OUTBOARD: VERY LONG SCARF, INSCRIBED LINES ON THE BOW SIDE TREE NAIL		
Wood Science: [rings, ARW, knots, sapwood, conversion] Radial. Clear growth band. Pith beyond upper edge. Some sapwood at 3 o'clock lower edge. c100H at aft end 180H + 20S at 3 o'clock in fan fossil end. ARW = 248/140. Straight ground.

196 P11_4 Toby N. Jones 31 October 2005

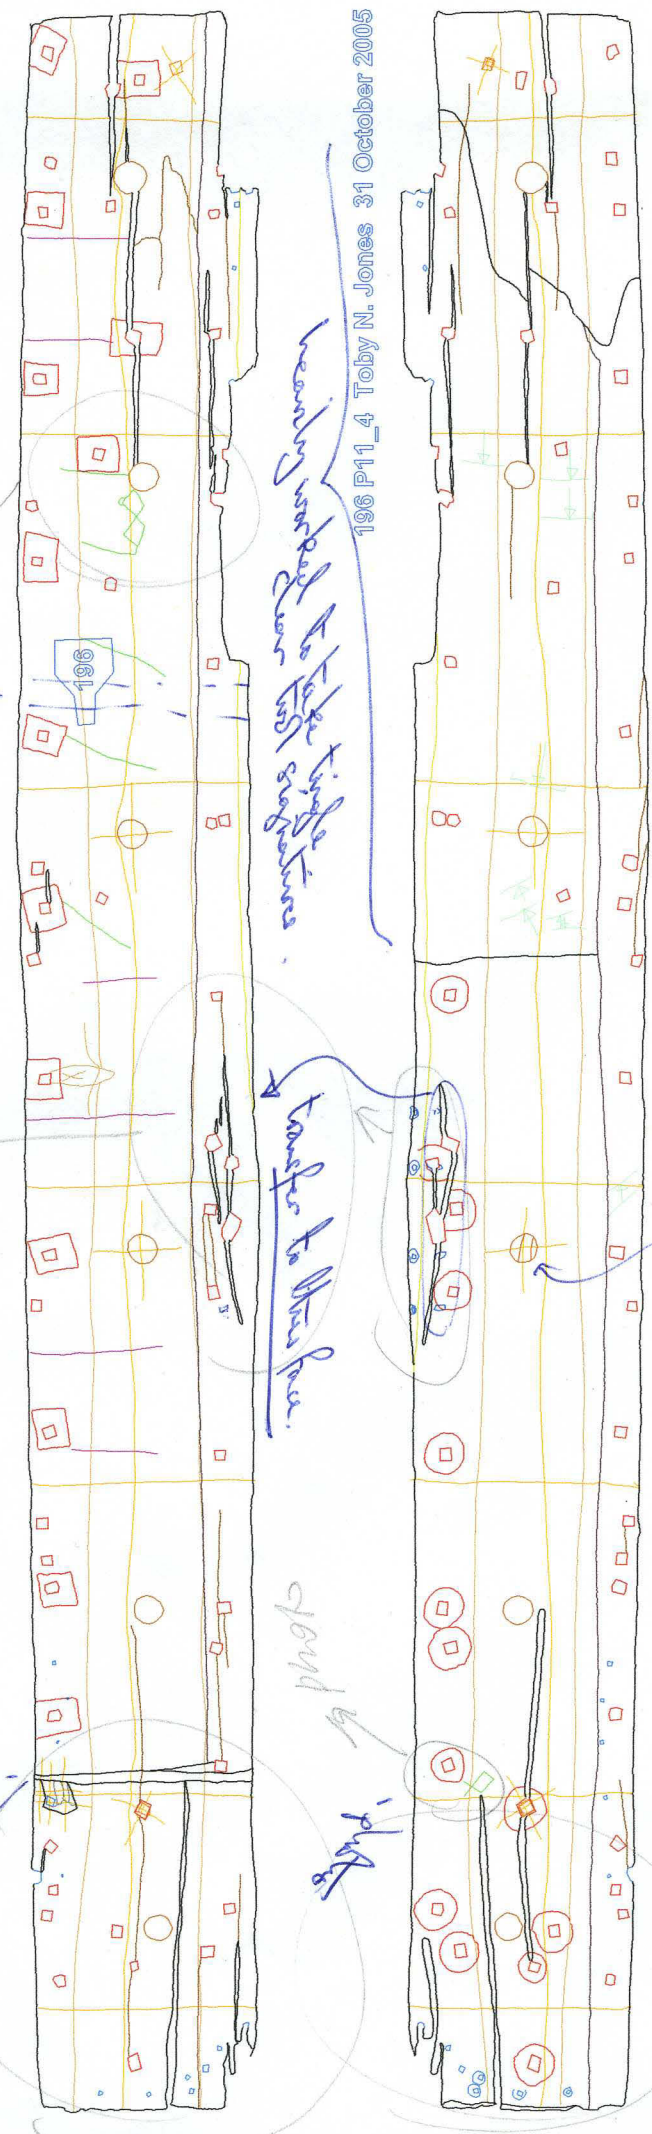
moving inward to take high photos.

transfer to this face.

photo
→ looking over beyond depth of scarf.
