Cow Tag 198 Function Code P11.3 P11.4

Brief Description: [timber element, p/s, condition, fragments]
Portuli Plank, broken off at scarf end facing aft; Forward scarf slightly damaged too

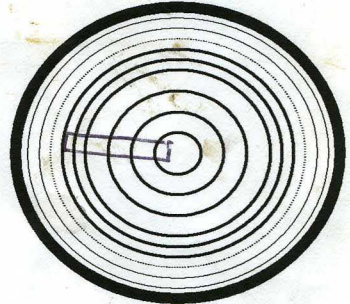
c 80H Radial, ARW = 23/80
straight-grained
Unsure which edge is nearest path.

Photos of scribed line
moulding of angled hole?

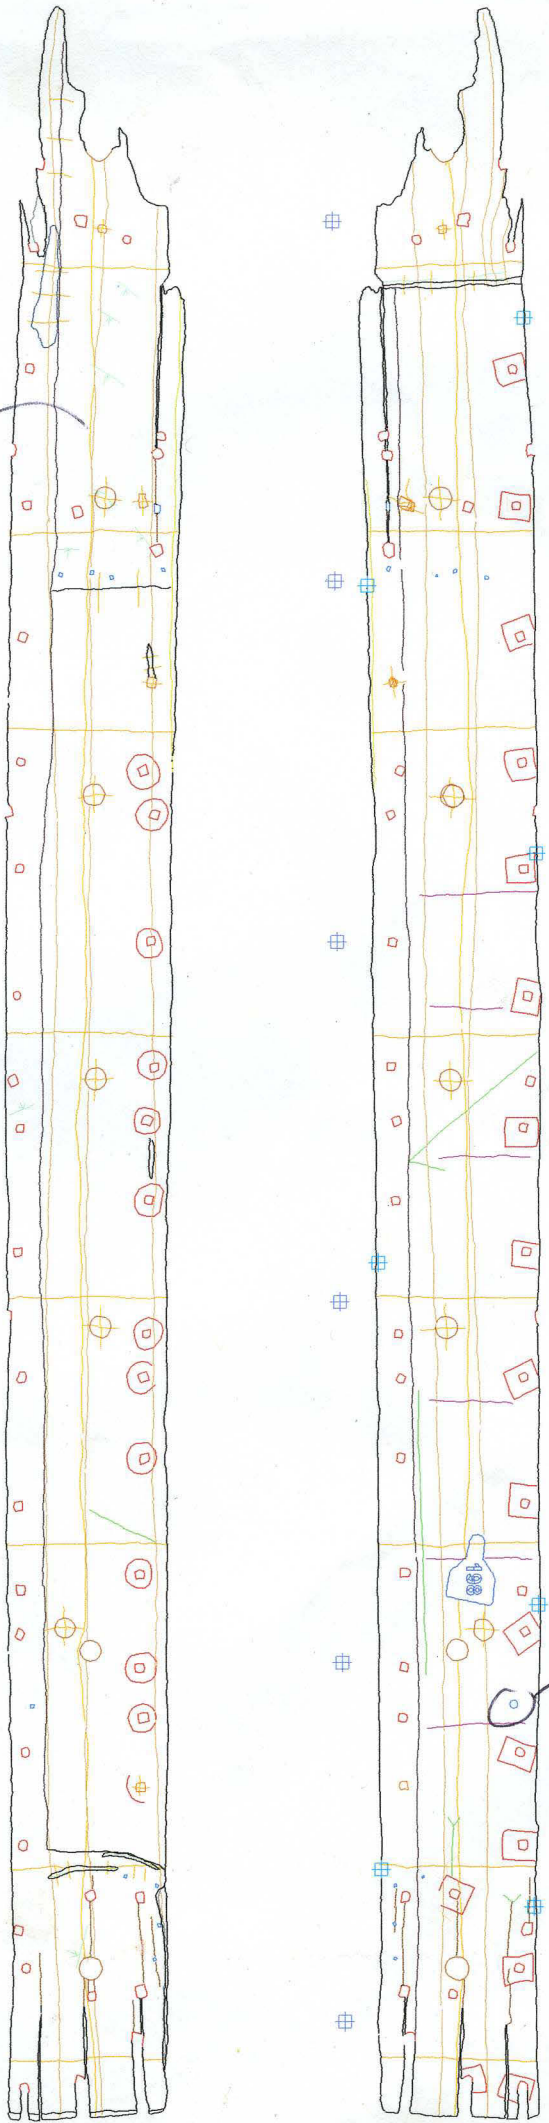
cut back to take
O/S traps

Armed hole (indicated)
normal from inward, has under
from station 22.
