Cow Tag 201 Function Code P 12-4

DAMAGED PLANK

201 P12_4 Monika Maleszka-Ritche 01.11.2005

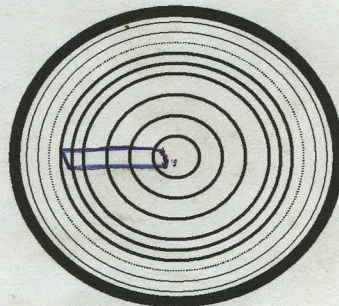
Radial, straight grained 3 large splits along grain. Age trend suggests pitch beyond upper edge c 75H ARW = 230/75

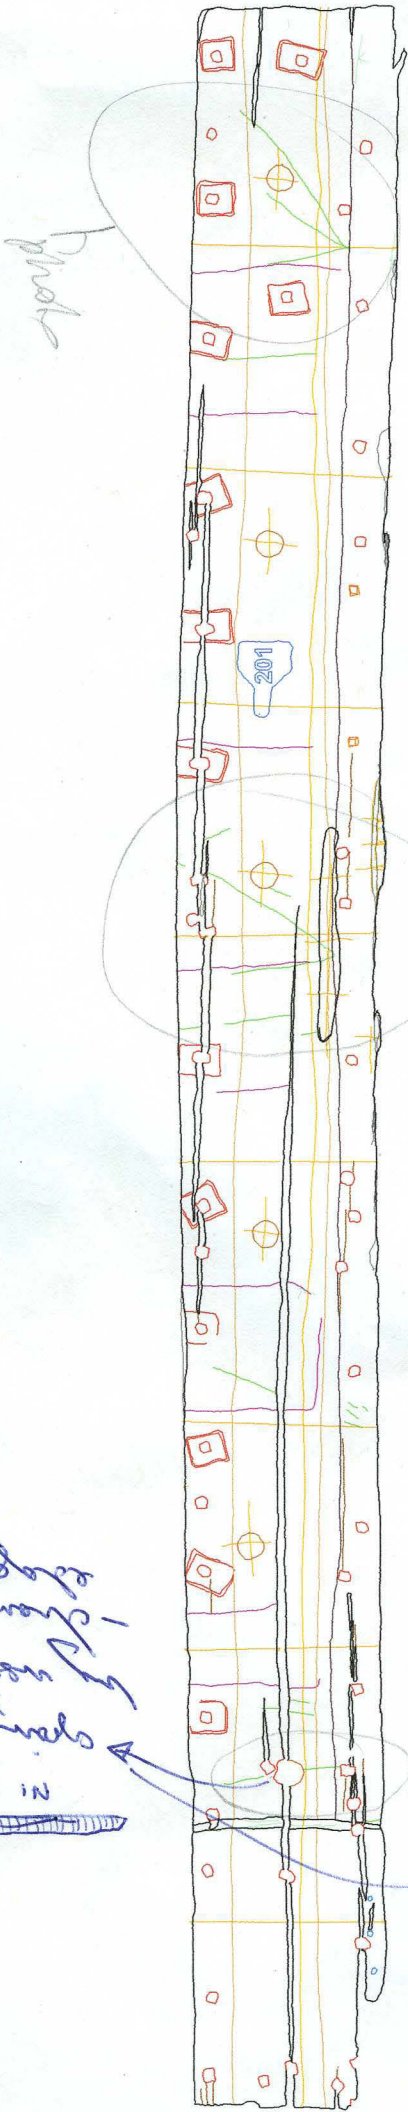
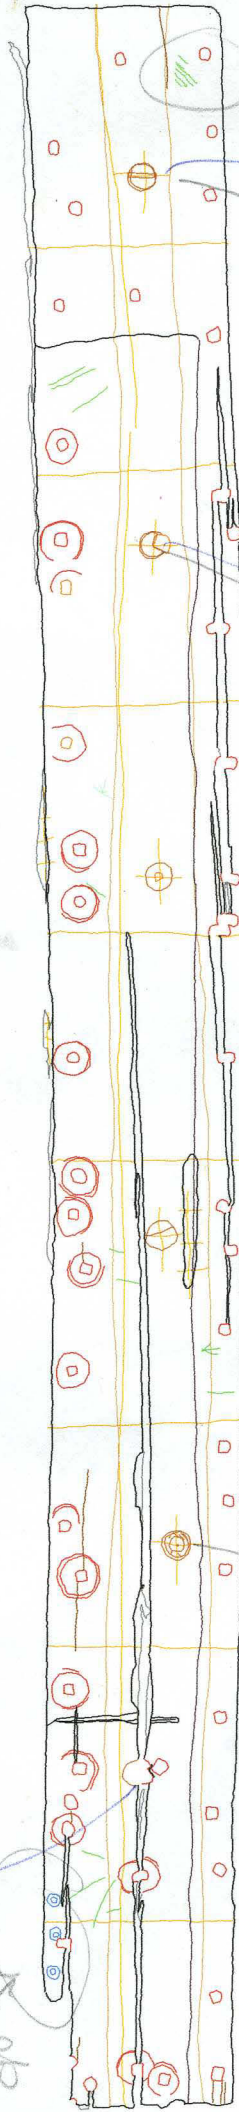
INBOARD LAM: PLANT MATERIAL MIXED WITH ANIMAL FE MAT. ~~END ON~~ - SAMPLED (NO 1614)

Bow Scarf joint seriously cracked, emended with tiny nails. Cracks stuffed with wire/resin/tar mix - which sampled.

INBOARD: MANY INSCRIBED LINES, WELL VISIBLE COMPRESSION MARKS FROM FRAMES.

OUTBOARD: SOME TREENAILS WEDGED

Photo nails made on scarf. This tar samples in scarf fill should be compared with usual tar throughout.
