| Cow Tag 207 | | Function Code 54.4 |
| Brief Description: [timber element, p/s, condition, fragments] VERY WELL PRESERVED PLANK | | |

207 S4_4 Toby N. Jones 15 March 2006

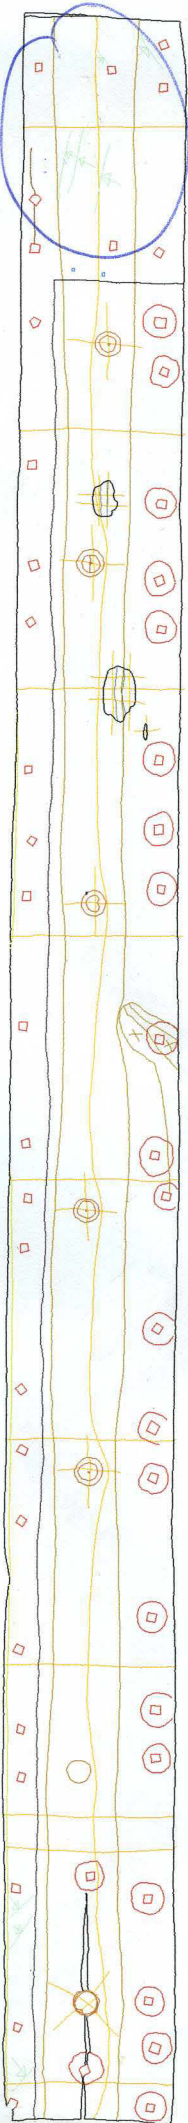
photos

| Notable Features: [tool marks, scribed lines, decoration, repairs] POINTS TO LOOK OUT FOR WHEN RECORDING ufos 6 INSCRIBED LINES AFT OF FORW. END, INBD. - Type 2. Several tear tears on inboard face near knots. | | |
| Wood Science: [rings, ARW, knots, sapwood, conversion] Substantial Sapwood, Tight grain - good dendro candidate. Interesting variety of treenail heads - narrow + wide mid ft. knots. Some knots off radial aft becoming radial forward. c 125H + 10'S ARW = 233/135. Pith beyond lower edge. | | |

| Recommended action: [samples, additional photos, moulding, queries and problems] Check inboard cross nail (see plot) against relevant framing timber for spike. DENJ. Photos - see plot. | | |

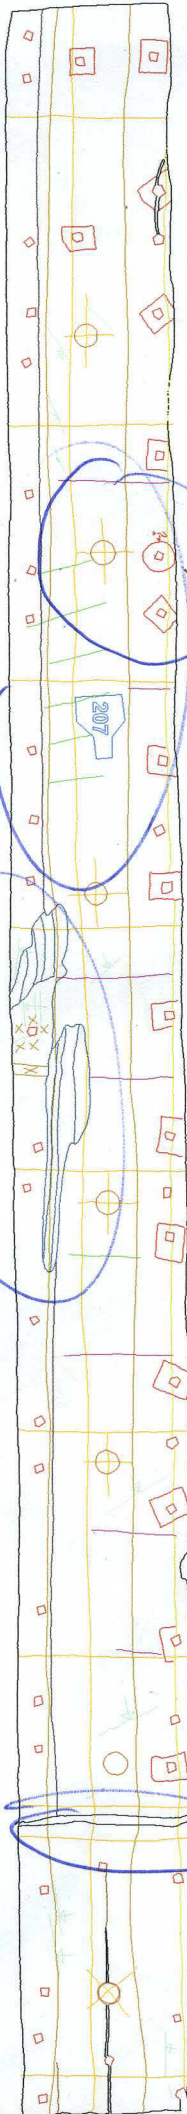
photos

press
 possible reverse nail
 but not ~~just~~ not
 - check v frame

this is large
 worn (damaged?)
