| Cow Tag 329 | Function Code S28.6 | |
| Brief Description: [timber element, p/s, condition, fragments] OB. LAND MISSING. FAIRLY SOLID PLANK Fragment of fore end | | |

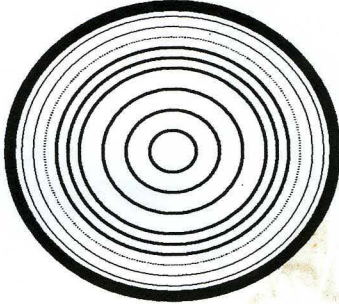
| Notable Features: [tool marks, scribed lines, decoration, repairs] POINTS TO LOOK OUT FOR WHEN RECORDING ufos IB: TYPE ① + ③ → ⑤ Outboard: 1 iron nail in trunnel, wood deteriorated IB: - HEAVILY ERODED UNDER FRAMES (?) - 3 POSS. CLAMP MARKS AT ATTEND ✓ - SAMPLES TAKEN FROM CRACK WITH TYPE ③ MARK + EDGE OF LAND | | |
| Wood Science: [rings, ARW, knots, sapwood, conversion] Radial - 105H . P.Ah beyond upper edge? ARW = 215 / 105. | | |
