DB 11/3/8

Cow Tag

346

FORWARD PART OF ~~THE~~ PLANK, FRAGMENT - ~~CO~~

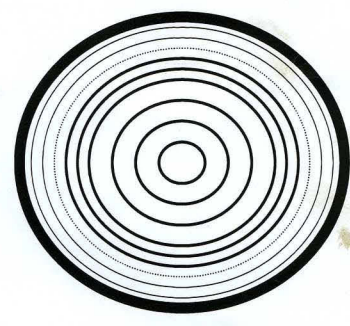
c 60 A radial - Pith beyond lower edge on growth rate.  
ARW = 210/60
