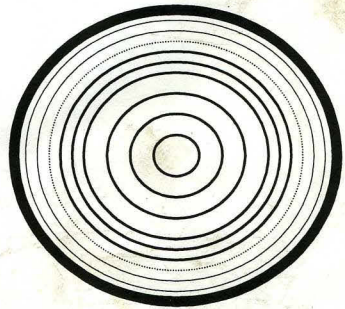
Cow Tag 467 476	Function Code S11.2
Brief Description: [timber element, p/s, condition, fragments] Plank in good condition	
Notable Features: [tool marks, scribed lines, decoration, repairs] POINTS TO LOOK OUT FOR WHEN RECORDING ufos Inboard; nail hole aft end 50cm from tree nail. additional nail on land aft end - wooden peg inserted - 20cm from Aft end cut board: ^{tool} marks on scarf 2 unsuccessful central points on either side of the 12th clinker nail on Aft of forward edge on inboard land	
Wood Science: [rings, ARW, knots, sapwood, conversion] Variable, looks tangential forward becoming radial aft. Aft: R, SOH, Pith uncertain ARW = 190 / 50.	
Recommended action: [samples, additional photos, moulding, queries and problems]	
Cleaned: 29/06/06 KHM MS	Recorded: MS 4/7/6 ReRec. 08/10/07
Checked: [corrections needed]	Photos: Initials & Date: NN 18/10/6
Corrections Done [desktop, Faro Arm?]:	Initials & Date:
