Cow Tag:

481

Function Code:

S10.8,

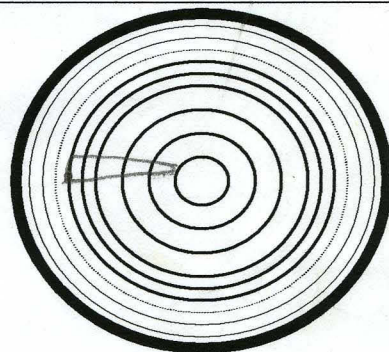
2 rebated cores 3 through small Fe nails (2 on land, one near end of forward scarf).

True radial at forward end, rays parallel into slightly angled upward lower face at aft. Spacing of scarf. 120H ARW = 202/120 Pith edge nearest lower edge

Photo of rebated cores.

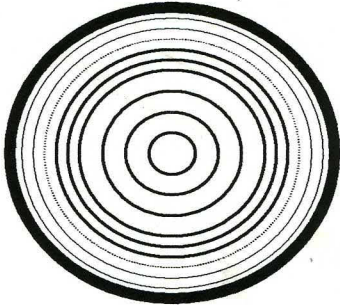
Cow Tag 481	Function Code 510-8	
Brief Description: [timber element, p/s, condition, fragments]		
<p>Notable Features: [tool marks, scribed lines, decoration, repairs] POINTS TO LOOK OUT FOR WHEN RECORDING ufos</p> <p><i>8th nail aft of forward edge, upper edge, outboard face, can see both the round drilled nail hole and square clinker nail impression.</i></p> <p><i>Three additional nails on forward scant.</i></p> <p><i>Some treenail heads have dimples</i></p>		
<p>Wood Science: [rings, ARW, knots, sapwood, conversion]</p> <div style="text-align: right;">
