Report 908

Archaeological watching brief at the former Guardsman public house, 129 Fratton Road, Portsmouth, 2007/15

2008

Site code	2007/15
Archaeology Unit report	908
PCC planning reference	06/00238/FUL
Ordnance Survey grid reference	465121 100442

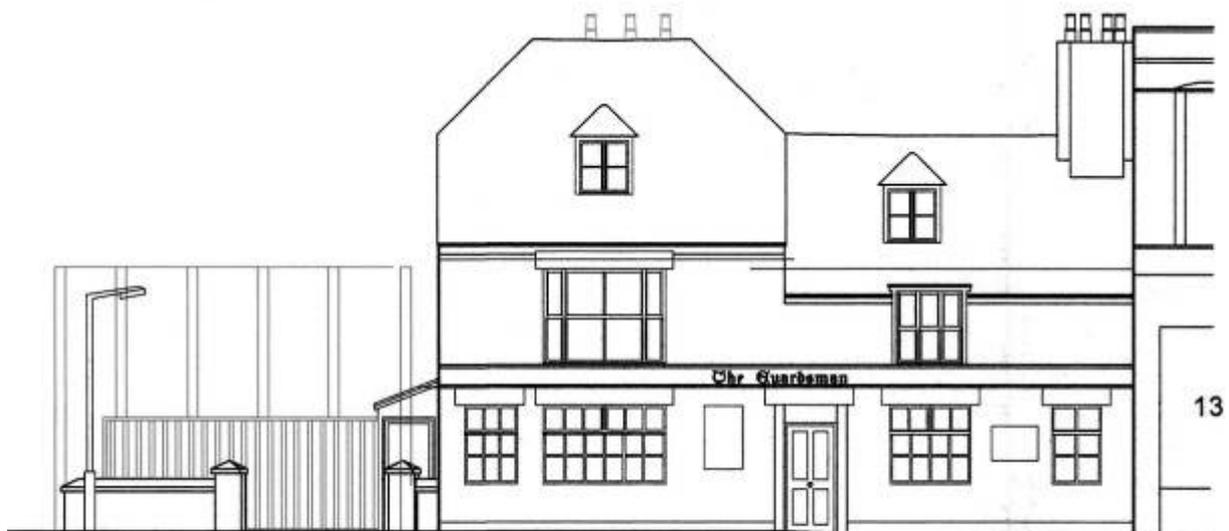
Figure 9. Front (east) elevation.

The exterior walls of the building were rendered. The street (east) frontage wing was built to two stories with garret rooms in the roof space (figure 9). The building was in two bays of different builds. The north end, being the earlier structure, had a gable roof aligned parallel with Fratton Road. It had a chimney stack at the east end along the roof ridge. The south end had a taller roof with half-hips at the north and south ends.

The openings were not original. At ground floor level there was a central door flanked on either side by windows of varying proportions. The watching brief showed that the southern window had been formed out of a former doorway. The wall below the inserted window was built in cement blocks, so the window was recent. However, the doorway may have been the original door into the southern bay. The existing door was located just to the north of the division between the two bays. There was a single window in each bay at first floor level. That of the south bay was taller, reflecting a greater ceiling height in this part of the building. There was a dormer in the roof slope of both bays.

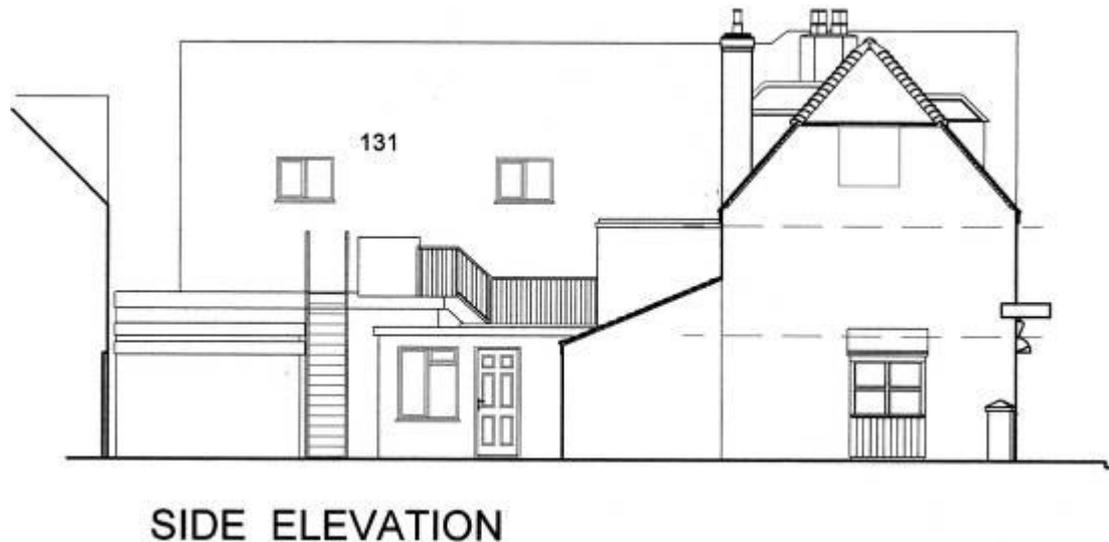
Figure 10. South facing elevation

The south elevation (figure 10) had a slightly off-centre door at ground floor level. It may have been inserted when the southern extension was added by 1938. There was a blocked window opening just below the half-hip. There was a single storey lean-to with a single pitched gable roof at the west end. This would have formed the western projection shown on the early maps.

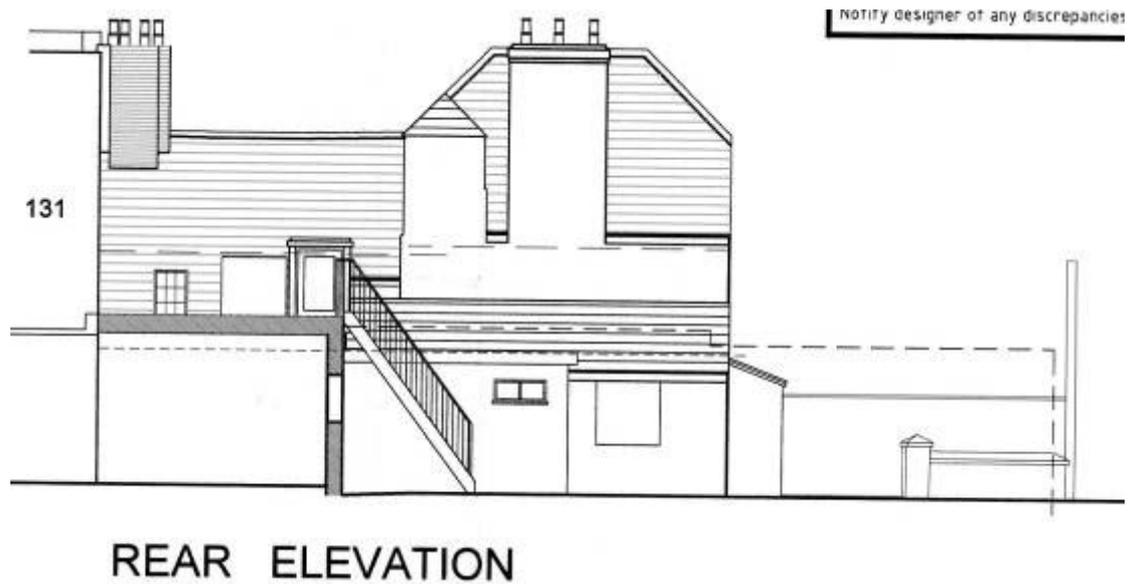
Figure 11. Rear (west) elevation.

The pre-development rear (west) elevation was very mixed and related mostly to 19th and 20th century extensions (figure 11). The main exception was the south end of the lean-to projection that appeared on the early maps. It was brick-built and may have been reformed when it was extended northwards by 1938.

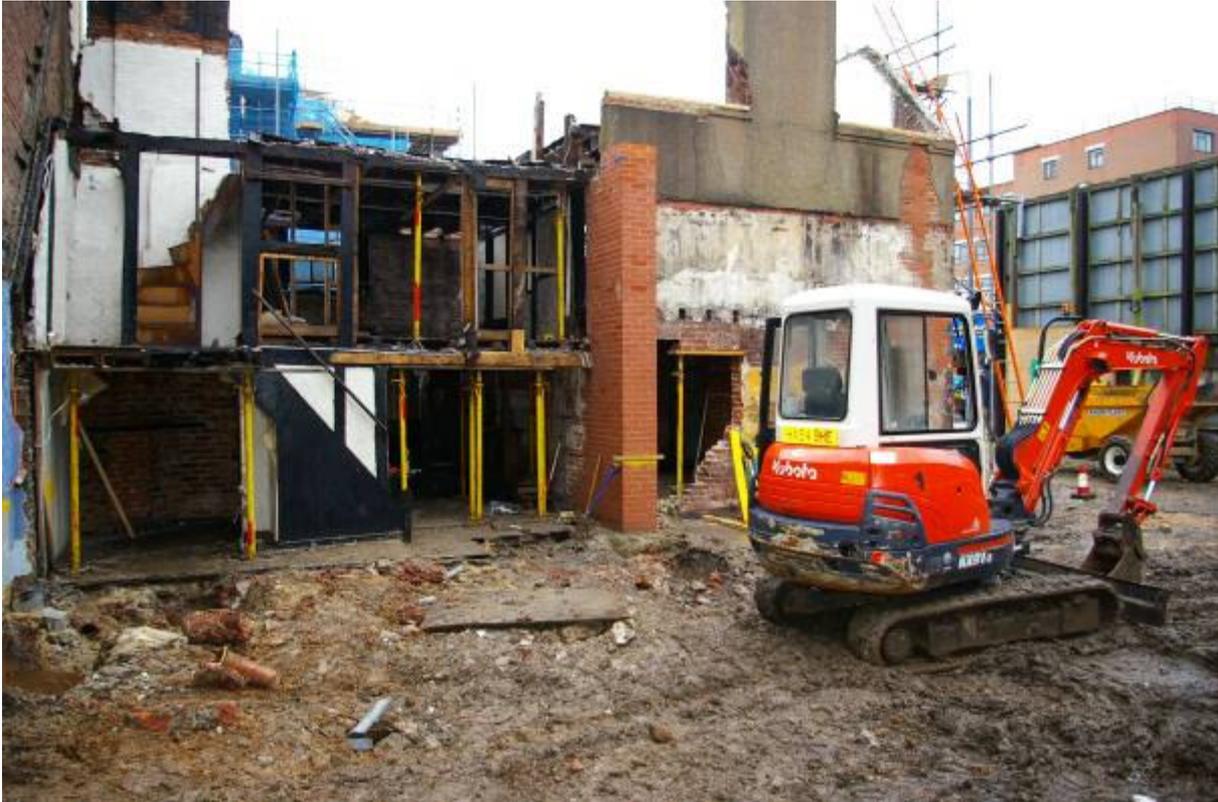
Figure 12. West elevation of the Guardsman after demolition of the extensions, looking east.

The western extensions were demolished as part of the present development, exposing the remnants of the original west wall (figure 12). The north bay (left of brick pillar in figure 12) was timber-framed though only the principal timbers survived at first floor level, and nearly the entire frame had been removed at ground floor level except possibly in the area of the staircase. Nicholson (2007) postulated that the building shown to the north on the enclosure map (figure 3) was built as one with the surviving northern bay, the two sharing the massive chimney stack at the north end of the bay. The watching brief produced little evidence to either support or deny this suggestion. The 20th century building to the north butted against a brick wall at the north end of the north bay. The girding-beam (ie the beam supporting the first floor) was bedded in to this wall, and the wall-plate rested on top of it.

The west wall of the southern bay (to the right of the brick pillar in figure 12) was brick-built. Much of the wall was rendered, but the bricks that were exposed appeared to be slightly larger and more highly fired than those in the north block, indicating a later date. The west wall had a tall, slender, chimney stack.

Part of the framing of the west wall survived (figure 12), though at least one stud and all but one of the mid-rails had been removed. There was an inserted partition wall to its east defining a corridor from the staircase.

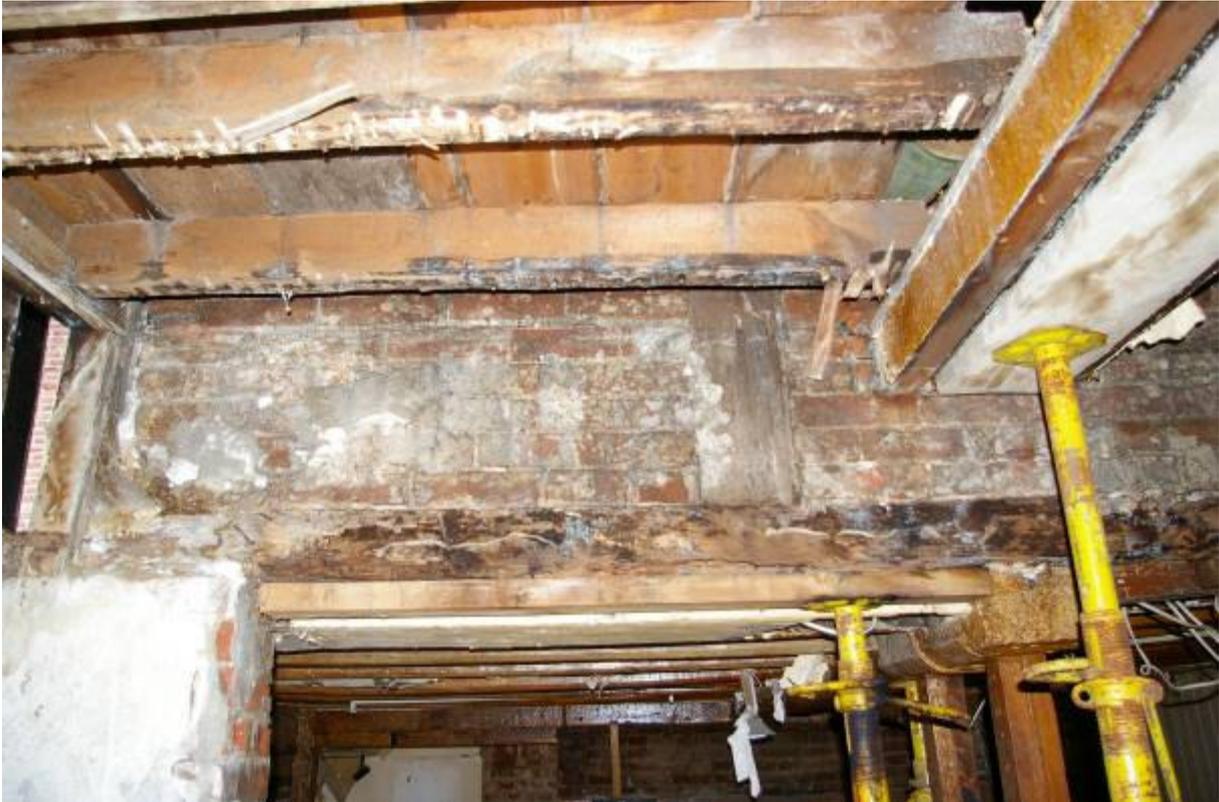
Figure 14. Surviving framing in the partition wall between the north and south bays, looking north from the south bay.

The partition wall between the two blocks had largely been removed, though elements of brick-filled framing survived below the ceiling (figure 14). This was almost certainly part of the frame of the earlier north bay.

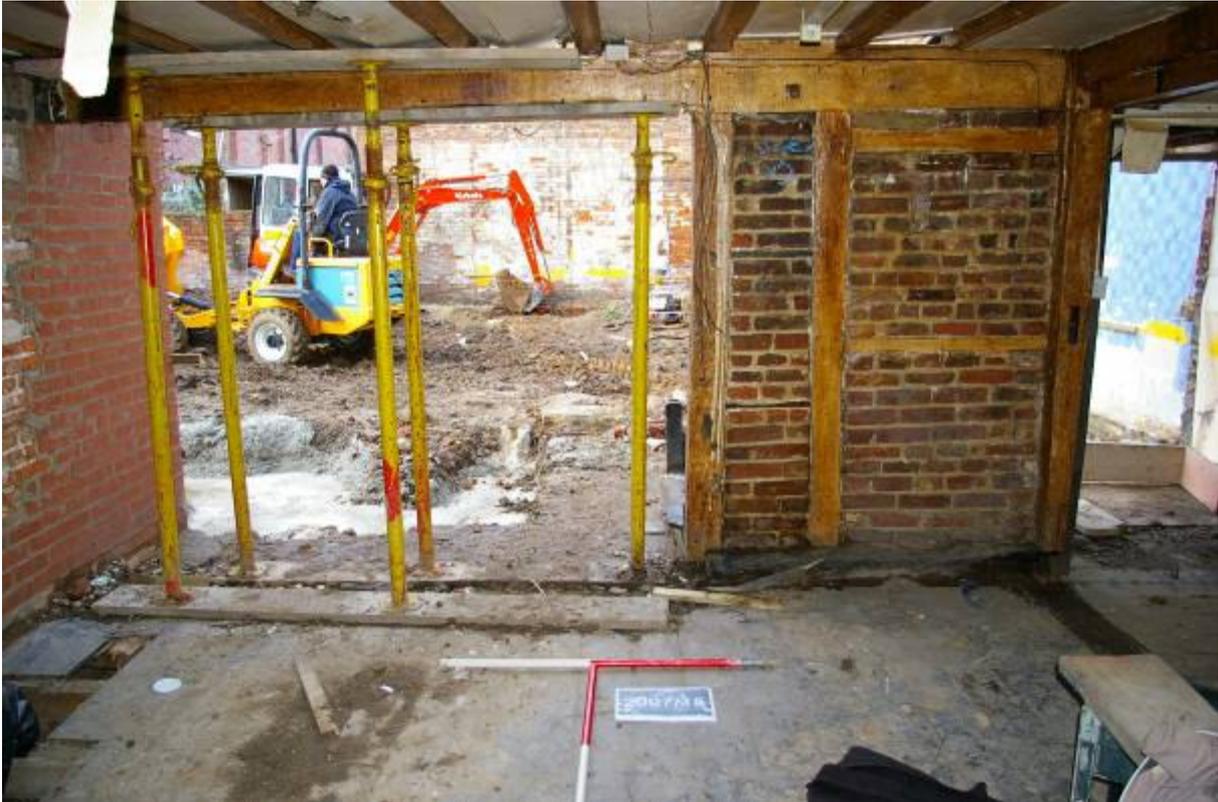
Figure 15. Surviving fragment of framing in the west wall of the north bay ground floor, looking west.

Most of the west wall had been removed. A small area of framing survived near its centre (figure 15). The staircase to the first floor was hung off its west face (figure 12) suggesting that the block to the west was of some antiquity. The north wall was rendered, and the base of the chimney stack butted against it with an open fireplace in its south face. A pre-1984 plan supplied by Nicholson shows a staircase on the west side of the chimney. It is possible that this was the original stair, and that that in the western room was a later addition, though probably pre-1870. The east wall had been rebuilt in brick. No trace of framing was identified. A door and two windows were set in it.

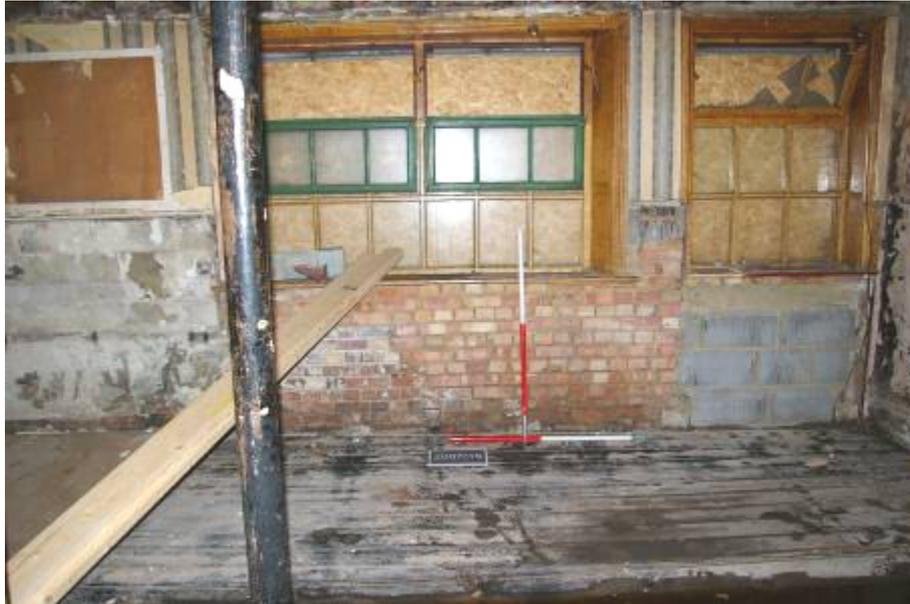
Figure 16. East wall of the south bay, looking east.

The south bay was of brick construction. There was no indication that it ever had any timber framing in its walls. The east wall was clearly altered in two phases (figure 16). The wall under the north window had been rebuilt in modern bricks. It appears that there had previously been a door to its south, but that this had been reformed into a window, the base of the door being blocked with cement blocks. It is probable that the blocking of this door was associated with the opening up of presumed earlier small bars to form a single large bar. Such a process was common in public houses from the 1960s onwards. There was a fireplace in the base of the chimney stack against the west wall.

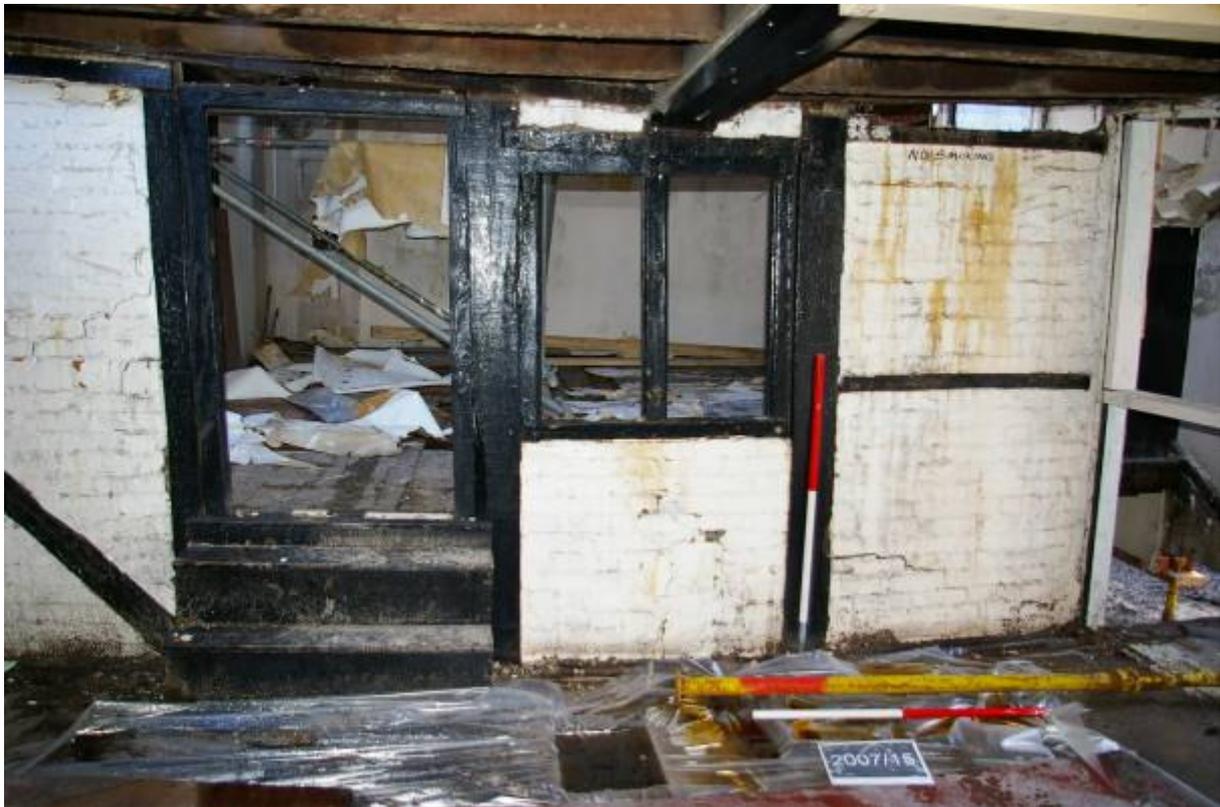
Figure 18. South wall of the north bay, looking south to the south bay.

The partition wall between the bays was timber-framed (figure 18), and presumably formed the south wall of the earlier north bay onto which the later south bay butted. There was a door between the bays towards the east end of the wall. There were two steps up from the north bay in to the south bay. An internal window was present to the west of the door.

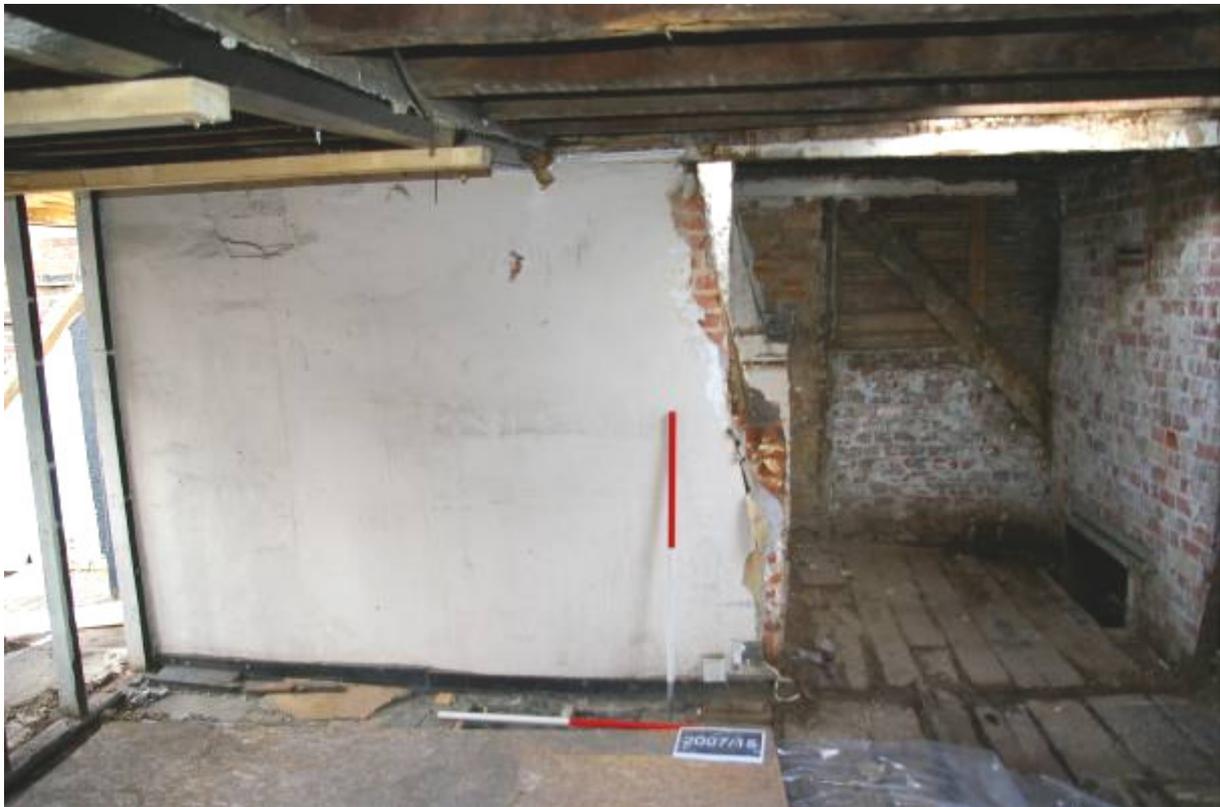
Figure 19. the north end of the north bay, looking north.

The chimney breast in the north wall was blocked off by an inserted partition wall to the east of the corridor as far as the east end of the chimney breast (figure 19). This partition screened off the staircase to the west of the chimney (figure 12). This had been removed at ground floor level by 1984, but survived to second floor level as a wooden winding staircase. It was probably quite modern in its present form. The staircase from the ground floor in the demolished western bay formerly rose from in

front of this staircase at the north end of the corridor. The wall to the east of the chimney was quite complex (figure 19). Its base, below the framing mid-rail, was constructed of rough, hand-made, bricks to a height of about 1m. Above the mid-rail the wall was formed of laths which appeared to be plastered on the north face. A large wall-brace rose from the east wall to the stud by the chimney. The east end of the mid-rail was tenoned into this brace. The south face of the brace was pecked indicating that it had been rendered at some time in the past.

The east wall had been rebuilt in a different type of brick from that used in the north wall (figure 19).

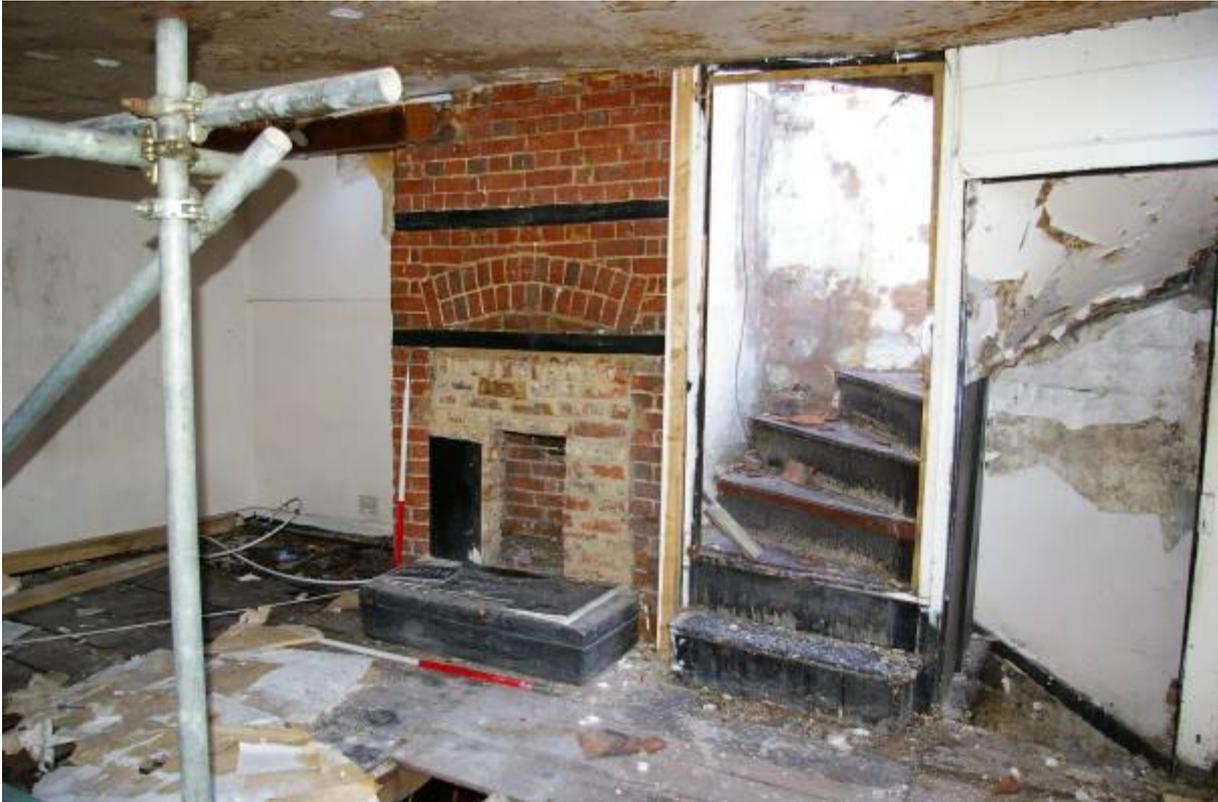
Figure 20. Fireplace and staircase in the west wall of the south bay first floor, looking south-west.

The first floor of the south bay was a plain, brick-built room butting against the north bay. It had a chimney breast in its west wall (figure 20). The actual fireplace had been much reduced in size, perhaps to give a flue for a gas fire. There was a winding staircase to the second floor on the north side of the chimney breast.

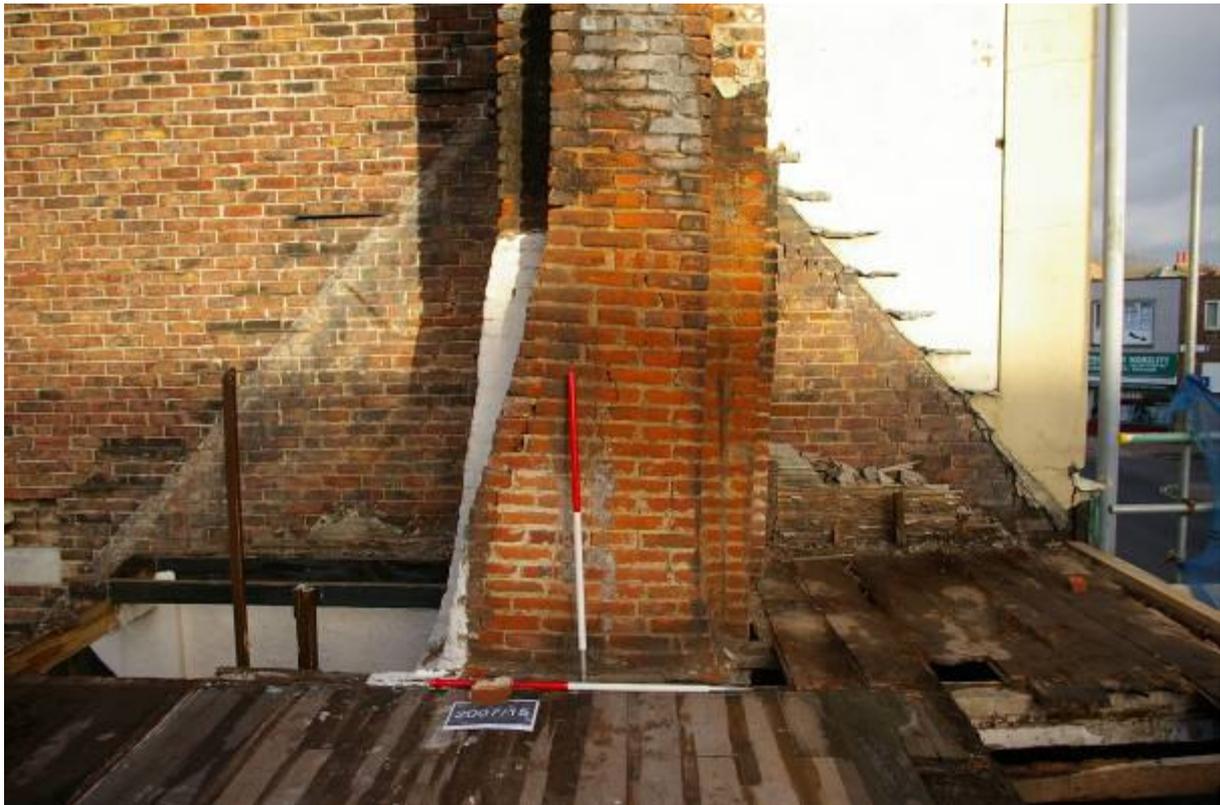
Figure 22. The north end of the second floor after the removal of the roof, looking north.

The chimney at the north end of the north bay rose through the second floor roof space (figure 22). There was no fireplace in it, so it is unlikely that the second floor was originally intended to be a living space. Small remnants of lath and plaster survived above the frame's tie beam on either side of the chimney, especially to the east. The plaster was on the north face. The brick wall of the late-19th century building to the north butted against the plaster. The winding staircase from the first floor rose to the west of the chimney

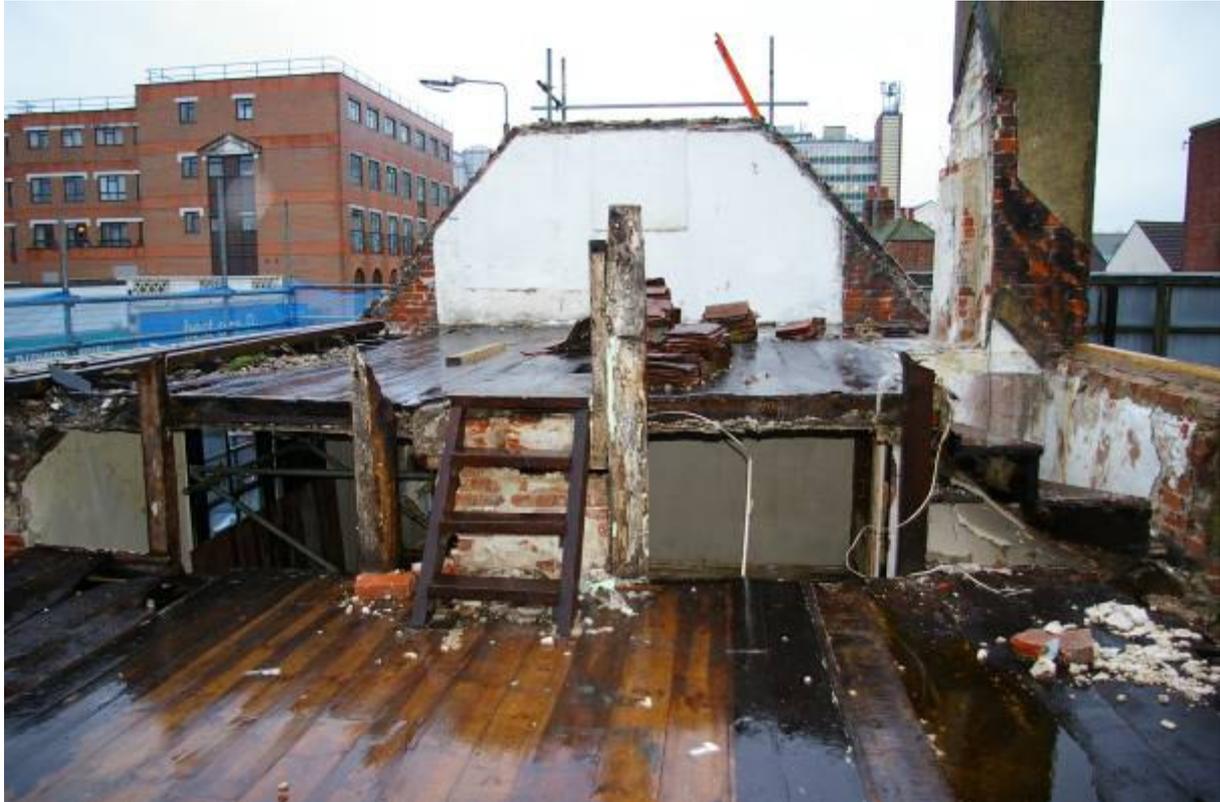
Figure 23. Second floor south bay, looking south.

Some elements of the frame wall at the south end of the north bay survived (figure 23). The tops of most of the posts had been broken off. The difference in height between the floor levels of the two bays was accommodated by a three-tread wooden step.
