Orchard Manor Martin Hussiantree – a brief assessment of the northern cross-wing and its context

Mike Napthan MIFA 3rd July 2012

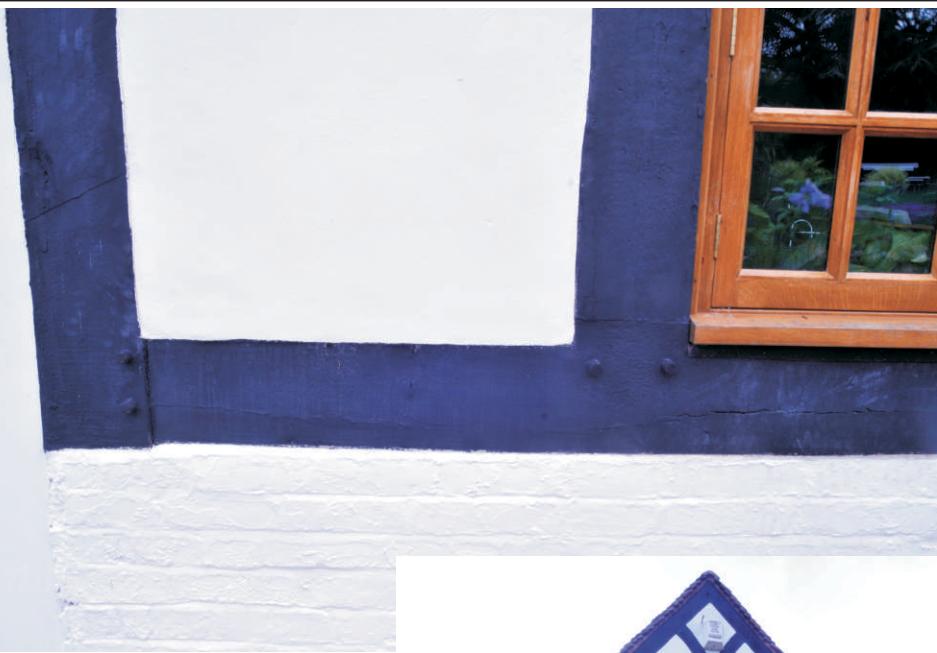
The main element of the present structure that will be affected by the development of the intended garden room is the NW elevation. The framing has been restored in relatively recent times, and some timber replacement has occurred, most notably the sill beam which has been replaced at a level well above ground level, the principal posts having been cut short, probably because of decay. The posts have been cut off at different levels, and the new sill beam is shaped to accommodate the shortfall in length of the intermediate posts. The area beneath the sill beam has been built up in brick. The dating of these repairs is likely to be c1950-1970s. The panel infills are of modern cement render, reportedly on a backing of chickenwire. The panels have been rendered flush with the framing, and some of the apparent regularity of the framing may be seen on close inspection to be actually a paint effect. Several of the joints have been patched with cement, but again the extent of these repairs has been disguised with paint. The collar has a timber patch repair at the foot of the curving queen braces. The box framing has no other visible bracing on this elevation, though there are (rearranged) braces on the opposing gable. All windows on this elevation are of relatively recent date. The windows of the upper floors are mid 20th C softwood side opening casements (with "heritage" style ironmongery) and the ground floor windows are recent good quality oak side opening casements. The framing shows little

sign of distortion, and this is unusual in a building where the lower parts of the posts appear to have been removed due to decay. Many of the pegs are also rather fresh-looking and it may be suspected that the framing has been extensively refurbished.

It is significant that the lower elements of both gable ends have apparently been cut back – presumably because of decay. That the framing has been cut back is clear from the fact that the sill beam on the NW elevation does not continue beneath the corner posts, the intermediate posts terminate at a different level, and also the north western storey post has a scarfed partial repair. It is very unlikely that oak (even poor quality oak) would have deteriorated so fast that such major repairs of substantial posts would be required within a century of construction. As the ground floor elements of the eastern gable end have also been apparently remodelled to form a porch and hallway it must be suspected that there had also been problems with the framing in this area, amounting perhaps to extensive rebuilding. The use of cement render panels has left the building vulnerable to water penetration, as cracking due to differential expansion is inevitable with this type of infill. Whilst flexible sealants have been used on the panel borders these have a very limited service life, and in the interests of long term maintenance and thermal efficiency it would be advisable (in due course when refurbishment is needed) to replace the cement rendered panels with a more flexible and breathable alternative. In the long term the provision of pent-board weatherings may assist in deflecting water from the face of the wall – this is a traditional, and low impact method of preventing water ingress where there is insufficient roof overhang (as is clearly the case on the NW gable end). The lack of any roof projection at the gable ends is almost certainly the result of ill-informed replacement of the roof structure of the north wing in the mid 20th C (internal inspection of the roof of this wing shows it to have machine sawn softwood rafters) – it is general in timber framed buildings to have a roof projection over the eaves and gable ends of 8"-12" minimum to protect the framing and infill panels from the wet. The addition of barge boards adds to the protection. The present roof looks rather modern and bare as it lacks these important functional and traditional details.

Detail of frame repairs to NW elevation
of cross-wing

The intended scheme will require the removal of the relatively recent (mid-late 20th C) sill beam from the NW gable end, the removal of the modern brick plinth wall and modern fenestration and infill panels. None of these are of historical or architectural significance as they do not even appear to replicate the historic arrangement. The only impact of the proposed scheme on historic fabric would be the further truncation of the already truncated intermediate posts. It may be possible to retain the central intermediate post and scarf on additional timber to restore the post to its original length. This would restore some structural integrity to the truncated original frame, whilst retaining the post as a feature within the intended island unit.
