# STAUNTON HAROLD CHURCH

ASHBY-DE-LA-ZOUCH, LEICESTERSHIRE

## Fabric Survey of the North Aisle Roof

Document No: TJC2014.60

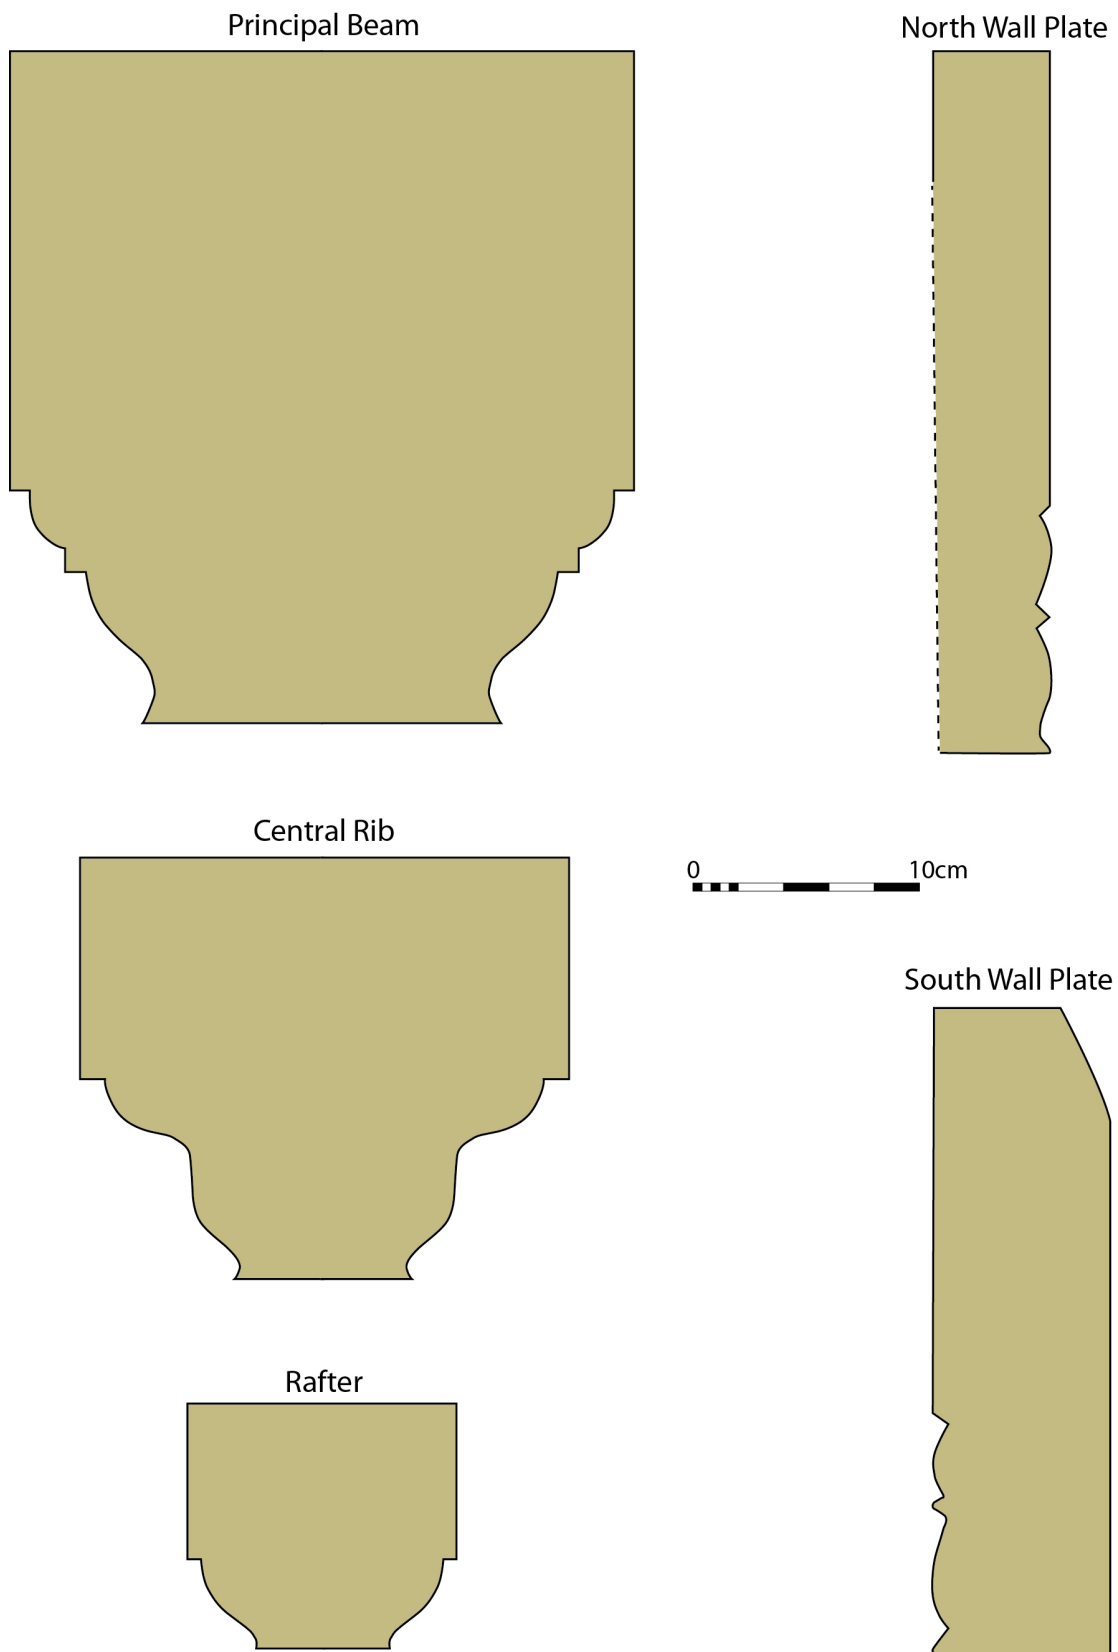
**Figure 5:** Moulding profiles for roof beams.

Centrally positioned between the principal beams are central ribs, which are pegged and tenoned together (**Appendix I.13**). These timbers are c.1.63m in length with a scantling of 0.22m x 0.19m. The undersides of these beams are carved on the edges (**Appendix I.14**) with a double cyma reversa moulding (**Figure 5**).

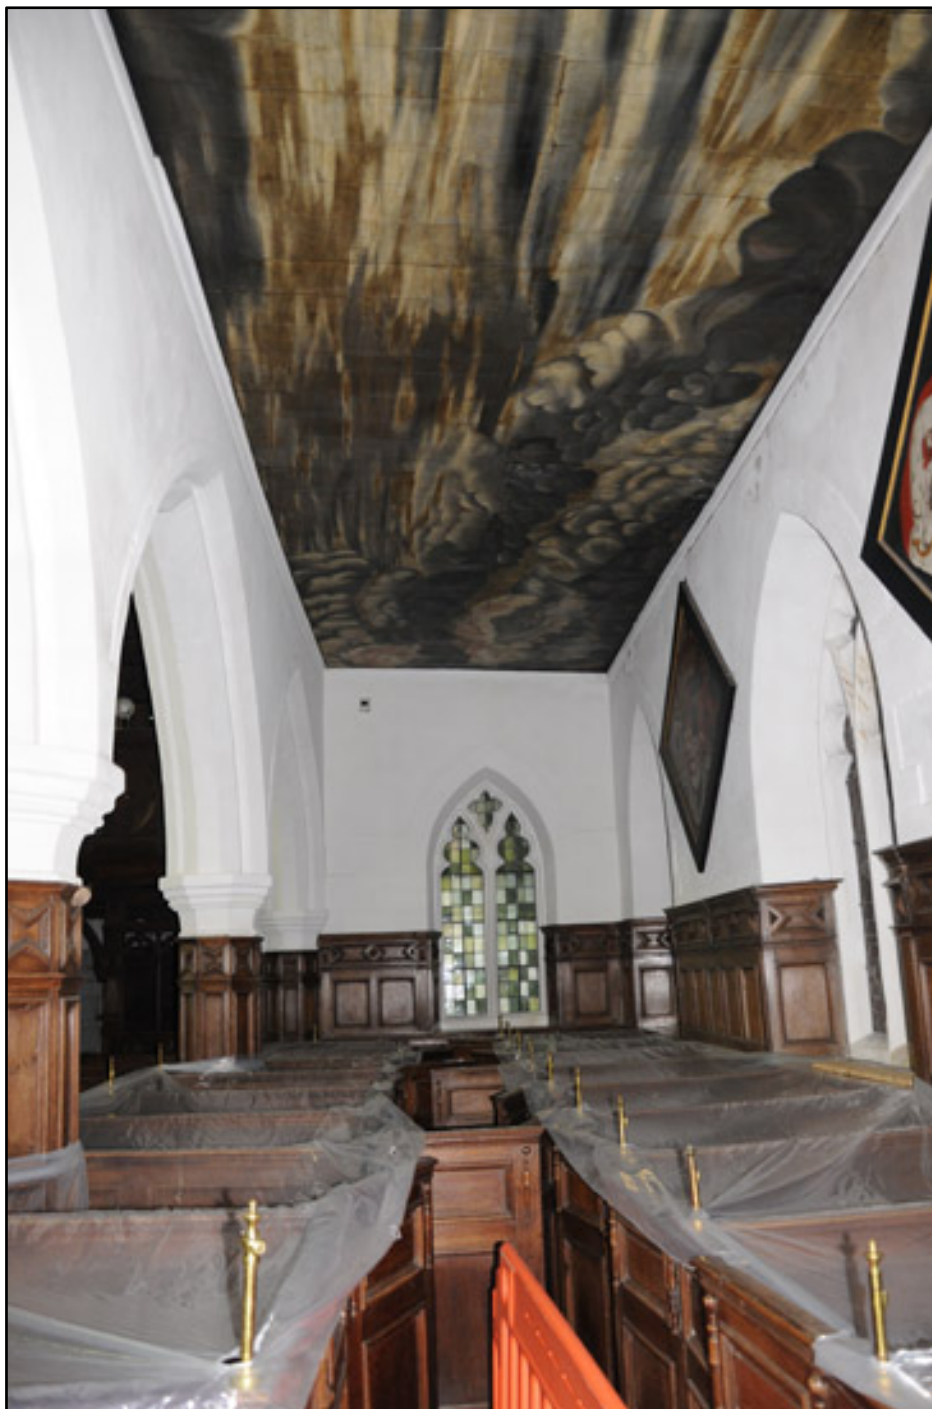
The north aisle of the church was built as part of the primary phase of construction c. 1653-55. It is comprised of a rectangular space (**Appendix 1.1**), with a three arched arcade to the south opening on to the nave (**Figure 2**). The ceiling (**Appendix 1.2**) comprises tongue and groove boards that are nailed in position at the center. Two boards span the width of the aisle (**Appendix 1.4**), with approximate measurements of 14-20cm (width) x 1.2-1.3m (length) and 0.5-0.1cm in thickness. The boards are decorated with a cloud design in oil paint, which was applied from below once the boards had been nailed in place. Around the edge of the painted ceiling is a board with a simple moulding forming a crude cornice (**Appendix 1.3**). Its purpose may have been to support the outer edge of the boards and conceal any gaps along the edge.

**Appendix I.I:** View looking west along north aisle; note painted ceiling.

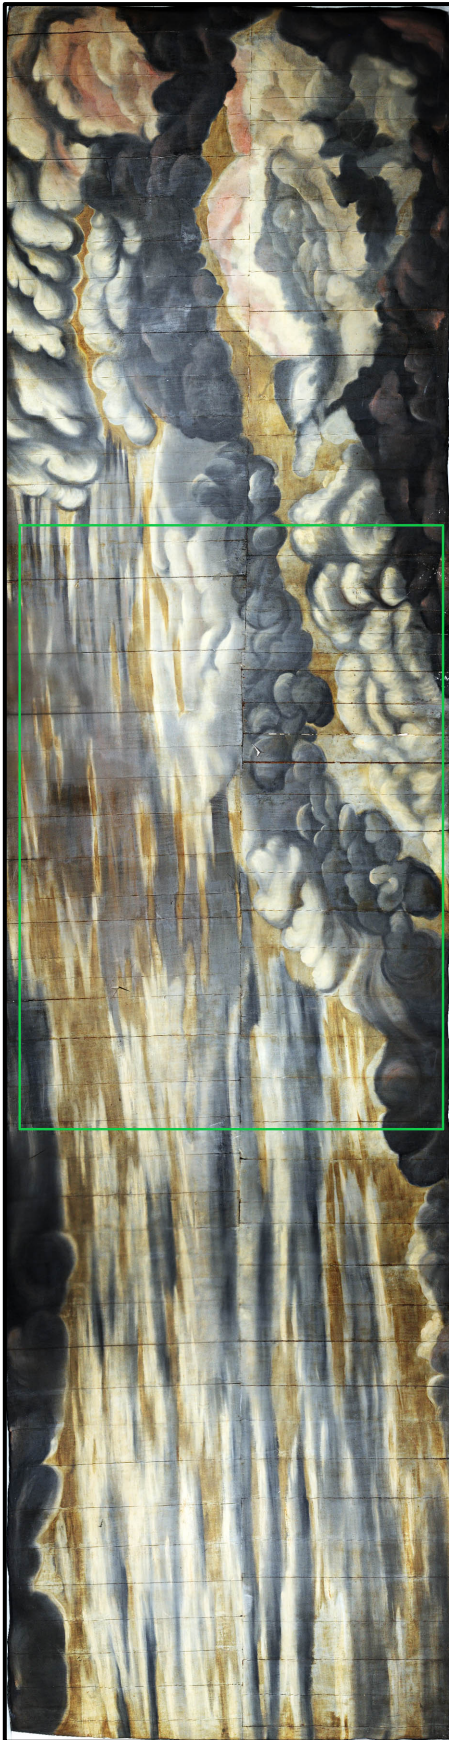
**Appendix 1.2:** Photographic montage of the north aisle painted ceiling from below; note the area of the roof surveyed above is outlined in green.

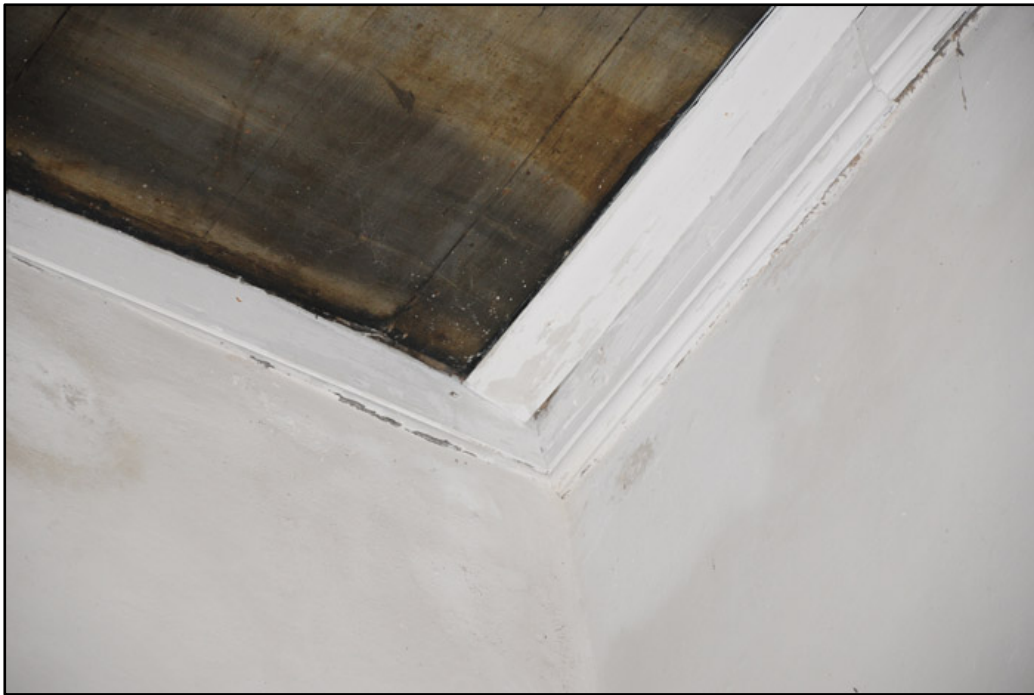
**Appendix I.3:** Detail of northeast corner of ceiling along north aisle; note timbers used to form a cornice below boards.

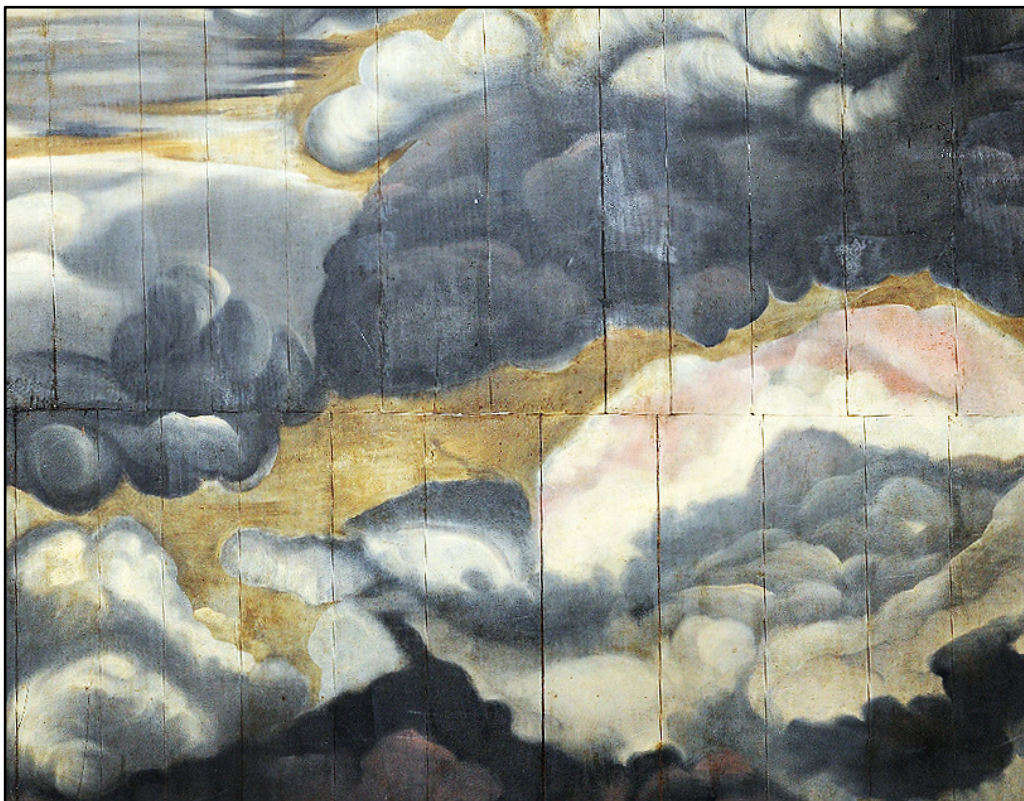
**Appendix I.4:** Detail of painted boards on ceiling of north aisle; note irregular size of boards.

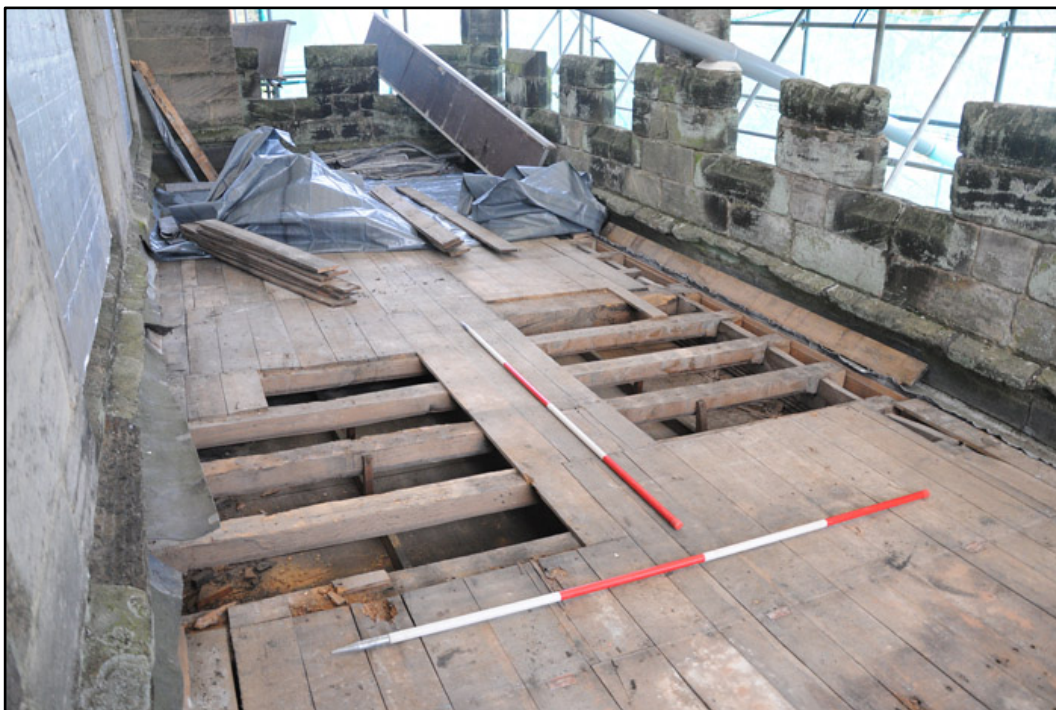
The roof was covered with thick sheets of lead (4-5cm) that were fixed to timber boards (**Appendices 1.5, 1.6**). The lead was rolled in position, although unusually, the joints were not wrapped around an internal wooden pole.

Appendix I.5: General view looking west along north aisle roof (2m scale).

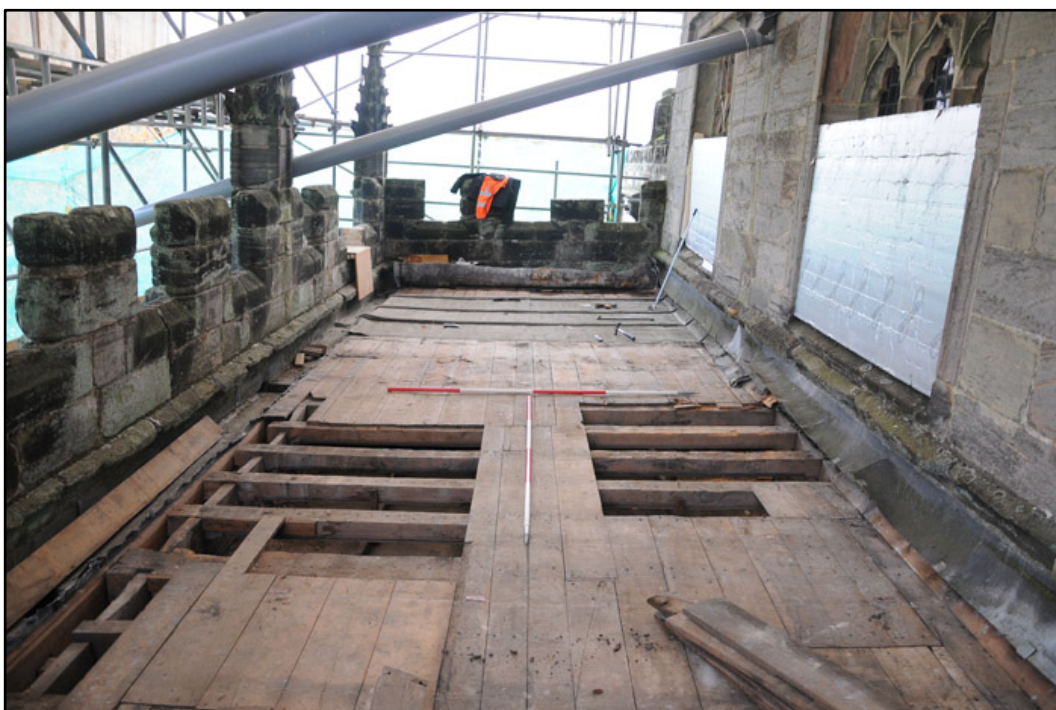
Appendix I.6: General view looking east along north aisle roof (2m scale).

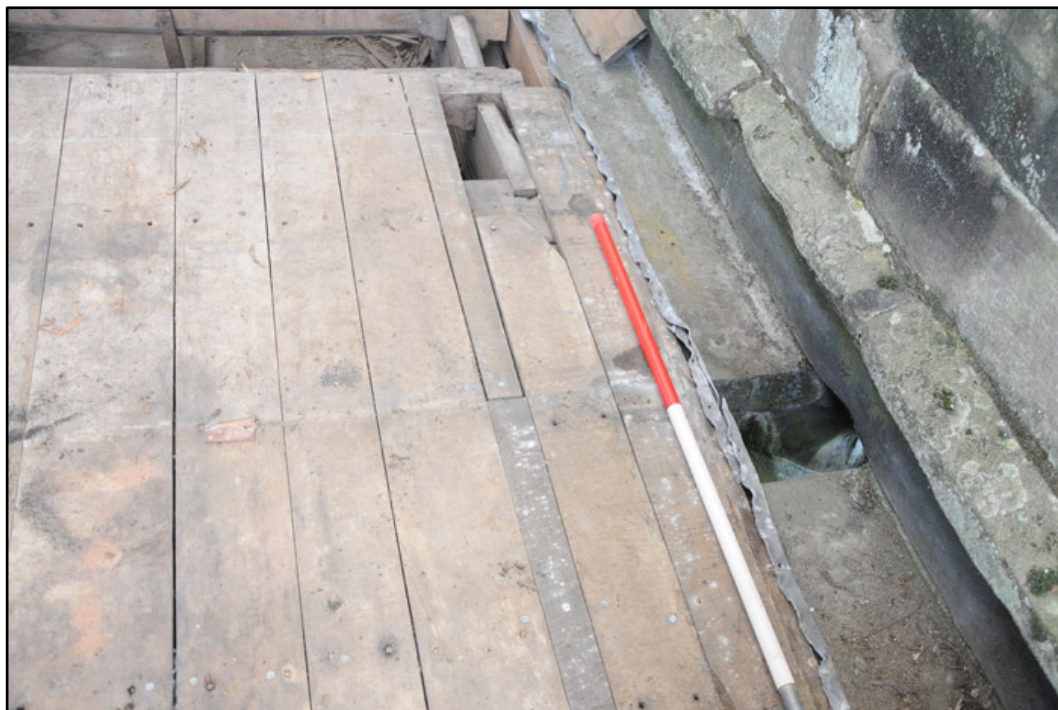
The lead contained no features or incised marks or historic significance, and is interpreted as dating to a comprehensive programme of repairs undertaken with a grant from the Pilgrim Trust in 1953. The boards appeared to be made from oak (**Appendix I.7**) and were c.0.2m wide and nailed in position with hand made nails (**Appendix I.20**) and orientated north-south.

**Appendix I.7:** General view of upper face of roofing boards after lead sheeting removed (1m scale).

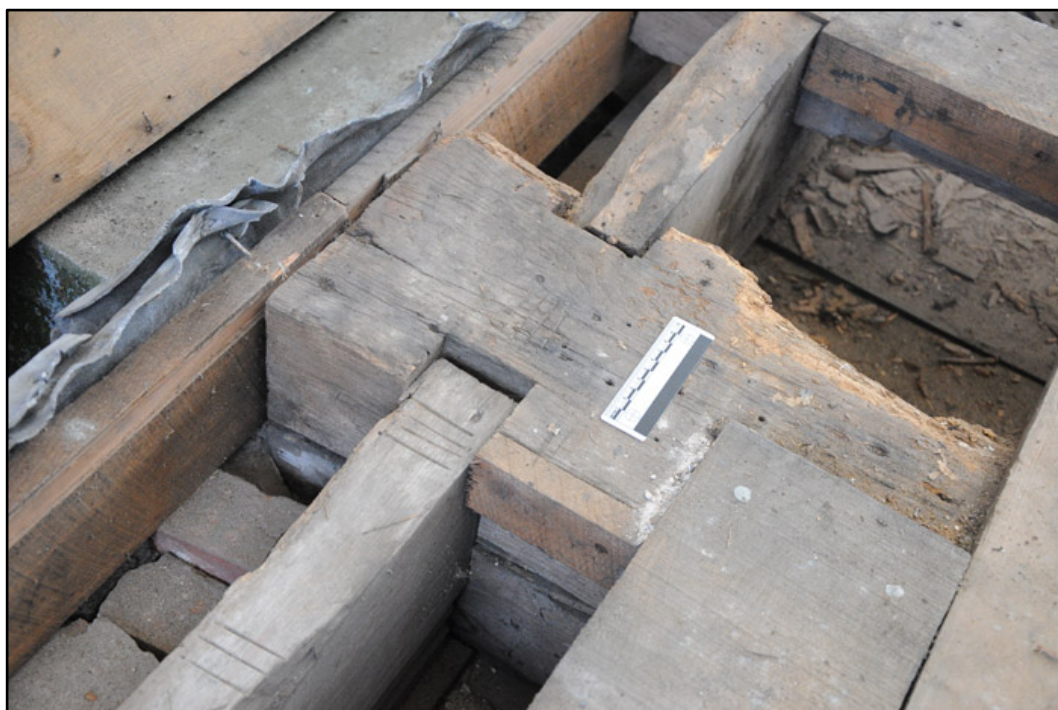
**Appendix I.8:** North wall-plates that are tenoned on either side of principal rafter 4; note assembly marks (10cm scale).

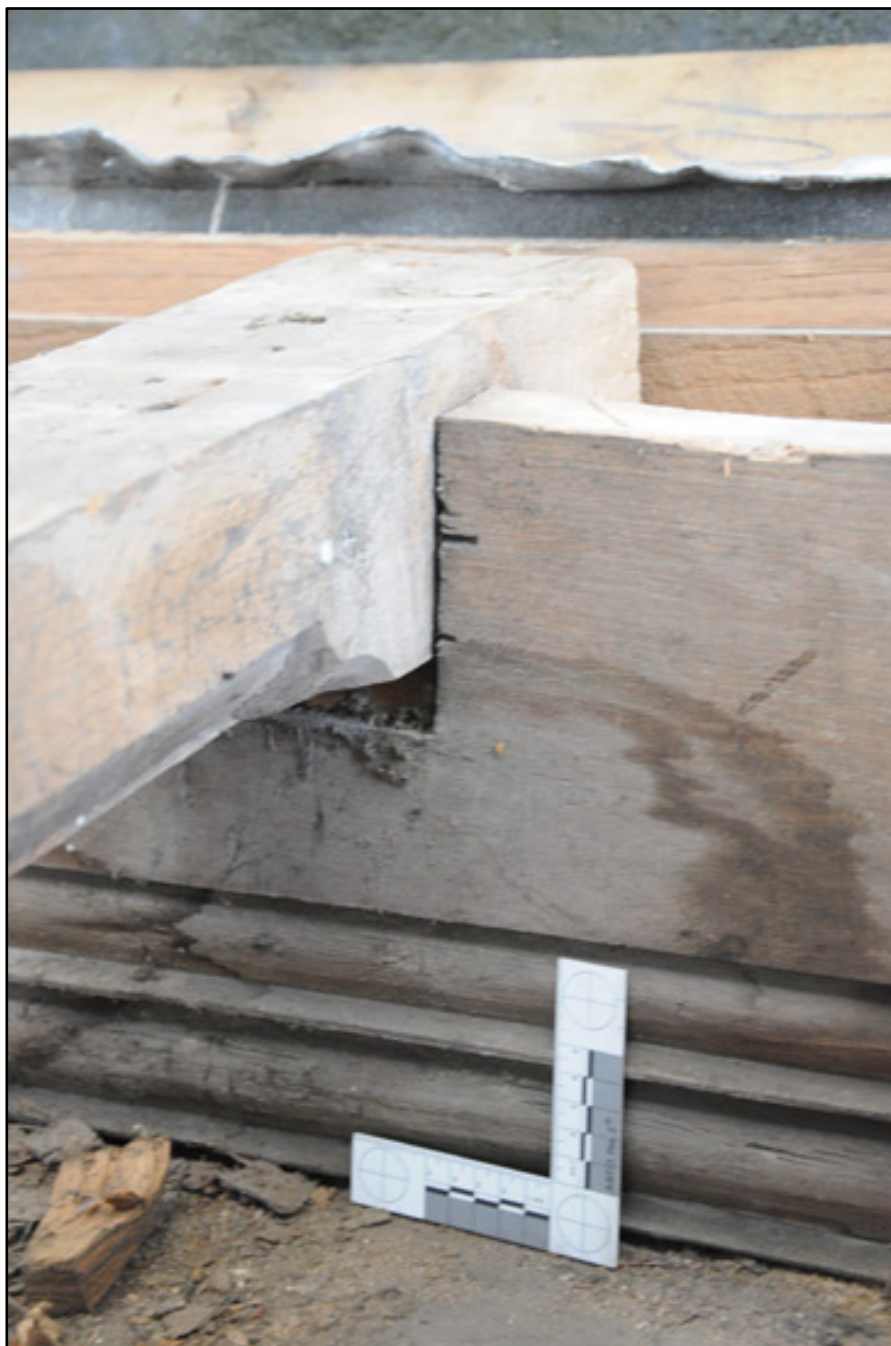
Secured with tenons on either side of the principal beams are timber wall plates (**Figure 4**). Those along the north wall (**Appendix I.10**) measure 0.08m x 0.28m and are carved on the inner face (**Appendix I.9**) with torus and triangular reeded mouldings. On the upper face at either end of the sections of wall plate are incised Roman Numerals (**Appendix I.8**), which indicate the numerical sequence runs from north to south. The wall plate along the south clerestory wall (**Appendices I.16-18**) measures 0.05m x 0.31m and is partially recessed into the masonry (**Appendix I.16**). The exposed face of the clerestory wall plate still retains a horizontal red pencil marking out line (**Appendices I.16, I.17**) that denotes the base of the tenons into which the rafters are housed. The inner face of the clerestory wall plate mirrors the carved design on the north wall plate (**Figure 5**).

**Appendix I.9:** Detail of moulding on inner face of north wall-plate (10cm scale).

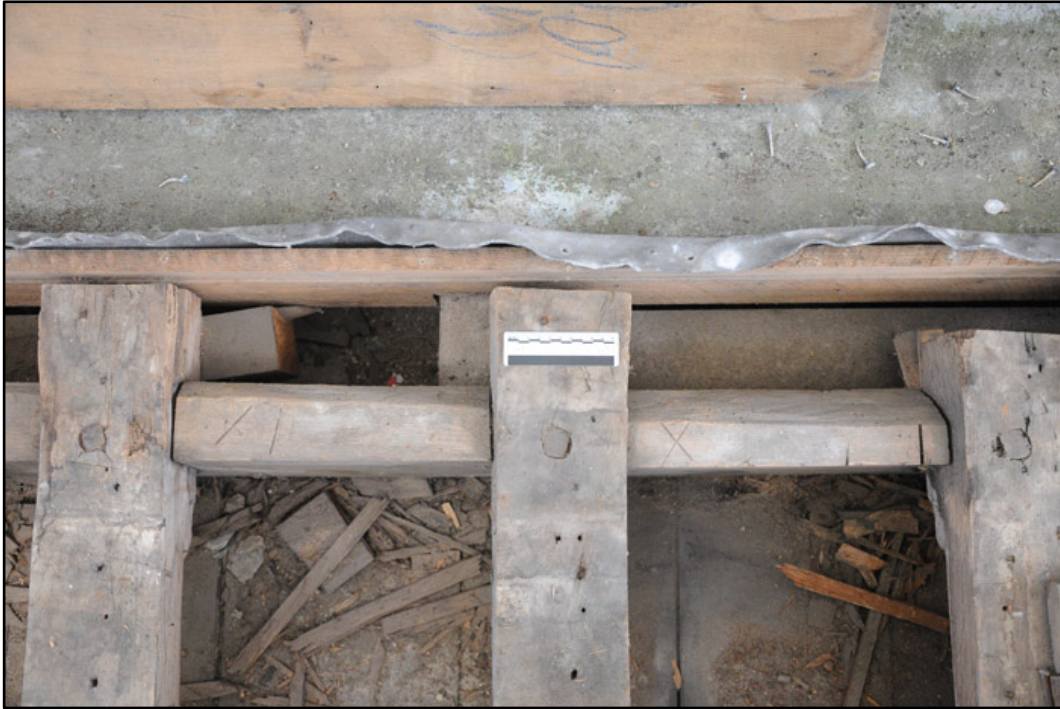
**Appendix I.10:** Detail of assembly marks on upper face of rafters secured into north wall-plate (10cm scale).

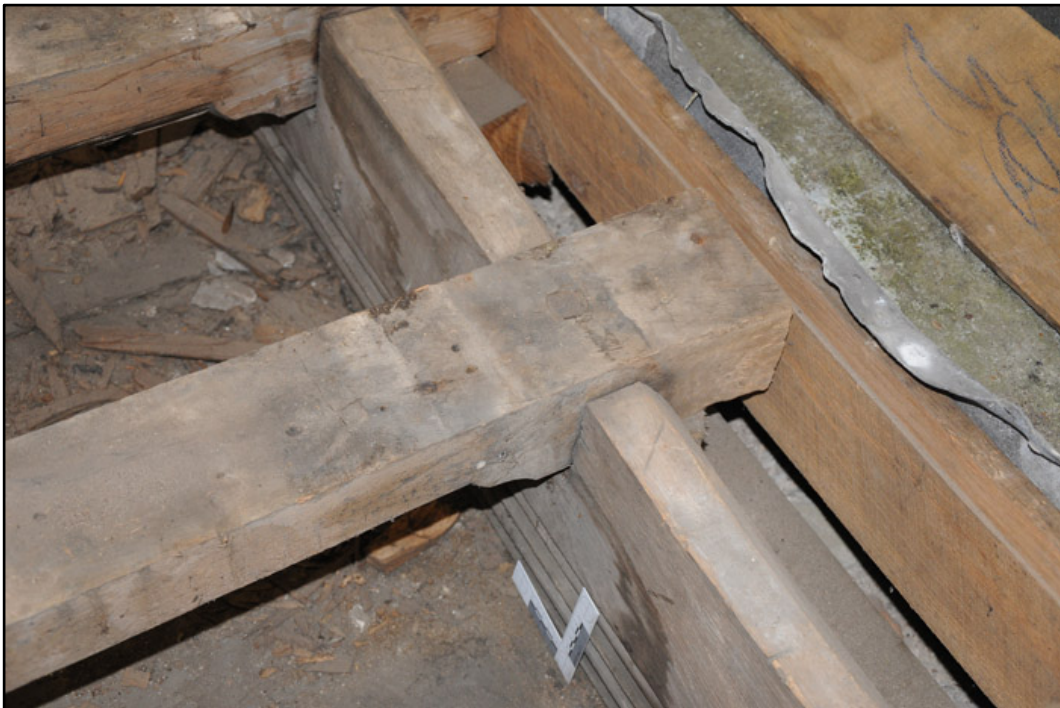
**Appendix I.11:** Detail of rafter secured with a peg in north wall-plate; note assembly mark 'X' (10cm scale).

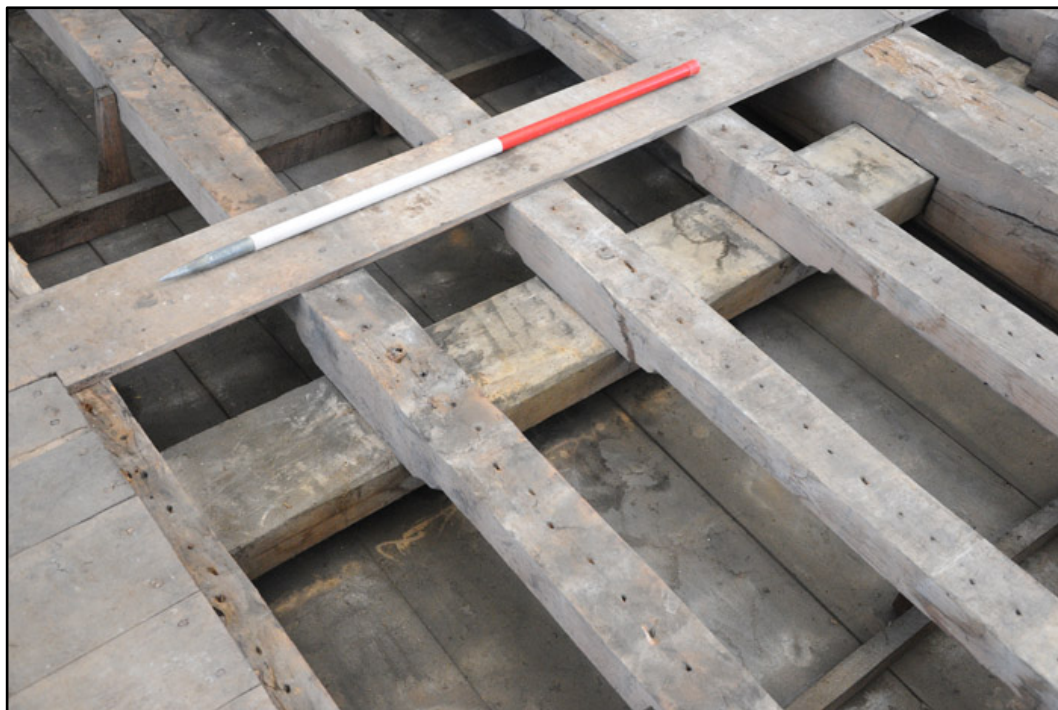
Over-sailing the central ribs (**Appendix I.12**) are transverse rafters that span the full width of the aisle below (**Figure 4**). These timbers measure c.3.75m with a scantling of 0.12m x 0.11m. Each rafter is pegged from above into the central rib (**Appendix I.12**). At the south end the rafter is tenoned through the wall plate and into the masonry of the clerestory wall (**Appendix I.16**). At the north end the timbers are housed in similar through tenons cut in the north wall plate (**Appendix I.9**), but secured from above with wooden pegs (**Appendix I.10**). They are carved on the underside with cyma reversa mouldings (**Figure 5**), which terminate in a lamb's tongue stop detail on either side of the central rib and against the wall plates (**Appendix I.17**). On the upper face of each rafter at the joint with the north wall plate are incised Roman numerals. These form a continuous sequence of assembly marks comprising of crude incisions (**Appendix I.10**). It is assumed they continue along the length of the roof, although only marks **VIII** to **XVI** were exposed during the survey (see **Figure 3**). They run from north to south, matching the other assembly marks along the north edge of the roof.

**Appendix I.12:** Detail of upper face of rafters that over sail the central rib; note each is secured with a peg (1m scale).

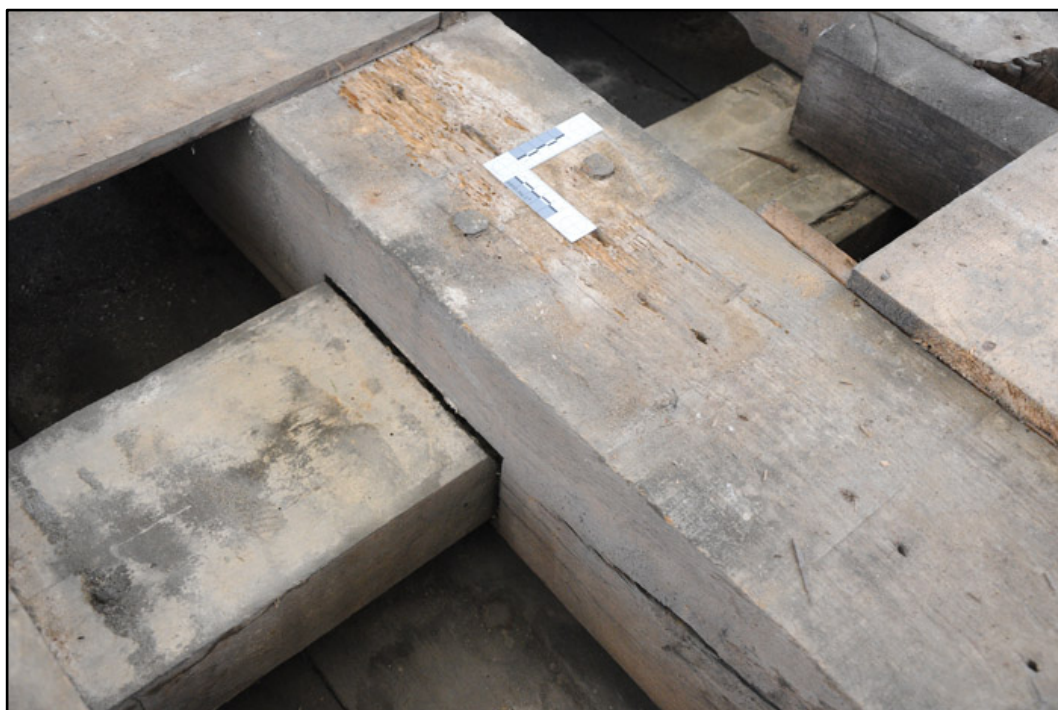
The roof structure comprises six principal oak beams that span between the clerestory wall and external wall of the north aisle. They measure c.3.8m in length (**Appendix I.13**), with a scantling of 0.27m x 0.3m (**Figure 5**) and are separated from one another at 1.9m centers. The underside of these beams is carved with chamfered and cyma reversa and quarter round moulding details that still retain crisp edges (**Appendix I.15**), and have never been painted or treated. The ends of these beams were not visible as they were built within the masonry walling of the church, however, on the upper face along the north wall consecutive numerical assembly marks were recorded (**Appendix I.8**). These were in the form of deeply incised Roman numerals. Only the two central beams were exposed during the survey, being numbered III and IIII. From these marks it can be inferred that there are a total of six principal beams along the length of the roof (see **Figure 3**), with I located at the north and IV to the south.

**Appendix I.13:** Detail of upper face of principal rafter 4; note central ribs are tenoned and securing with pegs (10cm scale).

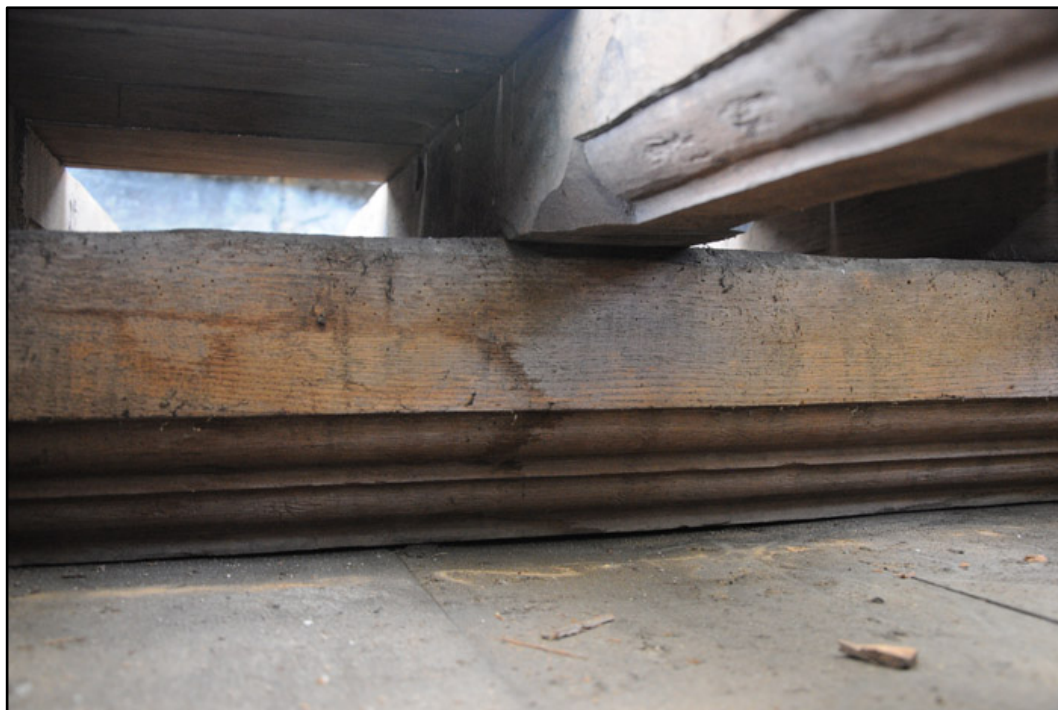
**Appendix I.14:** Detail of central moulded rib with over sailing rafters.

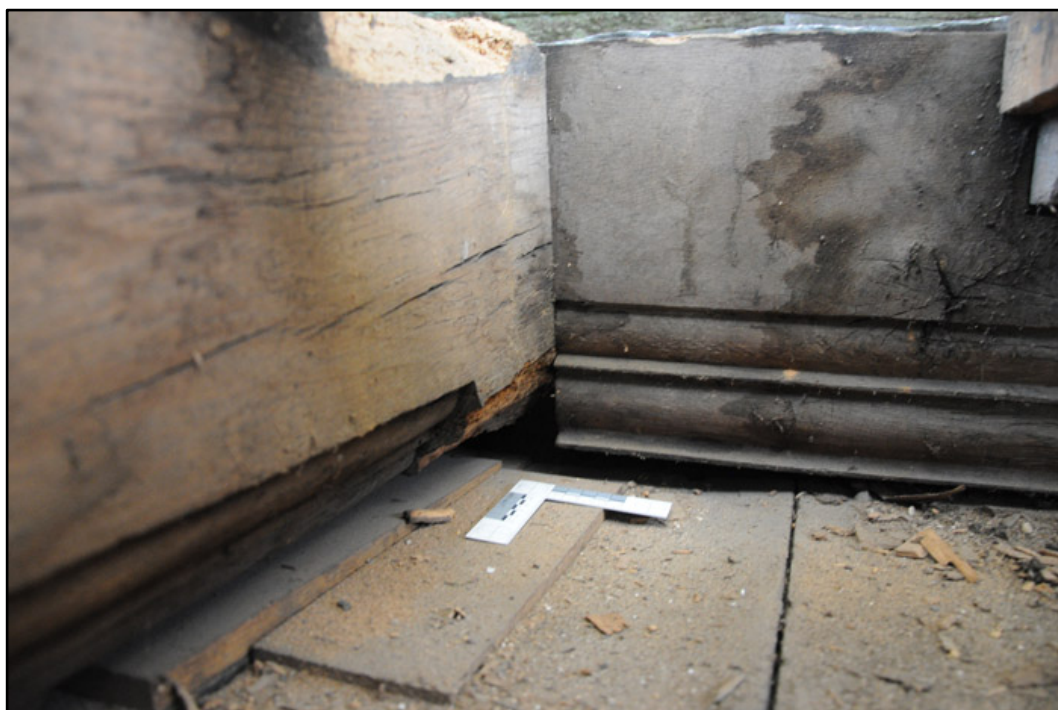
**Appendix I.15:** Detail of joint between principal beam 4 and north wall-plate (10cm scale).

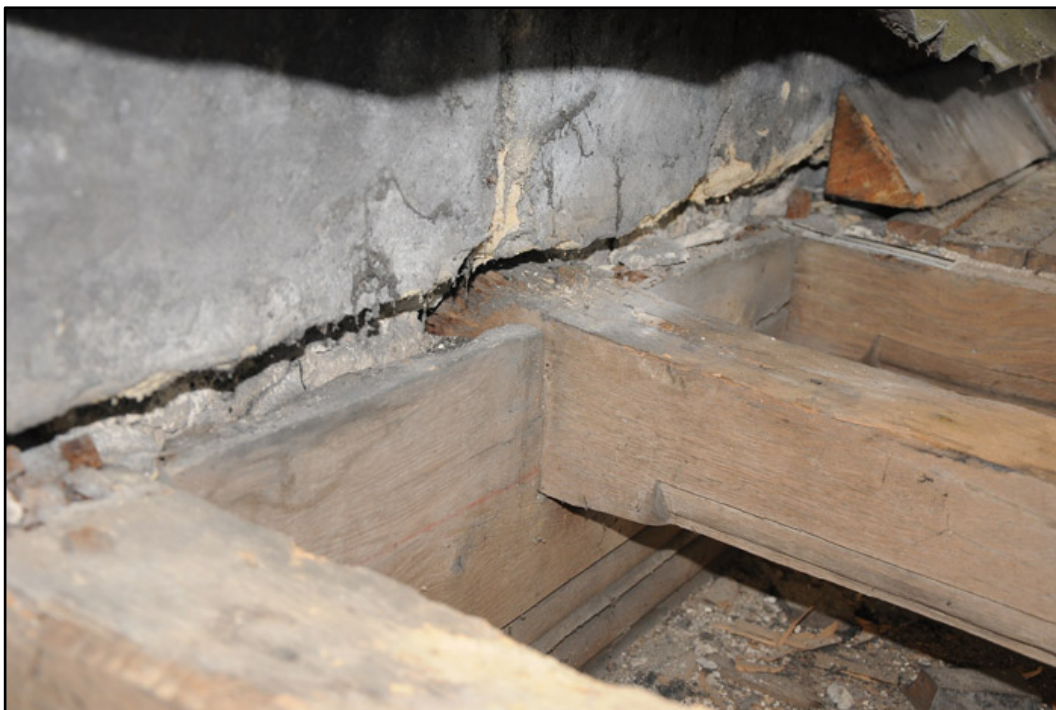
**Appendix I.16:** Detail of clerestory wall-plate; note how the ends of the rafters are recessed into the masonry.

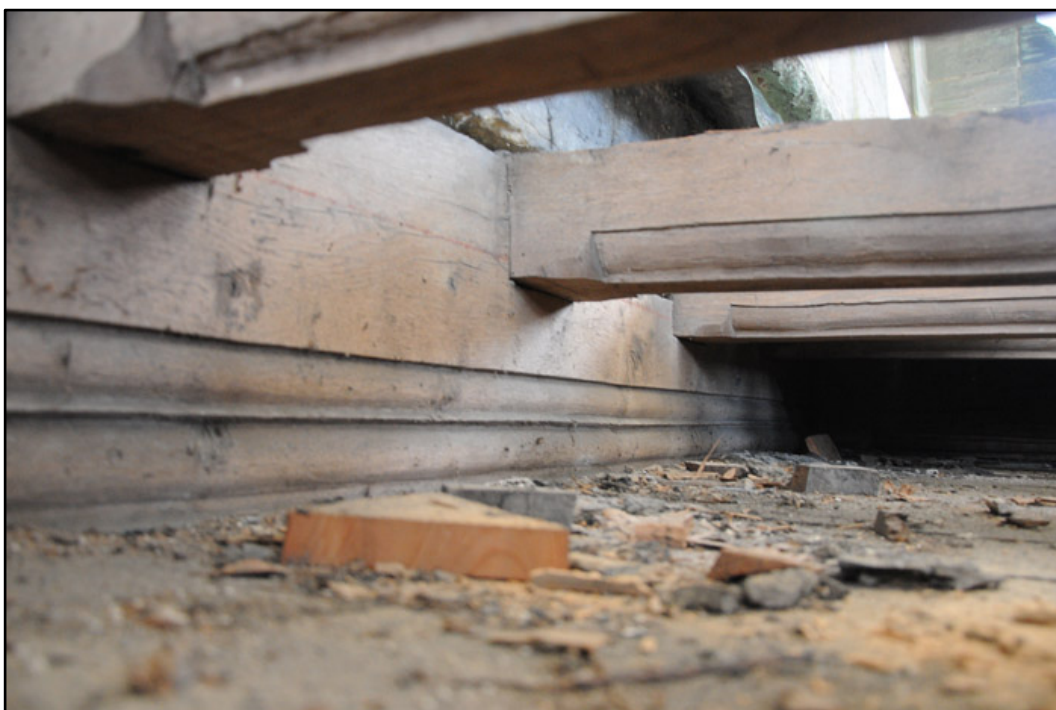
**Appendix I.17:** Detail of clerestory wall-plate; note crisp and unpainted mouldings on underside of the rafters.

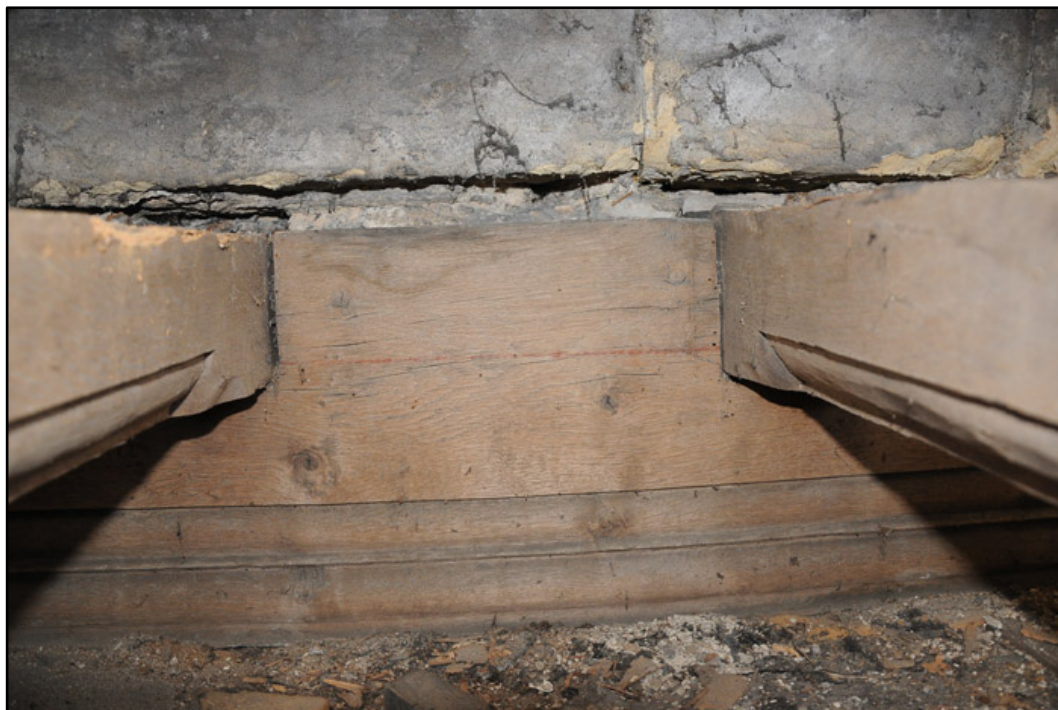
**Appendix I.18:** Detail of clerestory wall-plate above North Aisle; note original setting-out red pencil line.

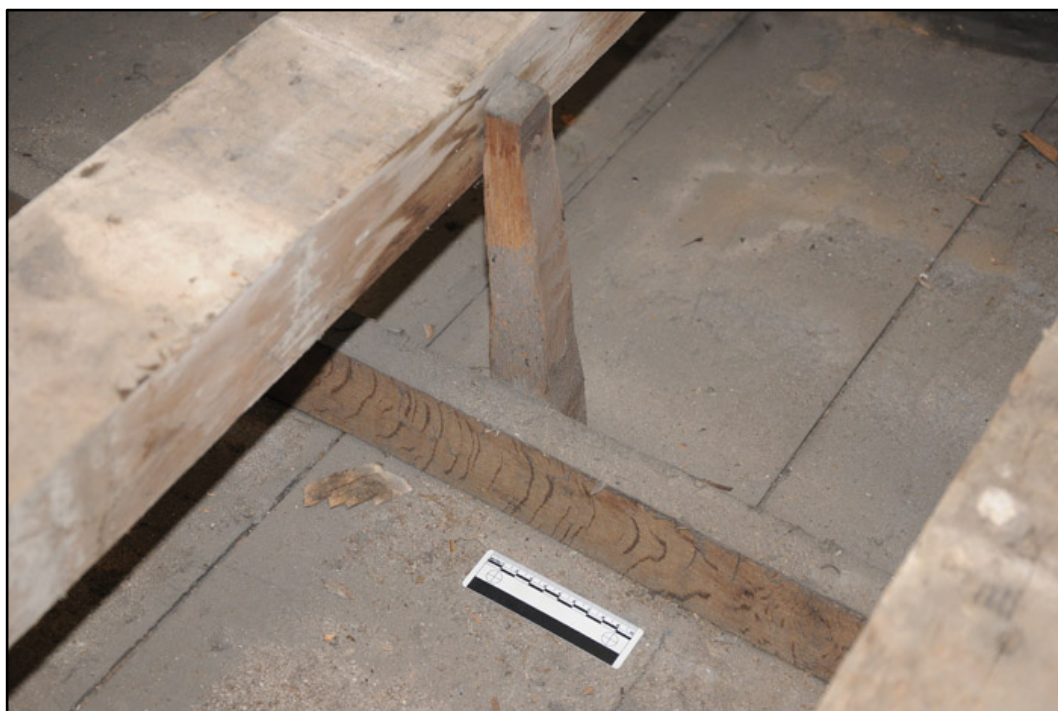
Attached to the sides of the rafters are roughly cut wooden struts (**Appendix I.19**) that support a framework of batons, on to which the ceiling boards are nailed from below (see **Figure 4**).

**Appendix I.19:** Detail of secondary struts used to hang boards for painted ceiling below (10cm scale).

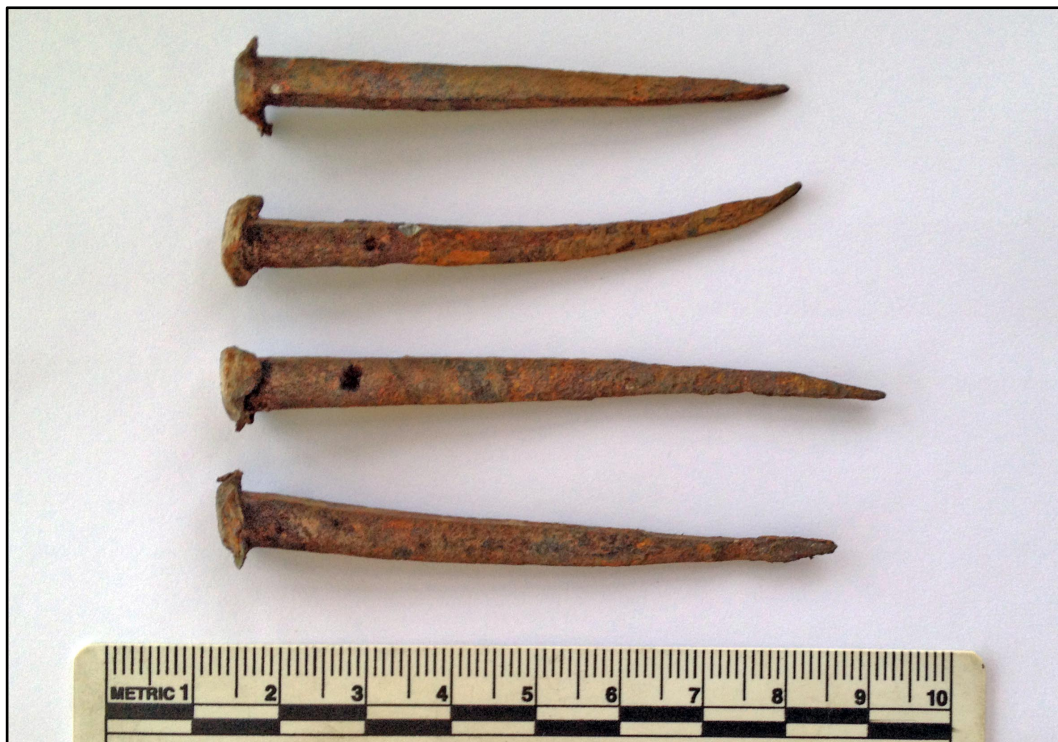
Appendix I.20: Detail of hand-made iron nails (10cm scale).
