THE HA HA

PRIEST WOOD AND VICAR WOOD KEDLESTON HALL, DERBYSHIRE

Archaeological Evaluation and Walkover Survey on behalf of the National Trust

Document No: TJC2016.25
OASIS No: thejessop-255360

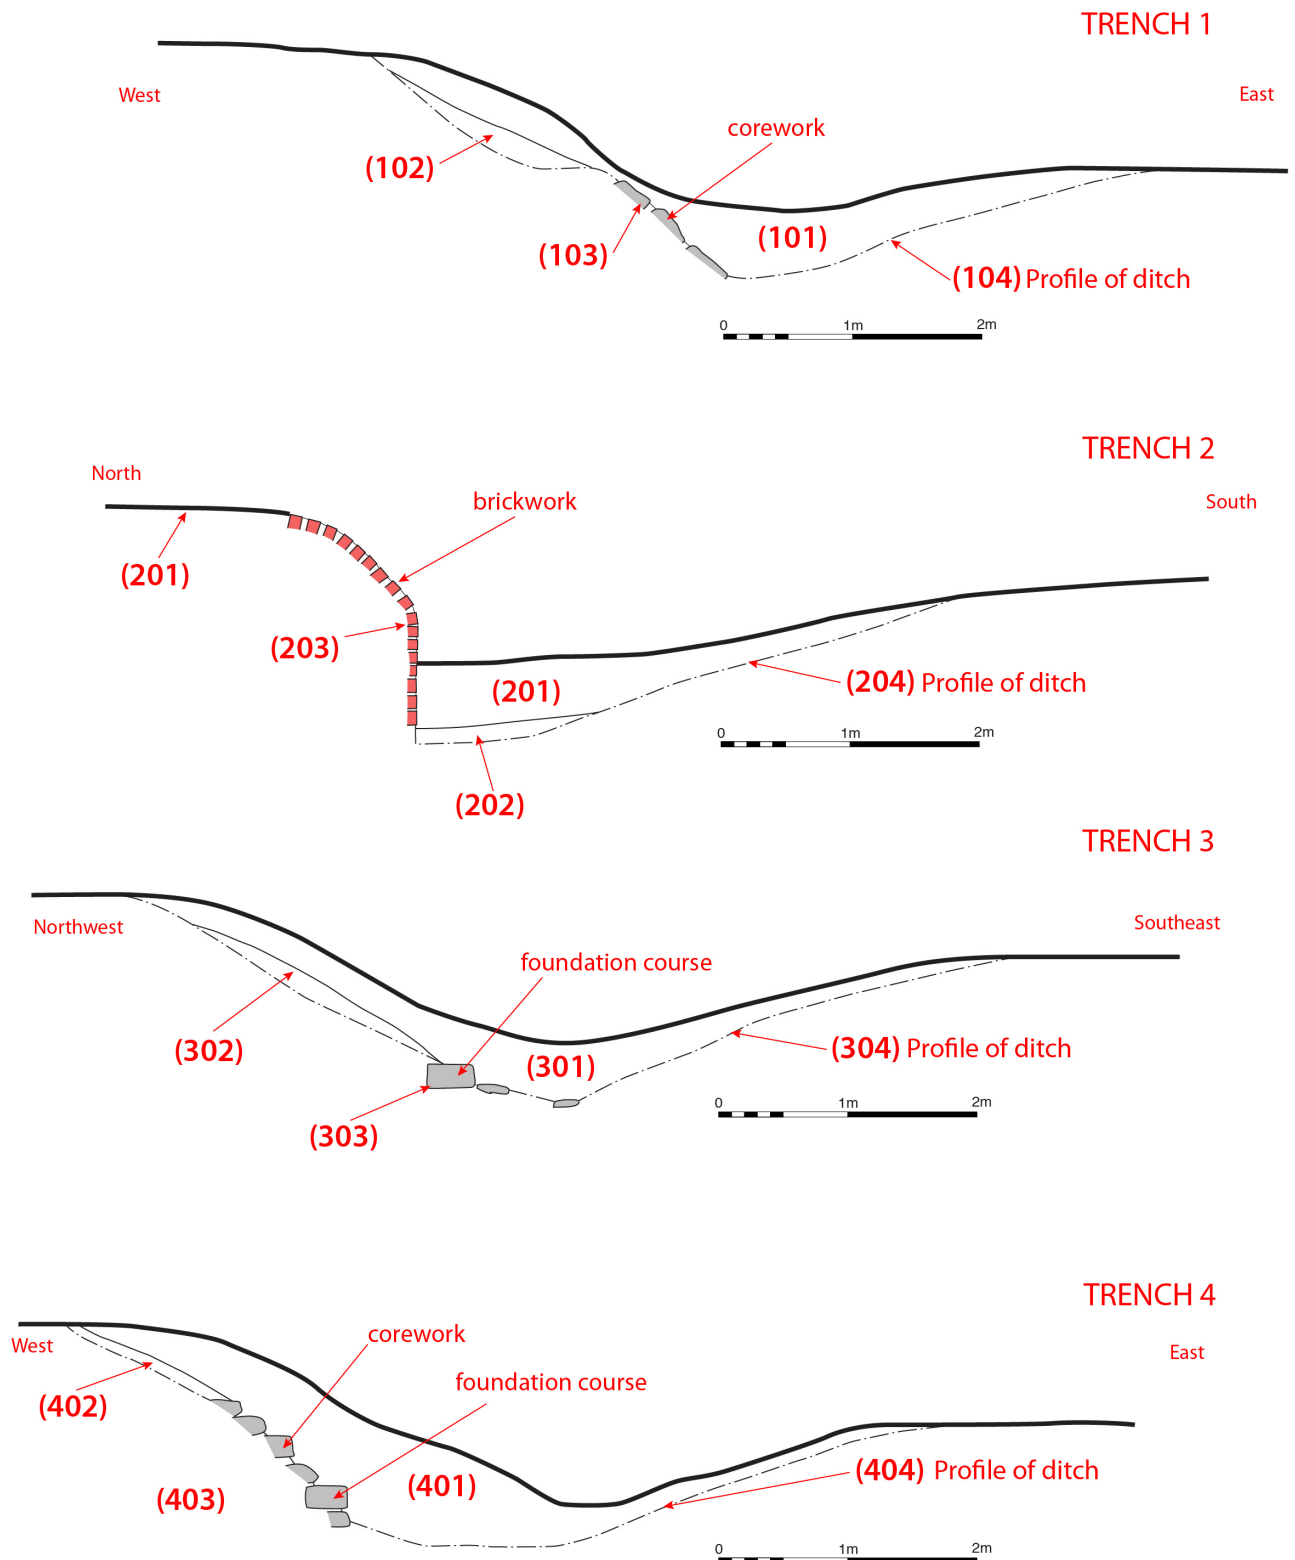
Figure 3: Profiles of excavated sections of ha ha (Tr1-Tr4)

The excavation of the western part of the ha ha in four locations (**Tr1-Tr4**) has successfully identified three different methods of construction. The two trenches along the southwestern edge of the Pleasure Grounds (**Tr3-Tr4**) were of a similar construction, with a stone foundation course set into the natural clay ground surface (**Appendices 3.9, 3.13**), and which had been re-profiled to form an embankment, or terrace walk. The lack of substantial amounts of facing stones is indicative of stone robbing. It is however, unclear whether the ha ha had a vertical face along this section, although once the walling had been removed the effect of natural erosion on any unsupported earth face would have gradually collapsed into the ditch. The construction of the ha ha along the northwest part of the ha ha (**Tr2**) is unlike any other section at Kedleston, which has an angled profile formed from handmade bricks (**Appendix 3.7**).

It is recommended that, should the ha ha be restored, an intermittent archaeological watching brief should be maintained to ensure that the correct alignment and ditch profile is achieved during any ground works.

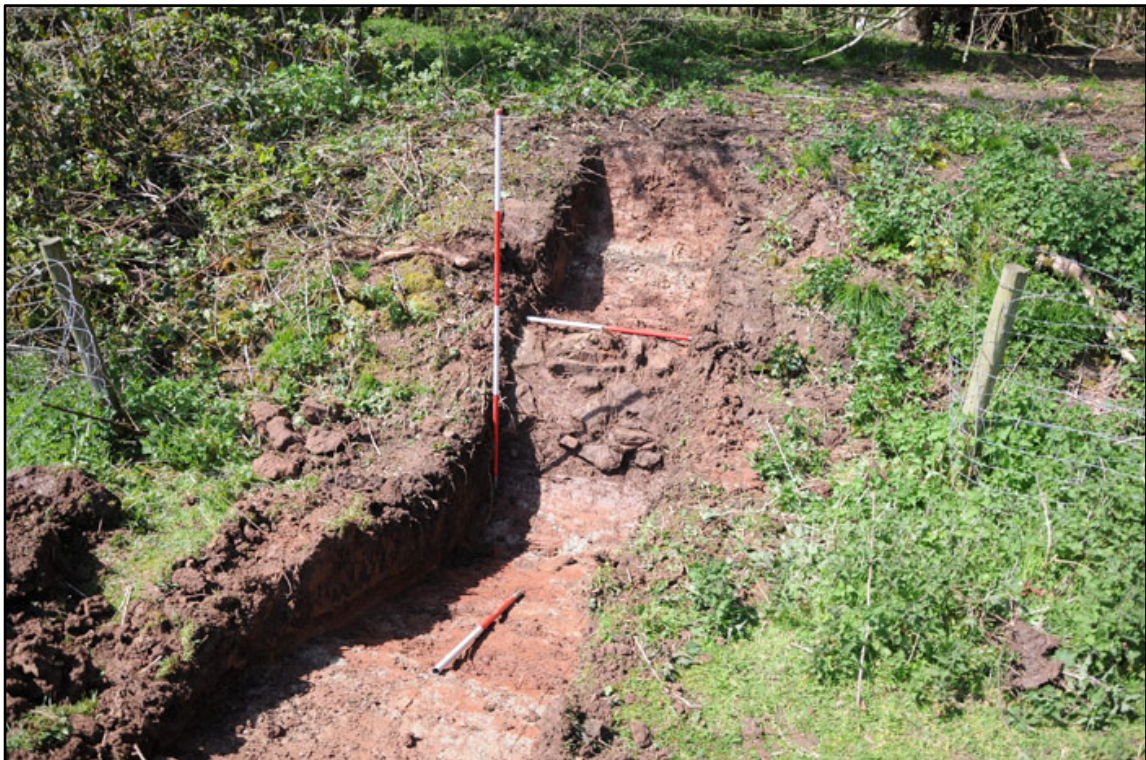
Following removal of the topsoil **I01** a section of revetment stonework **I03** was exposed c.0.6m in height that continued across the width of the trench (**Appendix 3.2**). Above this walling no traces of stonework were noted. It is suggested that any upper stone is likely to have been removed for re-use elsewhere as only a small amount of loose stone was recorded at the base of **I03**. The wall comprised of roughly coursed stones, or irregularly cut blocks, forming a slightly angled or battered face. No traces of bonding material such as mortar were noted. Occasional fragments of red brick were inserted in the stonework (**Appendix 3.3**). This section of the ha ha had no foundation, with the lowest courses embedded directly into the clay bank **I02** to the rear.

Appendix 3.2: General view of TrI with exposed ha ha walling, looking west (1m/2m scale).

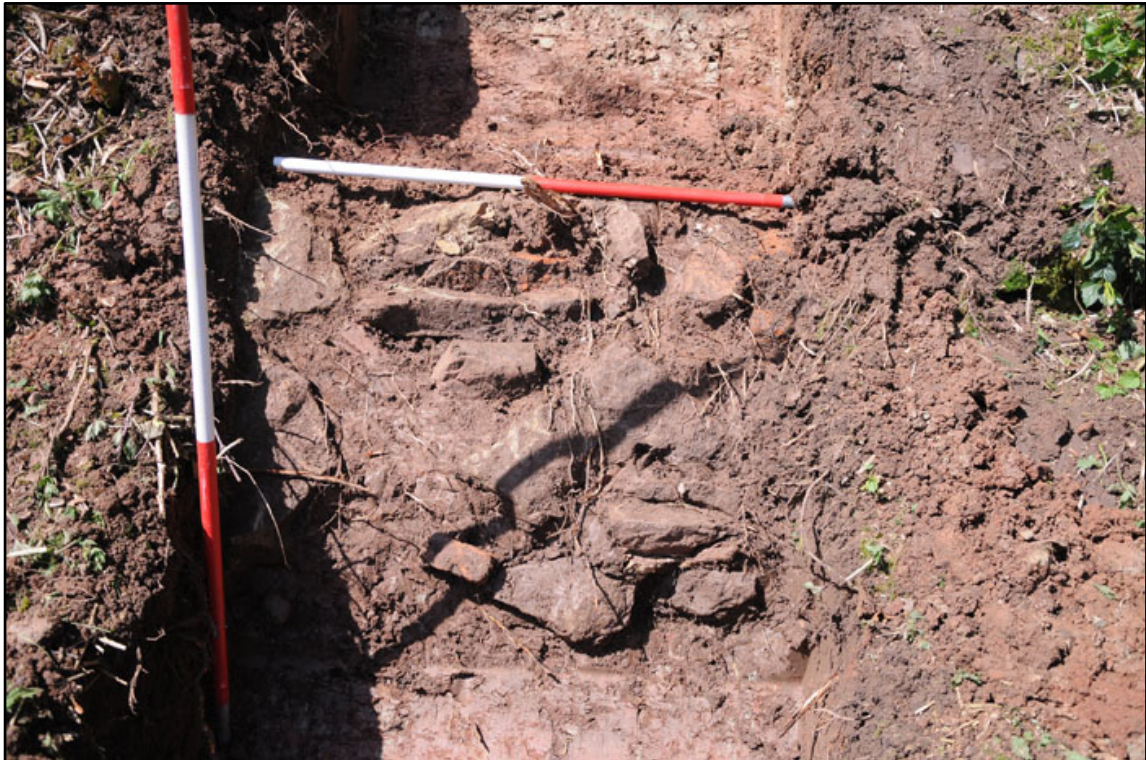
Appendix 3.3: Detail of exposed ha ha walling in TrI, looking west (1m scale).

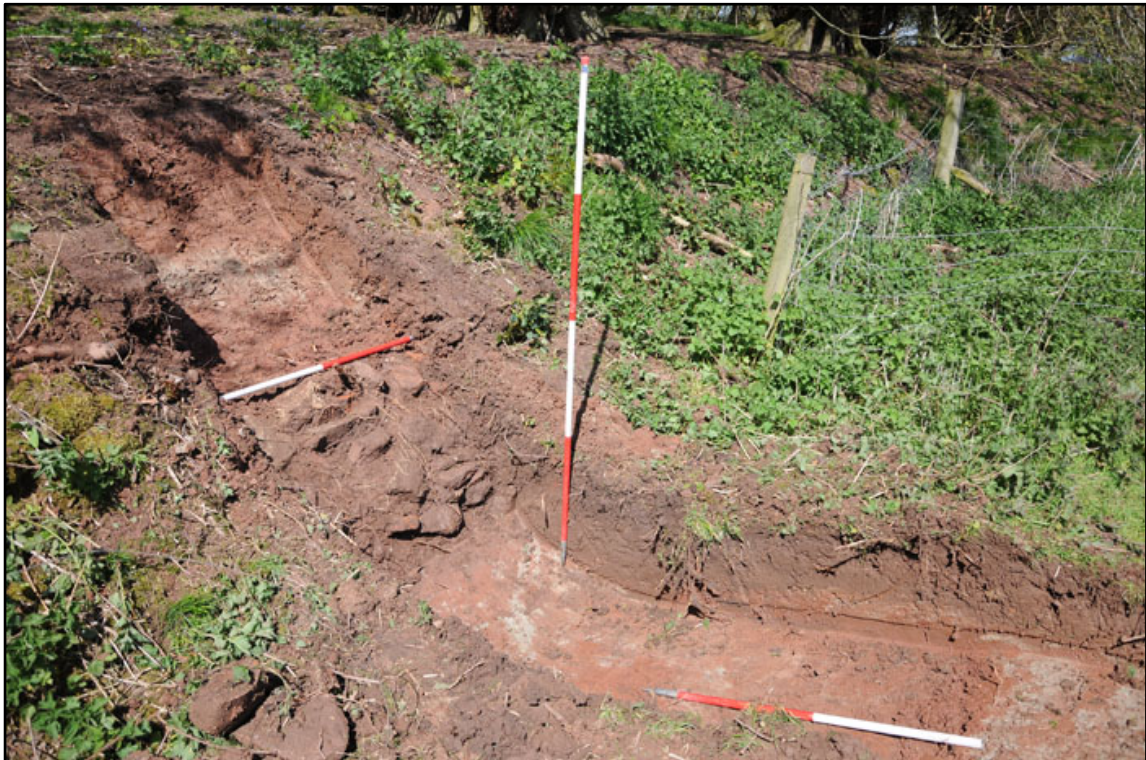
Appendix 3.4: General view of ditch profile in TrI, looking north (1m/2m scale).

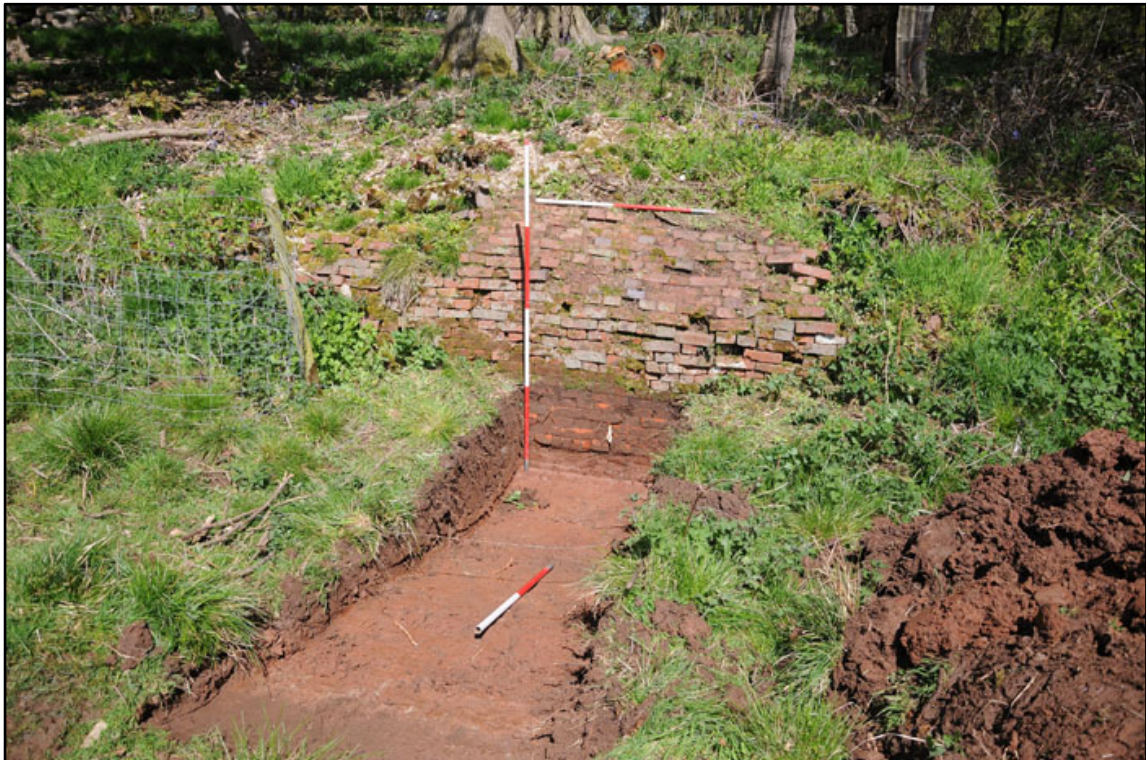
Appendix 3.6: General view of Tr2 with brick walling of ha ha exposed, looking north (1m/2m scale).

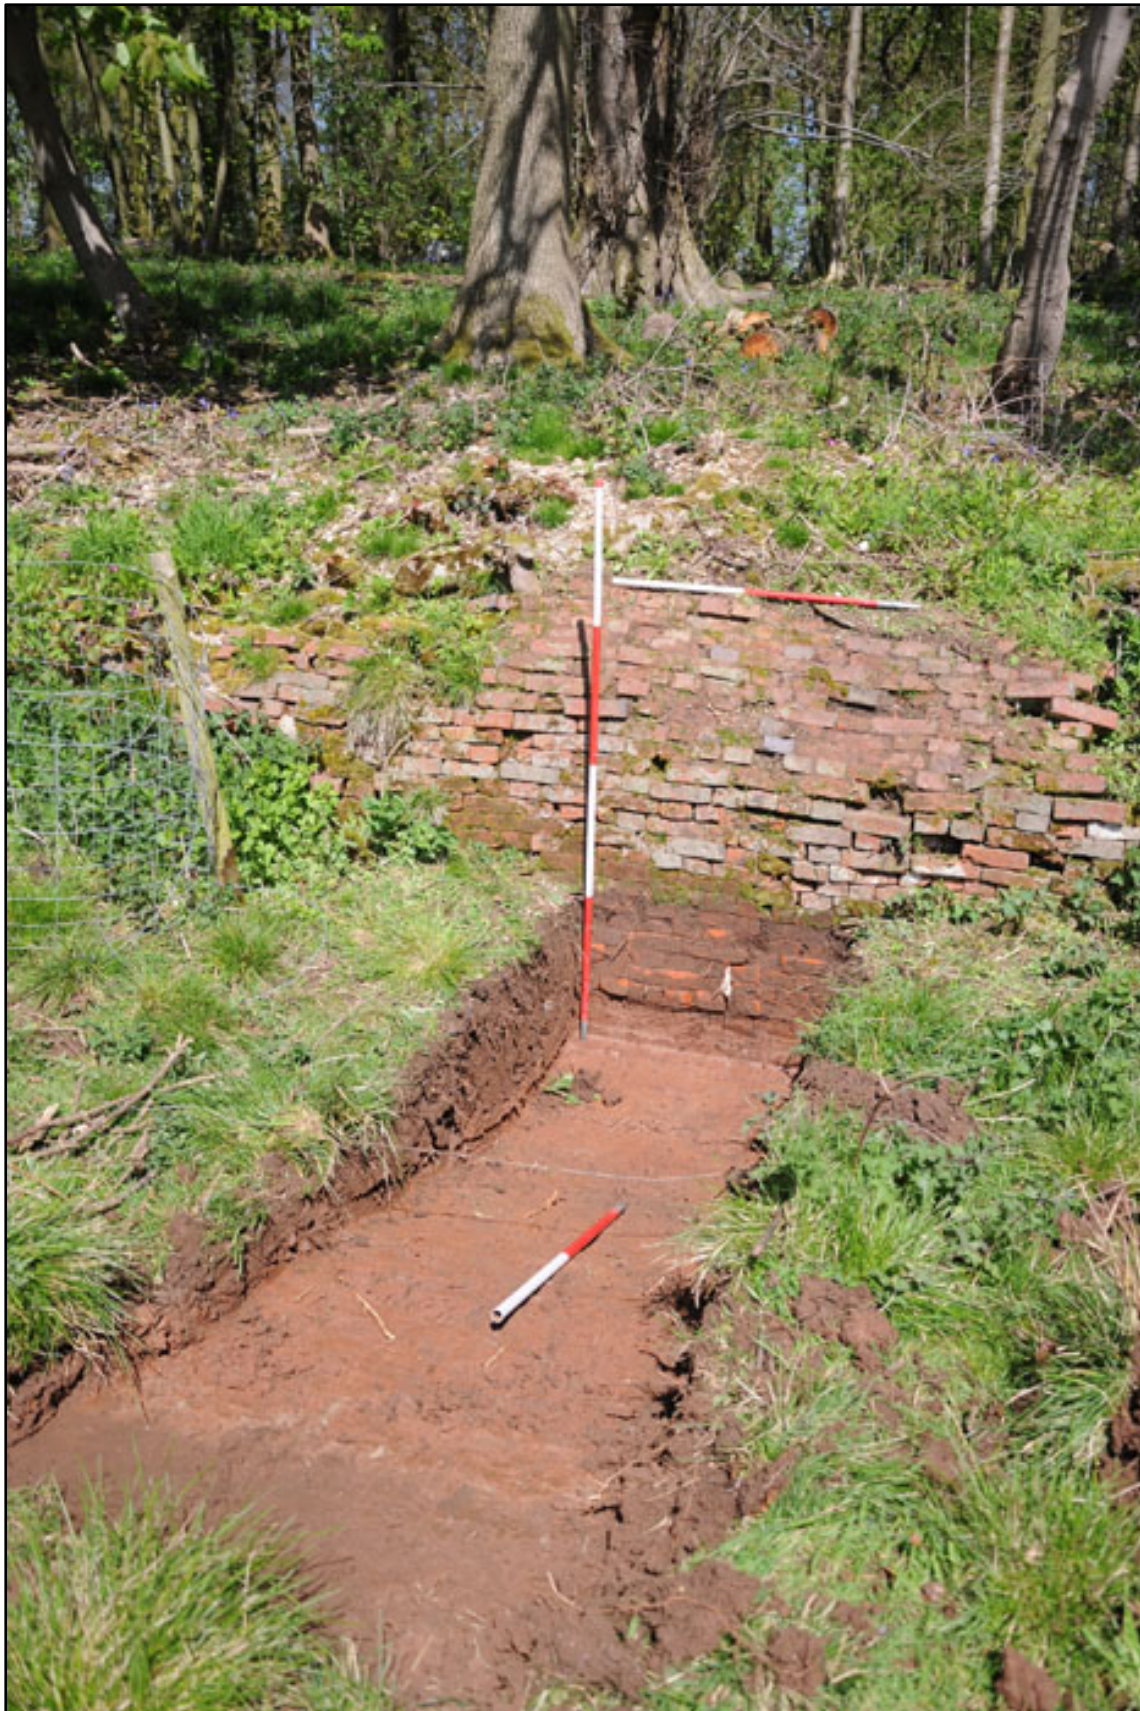
Once the vegetation from the brickwork had been cleaned back and the topsoil **201** within the ditch excavated, the ha ha was found to comprise of an angled brick wall **203** (**Appendix 3.6**), with a vertical face 1.05m in height. The brickwork was not bonded with mortar and appeared to be set within the clay bank **202**, with a random pattern mainly comprising of stretcher courses. The bricks were handmade and orange in colour, each measuring 23-24cm x 11cm x 6cm. No foundation course, or footings were recorded.

At the base of the brick walling the ground level gently sloped to form a ditch **204** c.4m in length, **204** (**Appendix 3.7**).

Appendix 3.7: Detail of brickwork and bank profile in Tr1, looking north (1 m/2m scale).

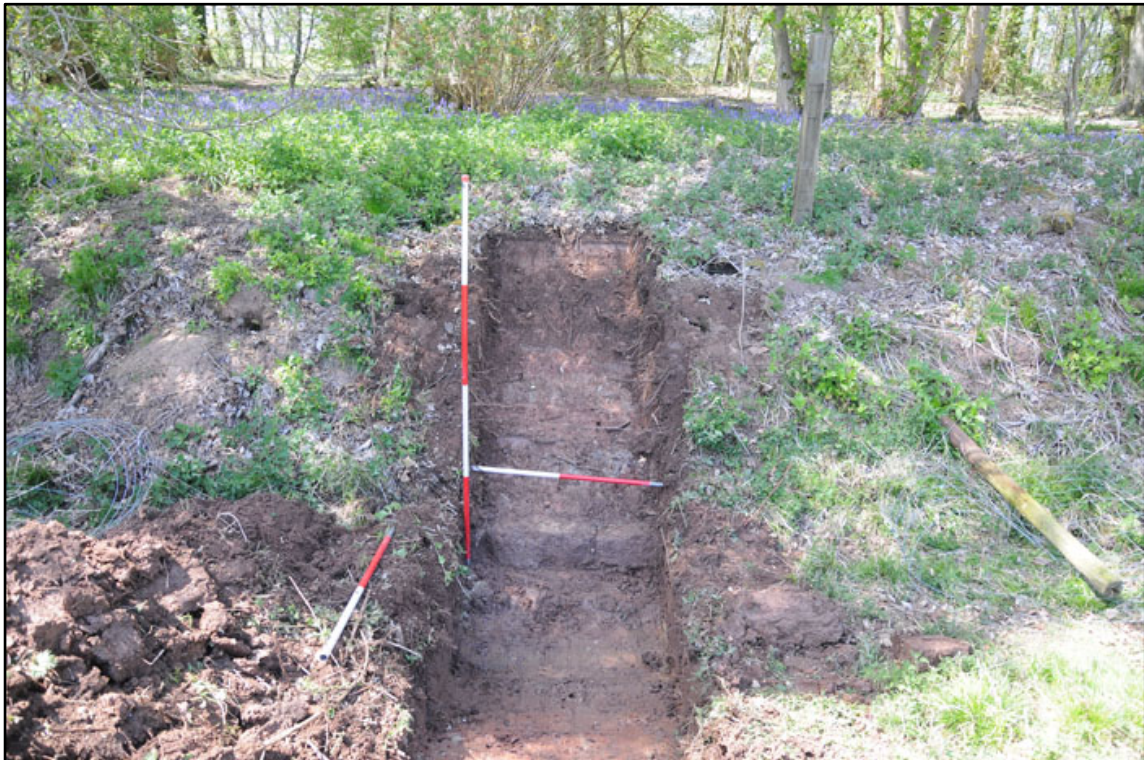
Following removal of the topsoil **301** only a single course of stone was found at the base of the trench **303** (**Appendix 3.9**). This course is interpreted as a wall foundation, however very few traces of stone, or brick were noted during the excavation and it is assumed that the former wall face of the ha ha has been completely removed for use elsewhere. The foundation course was set within the clay bank **302** (**Appendix 3.10**), and no bonding material was present.

Appendix 3.9: View of excavated Tr3, looking northwest (1m/2m scale)

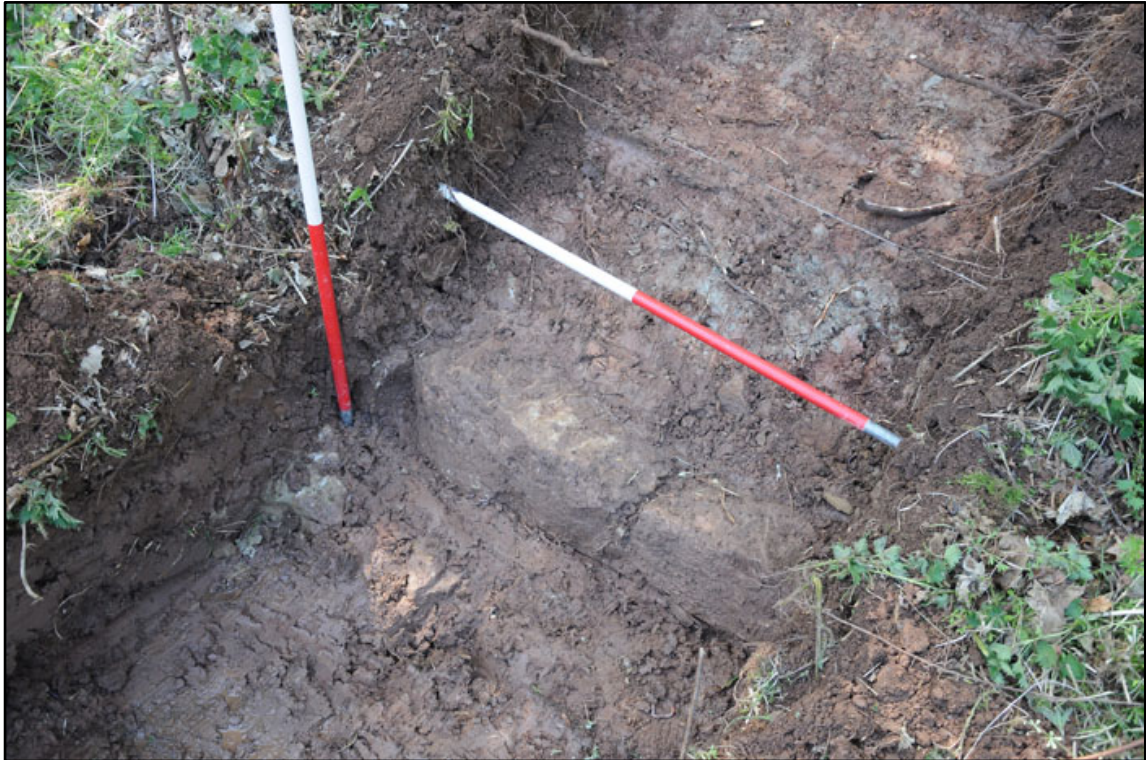
Appendix 3.10: Detail of single foundation course exposed in **Tr3**, looking south (1m scale).

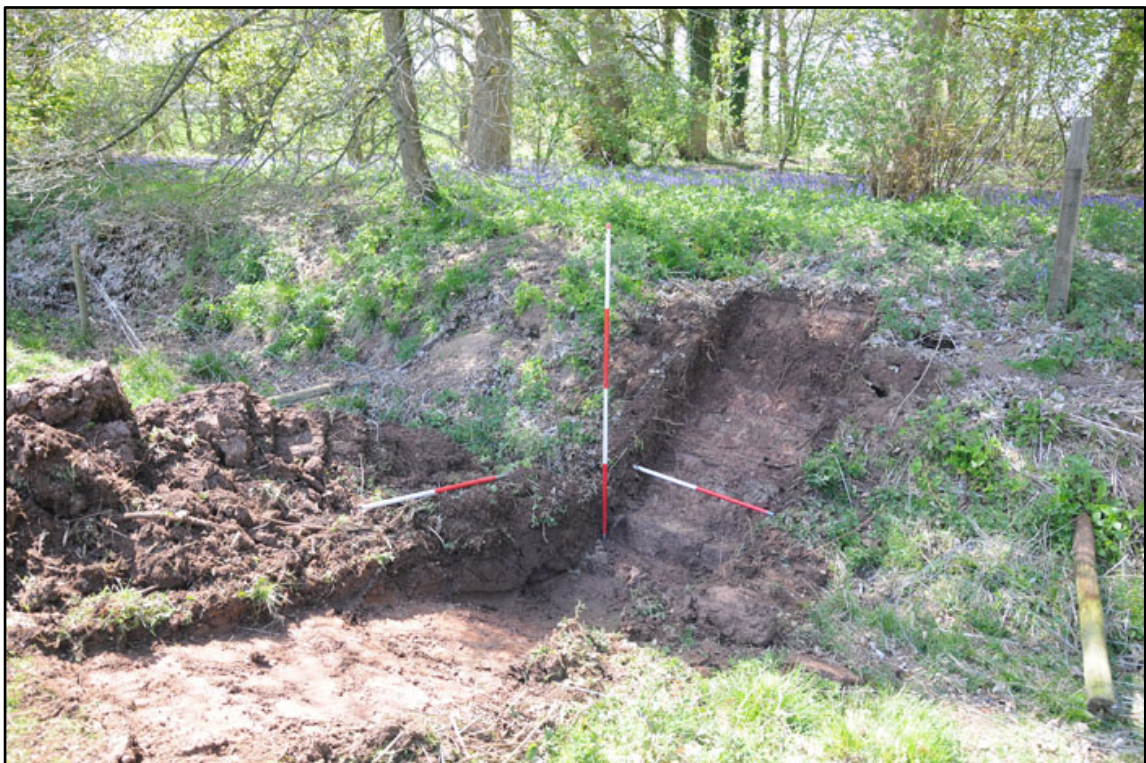
Appendix 3.11: View of ditch profile in **Tr3**, looking west (1m/2m scale).

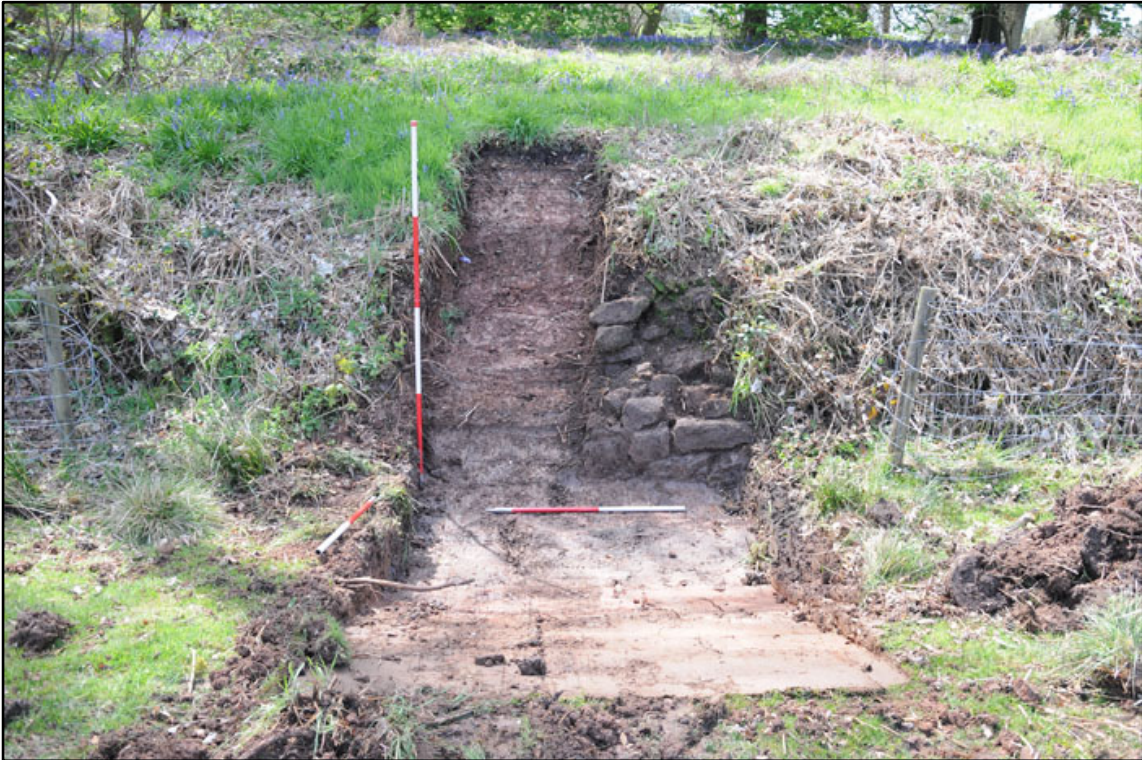
Tr4 measured 1.8m x 6.6m and was orientated west-east (**Figure 2**). Prior to the excavation, a small area of masonry was visible, obscured partially by vegetation. The ha ha comprised of a steep bank c.1.8m in height, with a steeply angled profile (**Appendix 3.12**). The initial cut of the trench (southern side) contained no stonework, nor was any evidence for the ha ha observed, so the trench was extended 0.9m to the north (**Appendix 3.13**).

Appendix 3.13: General view of Tr4 following excavation of trench, looking west (1m/2m scale).

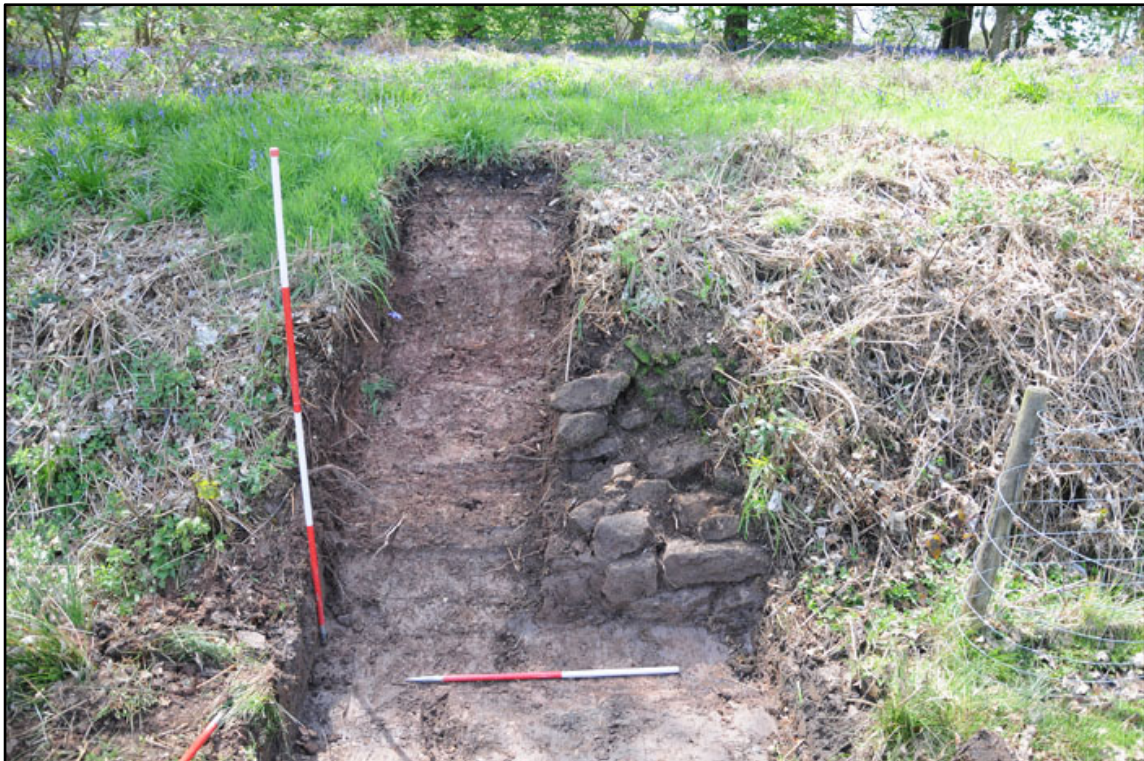
Following removal of the topsoil **401** in the northern half of the trench, two offset foundation courses of horizontally bedded stone were exposed **403** (**Appendix 3.14**), with an angled section of corework above, approximately 0.8m in height. It is suggested that there was originally a stone wall face above this corework, although this has been removed. The stonework was set within the clay bank **402** and no bonding material was present.

Appendix 3.14: Detail of Tr4, looking west; note surviving section of coursed foundation stones (1m/2m scale).

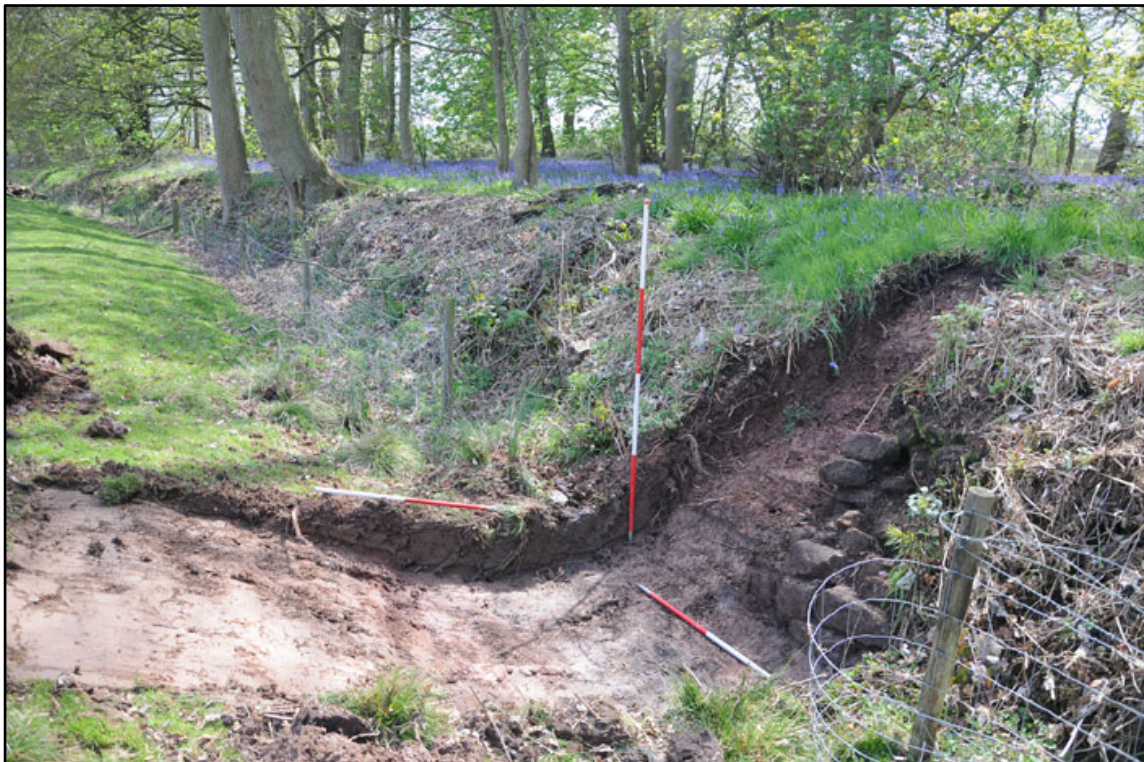
Appendix 3.15: General view of ditch profile in Tr4, looking south (1m/2m scale).

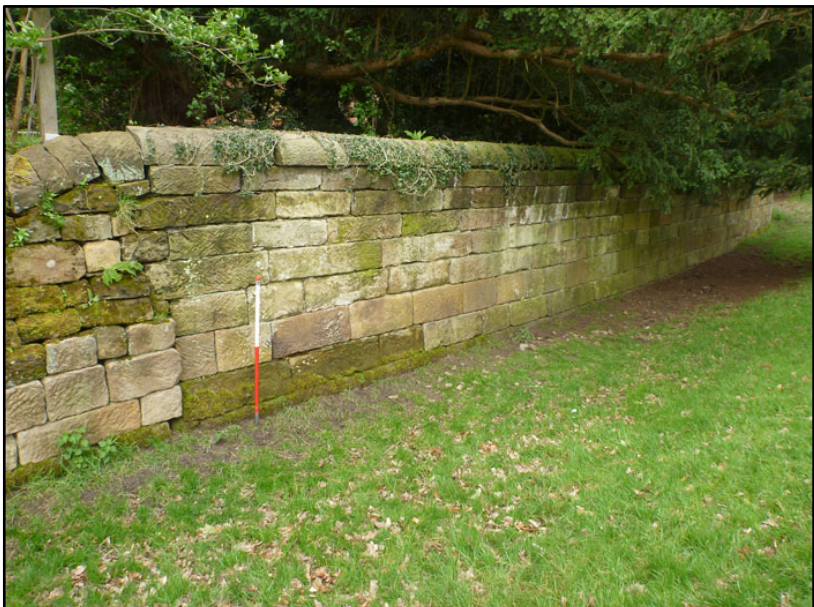
Segment B	Description	Ditch
<p>Length = 20m</p> <p>Nick Cox No.28</p> <p>NT repairs 1997-99</p>	<p>Vertical stone wall made from large ashlar cut blocks of sandstone, with long rounded sandstone copings (70-80cm in length). c.1.9m high.</p>

<p>Flat bottom with sloping bank, c.4m wide</p>

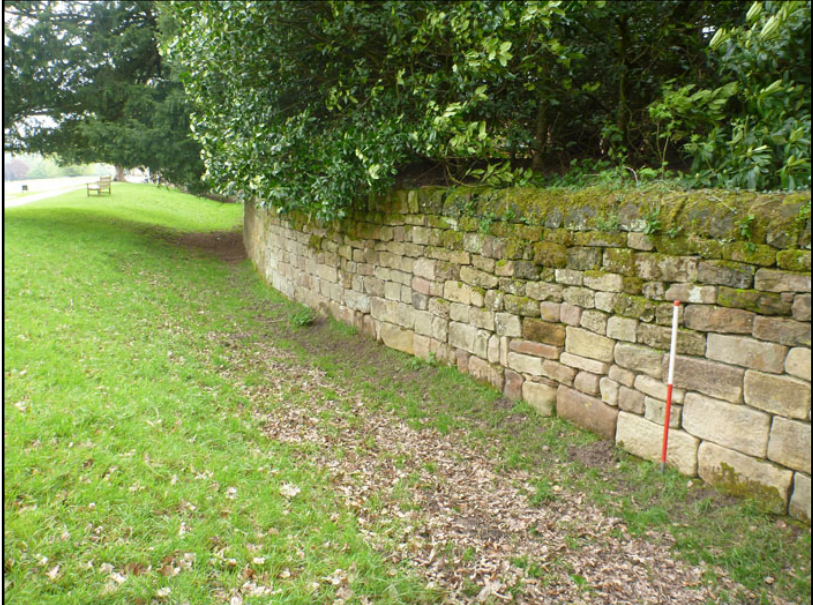
Segment C	Description	Ditch
<p>Length = 21m</p> <p>Nick Cox No.28</p> <p>NT repairs 1997-99</p>	<p>Vertical wall comprising of irregular coursed roughly cut blocks of sandstone. Rounded copings. c.1.5m high. Sections rebuilt.</p>

<p>Narrow bottom with sloping bank, c.4m wide</p>

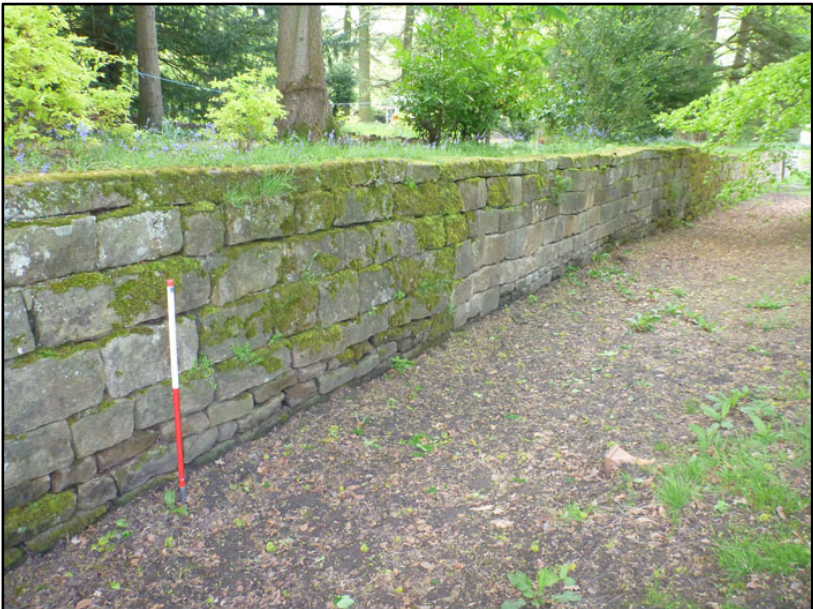
Segment D	Description	Ditch
<p>Length = 185m</p> <p>Nick Cox No.27</p> <p>NT repairs 1997-99</p>	<p>Vertical sandstone wall comprising of roughly dressed and squared blocks, laid in irregular courses. Rebuilt central section with large sandstone blocks with modern cement. Similar in character to segment A. c.1.5-1.6m high.</p>

<p>Flat bottom with rounded bank</p>

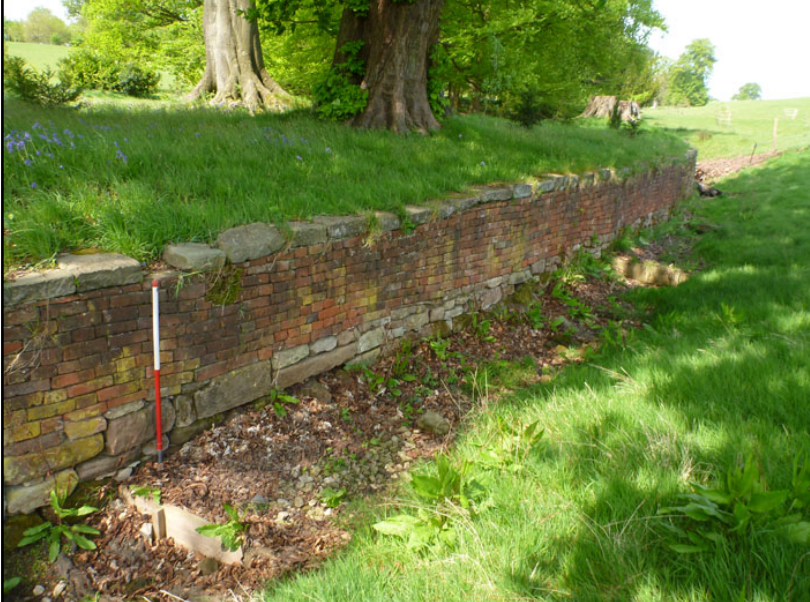
Segment G	Description	Ditch
Length = 16m Nick Cox No.26 NT repairs 1997-99	<p>Vertical wall comprising of an irregular sandstone foundation using a mixture of cut and unworked stones. With an upper section formed from 11 courses of handmade brick with a sandstone coping. Rebuilt sections. c.1.2m high.</p>

Shallow ditch, waterlogged with steep bank

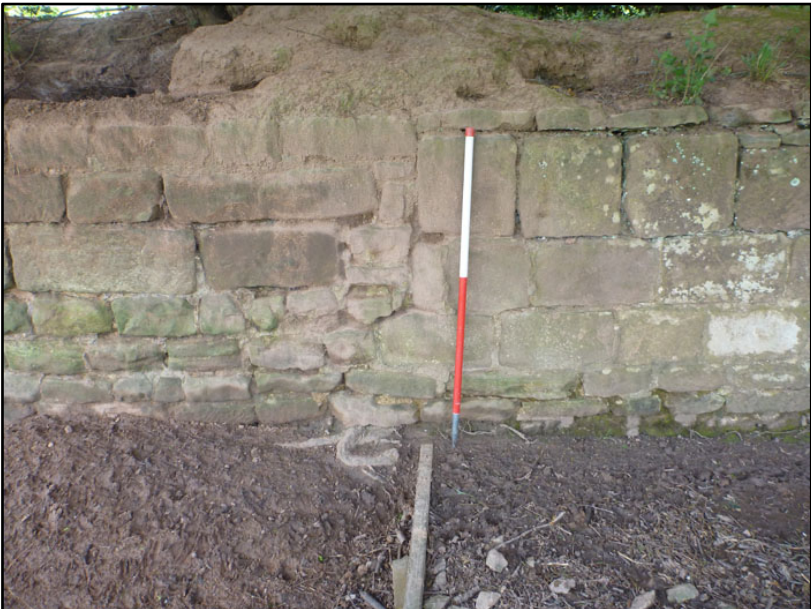
Segment H	Description	Ditch
Length = 100m Nick Cox No.26 NT repairs 1997-99	<p>Vertical stone wall comprising of irregular widths of roughly cut sandstone blocks of differing sizes. Traces of mortar repointing. c.1.1m high. In places larger stone blocks form a top course.</p>

Flat base with steep sloping bank, c.3m

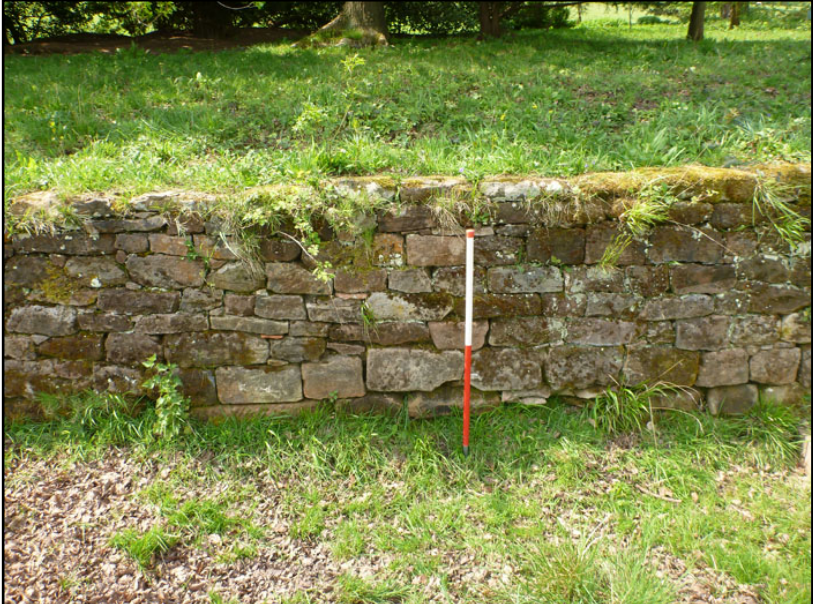
Segment I	Description	Ditch
<p>Length = 120m</p> <p>Nick Cox No.26</p> <p>NT repairs 1997-99</p>	<p>Vertical stone wall comprising a mixture of cut ashlar blocks and roughly cut stones. c.1.2m high. In places a narrow stone course forms a coping. Rebuilt sections and two vertical joints noted.</p>

<p>Narrow ditch with sloping bank, c.3.5m</p>

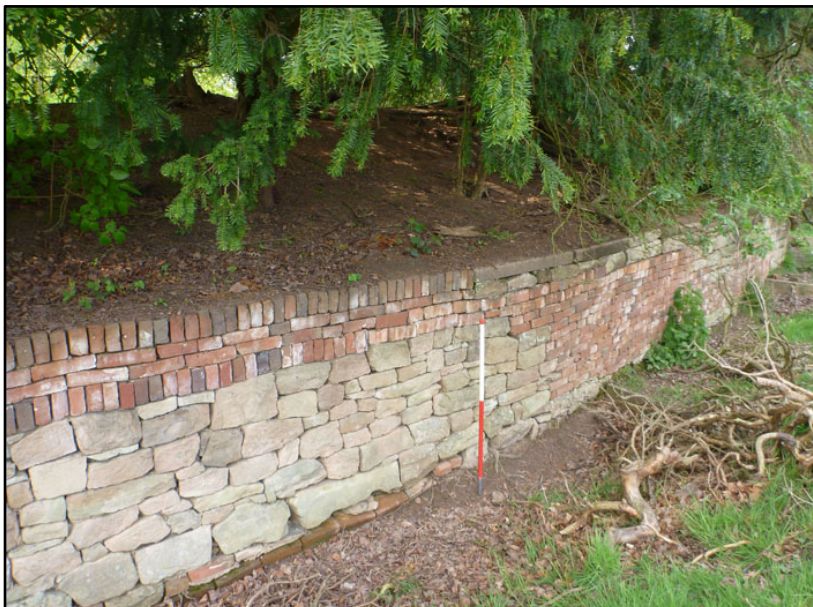
Segment J	Description	Ditch
<p>Length = 80m</p> <p>Nick Cox No.25/26</p> <p>NT repairs 1997-99</p>	<p>Vertical wall comprising of random coursed irregular cut sandstones, some roughly cut blocks. No coping. Brick course at base and sections of brick repair at top. c.1.3m.</p>

<p>Narrow ditch with sloping bank, c.3.5m</p>

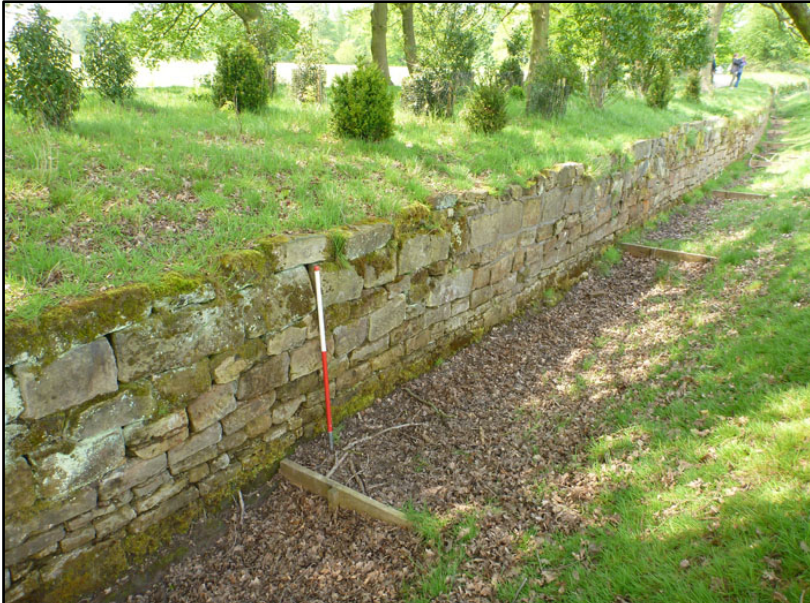
Segment L	Description	Ditch
<p>Length = 190m</p> <p>Nick Cox No.24/25</p> <p>NT repairs 2001-02</p>	<p>Vertical wall comprising of irregular coursed sandstone blocks with stone copings. Sections of brick repair in upper courses. Sections rebuilt with brick. Lower courses contain narrow stone courses and wall appears to be extensively rebuilt. c.1.2m high. Inserted gate with brick reveals. Collapsed section with corework exposed.</p>

<p>Narrow ditch with a steep bank c.4m</p>

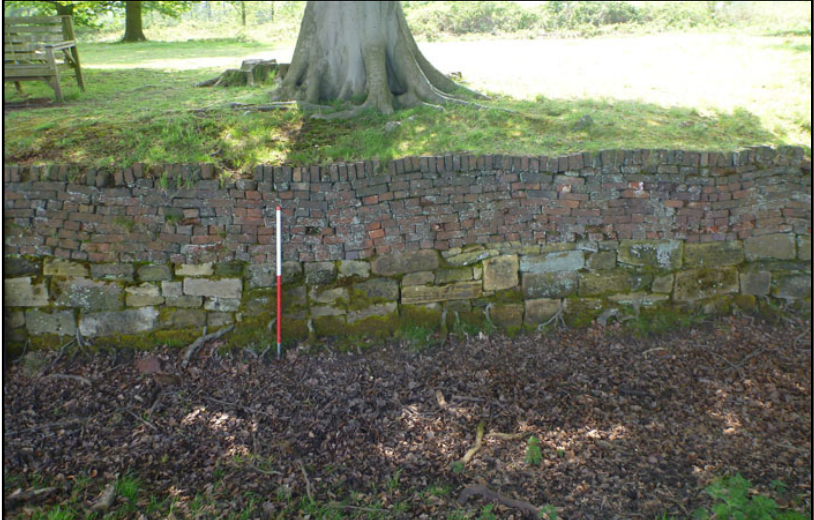
Segment M	Description	Ditch
Length = 160m Nick Cox No.24 NT repairs 2002-03	<p>Slightly angled wall comprising a mixture of sections with the upper 10 courses of handmade brick, alternating header and stretcher courses. Occasional traces of lime mortar. c.1.3m high. Lower courses c.0.4-0.55m comprise irregular sandstone blocks.</p>

Shallow bank and gently profiled ditch

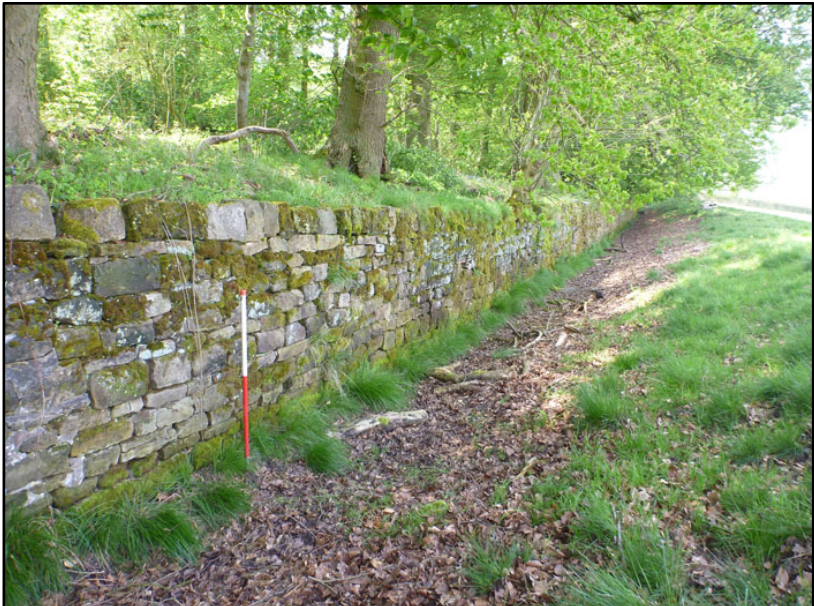
Segment N	Description	Ditch
Length = 175m Nick Cox n/a NT repairs 2004	<p>Slightly angled stone wall, comprised of irregular coursed rough cut blocks of sandstone. End on blocks form a coping. The wall has the general appearance of a drystone field wall and is in good condition. c.1.3-1.4m high.</p>

Steeply sloping bank conceals wall from lower down hillslope

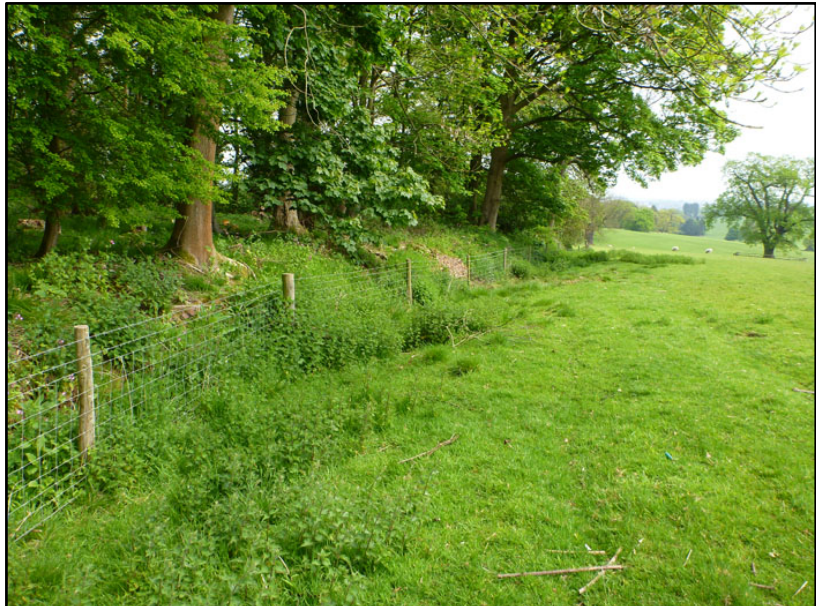
Segment P	Description	Ditch
<p>Length = 105m</p> <p>Nick Cox n/a</p> <p>NT repairs n/a</p>	<p>Brick faced wall with an angled upper section (heavily overgrown). Hand made brick, although in places the bricks have been removed and laid along the top of the ditch (See Tr2).</p>

<p>Steeply sloping bank</p>

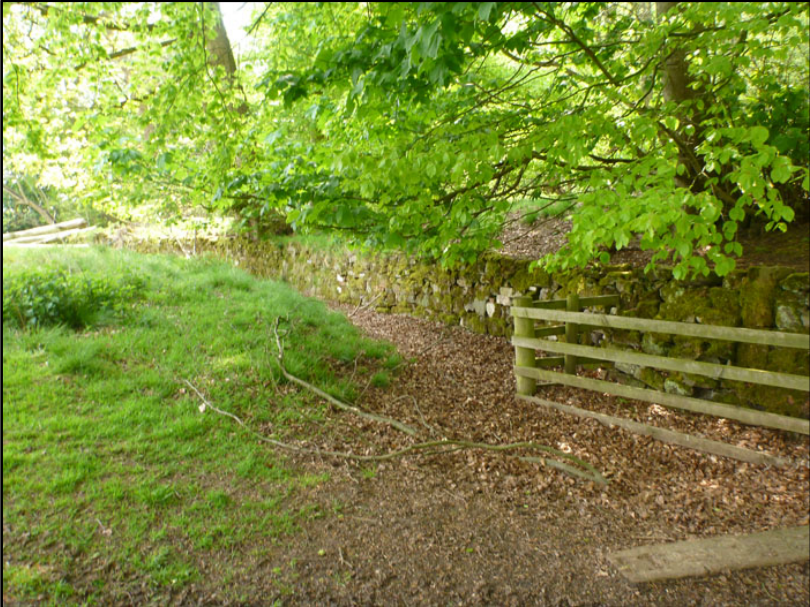
Segment Q	Description	Ditch
<p>Length = 135m</p> <p>Nick Cox n/a</p> <p>NT repairs n/a</p>	<p>Slightly angled wall comprising of irregular coursed stone and brick in random courses. The northern section has been rebuilt using a mixture of stone blocks, including architectural fragments. The southern section has no wall face and comprises of a steeply sloping bank (See Tr1).</p>

<p>Gentle sloping bank (overgrown)</p>

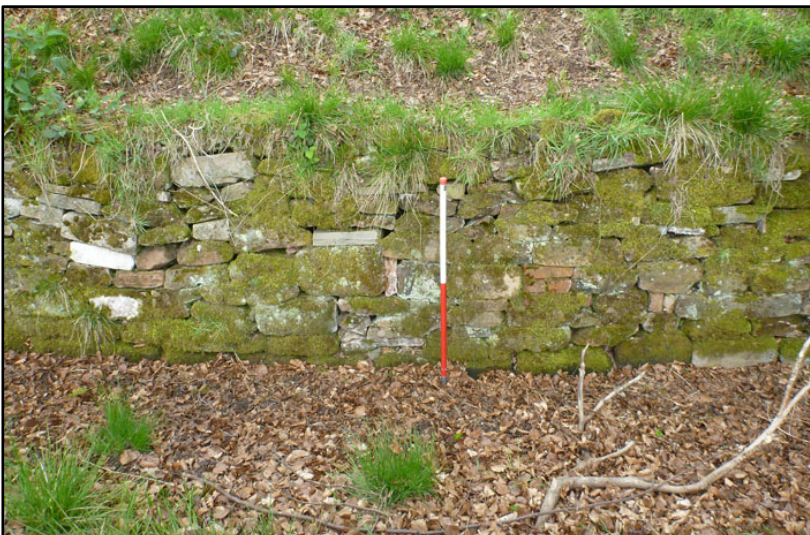
Segment R	Description	Ditch
<p>Length = 175m</p> <p>Nick Cox No.23</p> <p>NT repairs 1997-99</p>	<p>Slightly angled stone wall face, c.1.2-1.4m in height. Walling comprises of irregular coursed sandstone with evidence for partial rebuilding with occasional slate packing and brick fragments. No coping stones.</p>

<p>Narrow ditch and steep angle to bank, c.4m</p>

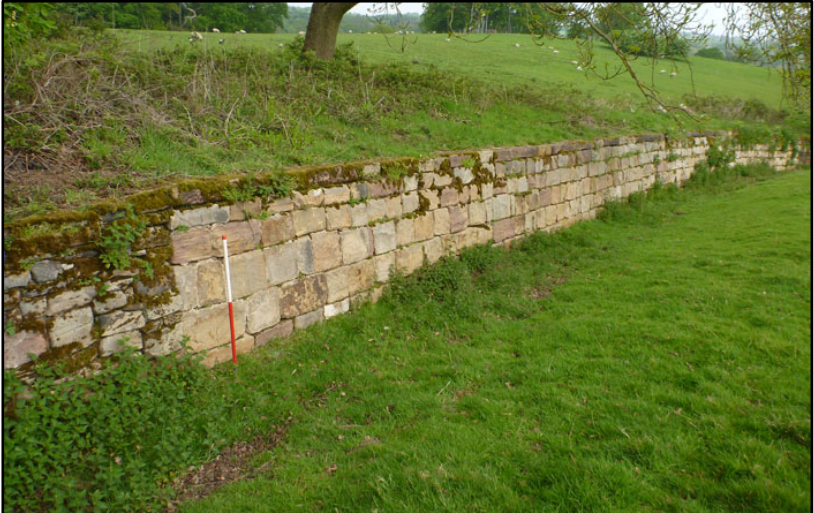
Segment S	Description	Ditch
<p>Length = 540m</p> <p>Nick Cox No.21-23</p> <p>NT repairs 1997-99</p>	<p>This is the longest and most substantial section of ha ha overlooking southwest parkland. It comprises of a slightly angled stone wall comprising of 5 courses of squared sandstone blocks with thin copings. c.1.4-1.7m high. Eastern section has 4-5 courses of handmade brick at the base acting as a foundation. Evidence for projecting metal fence at top to deter livestock.</p>

<p>Narrow ditch with steep bank that opens out to a wider ditch in places</p>

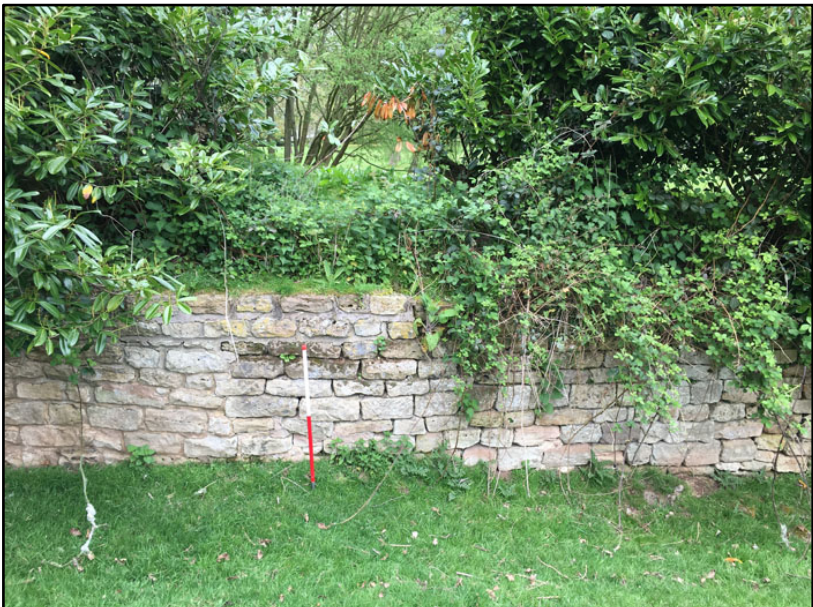
Segment W	Description	Ditch
<p>Length = 37m</p> <p>Nick Cox No.31</p> <p>NT repairs 1994-96</p>	<p>Vertical stone wall comprising of small block of coursed roughly squared stone. c.1.2m high. No coping stones and cement repairs.</p>

<p>Gently sloping ditch</p>
