THE HA HA

PRIEST WOOD AND VICAR WOOD KEDLESTON HALL, DERBYSHIRE

Archaeological Evaluation and Walkover Survey on behalf of the National Trust

Document No: TJC2016.25
OASIS No: thejessop-255360

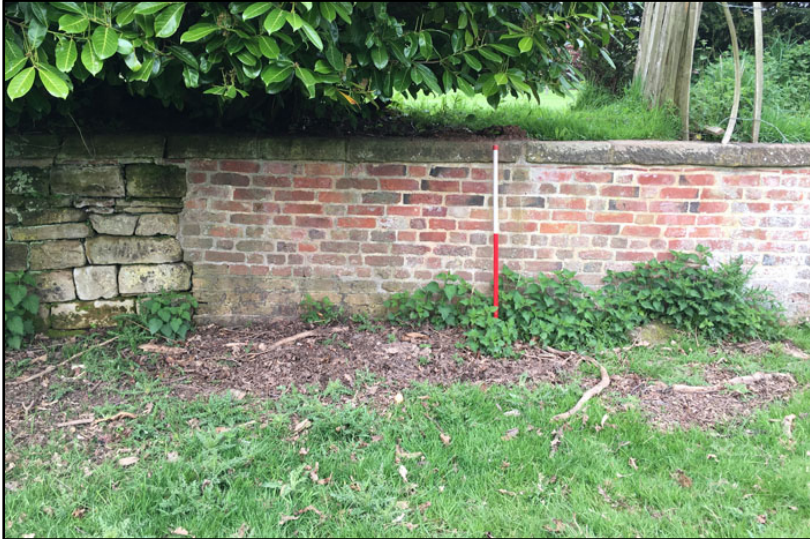
Segment X	Description	Ditch
<p>Length = 31m</p> <p>Nick Cox No.31,32</p> <p>NT repairs 1994-96</p>	<p>Vertical brick wall with an offset sandstone coping. C.1.5m high, being raised from c.1.25m with a row of header bricks on edge. Irregular bond with a buff sandy mortar. Contains inserted brick culvert. Rebuilt ashlar section beneath pavilion.</p>

<p>Narrow ditch with a steep bank</p>

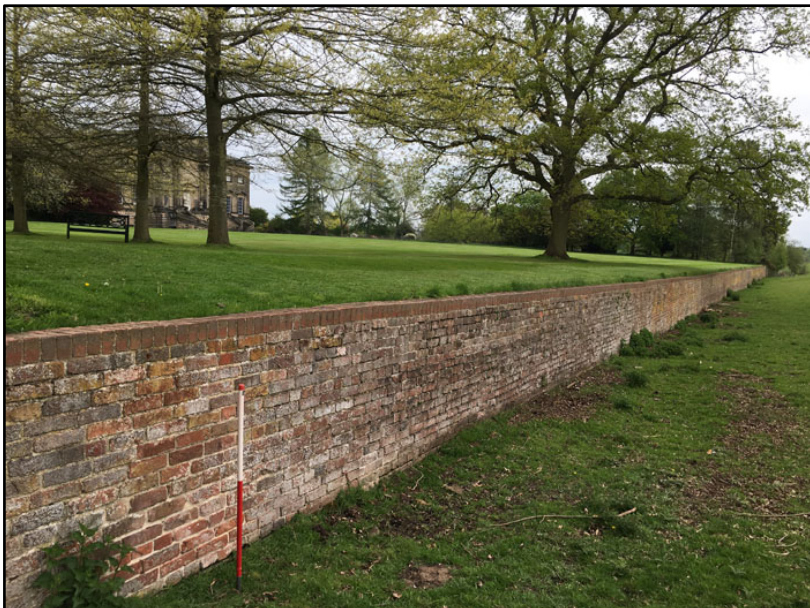
Segment Y	Description	Ditch
<p>Length = 170m</p> <p>Nick Cox No.32</p> <p>NT repairs 1994-96</p>	<p>Ha ha along west side of gardens, forming rear prospect to the Hall. Comprises of a vertical brick wall face with no copings, but a row of header bricks forming an edge level with the grass lawn. c.1.35-1.75m in height towards the centre. Access door at south end and stone culvert. Possibly rebuilt with early 20th century bricks.</p>

<p>Broad gently sloping ditch</p>

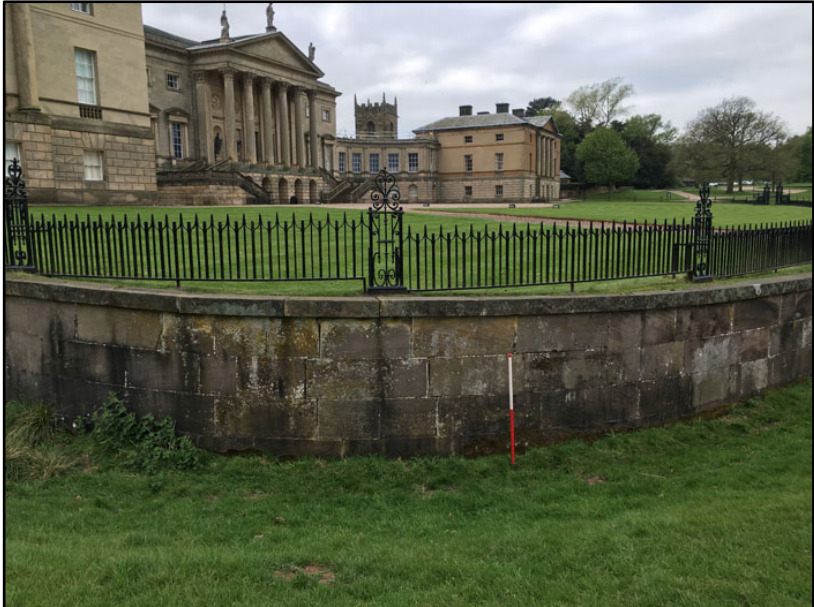
Segment AA	Description	Ditch
Length = 160m Nick Cox n/a NT repairs n/a	<p>Section of ha ha that defines the principal entrance forecourt Kedleston Hall. Comprises of cut ashlar sandstone blocks with an offset coping forming a vertical face, topped with decorative railings. c.1.4m high.</p>

Narrow ditch with a steep bank, c.3m wide
