MARBLE HALL FLOORING, KEDLESTON HALL, DERBYSHIRE

Historic Fabric Survey on behalf of the National Trust

March 2017

Document No: TJC2017.03

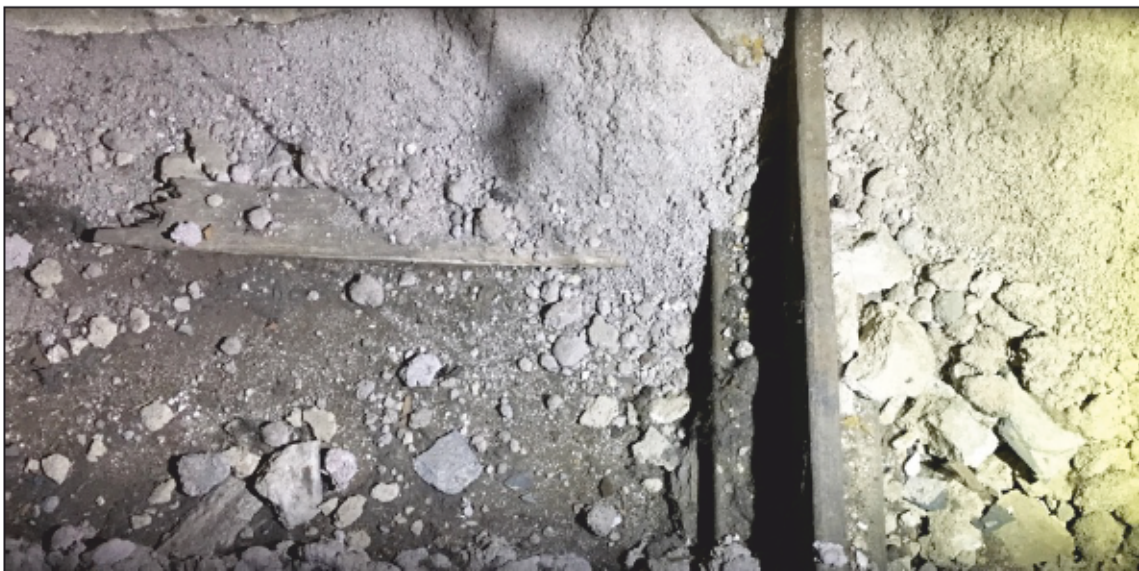
The marble paving around the edge of the heater is up to 6cm in thickness (**Figure 5**), below which the floor void measures 42cm to the underside of the lath and plaster ceiling of Caesars Hall. The floor heaters are a secondary insertion into the floor of the Marble Hall, c.1910 in date, although whether existing large paving slabs were reworked, or new ones introduced into the room to take the opening for each heater is unclear. The heaters are supported on two inverted T shaped narrow rails/RSJs that are orientated north-south (**Appendix 2.6**) and apparently fixed into the stonework beneath each column.

Appendix 2.6: Detail of inserted small RSJ's below floor in OB2 to support floor heater, looking north. **Photo No.23.**

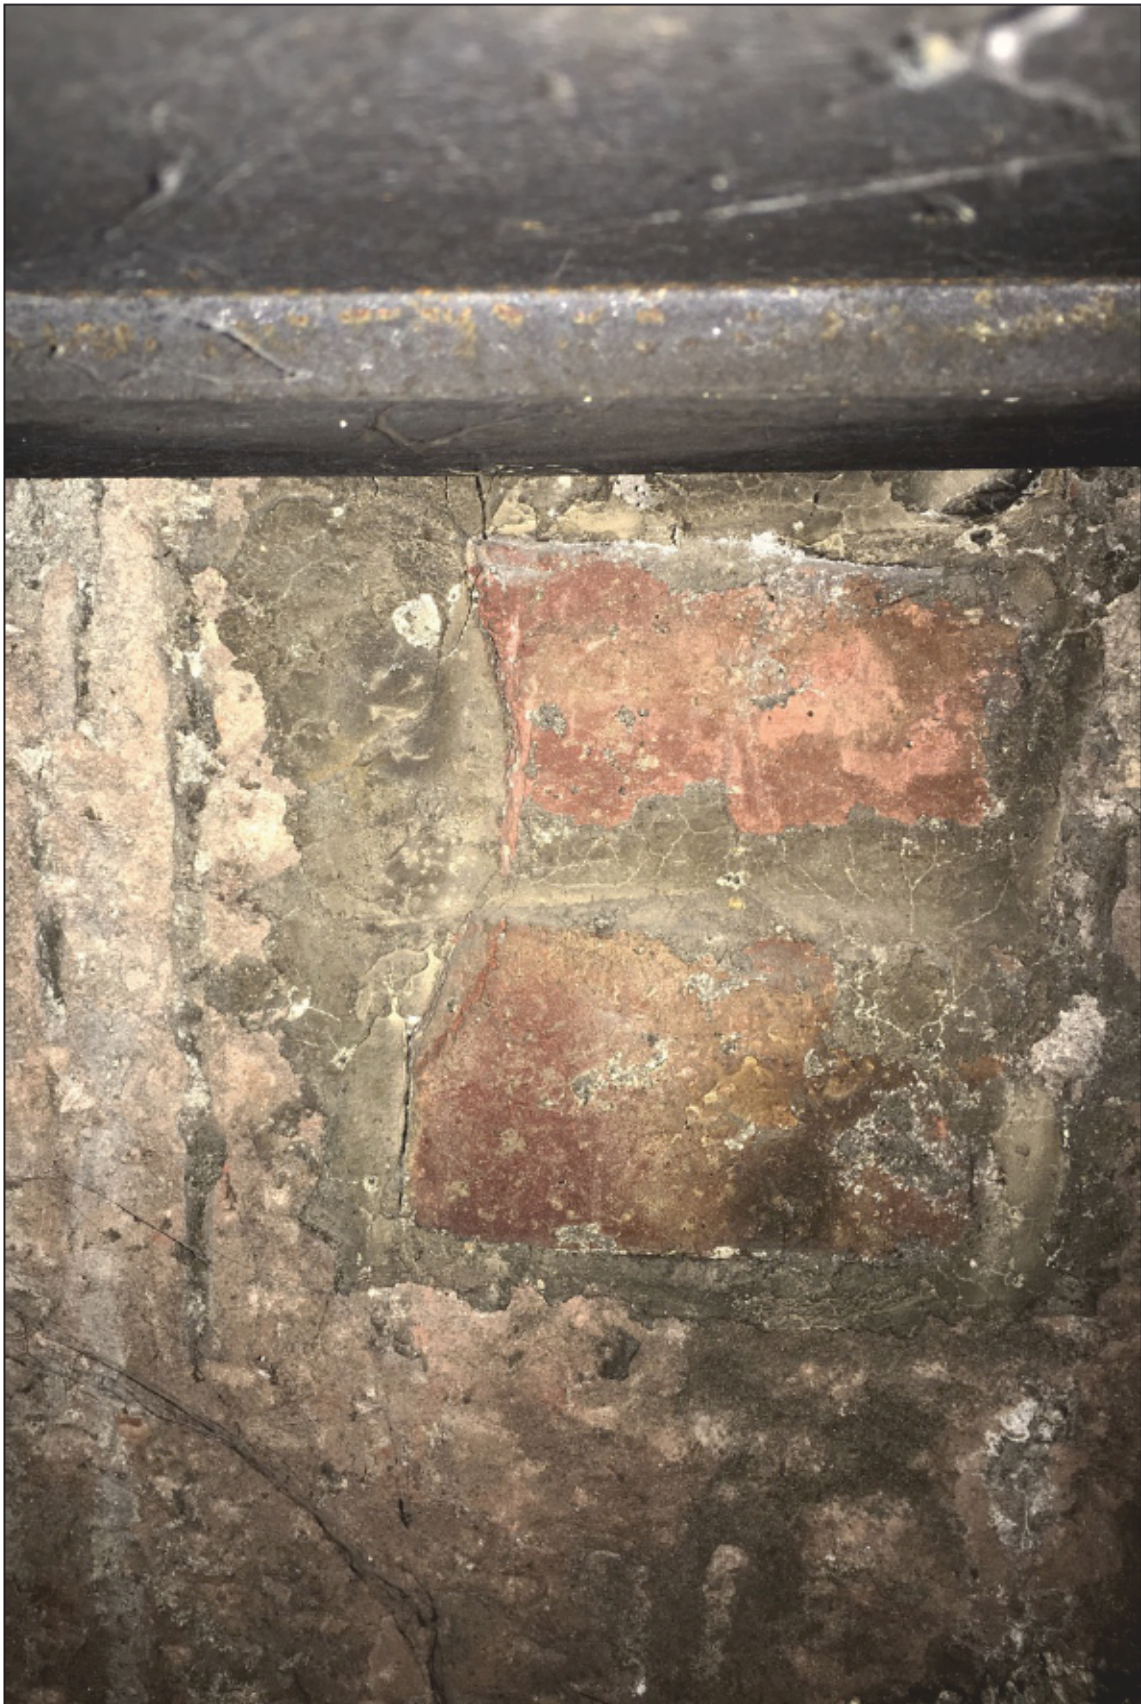
Beneath the floor evidence that the heaters are secondary survives as a blocked recess in the rough stonework beneath the marble column to the north (**Appendix 2.7**). The former opening has been infilled with two fragments, but was presumably intended for a north-south floor joist.

Appendix 2.7: Detail of brick blocking following removal of floor beam below floor in OB2, looking north. **Photo No.20.**

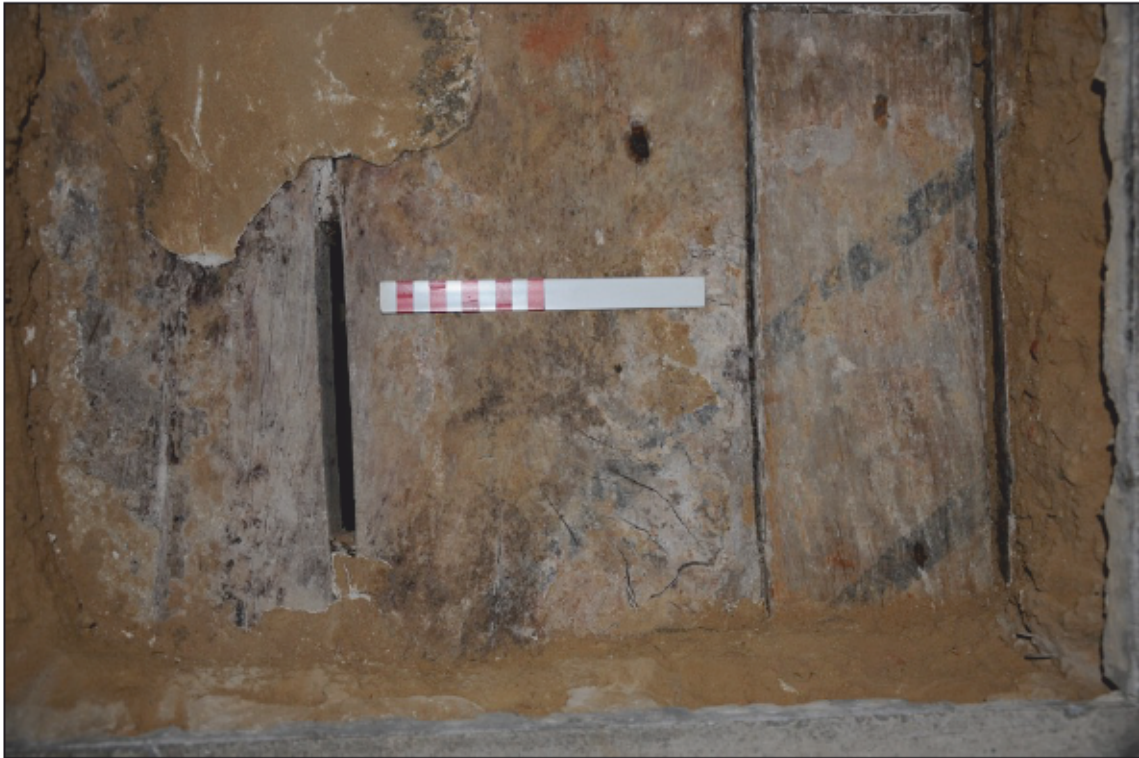
The final feature that was recorded within OB3 consists of two curved painted lines in the northeast corner (**Appendix 2.9**). They were applied directly to the upper surface of the floor planks and measured 2cm in width and were 13cm apart (**Appendix 2.10**). The lines continue below the mortar torching right to the edges of the exposed planks and are interpreted as the setting out of a paving design prior to the mortar being laid. It is interesting to note that the painted arcs have no resemblance to the finished marble paving in this part of the room.

Appendix 2.10: Detail of painted lines on floor planks in OB3, looking north (20cm scale). **Photo No.30.**

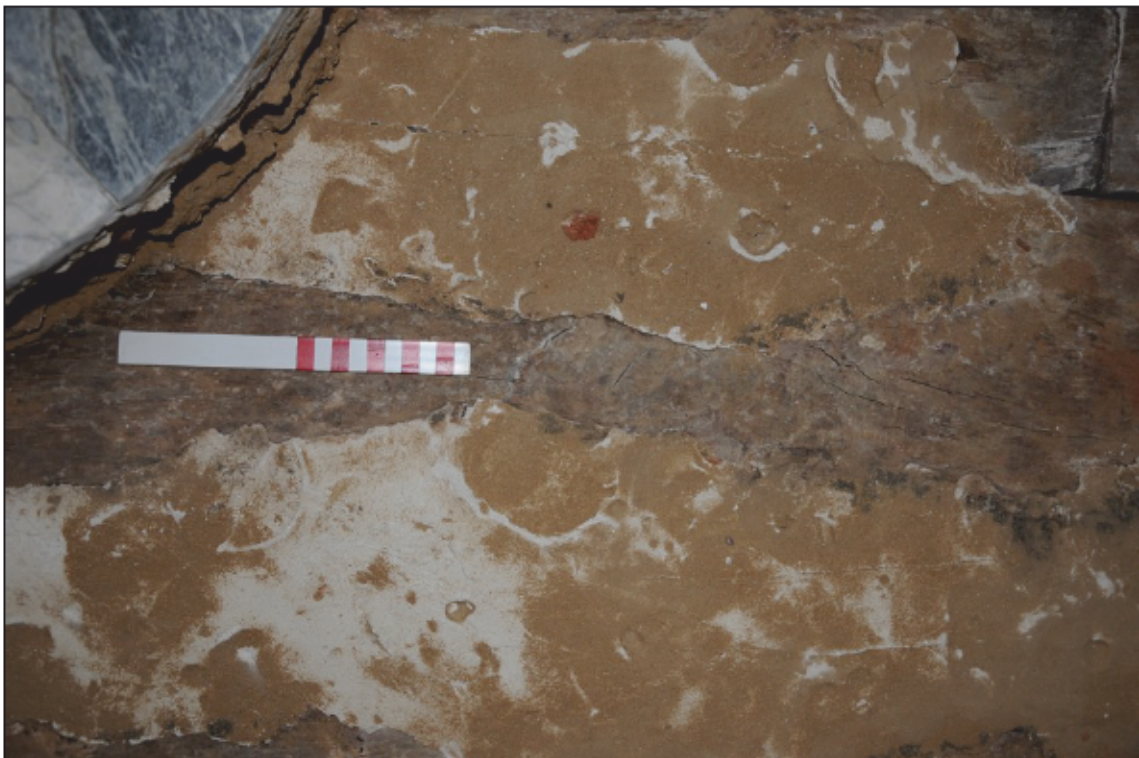
Covering the joints between the floor planks was a layer of mortar torching, which was 12–16cm in width and c.1cm in thickness (**Appendix 2.11**). The purpose of this mortar was to prevent the sand from seeping down to the ceiling void below above Caesars Hall. The mortar continued beneath the brick and mortar foundation that supported the circular roundel (**Appendix 2.13**), indicating that the floor planks and mortar torching pre-dated the formation of these foundations. The foundation for the roundel was however, laid before the sand sub-floor was laid down.

Within the upper surface of the mortar torching a series of impressed arcs were noted (**Appendix 2.11**) and upon closer inspection were found to be the heel prints from hob-nailed boots (**Appendix 2.12**). A total of three distinct impressions were recorded 6.5cm, 7.5cm and 9cm, although this wider mark may have been stretched (**Figure 9**). Two of the impressions contained evidence for hob-nails, which were sub-rectangular in form and concentrated around the edge of the heel, or in its centre.

Appendix 2.11: Detail of shoe impressions in mortar torching in OB3 (20cm scale). **Photo No.31.**

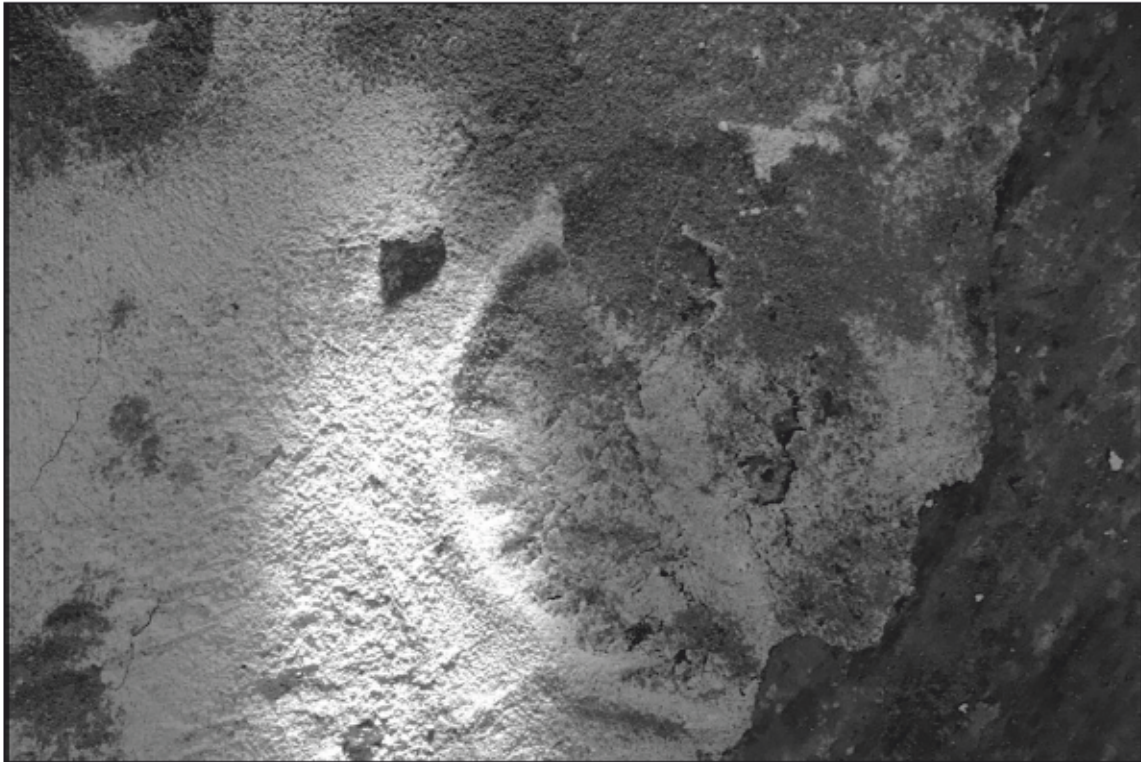
Appendix 2.12: Detail of heel impression in OB3; note hobnails. **Photo No.41.**

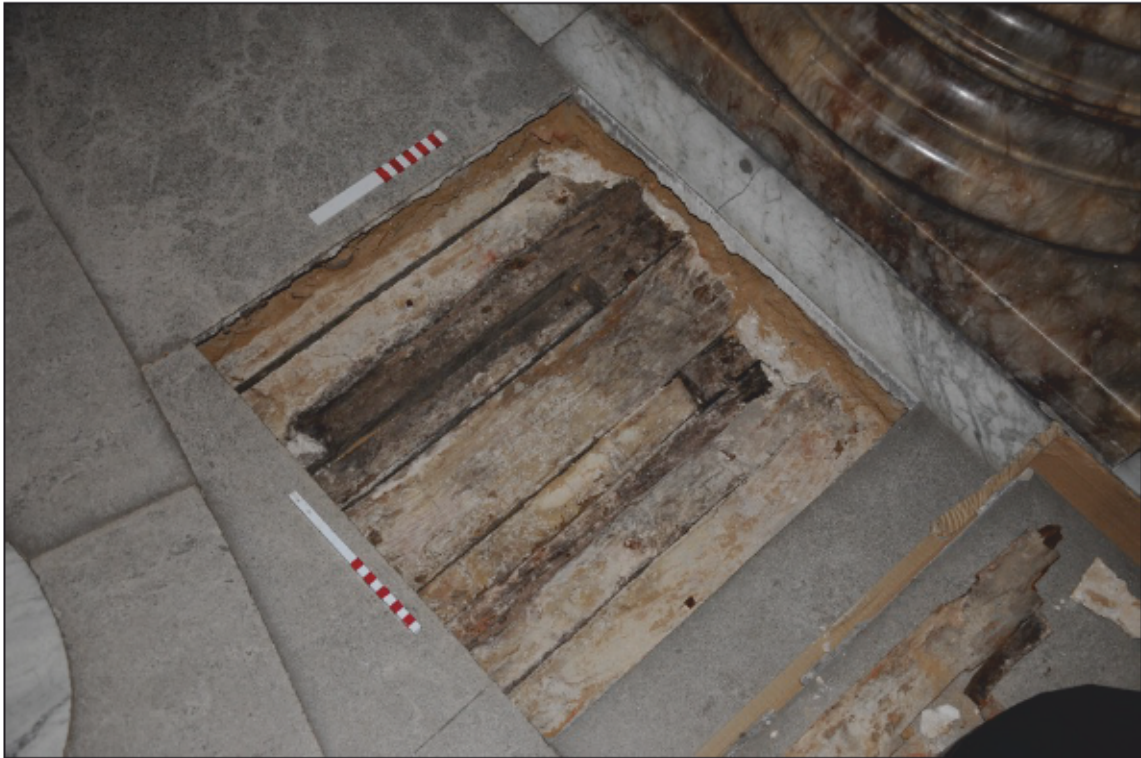
A single floor slab measuring 0.58m x 0.58m was lifted against one of the columns (**Appendix 2.15**) along the eastern side of the room (**Figure 3**), a site where water had historically been leaking from the roof above. The marble slab was 3.5cm in thickness, with a slightly beveled edge (**Figure 10**). Following the removal of the sand sub-floor (**Appendix 2.16**), a series of sections of timber planks orientated west-east were exposed. The timbers were set at differing heights and represent a historical repair or alteration in this area. Thin planks had been nailed into the top of the underlying floor beams, which had then been covered with a layer of mortar.

Appendix 2.15: General view of OB4, looking northeast; note inserted secondary planks (20cm scale). **Photo No.49.**

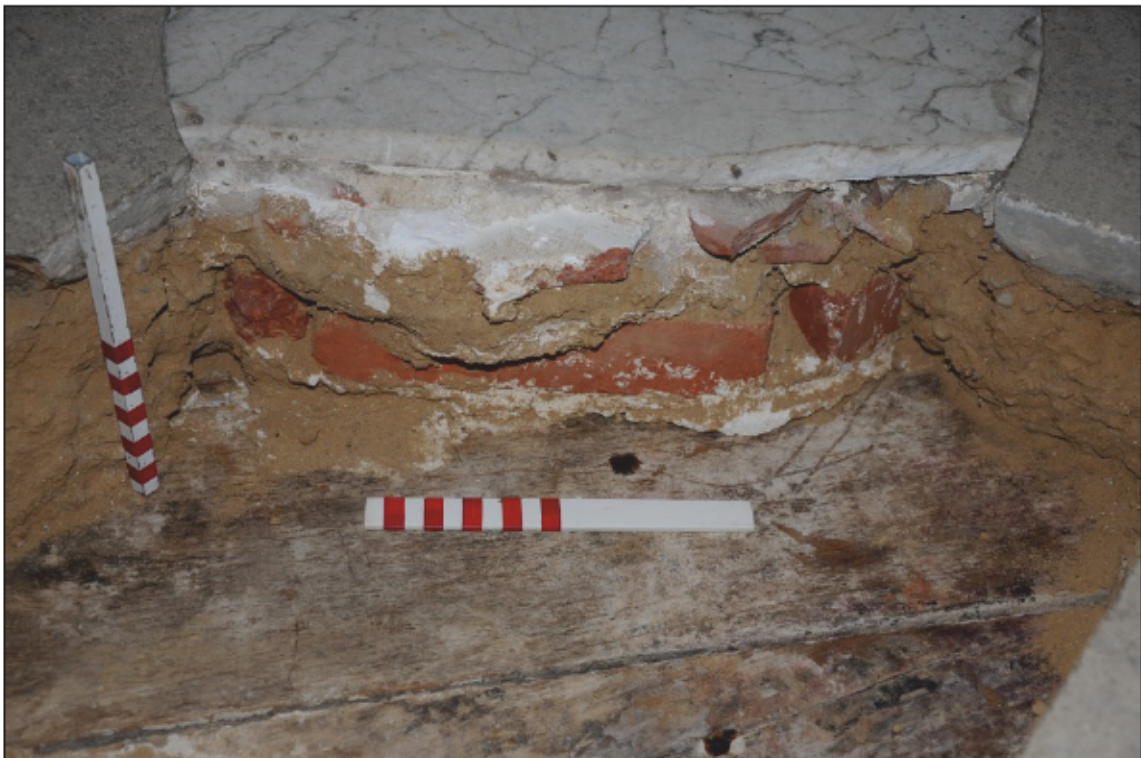
The edge of the foundations for two of the decorative marble petals were recorded, both of which were undercut by 2.5cm from the edge of the stone paving (**Figure 11**). One of these overhanging sections had broken off (**Appendix 2.18**), presumably resulting from a lack of support under the edge. The paving had a slightly beveled edge and traces of white mortar/grout were still adhering to the surface.

The weight of the floor was considerable and this is likely to have had a direct impact upon the deflection across the whole span of the room. In regards to the localised cracking that has occurred around the edge of a number of the marble paving slabs, it is suggested that this is partly due to movement within the sand matrix that supports them. The gradual loss of sand between the joints in the timber planks would account for a slight change in the density of the layer beneath the paving, and it has been noted that many of the mortared brick foundations beneath the principal decorative elements of the floor, such as the petals, roundels, or circular motifs are slightly undercut from the outer edge of the surface paving. In areas where the sand sub-floor has moved slightly, or if high pressure has been applied to the edge of the paving, the stone has cracked along the edge of the undercut foundation below.

Appendix 2.18: Detail of brick and mortar foundation below marble petal in OB5, looking south (20cm scale). **Photo No.60.**

4. The results of this recording exercise should be considered alongside the results of the structural survey and GPR survey, following which a rapid survey of the areas of cracking within the paving should then be undertaken to confirm whether it is mainly associated with areas where undercut foundations are understood to exist;

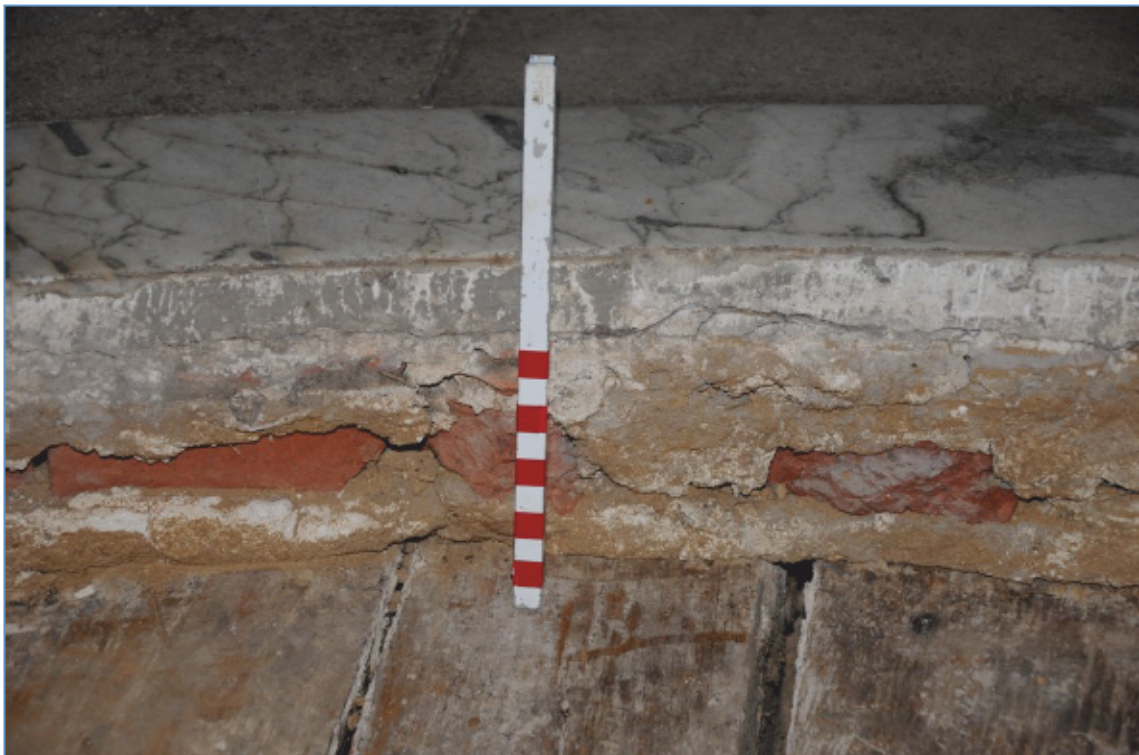
Appendix 2.24: Detail of brick and mortar foundation below outer arc of marble paving in OB6 (20cm scale). **Photo No.75.**

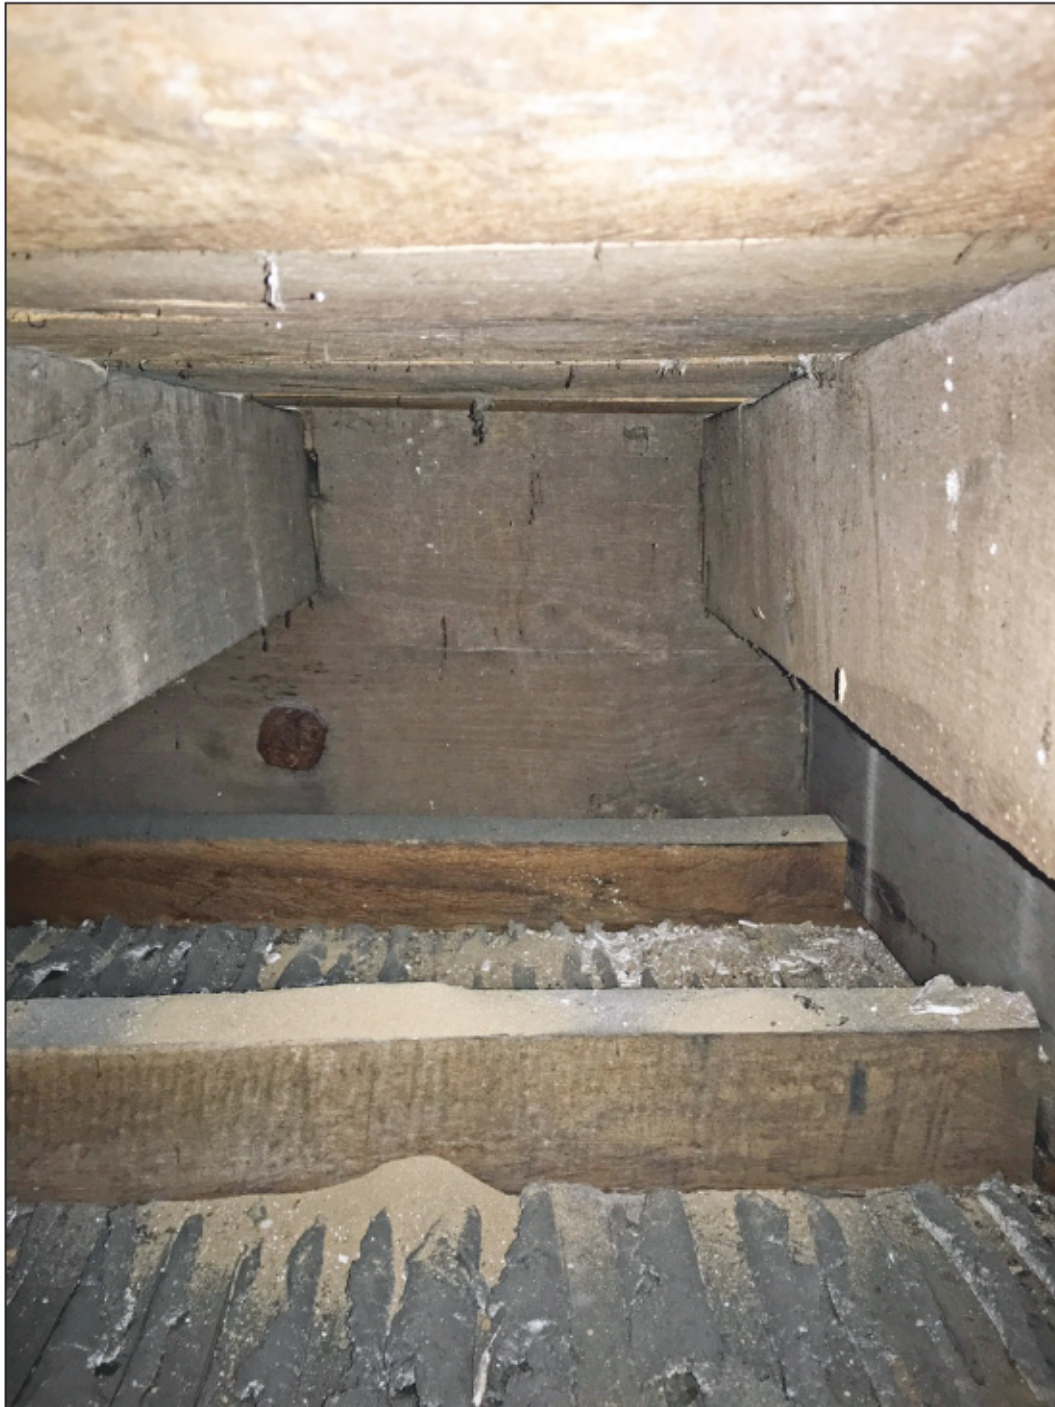
Appendix 2.28: View of floor structure below OB6, looking south; note bolt in floor beam. **Photo No.86.**

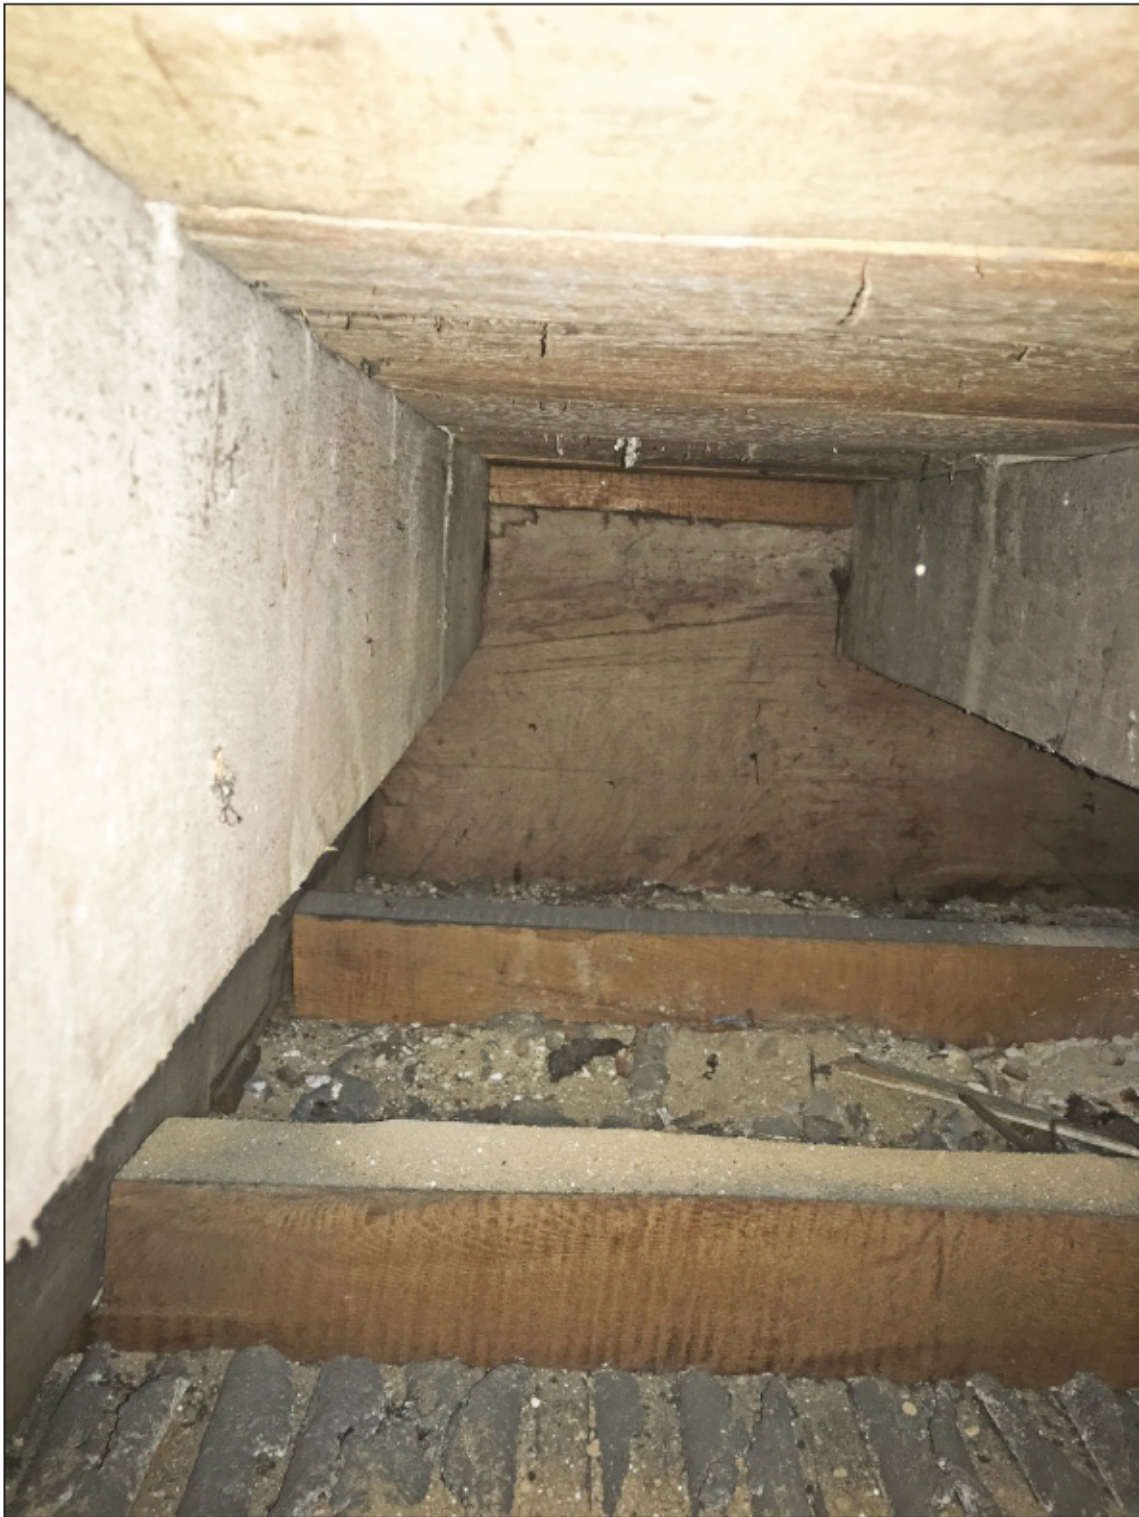
Appendix 2.31: General view of floor void in OB7, looking north; note ceilings joists extend under lower floor joist. **Photo No.96.**
