Glencoe Farm, Treen

Photographic Recording of Historic Barns

December 2010

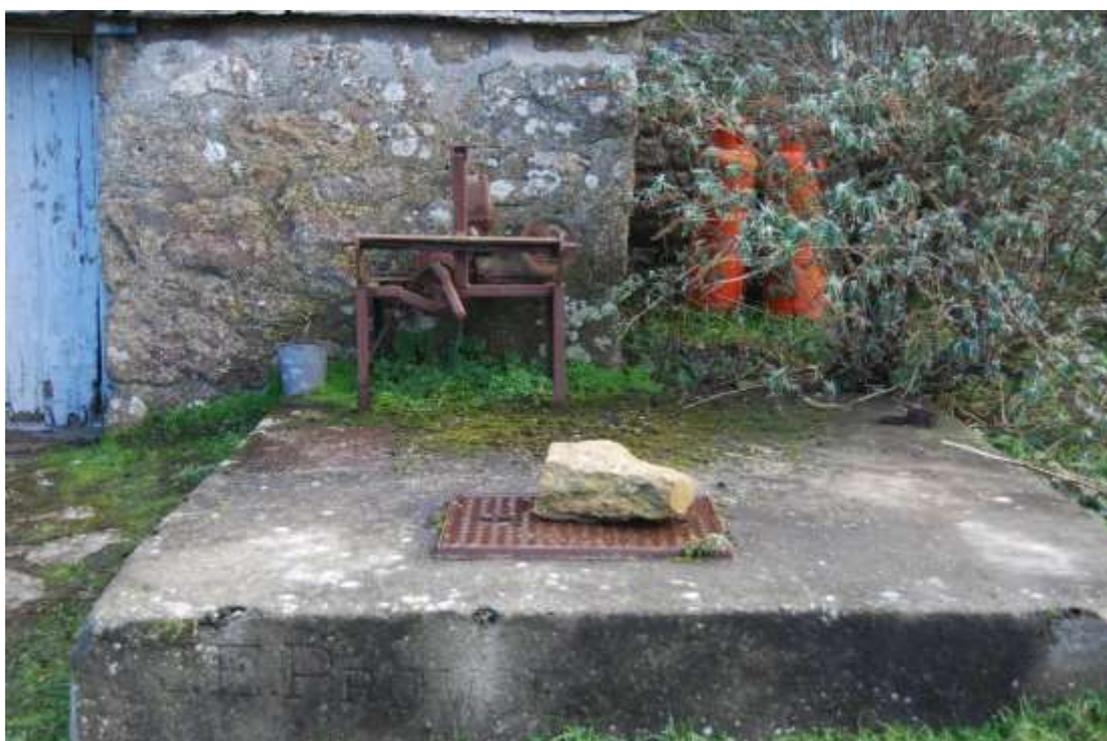
The building clearly functioned as a wash house and is sited adjacent to a handy water source – a well is located just outside the building, on the SW side of the doorway. Stand on a concrete platform overlying the wellhead are the remains of a tractor-driven water pump, which would have pumped water up to a header tank somewhere nearby.

Photo 6 Well head & pump

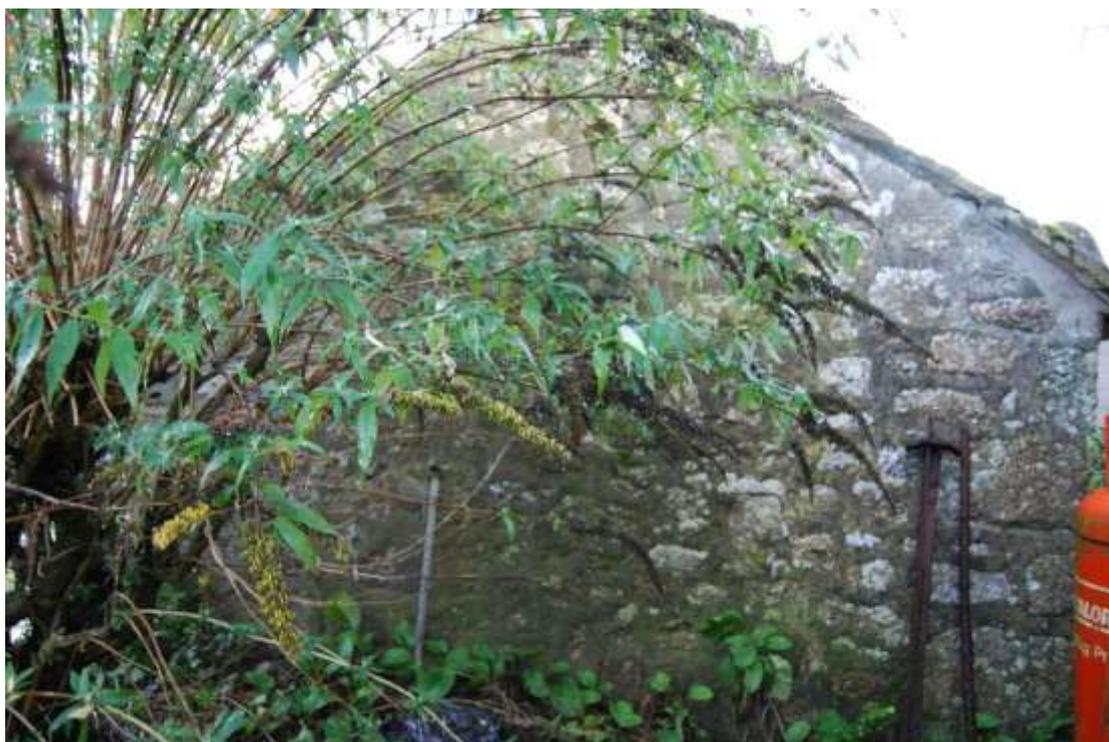
Evidence for alteration is visible at the SW end of the building where the SW side of the doorway has been rebuilt. The SW gable wall appears more uneven by contrast and may be original. On its inside stones projecting out from the wall face look superficial like the remains of a fire place but may be part of an effort to strengthen this section of (original?) walling; ironwork has also been used to patch up its base.

Photo 7 Barn 1 exterior SW gable

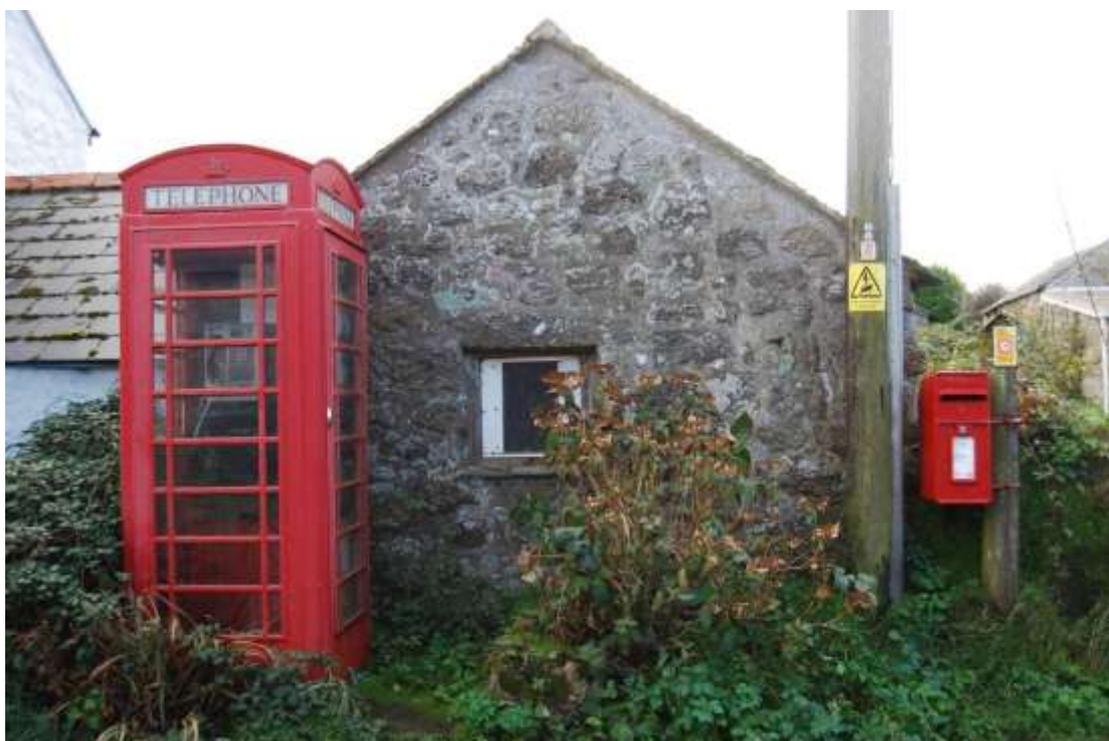
The outer face of the NE gable wall shows signs of later re-facing / rebuilding associated with the insertion (or enlargement) of the window here, with further evidence of modification to the right of the window where there is a distinct vertical line in the stonework.

Photo 8 Barn 1 exterior NE gable

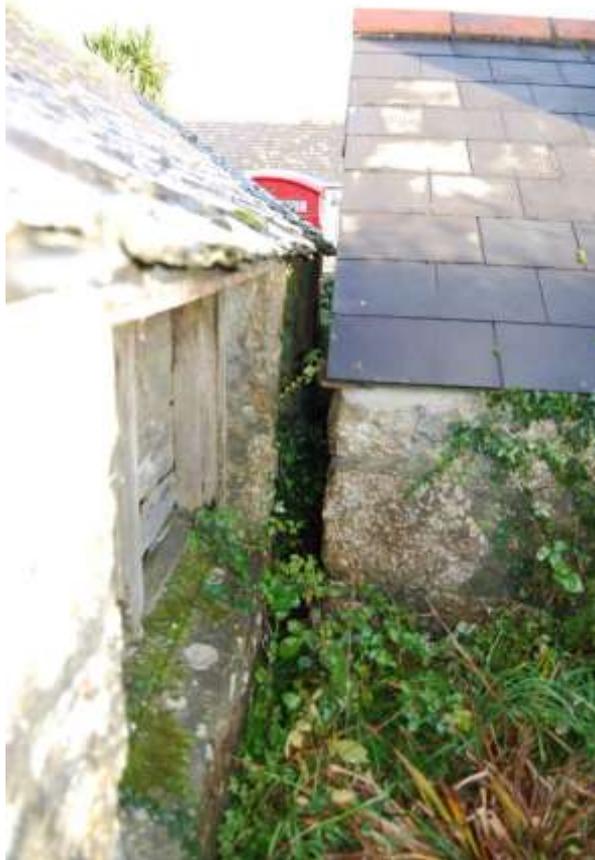
The SE wall of the building also appears to have been rebuilt (including the insertion / conversion of the window) and its outer face is only 39cm from the adjacent chapel, making it likely that this wall face had to be built / rebuilt back to front.

Photo 9 Barn 1 exterior SE wall, showing close proximity to chapel wall

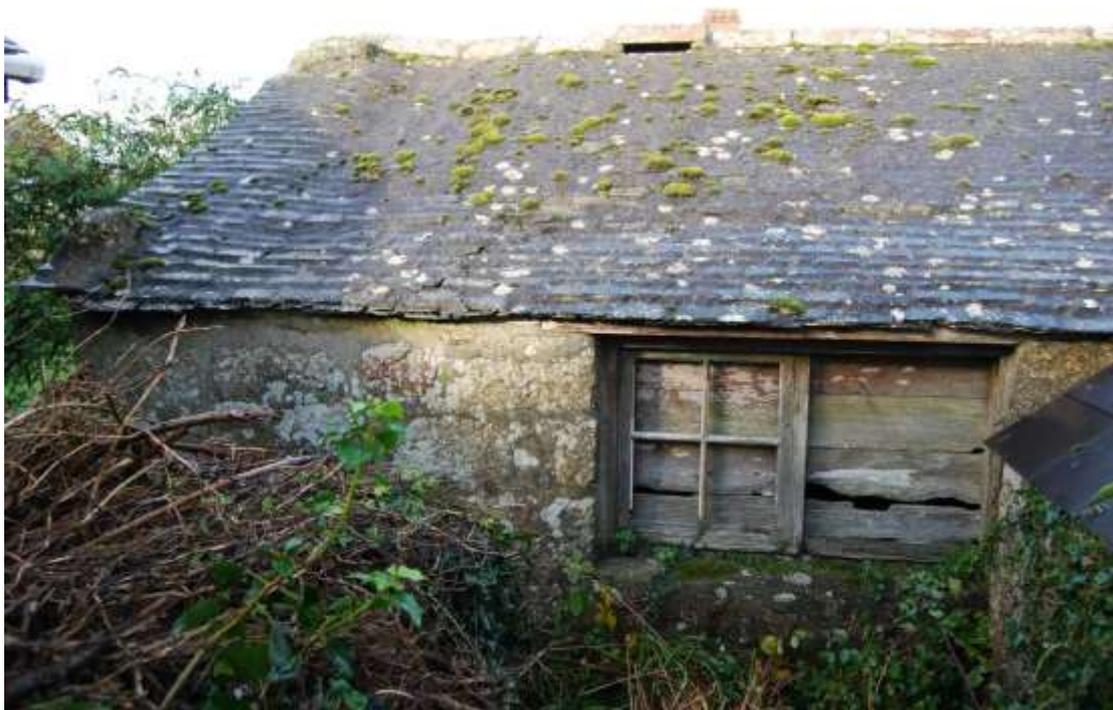
Opposite the doorway, in the SE wall, the larger window opening has wooden lintels and cement-mortared sills (externally and internally) and houses the remains of a horizontal sliding sash window (now boarded up on the inside). The window frame survives, together with the remains of one (fixed) sash and the recess in which the (no longer surviving) moveable sash would have slid. There are traces of the original greeny-blue paintwork.

Photo 10 Barn 1 exterior SE wall, showing remains of sliding sash window

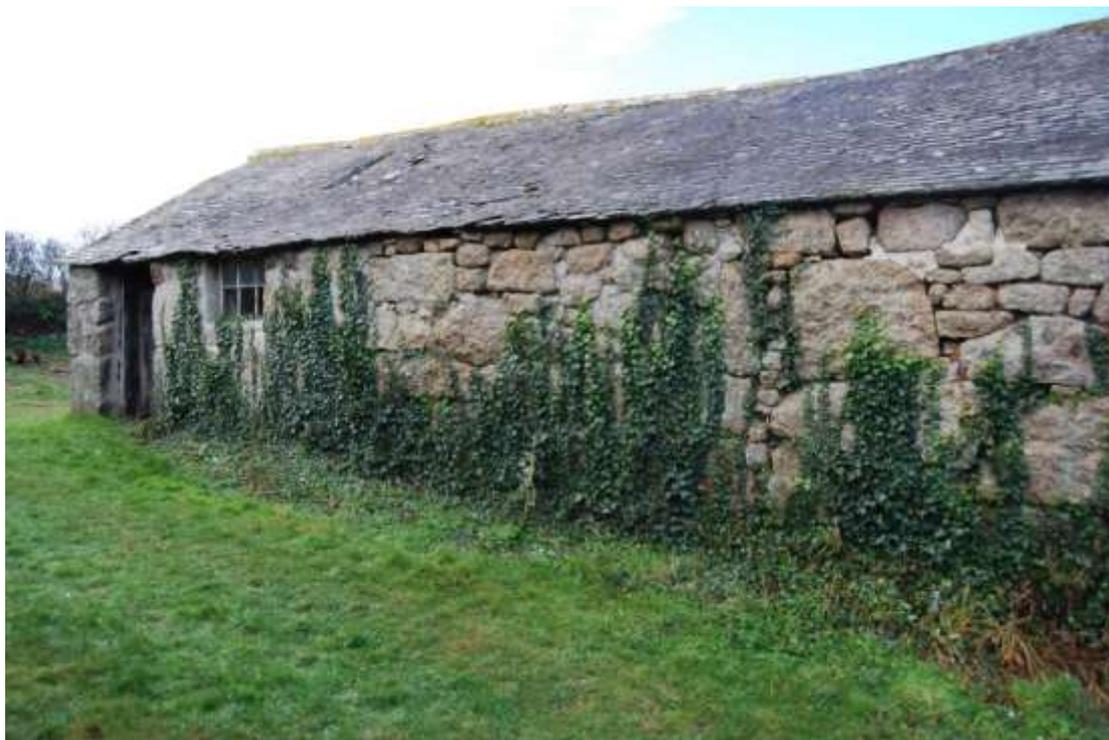
There is a small, single-paned sky light inserted into the SE roof pitch, above Room A. The roof is cracked and holed and, despite some repairs, in a very dilapidated state, with a granite stone cemented onto the bottom edge of the NW side of its SW gable edge in order to weigh it down.

Photo 15 Barn 2 exterior SE wall from E

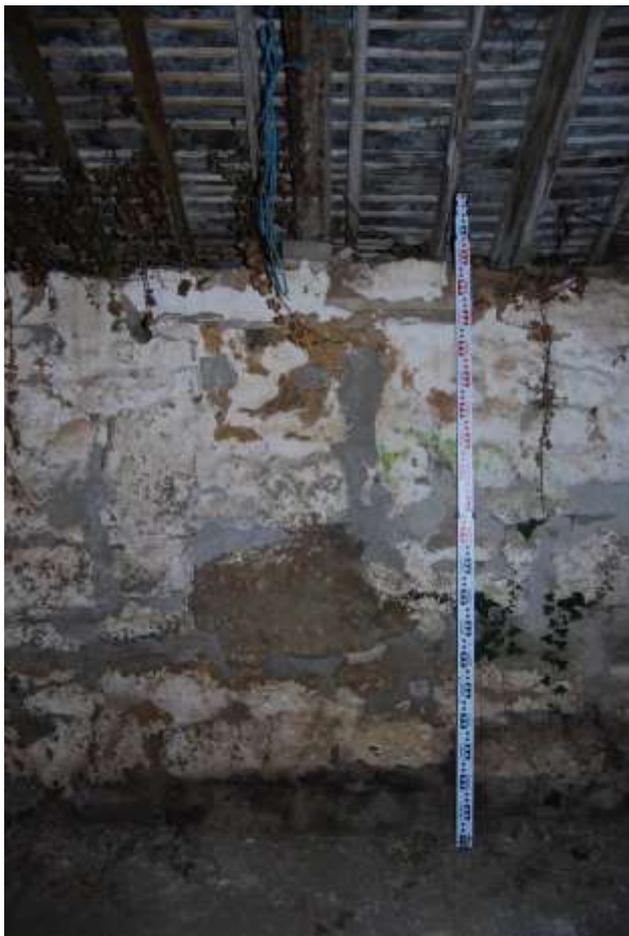
There is also a blocked opening in the SE wall of Room B, visible in both the outer and inner wall face, though not in a way that provides clear evidence of the size and function of the original opening. Outside it appears as a vertical edge in the stonework extending down to ground level, suggesting a former doorway. Inside, partially obscured by lime wash, the evidence suggests a blocked window, with remnants of a wooden lintel.

Photo 24 Barn 2 Room B interior blocked window in SE wall

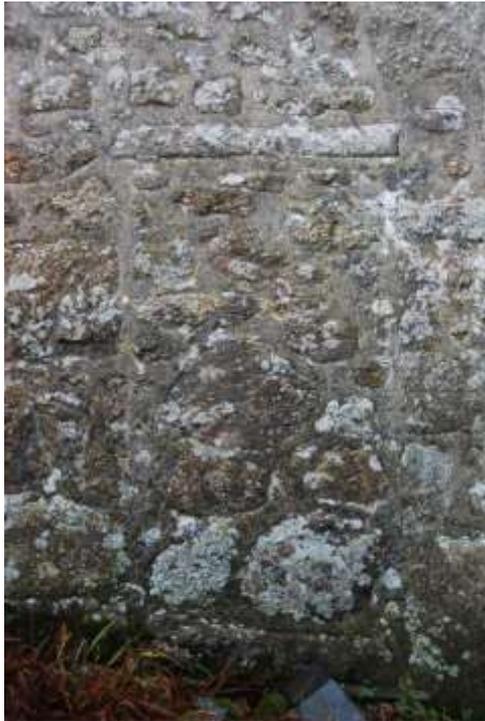
The blocked doorway in the SE gable may also relate to Phase 1. It has a granite sill stone and, interestingly, re-uses as its external lintel a sill or lintel stone from a mullioned window, salvaged from a house of earlier (pre-1800) date.

Externally, the doorway looks like it was blocked in one go (or possibly two as the stones used in the upper part of the blocking are smaller than those below). Internally, the upper part of the doorway is obscured by heavy lime washing, but in the lower half there is evidence for the opening having been modified four times (although 1 and 2 may be part of the same event):

Photo 27 Barn 3 Room B exterior SE wall blocked doorway, with part of mullioned window re-used as lintel

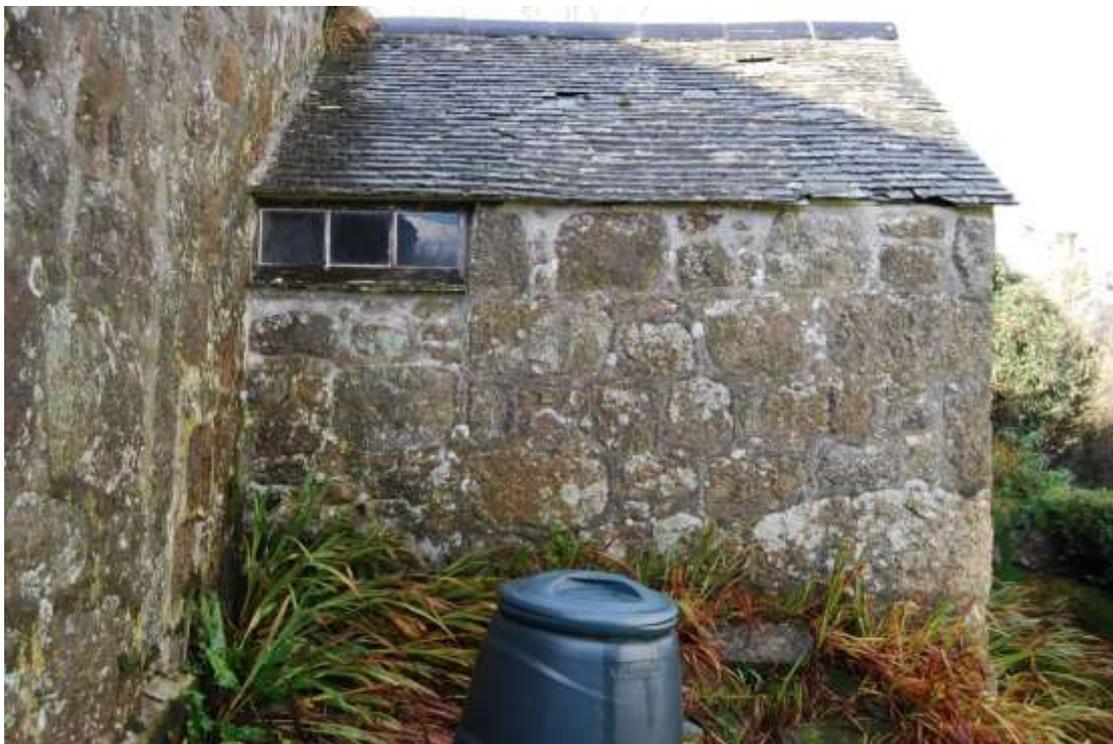
The Phase 2 building (Room A) survives relatively intact. Its original SE doorway extends to roof height, with no lintel. It was presumably blocked up during Phase 3, when the connecting doorway to Room B was cut through the SW wall, which was partly rebuilt in the process. A small fixed window of three panes, horizontally

Photo 29 Barn 3 Room A exterior SE wall, blocked doorway

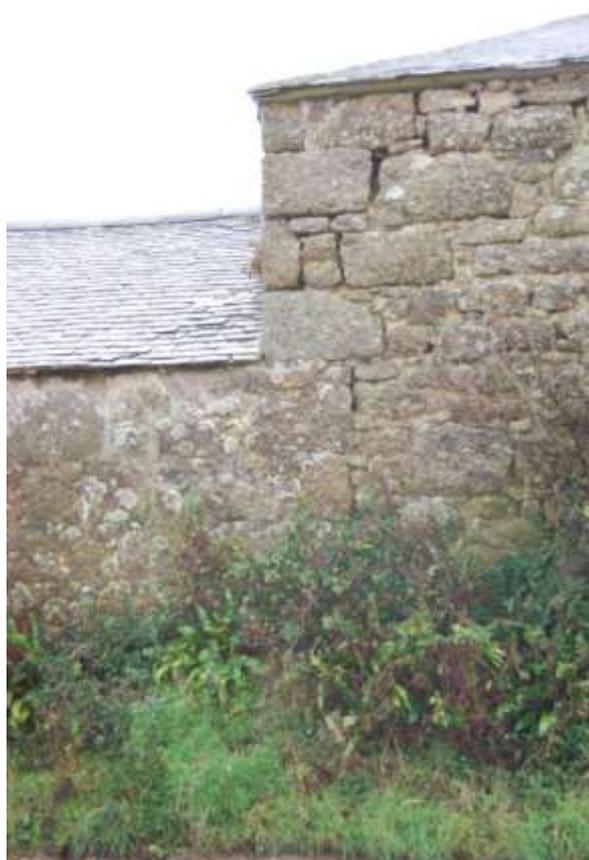
The phasing evidence contained within the structure of the existing building indicates that the NW half of Room B was built against Room A, which is, therefore, earlier in date. However, the location and plan of Room A does not concord with that of the building shown on the Tithe Map, and it is possible that the latter represents instead the SE half of Room B (particularly as the map shows it connected by a boundary wall to Barn 2, similar to today). If this is the case, Barn 3 has three key phases of development.

Photo 31 Barn 3 exterior NW wall, junction between Rooms A and B
