NORTHLIGHT HERITAGE	Former Sun Foundry
REPORT: 32	280 Kennedy Street, Glasgow
PROJECT ID: 4278161	
DATA STRUCTURE REPORT	Level 1 Standing Building Survey

Former Sun Foundry

28 Kennedy Street, Glasgow

Data Structure Report

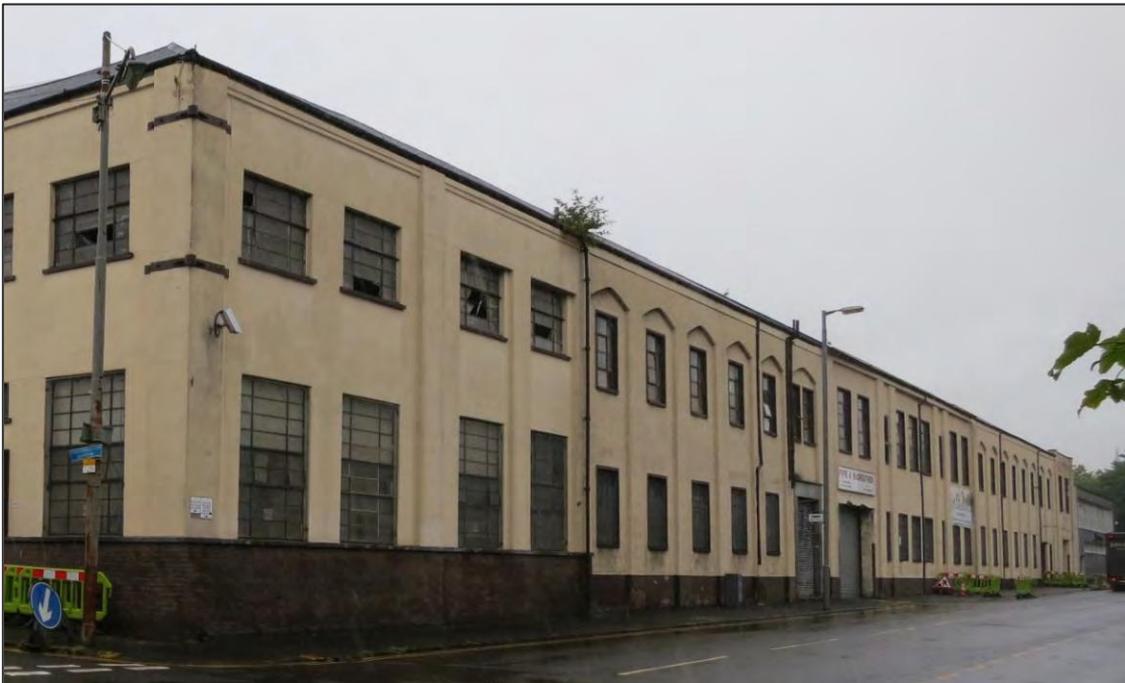
Plate 8: Looking east along the Kennedy Street frontage on 23rd July 2012. The roof has been reduced and altered from Plate 7 and the remnants of central tower and dormer windows have been removed. The eastern tower has been demolished (c.1970s?).

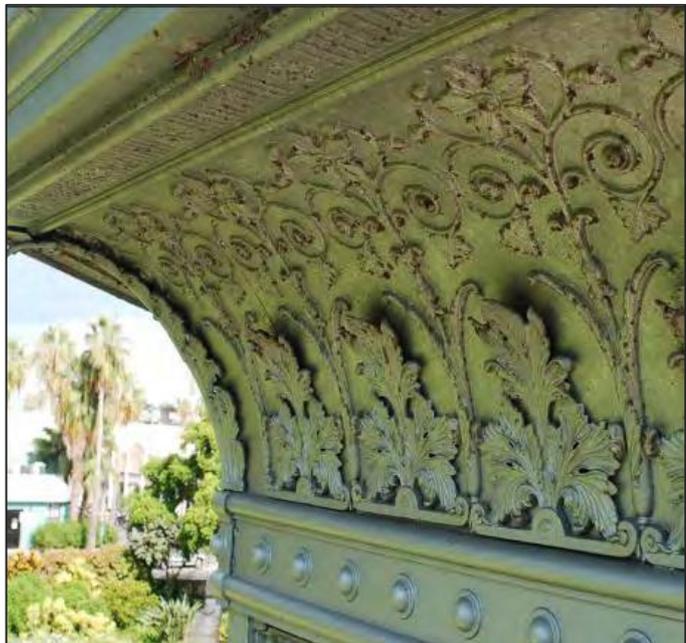
Plate 10: Detail of the fascia on the Hamilton Park bandstand, prior to conservation. Image courtesy of David Mitchell.

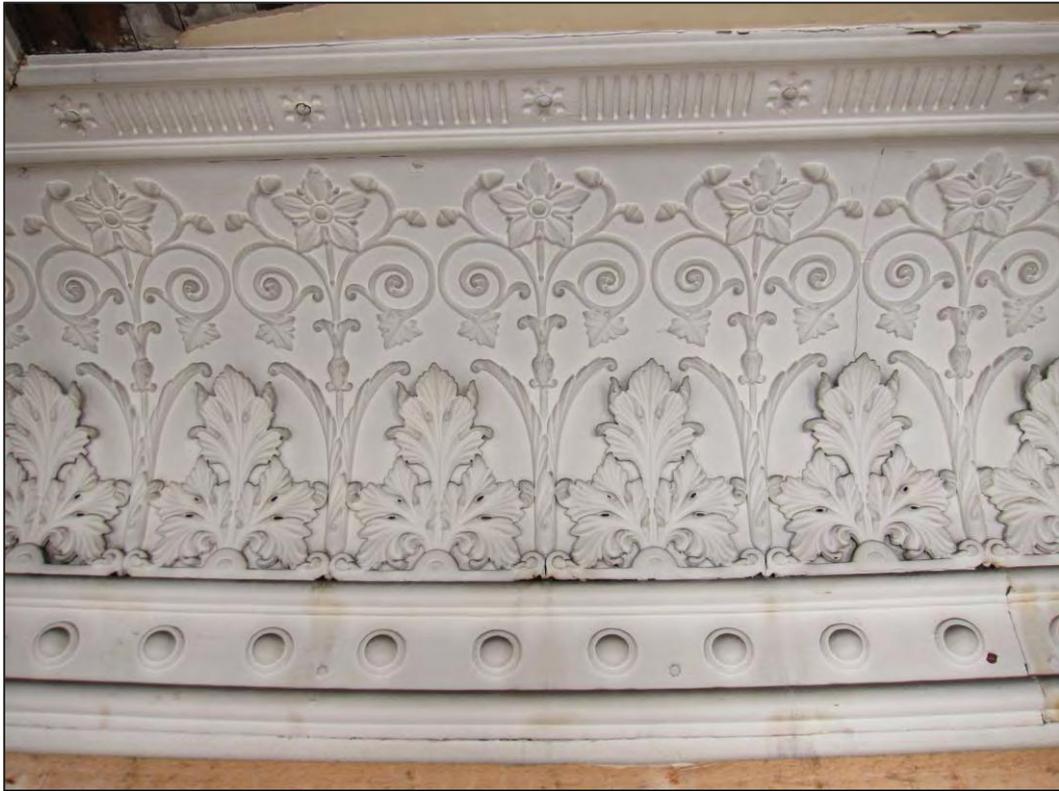
Plate 12: Detail of cornice/facia on northern wall of Room A

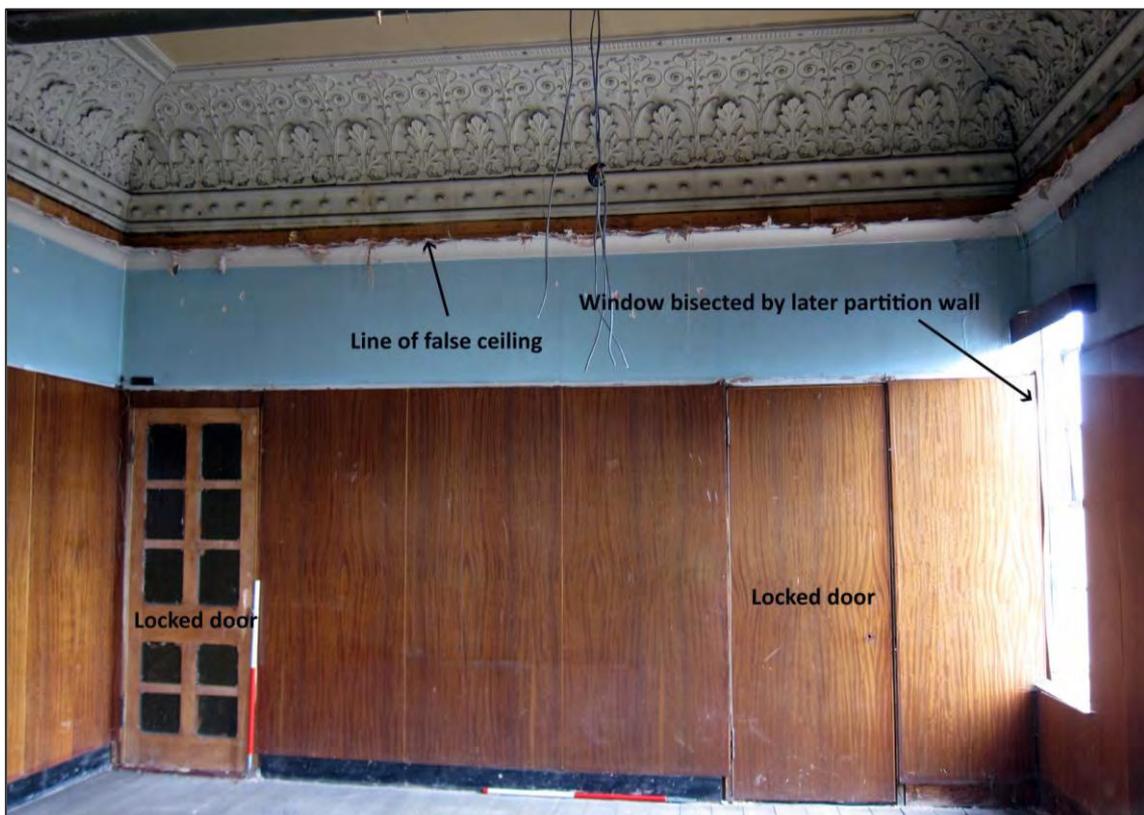
Plate 13: Cornice/facia on eastern partition wall & window cut by wall

The eastern wall clearly cut across one of the windows fronting onto Kennedy Street (Plate 13) indicating that it was a later insertion, while the window would have originated from the initial construction of the Sun Foundry. On the opposite side of the eastern partition wall was at least one, possibly two, bathrooms. No access was possible to this area due to the doors being jammed. The area to the west of Room A was cleared of all fittings with only the two windows onto Kennedy Street and a fireplace being present.

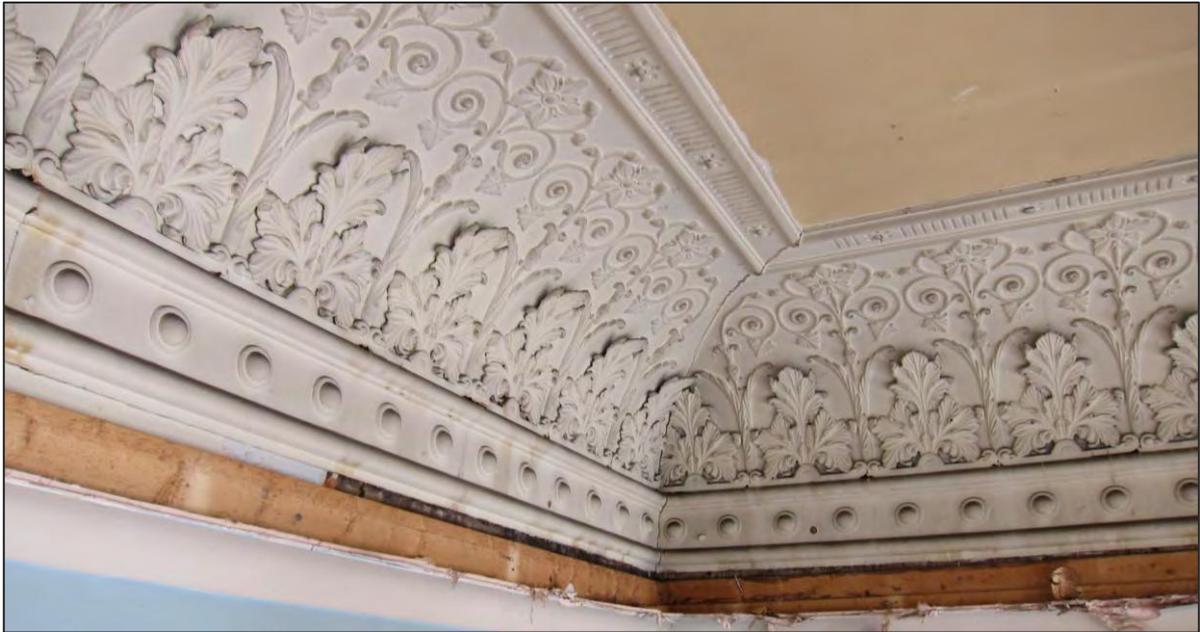
Plate 14: Cornice/facia at join of northern & eastern walls

The cast iron cornicing in Room A was in relatively good condition (Plate 14), was present on all four walls and was painted white although some discolouration had occurred. The only sign of damage was a roughly vertical crack on the southern wall section which had been repaired with plaster.

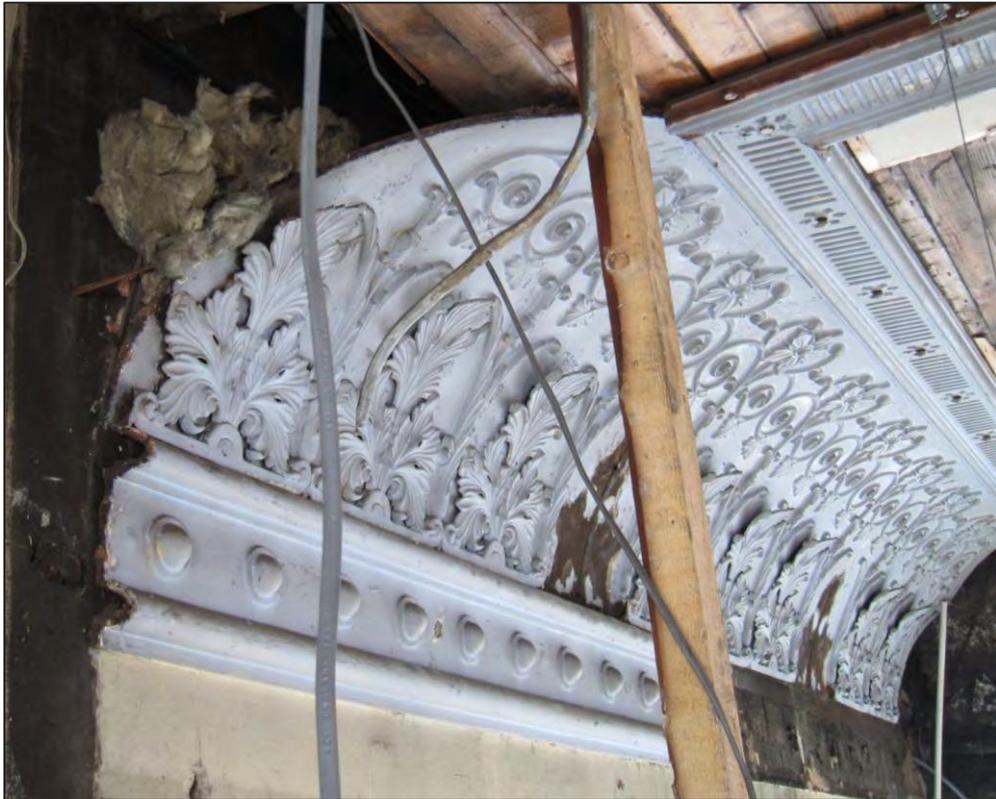
Plate 15: Detail of cornice/facia construction at south western corner of Room B

The cast iron corning in Room B had, in the majority, fallen off or been removed. Only the western wall (Plate 15 & 16), contained all three sections while the southern ceiling contained the ceiling trim only. Two of the relief leaf motifs had fallen off the section mounted on the western wall. The cast iron work here was painted light blue but a cream paint was visible beneath this in areas.

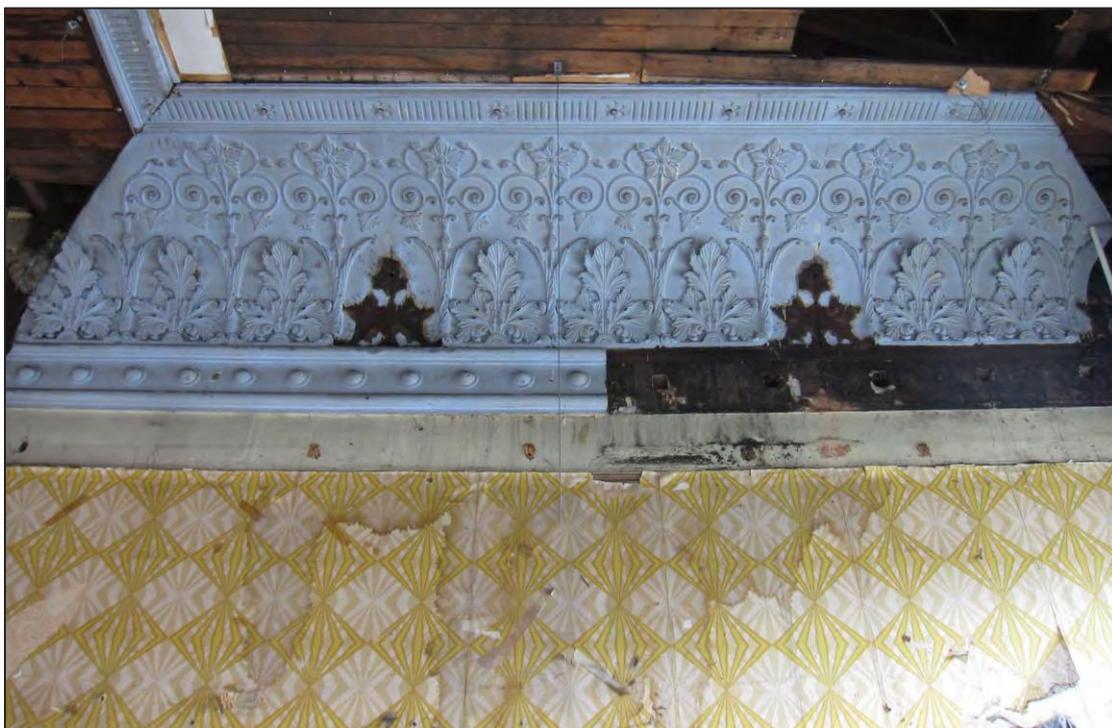
Plate 16: Detail of cornice/facia on western wall
