The Church of St Denys, Ibstock, Leics.

Archaeological Observation and Recording

PA report no PAL 2013/27

February 2013

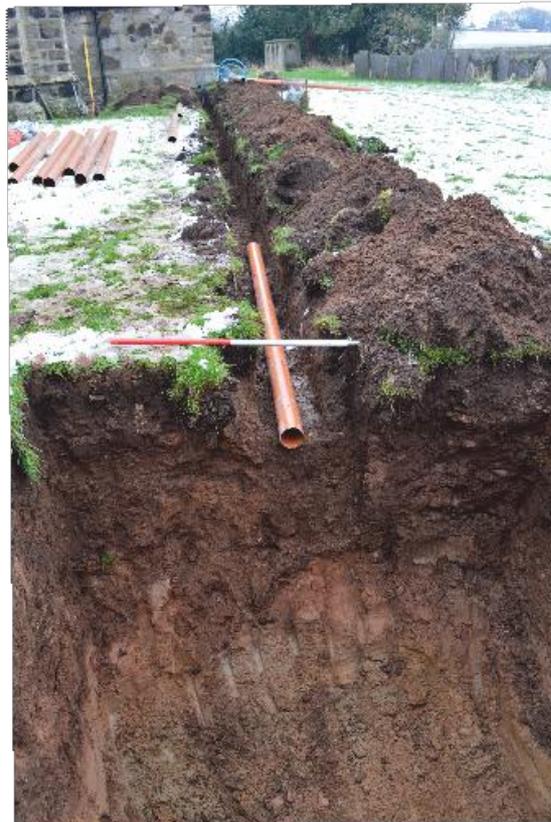
(Pl. 1). It was 15.35m long, 0.30m wide and 0.50m deep (Pl. 1). A shorter trench was dug diagonally from the junction of the vestry west wall with the tile apron at the base of the south aisle south wall to connect the foul water from the kitchen unit in the south aisle to the main trench (Fig. 2, Pl. 2). The Victorian brick foundations of the vestry were revealed (Pl. 3).

Pl. 2 Pipe trench looking east from the septic tank pit. Scale 1m

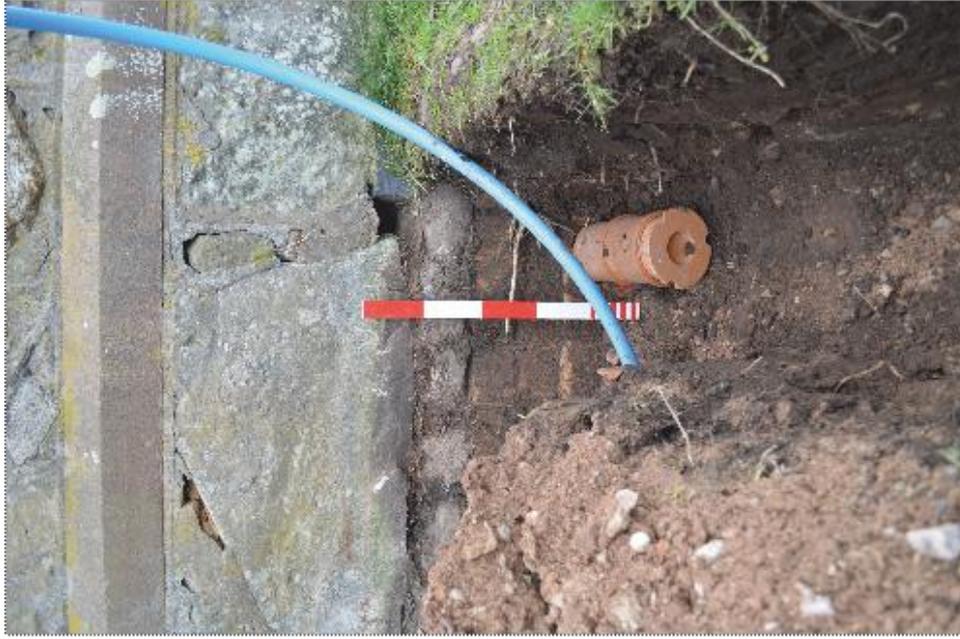
The topsoil beneath the turf, **100**, was a mid-dark brown sandy loam and was 0.20m deep. It overlay the graveyard soil **101** which was a mid-brown soil of similar texture to the topsoil. This was seen to the base of the trench, although in one or two areas the underlying natural sand and gravel **102** was visible in the base of the trench (Pl. 4).

Pl. 4 Toilet waste pipe at base of vestry wall, showing brick foundations, looking east. Scale 0.50m

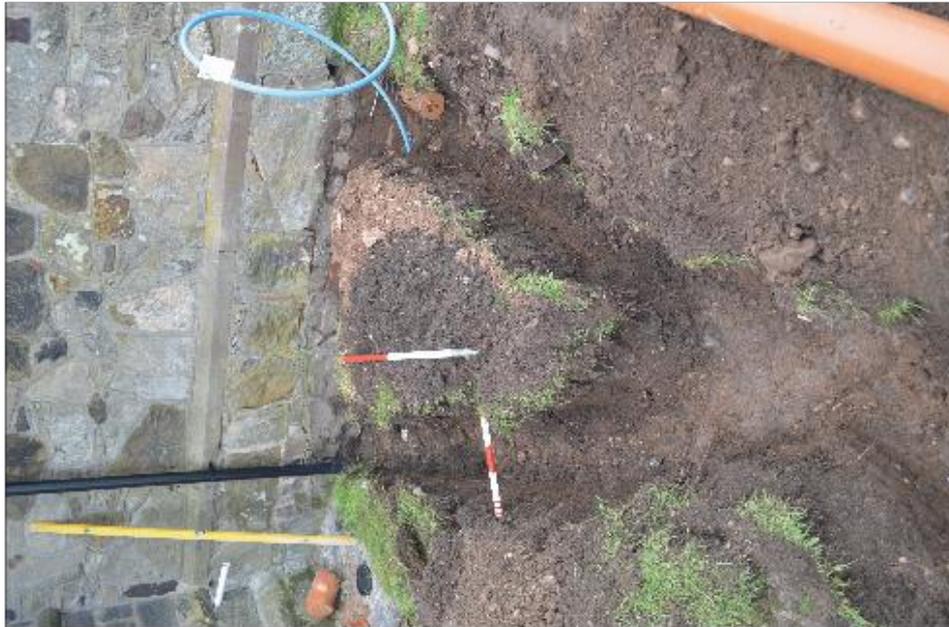
Pl. 3 Pipe trenches next to vestry wall for the kitchen waste (left) and toilet (right) looking east. Scales 0.5m and 1m

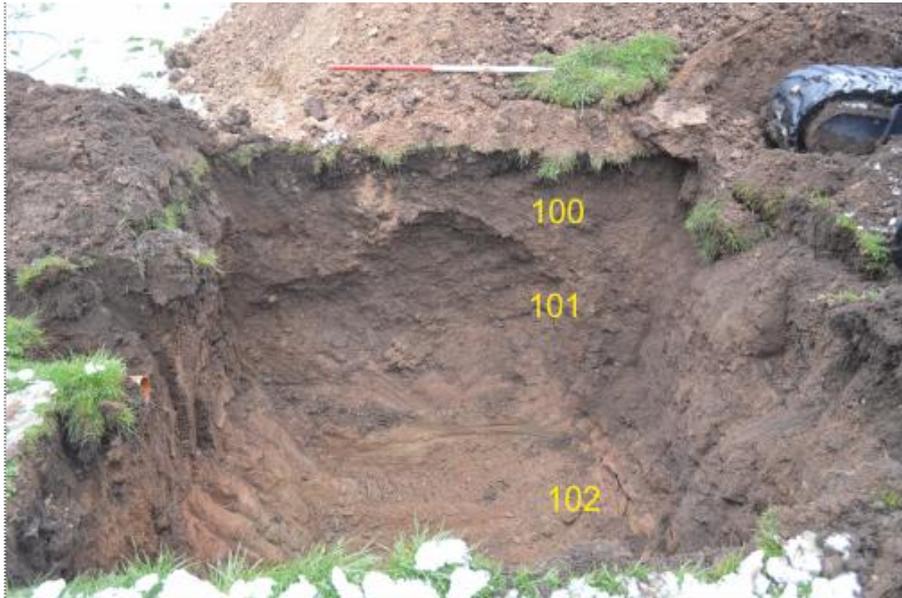
A near-square pit measuring 2.27m x 2.35m was excavated at the end of the trench to accommodate the Klargestep septic tank (Pl. 5). The sequence of deposits was the same as observed in the connecting trench. A few pieces of bone were retrieved from the graveyards soil **101** during the excavation but no burials were seen. The bone was reburied in the pit after the septic tank was installed.

Pl. 5 Septic tank pit, showing natural sand and gravels beneath the graveyard soi, looking south. Scale 1m

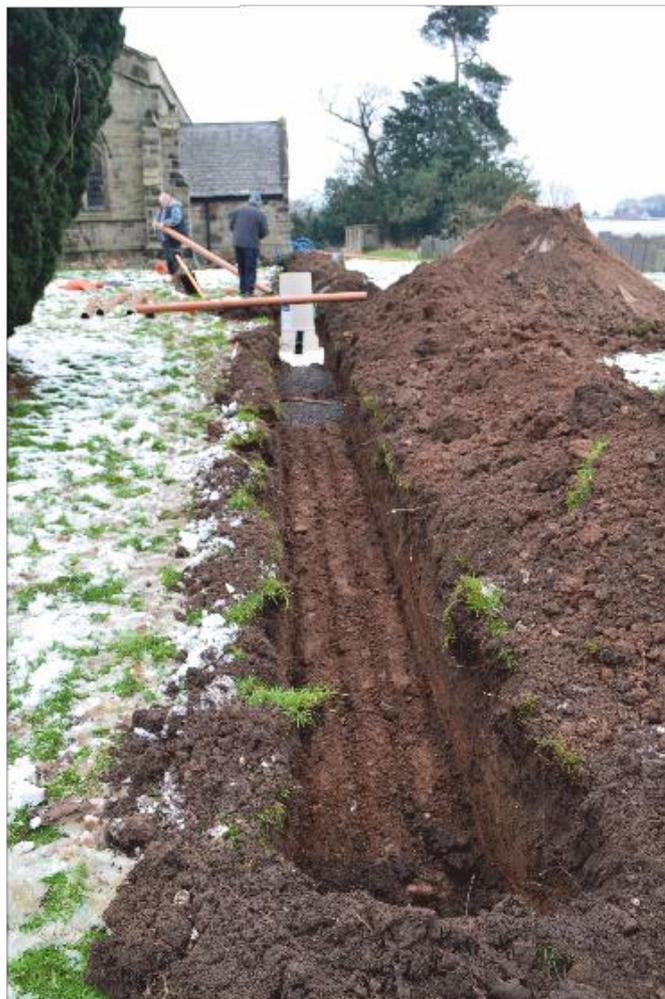
Extending west from the septic tank was a trench containing perforated piping which acts as a soakaway for the septic tank (Pl. 6). It was the same dimensions as before and extended to the churchyard boundary, 12.45m west of the septic tank pit.

Pl. 6 Soakaway trench looking east towards septic tank pit.
