# The Old Vicarage, Tadcaster

Report on investigations

West Yorkshire  
Archaeology Service

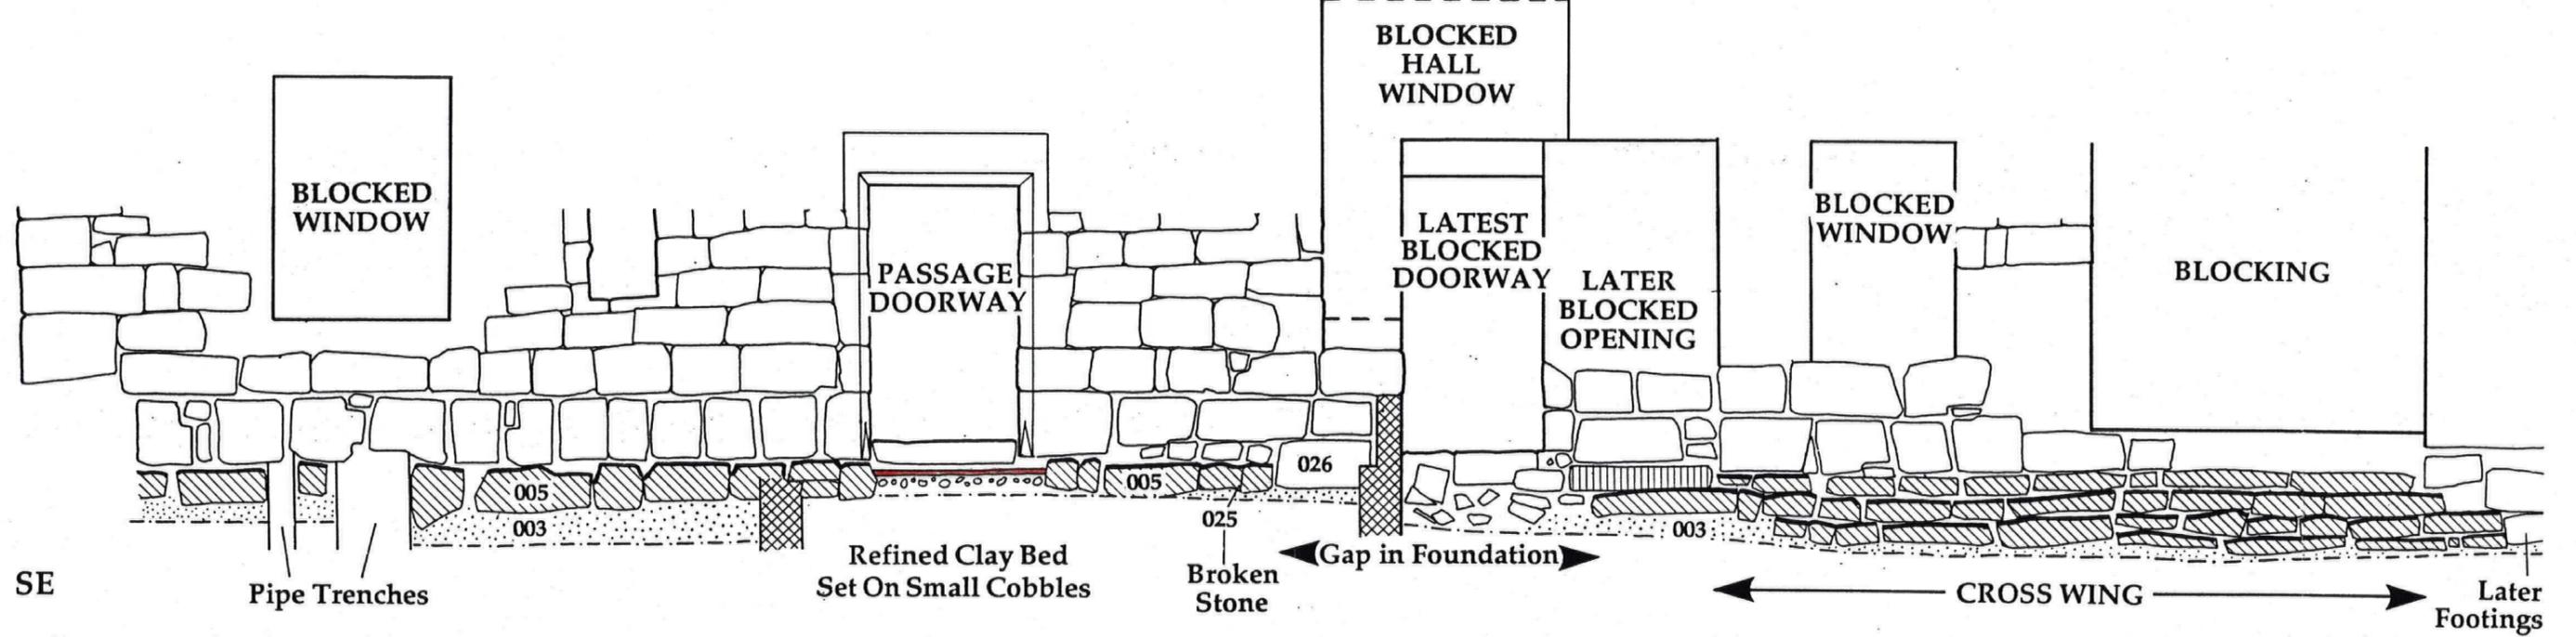
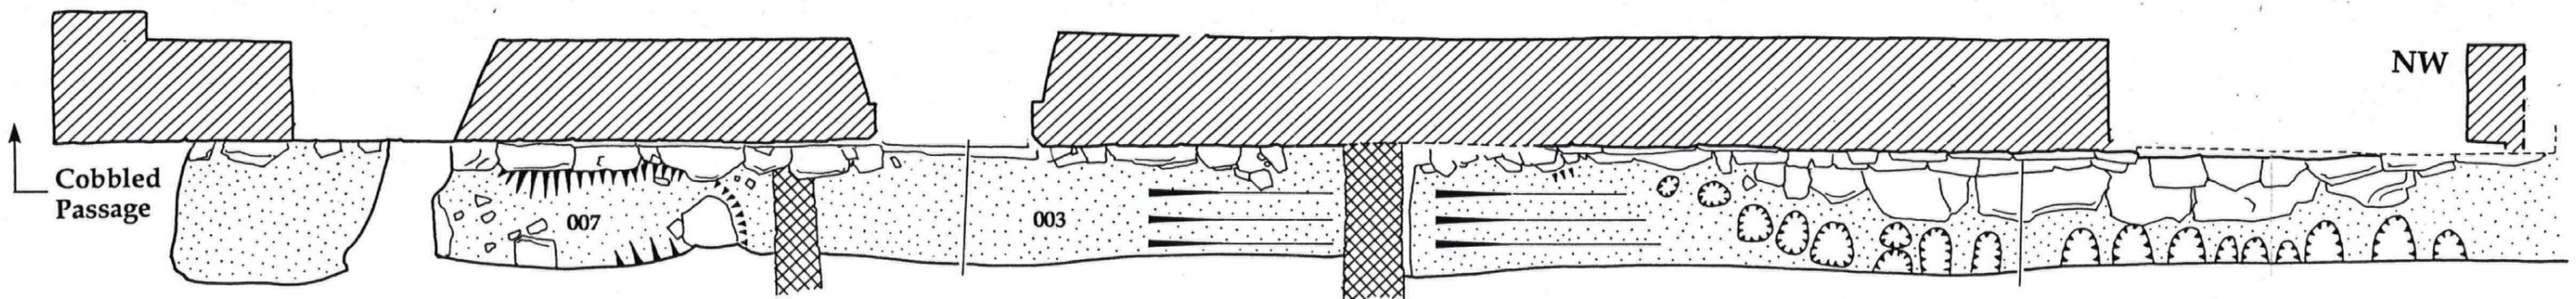
NORTH-EAST SIDE TRENCH

The character of the foundation below the north-east wall varies considerably, as do the layers which have built up against it. The remains, shown in elevation and plan in Figure 2, are described from south-east to north-west (left to right on the drawing).

The offset foundation south-east of the passage doorway was formed by a single line of irregular, unmortared limestone blocks (005). These had been set directly upon the surface of the clayey loam subsoil (003). The foundation had been cut by recent service trenches, and in the area between the passage entrance and the kitchen window a pit or drainage sump (007) had been dug just in front of the foundation.

The foundation was interrupted by the passage doorway. The existing threshold stone was clearly an insertion: it had been slotted between the jambstones. The excavations revealed the position of its predecessor, the ends of which had supported the broach-stopped jambstones. It had been set on a thin layer of refined, plastic clay which was itself founded upon small cobbles. The surface of the existing threshold is about 110mm above that of its predecessor.

In front of the passage doorway the surface of the subsoil was level, and only about 170mm below the surface of the threshold. The absence of erosion (in marked contrast to the area to the north-west), suggests that there had been some kind of hard surfacing—probably flagging—outside the doorway.

The row of offset foundation stones resumed on the north-west side of the doorway and continued for a distance of 1.5m; the north-west end stone (025) had a broken face, as if it had once projected outwards from the face of the wall, and had been roughly cut back. Beyond it, there was an ashlar block (026) identical to the walling stones above and flush with them. It marked the beginning of a 2.5m gap in the offset foundation. The broken foundation stone and the gap suggest that originally there had been a small outward projection of the building at this point. The implications of this for the structural history of the building are discussed below (Section 8). The former existence of such a projection could not be confirmed, since there were no foundation blocks running outwards from the wall. The erosion of the subsoil and the disturbances caused by more recent extensions would, however, have obliterated any evidence which might once have existed.

On the north-west side of the gap the offset foundation recommenced but its character was markedly different. It was composed of thinner, longer slabs, stacked up into receding courses. The depth of the courses increased as the surface of the subsoil sloped downwards to the north-west. The slope of the subsoil surface is itself significant. To the south-east it began close to the entrance passage, but occurred only in front of the foundation: the stones themselves were seated on a ledge of uneroded subsoil. North-west of the gap, however, erosion had clearly taken place before the foundation stones were laid down. This and the change in character of the stonework indicate two distinct phases of foundation. The cause of erosion was gardening: a series of small scoops in the surface of the subsoil had been created by spade digging.

Another break in foundations occurred below the threshold of the passage doorway. The jambstones of the door surround did not line up precisely with the gap in the foundation: on Figure 2 it can be seen that the right-hand jamb oversails the footings. This is, admittedly, a minor point of detail. Nevertheless, considered along with the indications of an earlier projecting hall window, as well as with the clear signs of rebuilding in the south-west wall on the opposite side, it does provide grounds for suggesting that the Vicarage as it survives is a late medieval rebuilding of an earlier timber house. Irregularities in the coursing of the south-west wall suggest building or rebuilding in stages; these coincide with changes in the character of the foundations. One of the window lintels has been identified as a reused fragment of medieval grave slab.

The foundations of the cross-wing in the north-east trench were undoubtedly of secondary construction: they had been laid after a period in which the site of the cross-wing had been part of a garden. In view of what has already been proposed on the early development of the building, it is possible that the addition of the wing occurred in the timber phase, before the late 15th-century rebuilding in stone.

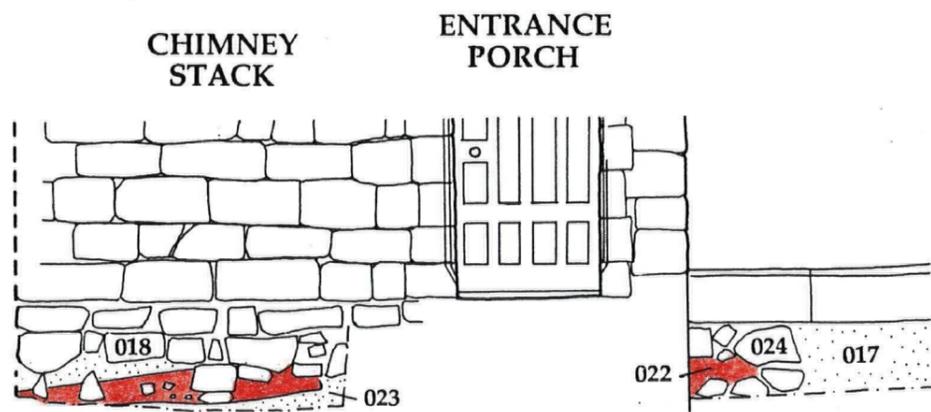
NORTH-WEST END TRENCH

Excavation outside the north-west end of the building was hampered by recent brick sub-structures, and by the need to retain access to the door. Nevertheless, it revealed foundations and other features from medieval times onwards.

The earliest remains were features—pits or postholes—cut into a silty loam layer 023. These remains were examined only superficially: they were below the level of the footings, and therefore related to earlier occupation; they could not, in fact, have been investigated adequately in the limited area excavated. Nevertheless, the associated pottery indicates that they mark occupation during the 14th and 15th centuries, if not earlier.

The stone footings of the present projecting chimney were founded upon a sticky refined clay (022) which largely sealed 023. The clay was similar to that used to bed the threshold stone at the north-east end of the cross passage. The foundations were less well constructed than those at the north-west end of the north-east side, which appeared to turn the corner and support this end wall. Therefore the projecting chimney may have been additional.

The entry porch, to the side of the chimney stack, did not have such deep foundations; it was probably a Victorian extension. It seems, however, to have replaced a shallower but longer projection, visible in the trench beneath the side wall of the entrance porch. This projection extended a little way beneath the adjacent foundation of the Victorian cross-wing: it is visible on the accompanying drawing (numbered 024). It may be the foundation of a first-floor latrine projection.

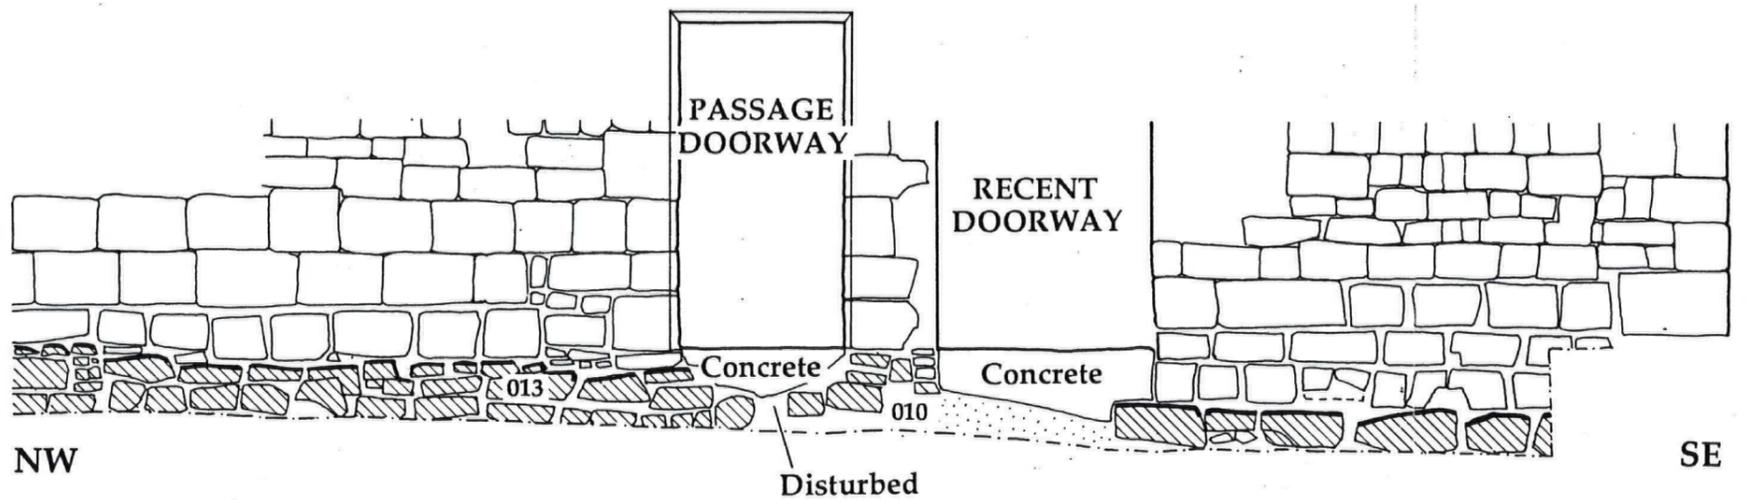
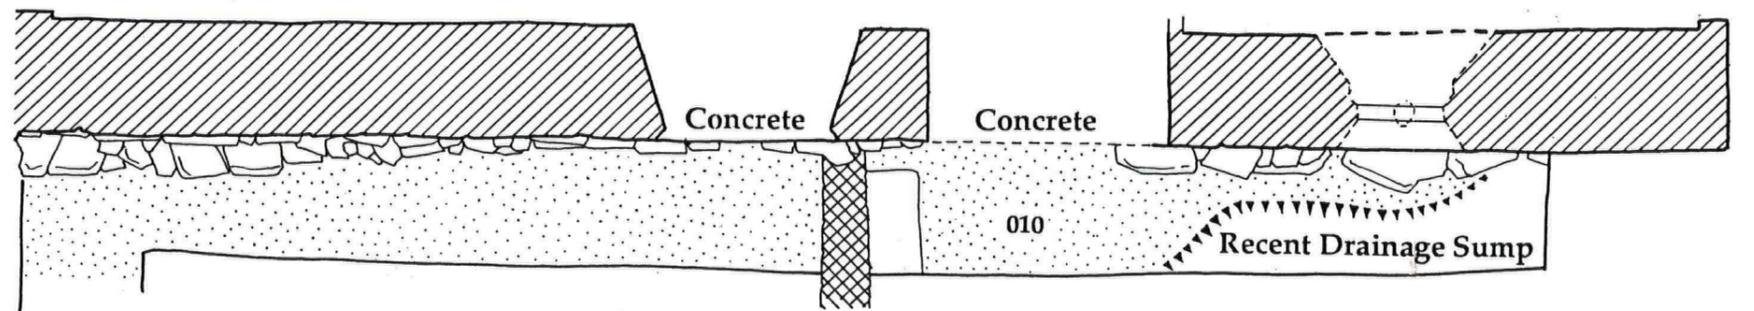
SOUTH-WEST SIDE TRENCH

A further trench was excavated along the south-west side of the building. It stopped short of the south-east end to avoid impeding public access.

Towards this south-east end, the footings of the kitchen bay were very similar to those on the opposite side of the room: a simple course of offset, undressed boulders. These boulders had been removed in front of the recent doorway; but immediately beyond that doorway, beneath the jamb of the original passage entrance, the foundation stones were smaller, and the height of the brown clayey loam (010) in which they were set indicated that the boulder foundation had not continued to this point.

On the far side of the cross-passage doorway the character of the footings changed yet again: the stones (013) were stacked up in rough courses to a higher level. There was no evidence of substantial subsoil erosion (as there was towards the north-west end on the far side). The undisturbed subsoil 010 was overlain by old topsoils 008 and 009 which had themselves been sealed by recent extensions to the building.

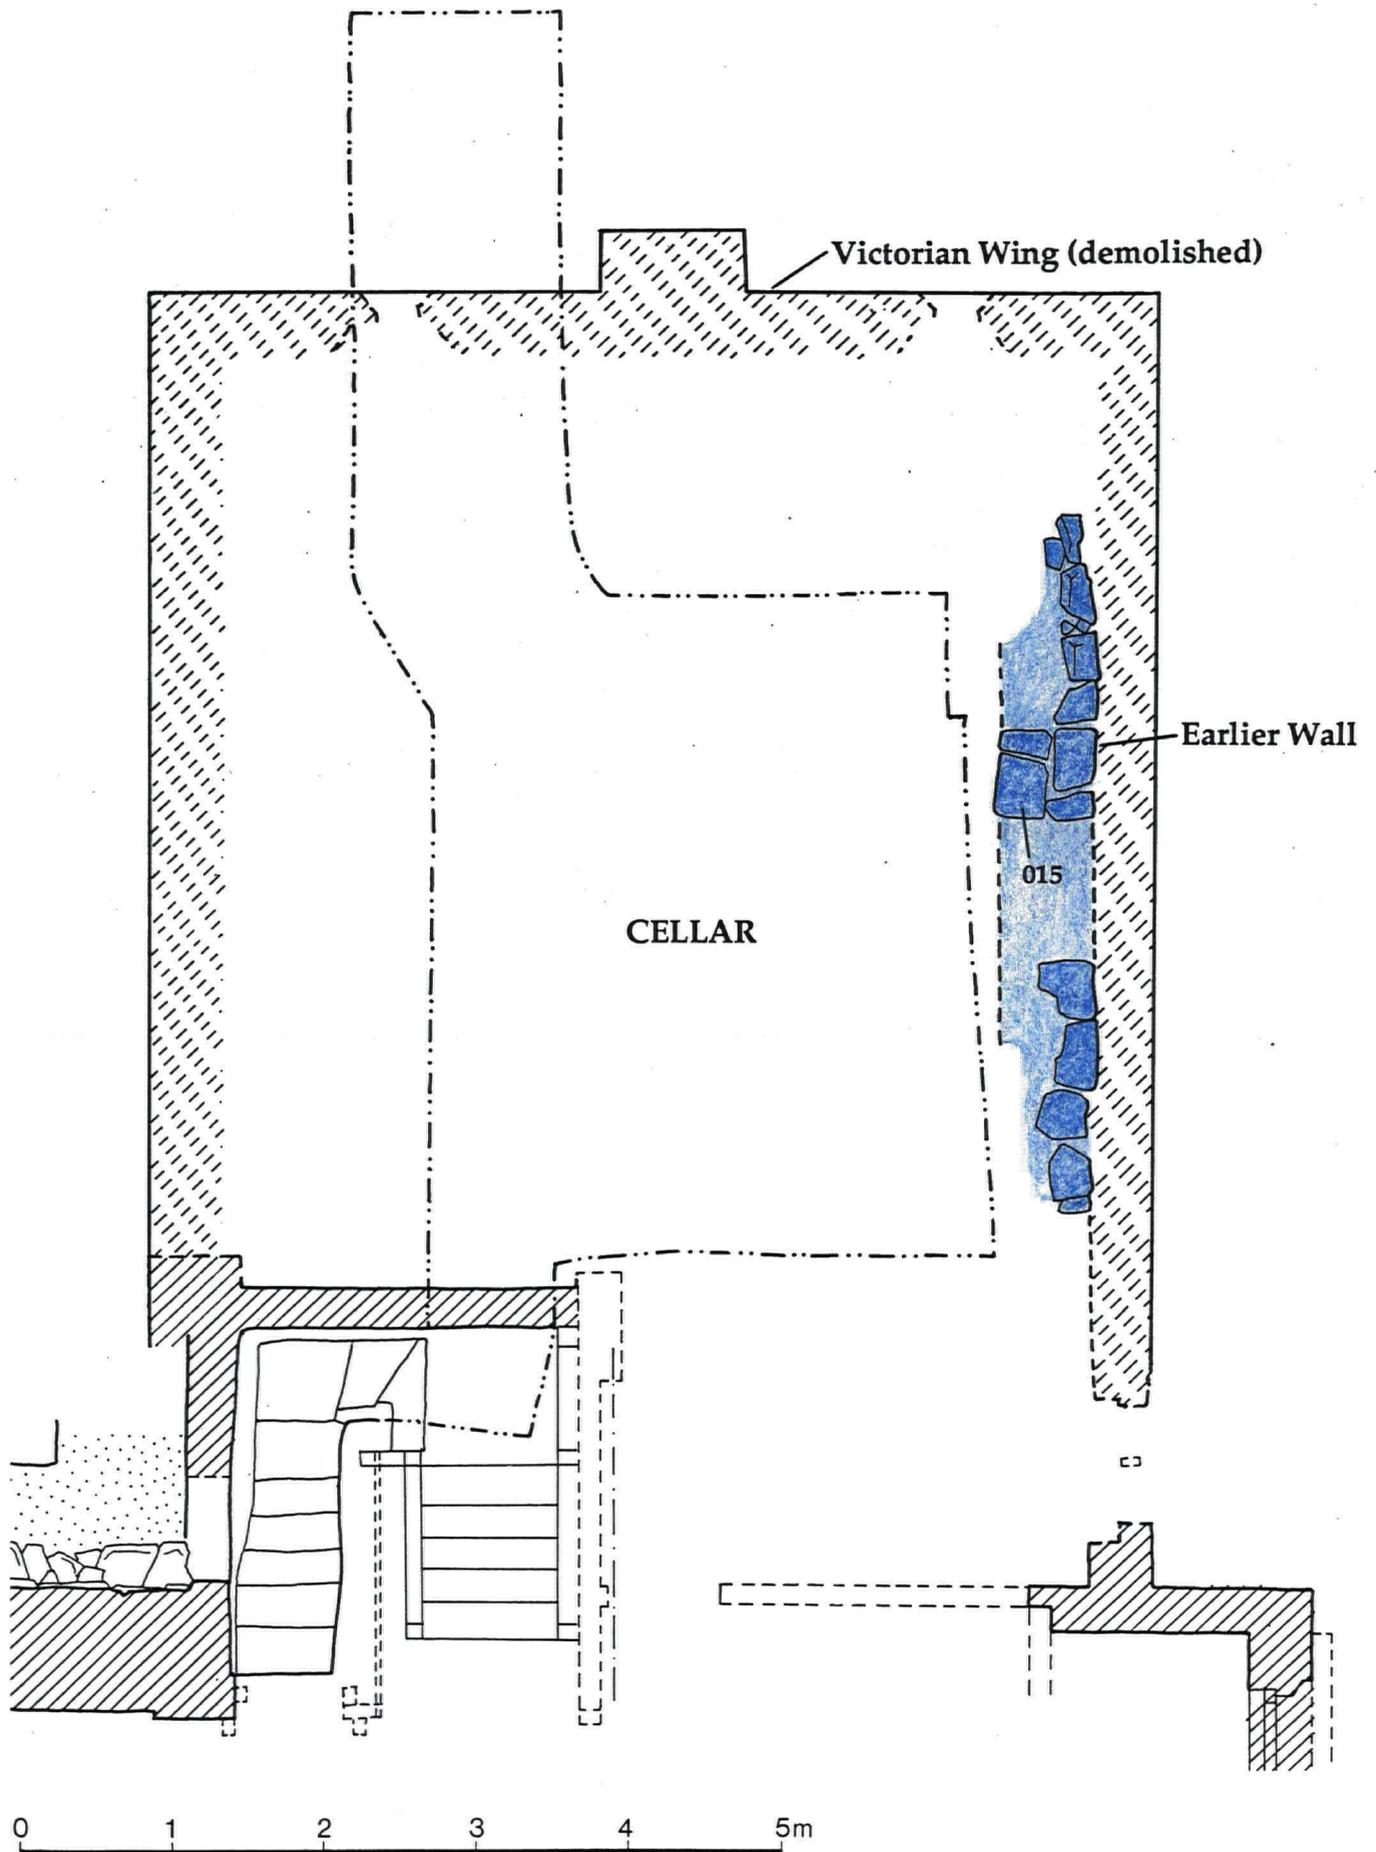
Fig. 3 Foundation stones of the pre-19th-century wing (marked in blue)

A Victorian wing at the north-west corner of the building had been demolished before investigations began. It is known to have been on the site of an earlier wing, and excavations were carried out in an attempt to establish the dimensions and position of the pre-Victorian structure.

Only on the north-west side was there any trace of the earlier structure. Fragments of the lowest course of unmortared foundation stones survived in the space between the Victorian foundation and the cellar; these are shown on the accompanying drawing (Fig. 3). They were sufficient to locate the precise position of the 18th-century wing, the dimensions of which are recorded in historical records.

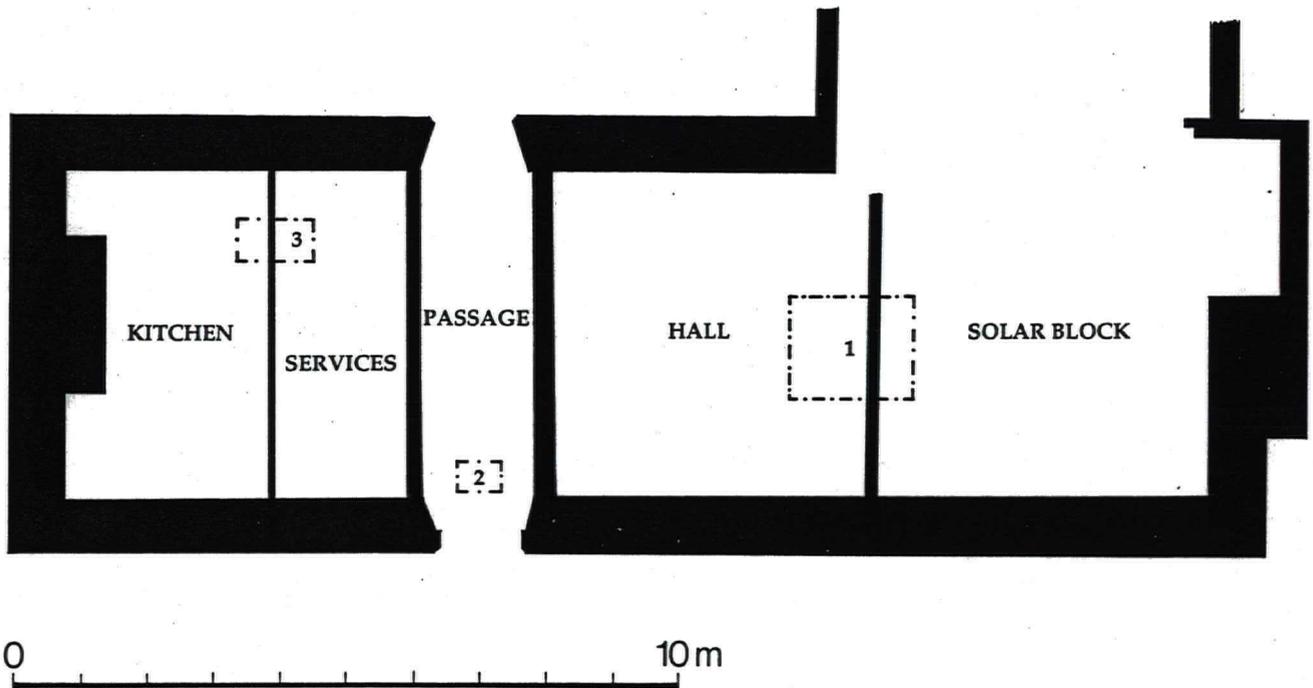
The excavation of the hall/parlour junction (Fig. 4, no. 1), close to the post supporting the cross-wing truss, revealed two phases of concrete flooring, extending to a depth of c. 450mm below the present surface. The limestone rubble base of the lower floor lay directly on the subsoil; though pre-concrete floor surfaces had been removed, there was a ledge in the subsoil surface in line with the hall/parlour partition, the hall being about 40mm higher.

An area exposed behind the north-east doorway of the cross-passage (Fig. 4, no. 2) revealed a floor of heavily worn and cracked limestone paving slabs measuring 400mm by 200-300mm by 140mm thick. The surface of these, about 80mm below the present floor surface, was at the correct level for the original (now absent) threshold stone in the north-east doorway. At the south-west end of the cross-passage there had been deeper disturbance in recent times; the paving slabs had been removed, leaving only the subsoil surface directly below the modern flooring.

The final area examined (Fig. 4, no. 3) straddled the line of the partition between kitchen and service rooms. In the services, there was further, but very fragmentary evidence of flagging: this was set about 160mm below the present floor surface, at a level lower than the passage flagging. On the kitchen side of the partition there was only burnt earth. The area examined in this trench had been very extensively disturbed by pipe trenches; nevertheless, it appears that the kitchen may have had an earth floor rather than stone flagging.

*Fig. 4 Approximate location of investigations inside the building*

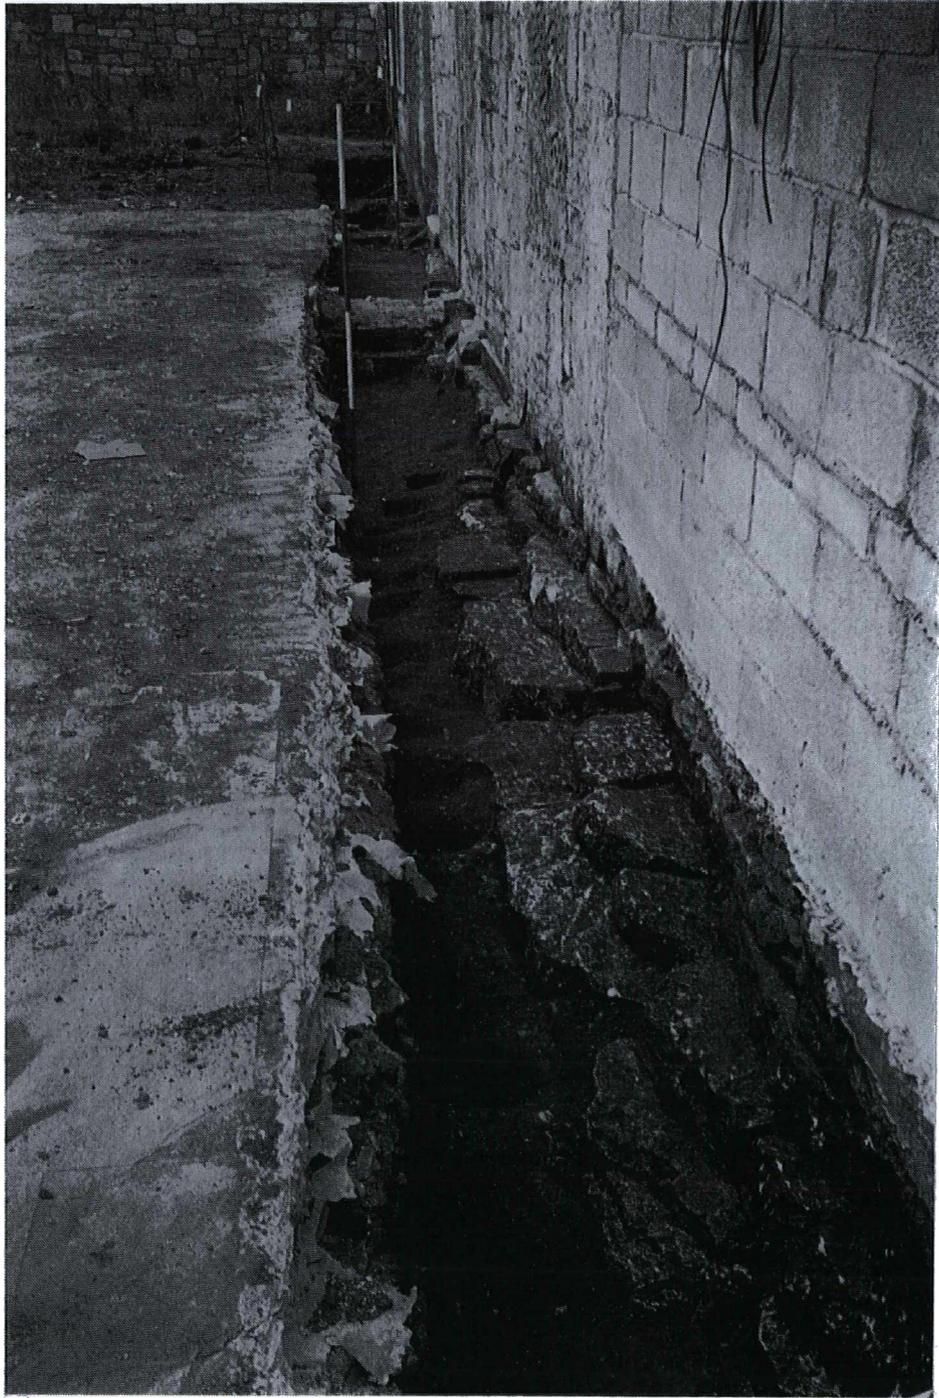
*Photograph of the trench excavated along the north-east side wall. The coursed offset foundation stones of the cross-wing and the scoops caused by medieval spade-digging are in the foreground.*
