Fig 1. Brackenridge Old Farmhouse (OF), south elevation, looking west.

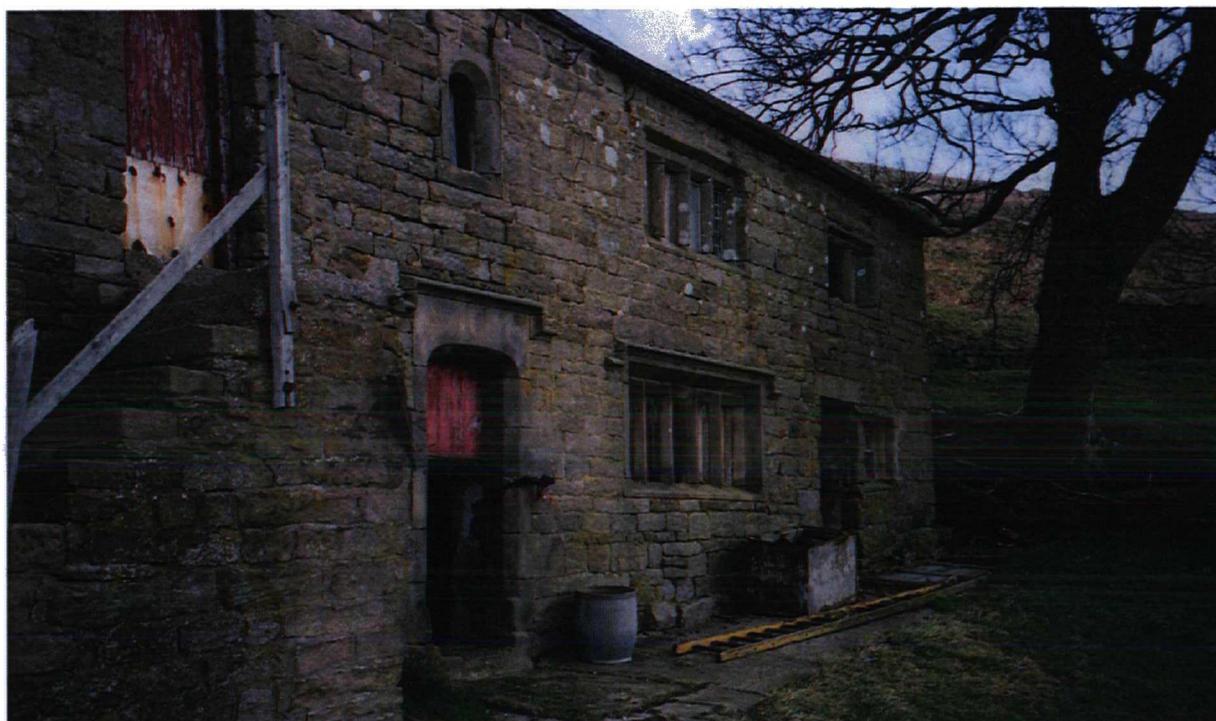
Fig 2. Brackenridge OF, south elevation, looking east.

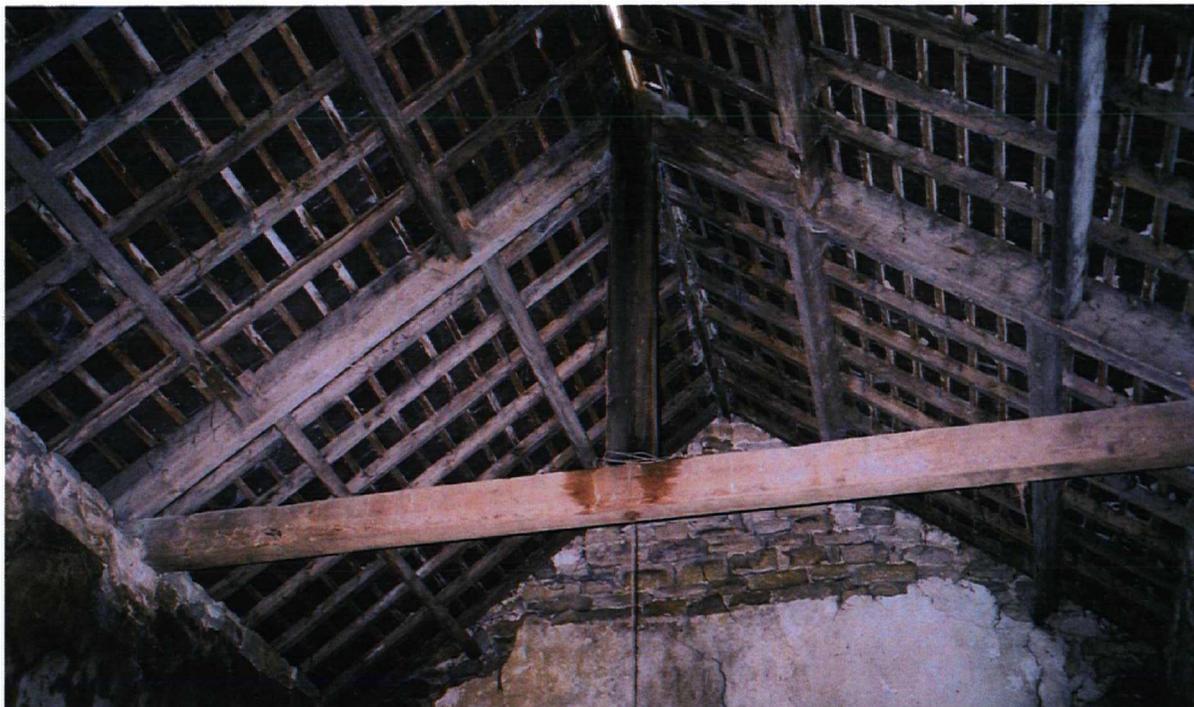
Fig 3 Brackenridge, showing the underside of the modern replacement roof.

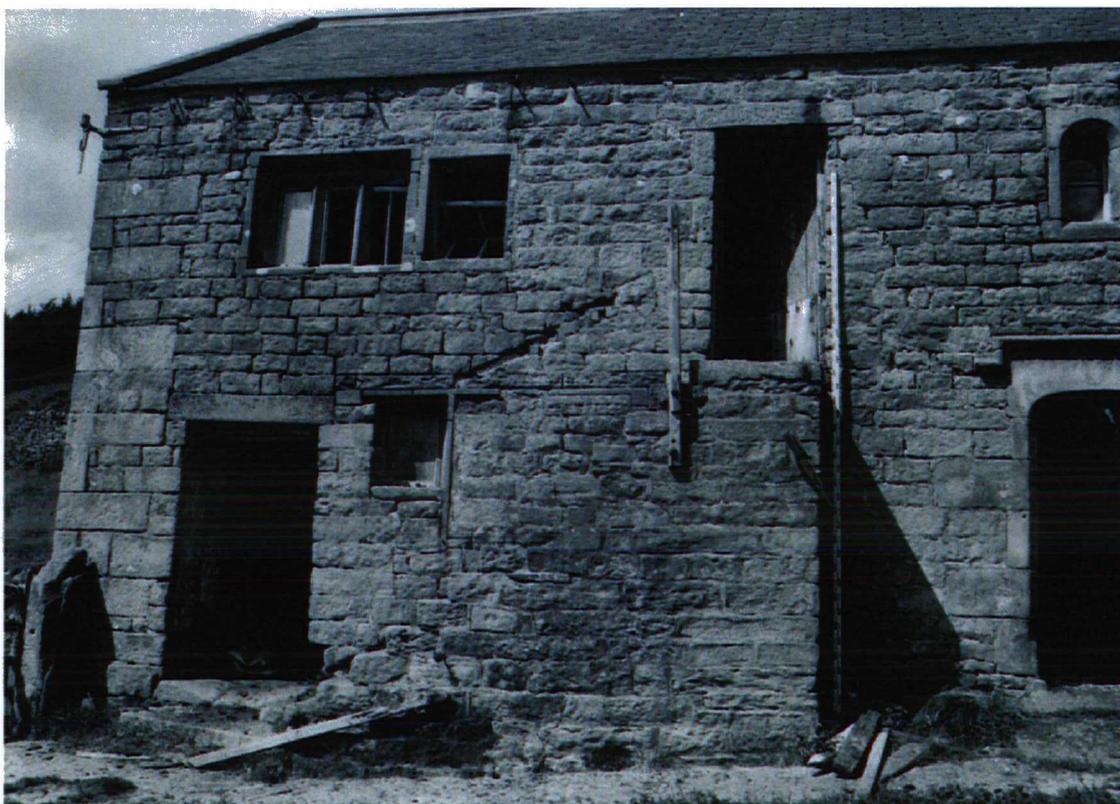
Fig 4 Brackenridge OF, west end, south elevation. The surveying staff used as a scale is extended to 4m.

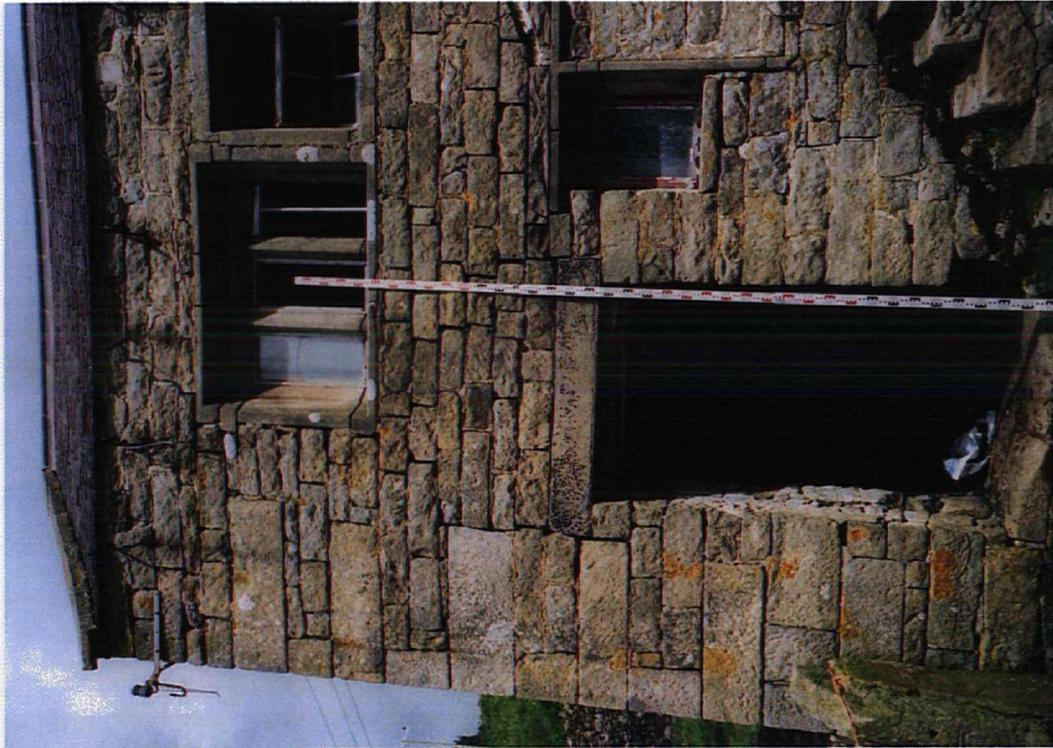
Figs 5 & 6. Brackenridge OF: detail of south elevation, west end.

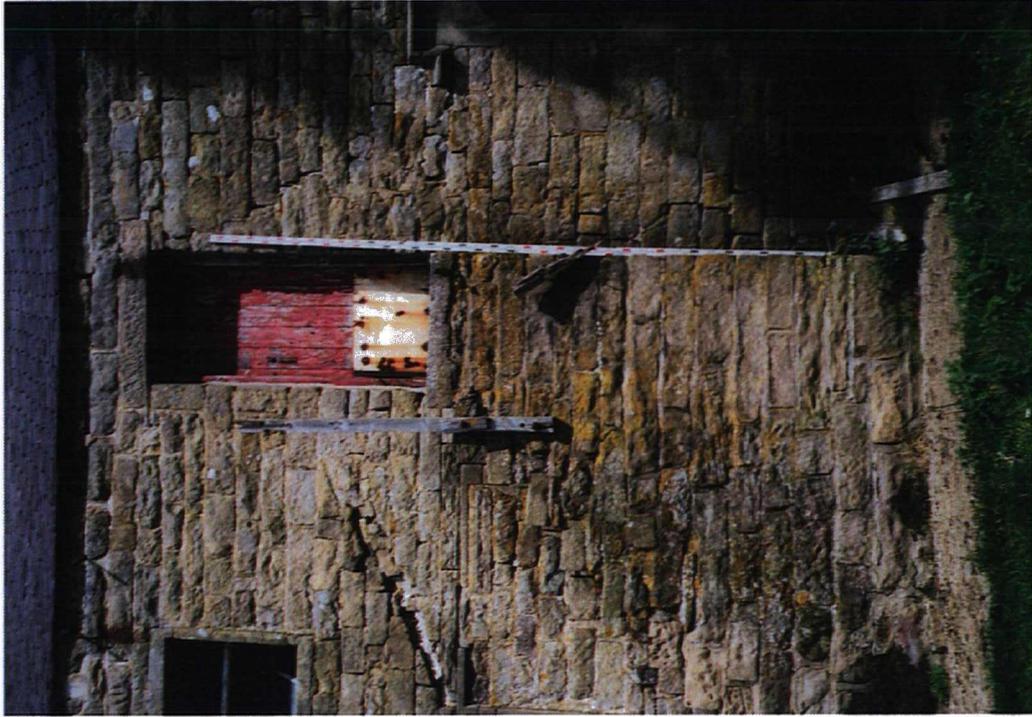
Fig 6. Showing the later external steps to first floor. Note the scar of a lean-to roof line predating the steps.

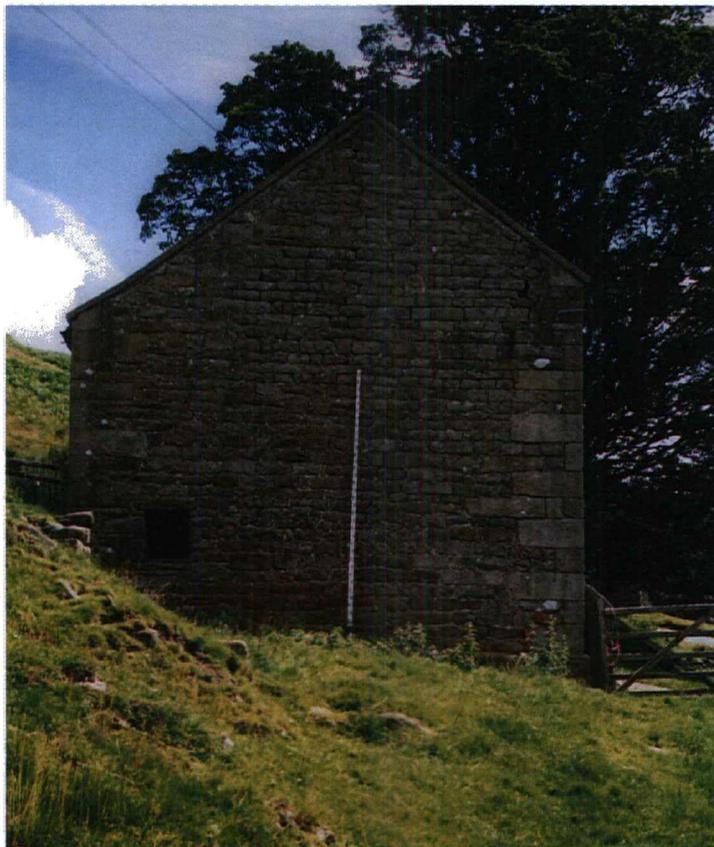
Figs 7 & 8. Brackenridge OF, west elevation. Fig 8 shows the offset stone plinth foundation.

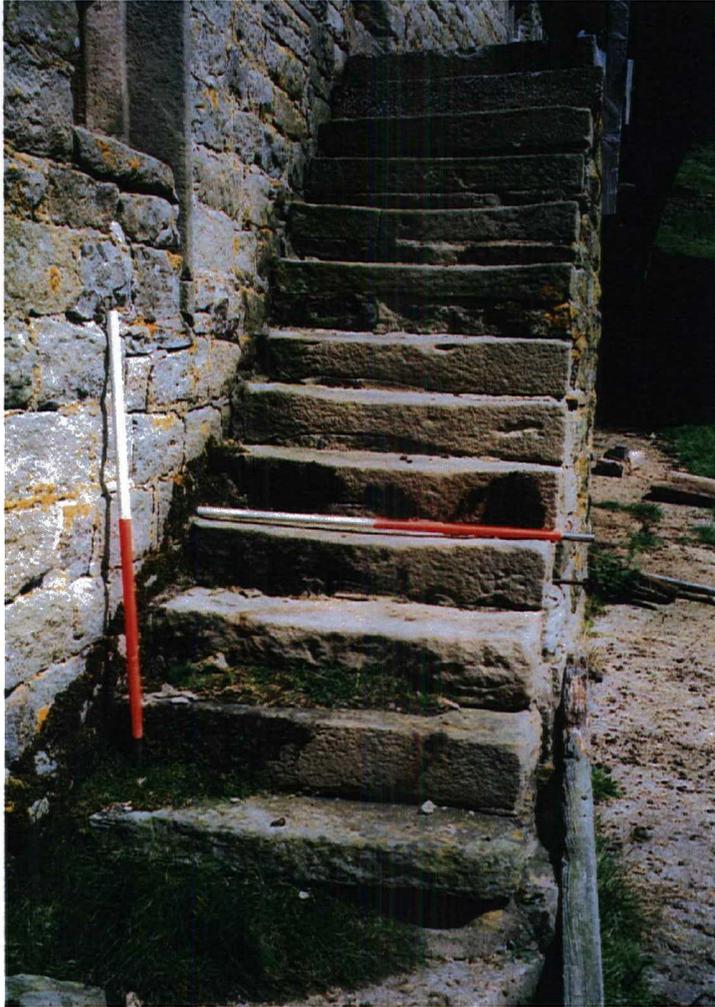
Figs 9 & 10, Brackenridge OF. 19<sup>th</sup> century steps. Note the wear on the underside of some steps, suggesting they have been turned over.

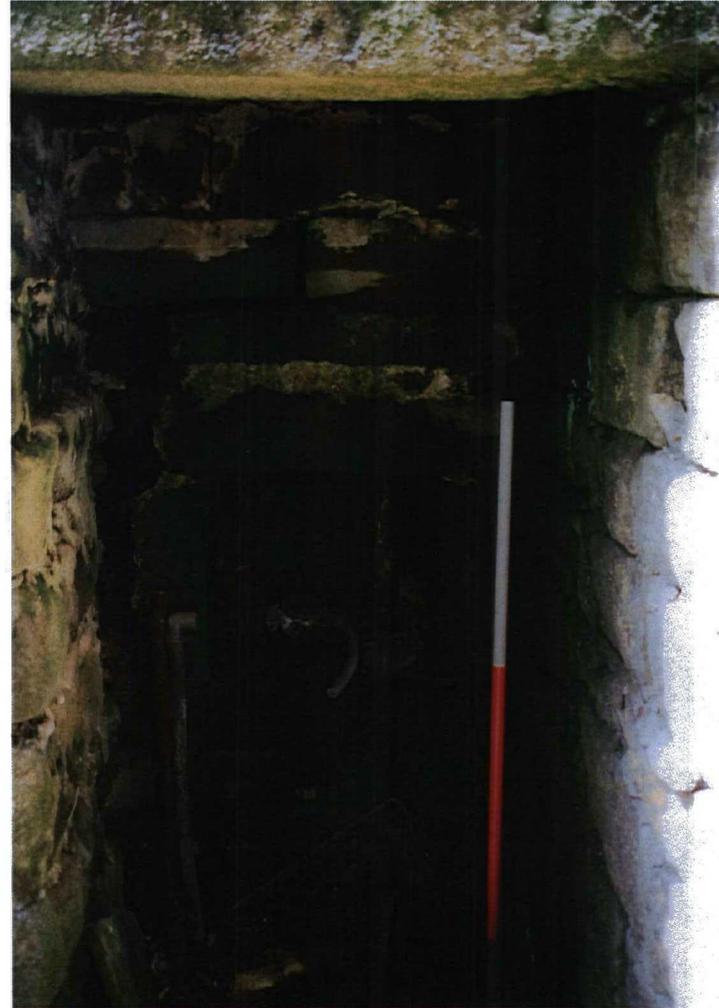
Fig 10 Beneath the steps showing small cupboard or lamp niche.

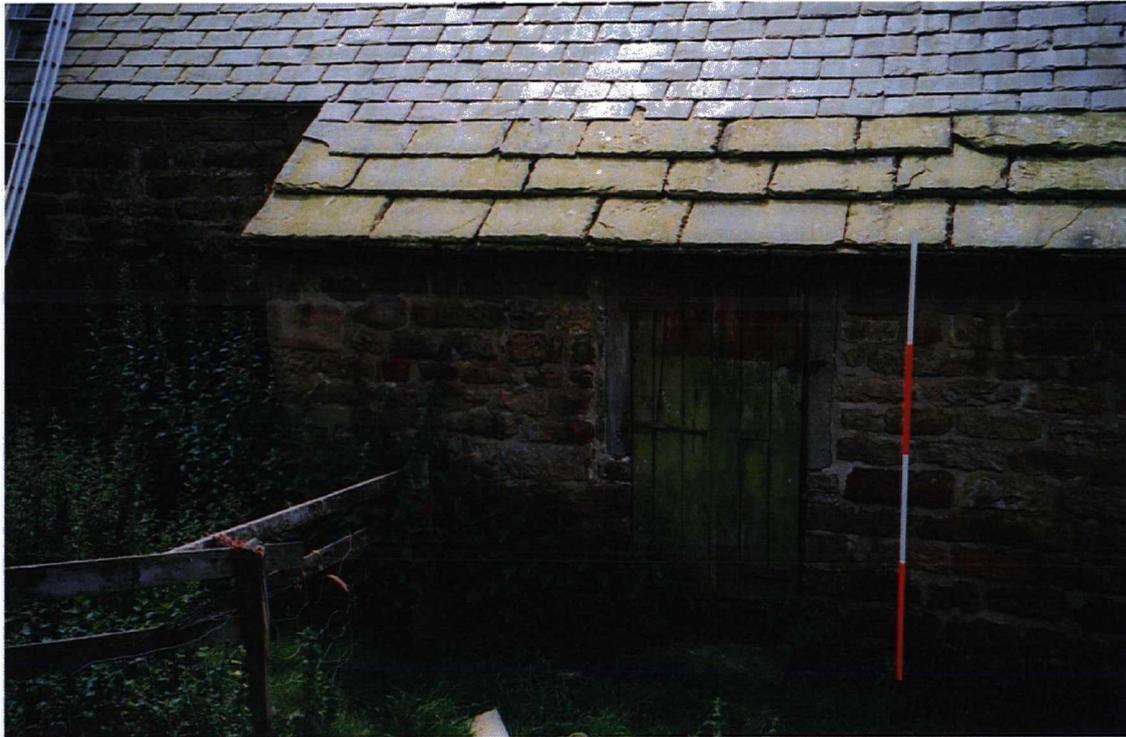
Fig 11. Brackenridge OF, north elevation. This elevation was originally free-standing to ground level. The open are on the north side of the house was eventually infilled to first floor level, and this door cut through the north wall, probably to bring hay-carts right up to the building for unloading.

Note also the later re-roofing, of Welsh slate with 3 rows of re-used (?) stone roof tiles.

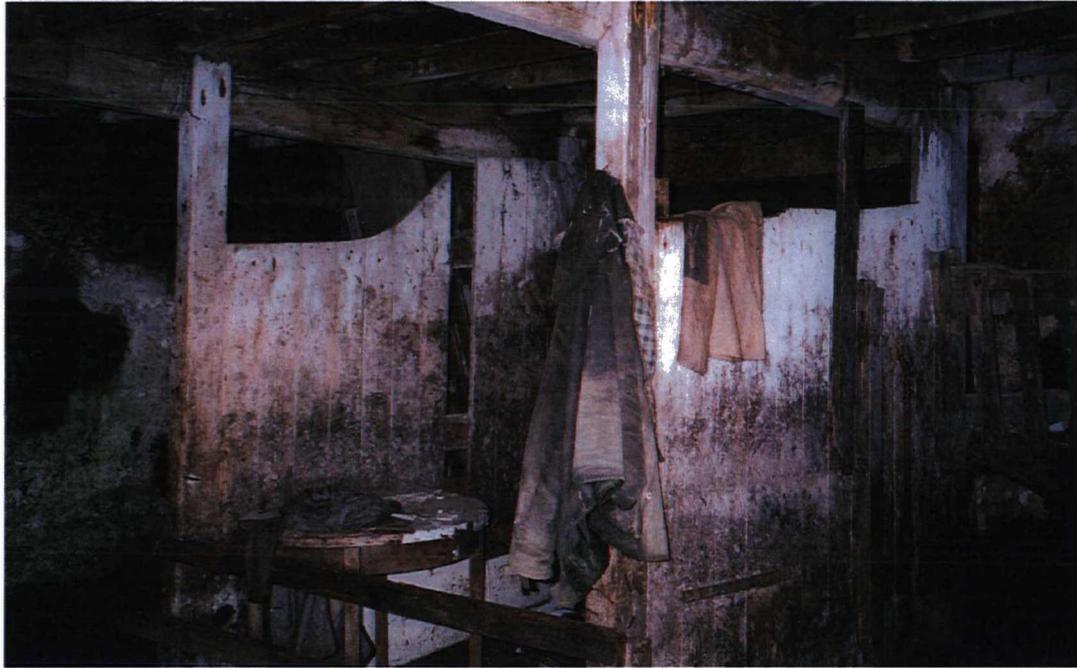
Fig 12 Brackenridge OF, interior ground floor, west end. The later stall partitions (above) mask a fine 19<sup>th</sup> century hearth or fireplace – Fig 13 below.

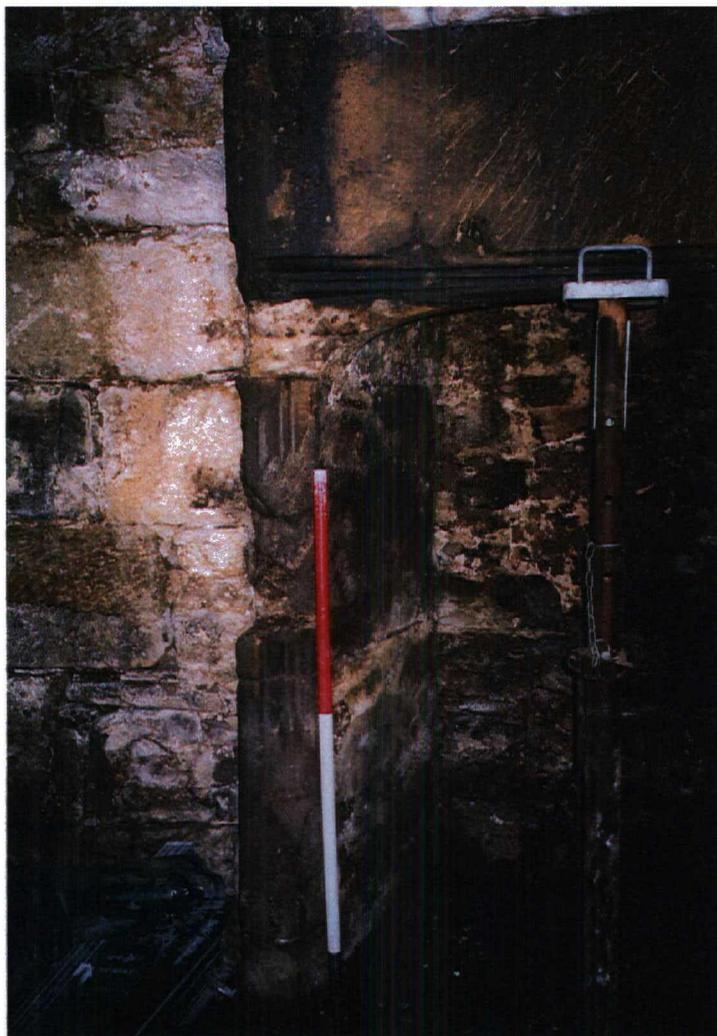
Fig 14. Detail of the hearth/fire surround shown at Fig 12 above.

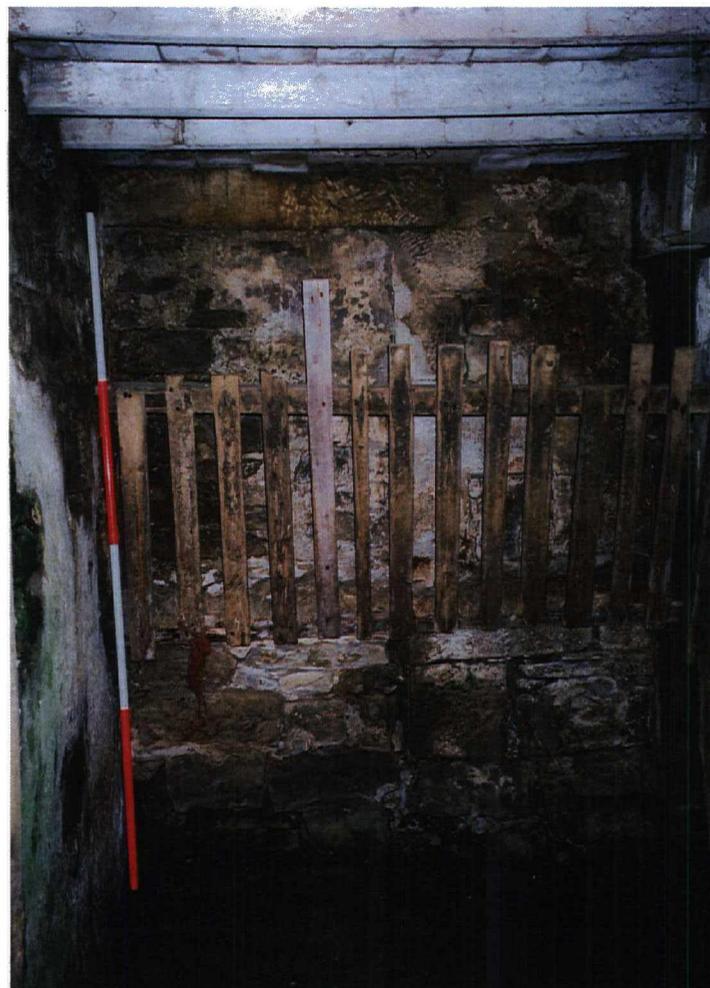
Fig 15. The hayrack in one of the stalls masks a blocked doorway - apparently leading to the outside, but mostly blocked by the north wall of the structure to the east.

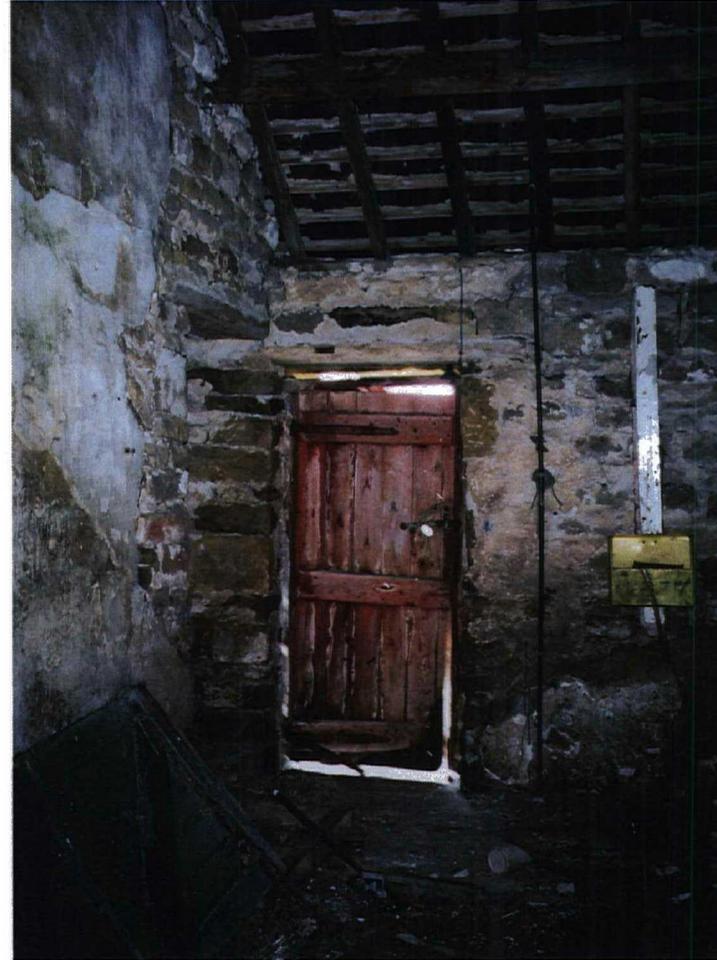
Fig 17. Brackenridge OF. West end 1<sup>st</sup> floor interior looking south.

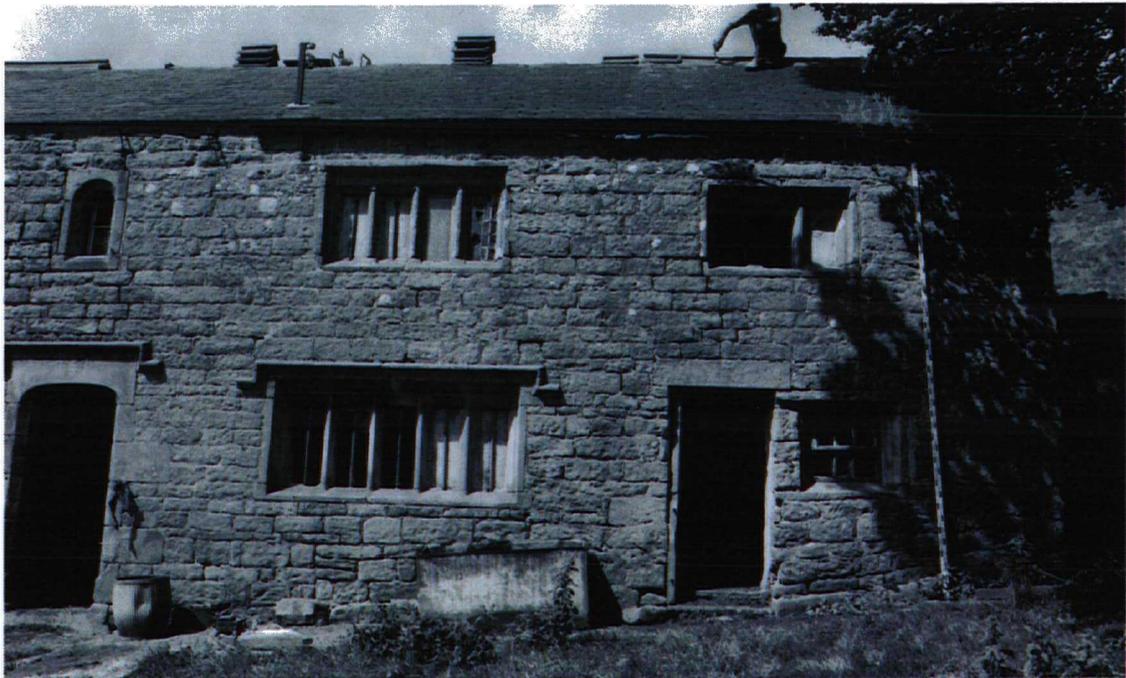
Fig 18. Brackenridge OF. South exterior elevation, the 2 central bays and the single east bay. These originally formed the main house.

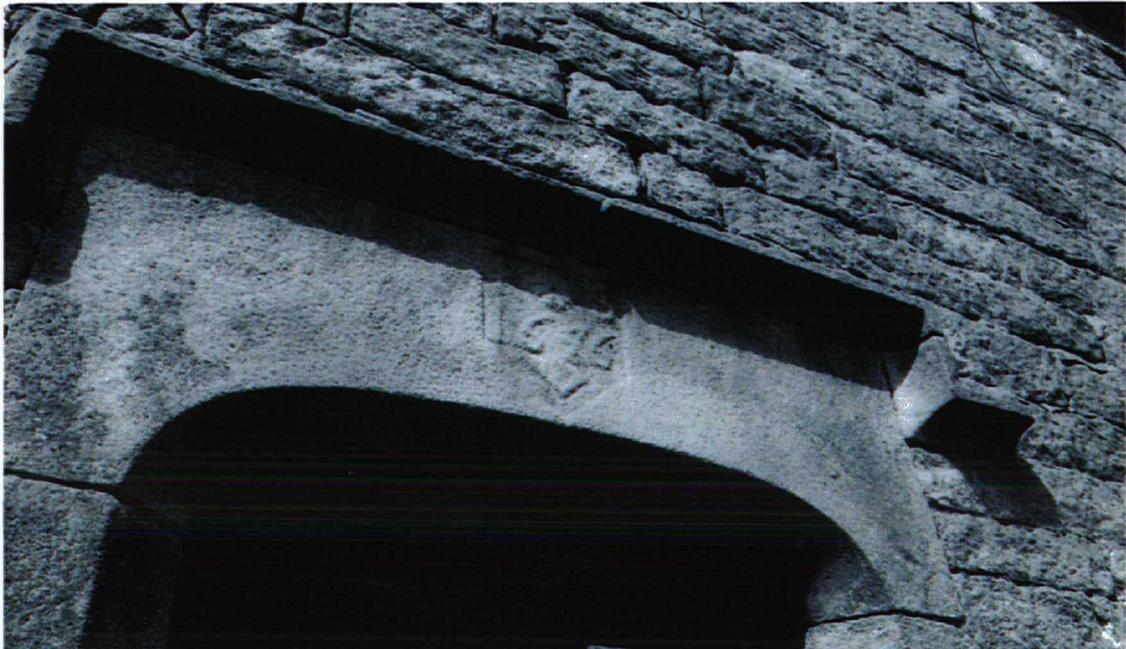
Fig 19 Detail of the basket-arched head and hoodmould of the main entrance, showing the carved shield with date and initials.

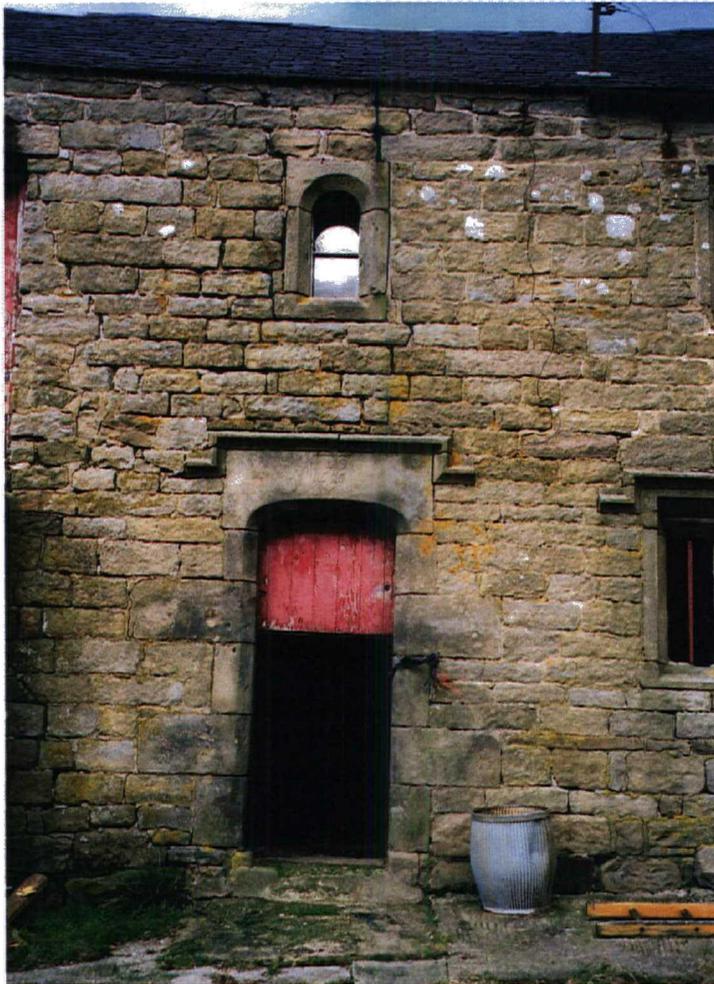
Fig 20. Brackenridge OF. South elevation: the main door with single light chamfered arched window above.

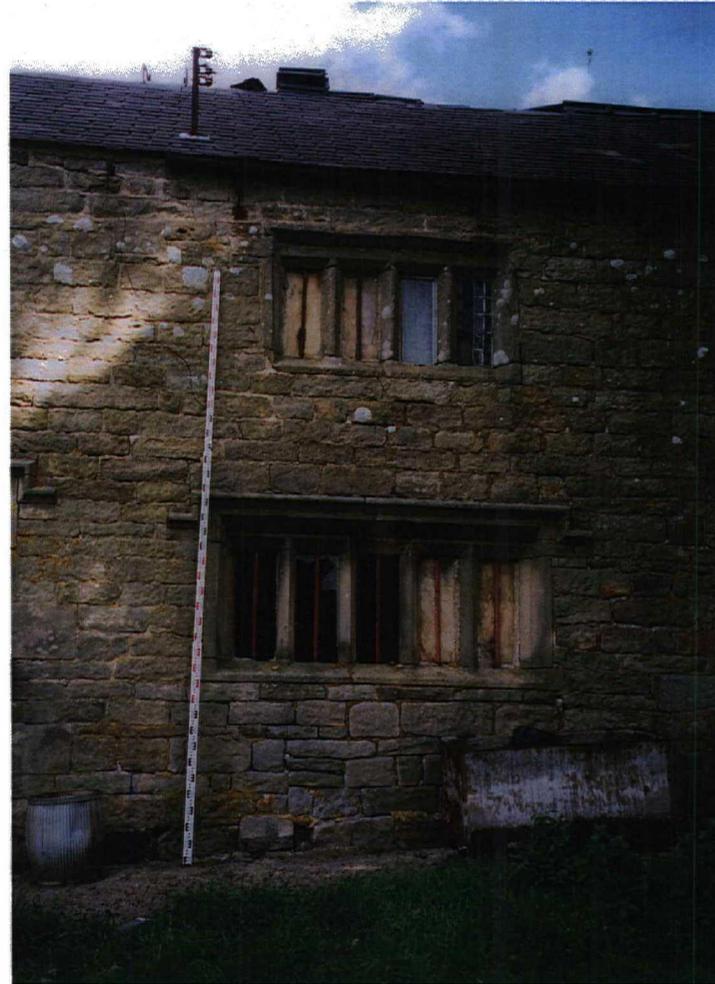
Fig 21. Immediately east of the main door, double-chamfered mullioned windows at ground and first floor.

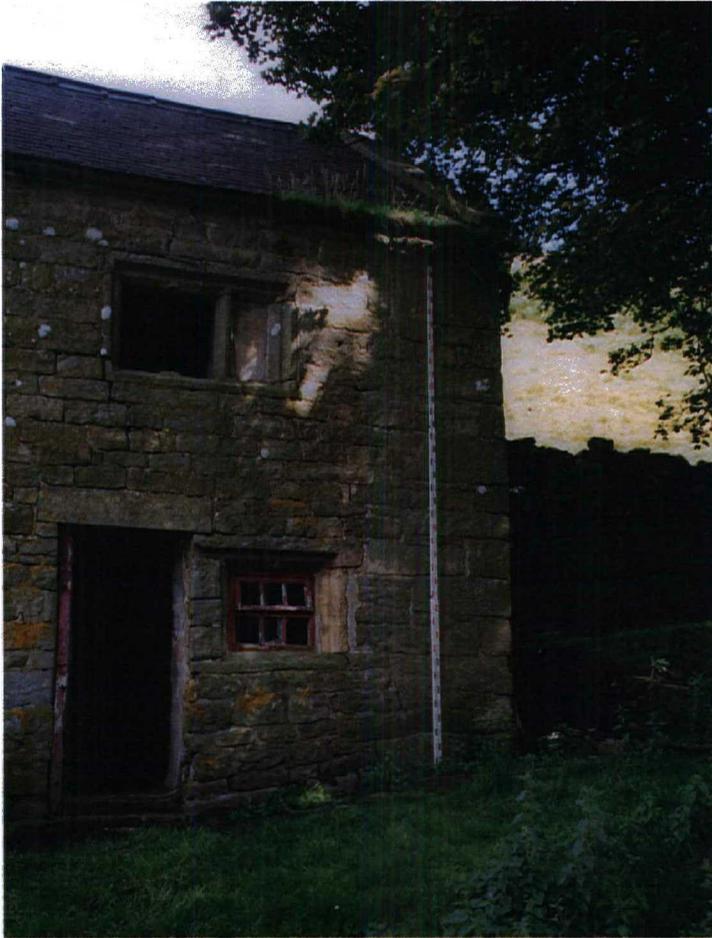
Fig 22. Brackenridge OF. South elevation of the east bay. The door and casement window have been inserted in a space originally containing a mullioned window.

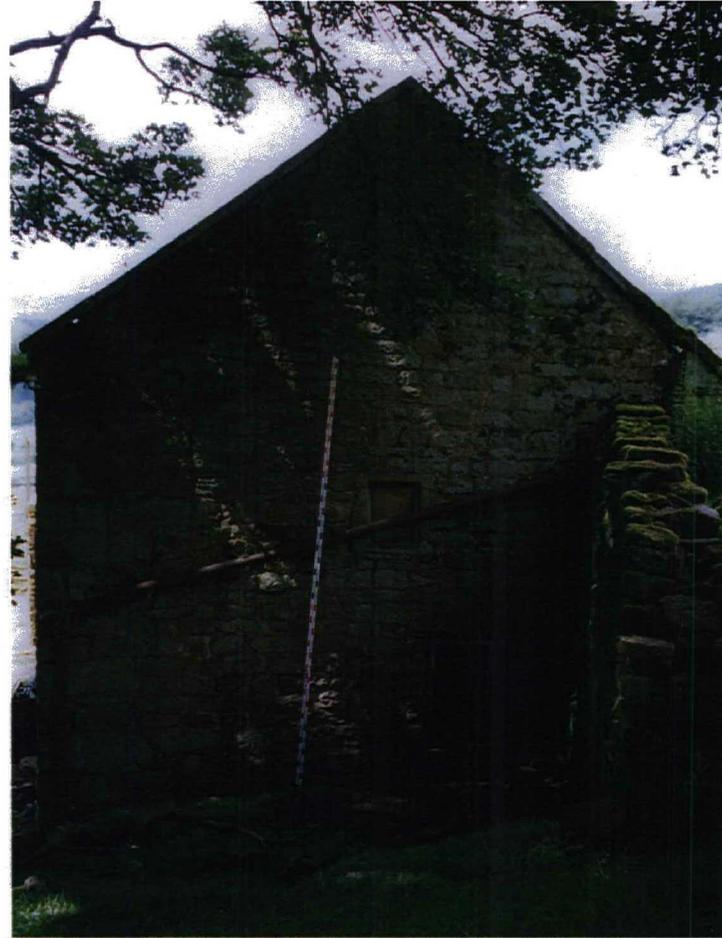
Fig 23. The east elevation, showing blocked windows and doors and a retaining wall, presumably to support the earth back-filled against the north wall of the house.

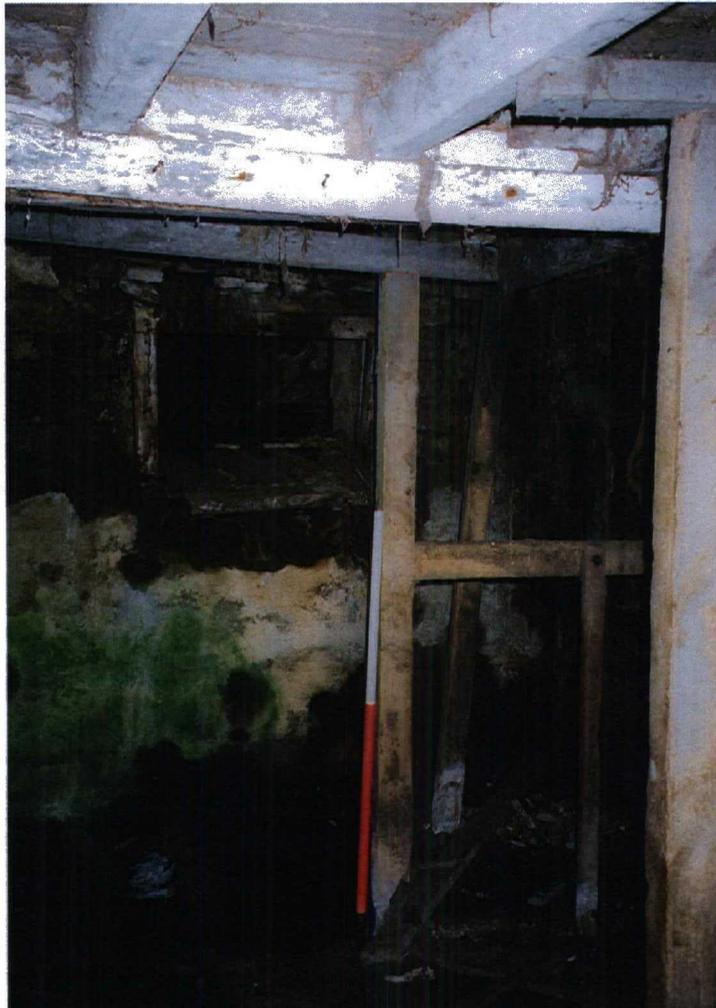
Fig 24. Brackenridge OF. Interior of east bay, showing blocked window on north wall.

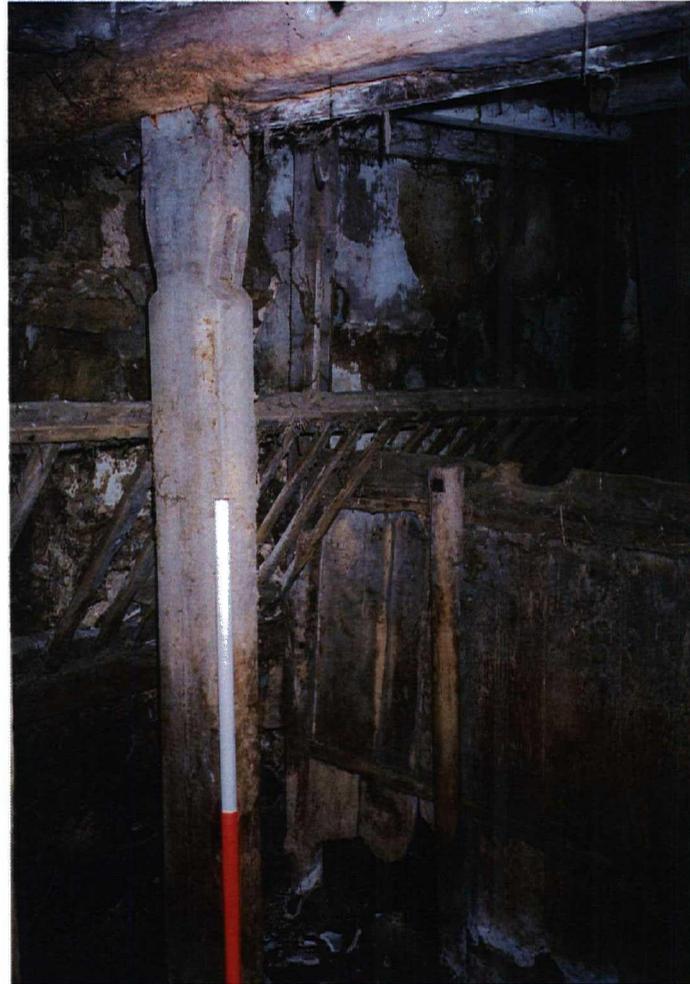
Fig 25. Timber boskins and hay racks for cattle. The re-used kingpost in the foreground may be all that remains of the original roof.

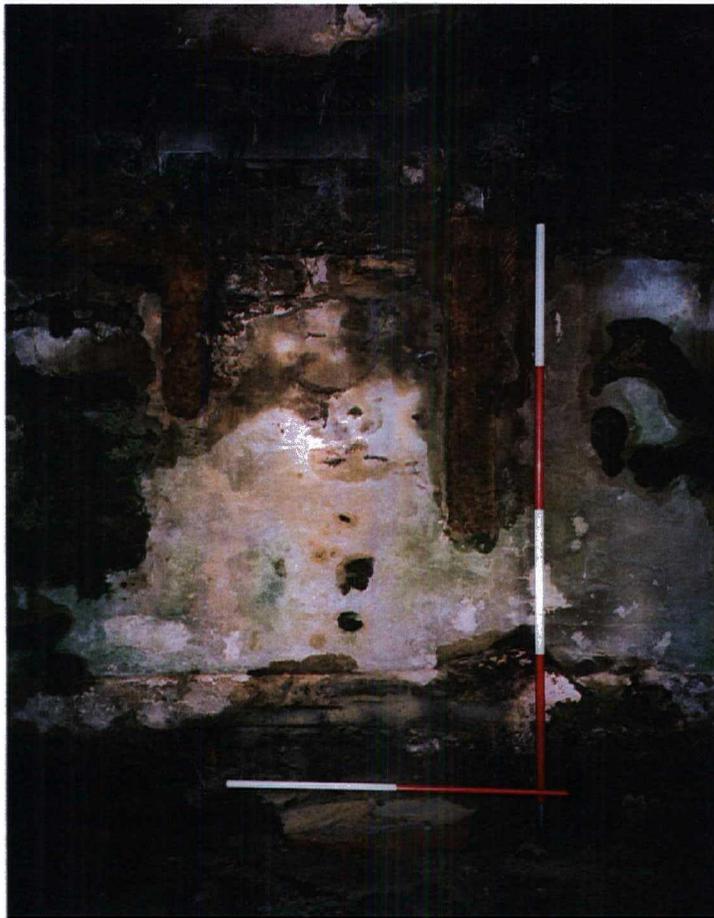
Fig 26 Brackenridge OF. Blocked door in north wall, with jambs of softer yellow sandstone which occurs randomly elsewhere in the building..

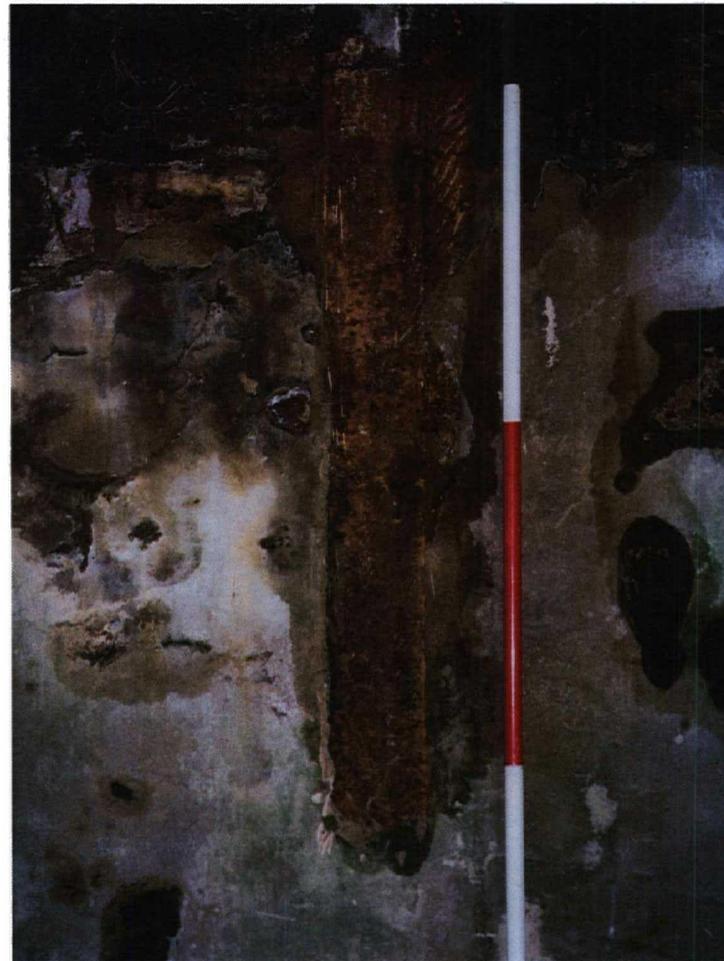
Fig 27 Detail of blocked door in north wall

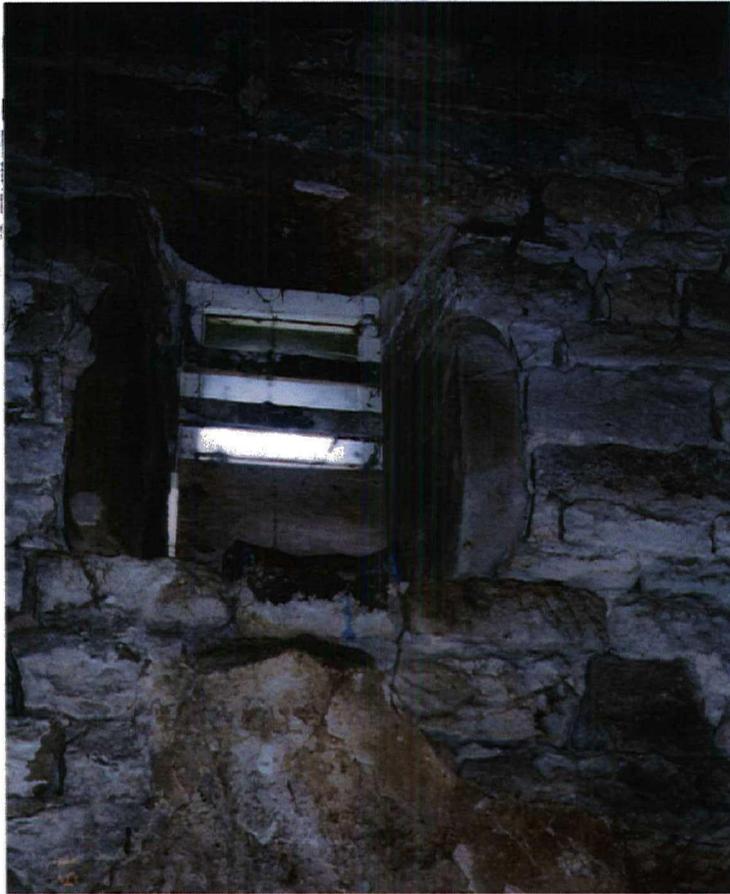
Fig 28 Brackenridge OF. Louvered window at first floor level in north wall. Probably a later insert for ventilation of the hay loft

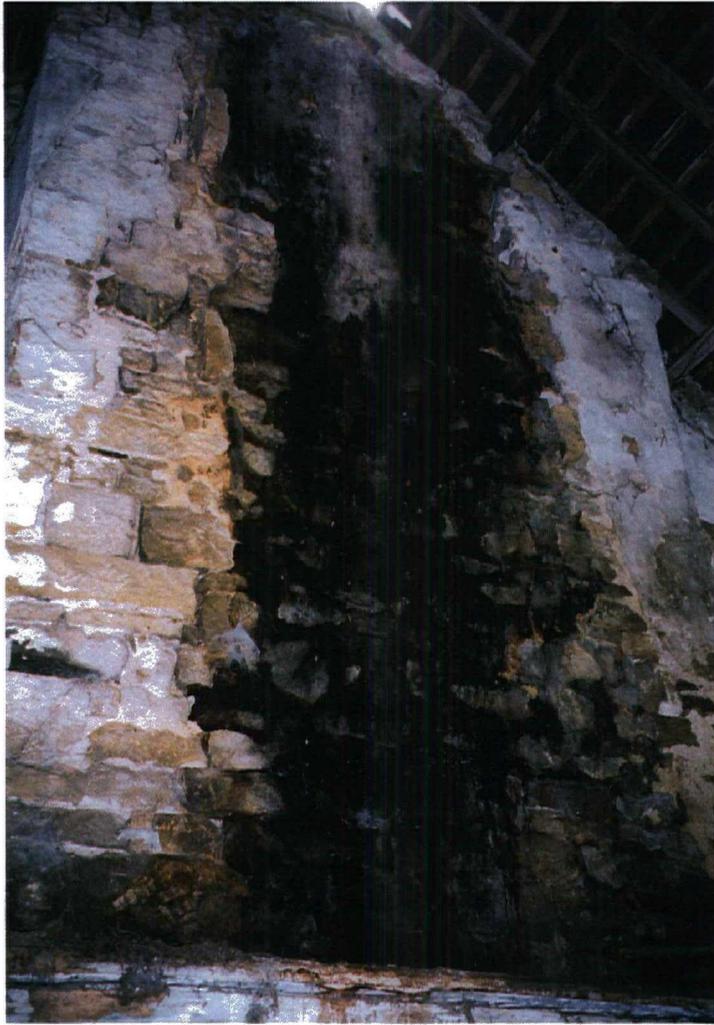
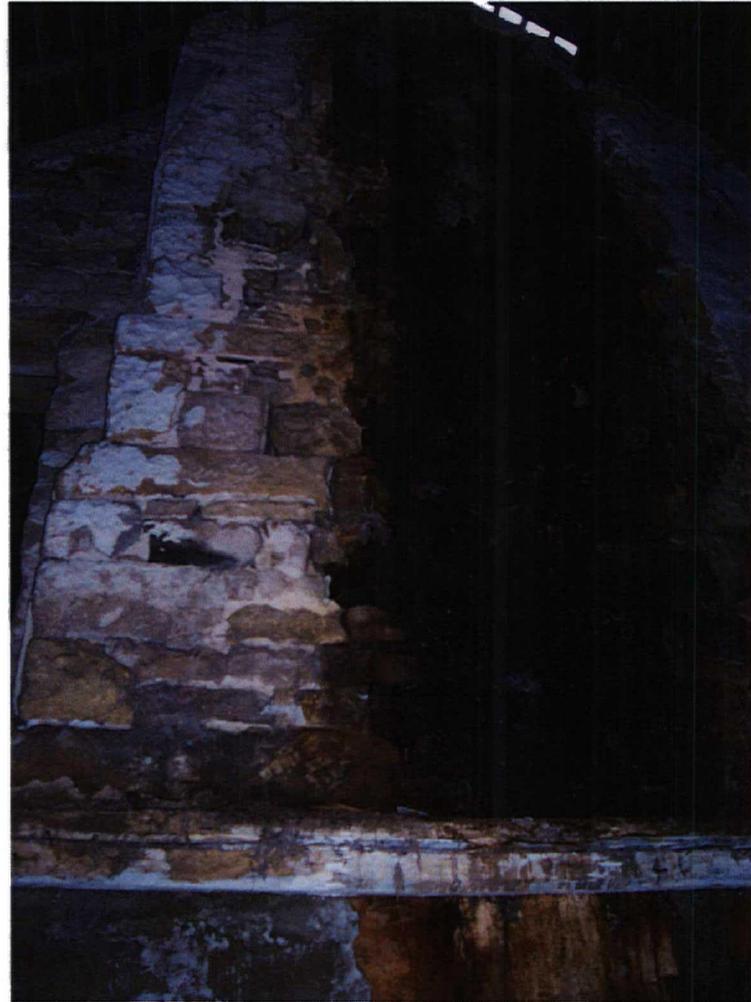
Figs 29 & 30, Brackenridge OF. The triangular sooted stain left after the removal of the 17<sup>th</sup> century smoke-

hood, with the remnants of 4 pairs of supporting corbels, on the western interior wall of the middle two bays of the main house

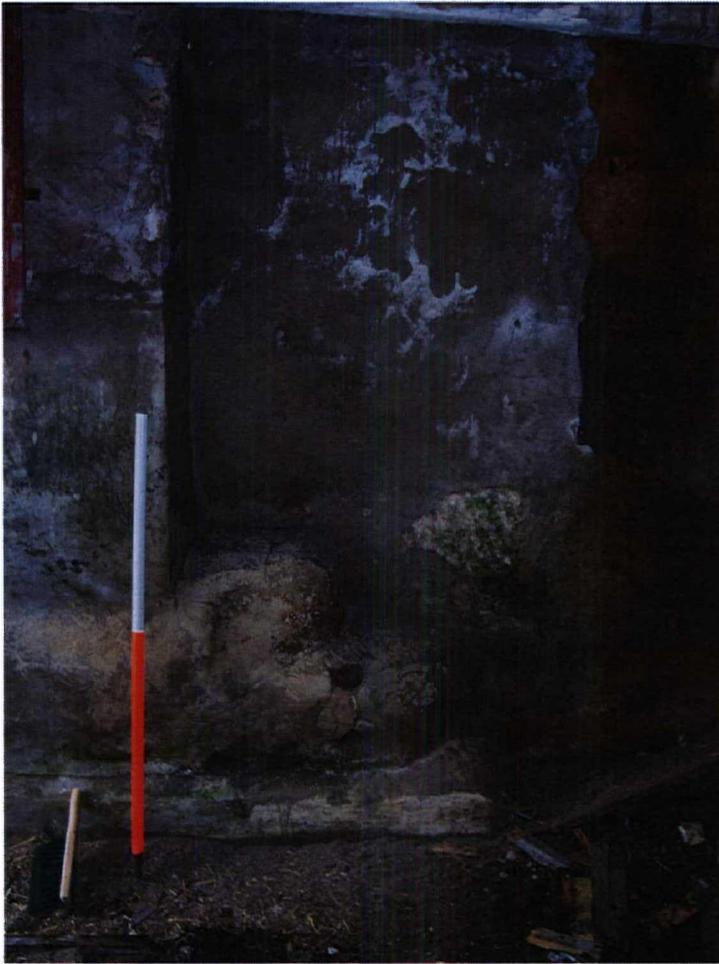
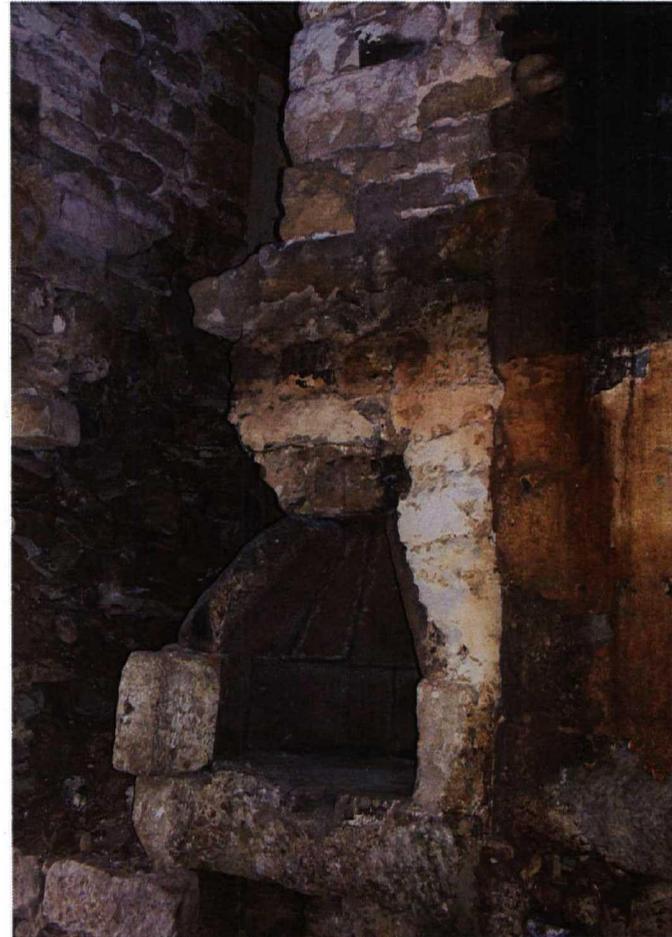
Figs 31 & 32. Brackenridge OF. The 17<sup>th</sup> bread oven blocked up at the north corner of the hearth; unblocking it revealed the details of its construction.

The door was missing, and the interior showed no sign of the expected burning from hot coals.

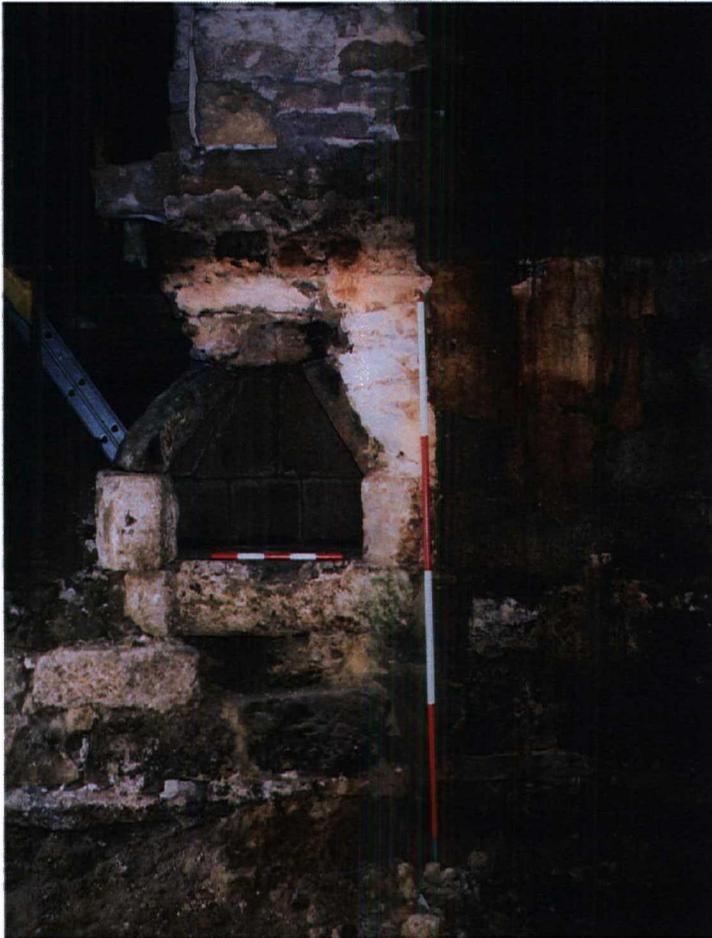
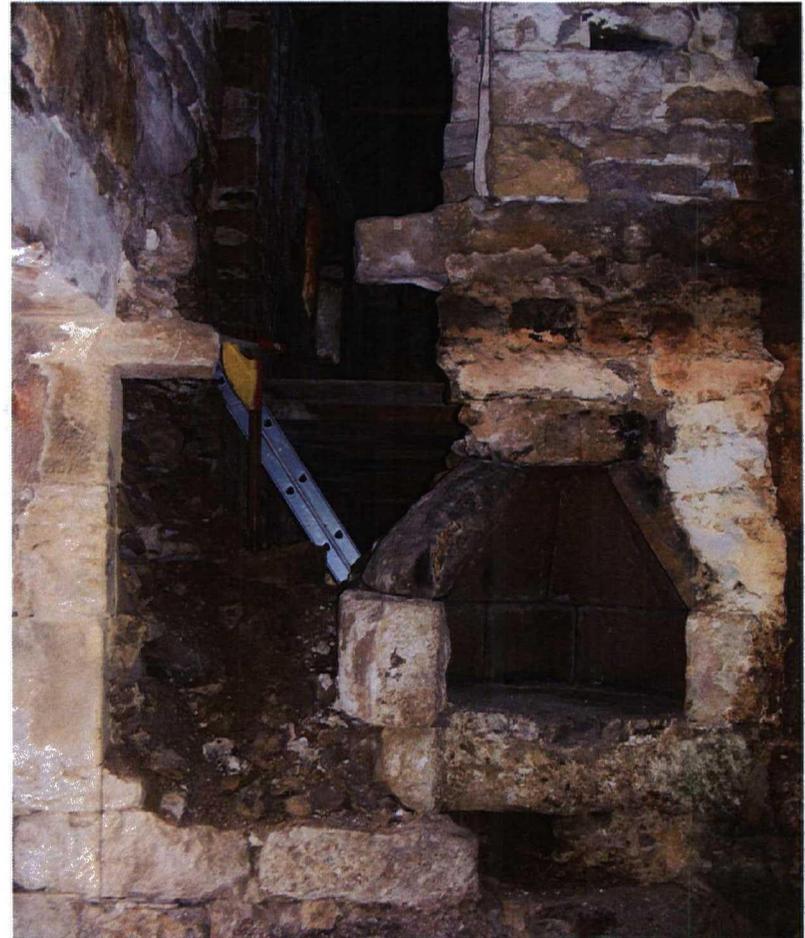
Figs 33 & 34, Brackenridge OF. The bread oven shown with metric scales (above); and its relationship to the sooted hearth (above, right)

and to the main south wall (above, wall at the left). The demolition for the new link between the west end and the mid bays (above) shows that there was no ground floor link between these areas in the original building.
