Fig 1. Brackenridge Old Farmhouse (OF), south elevation, looking west.

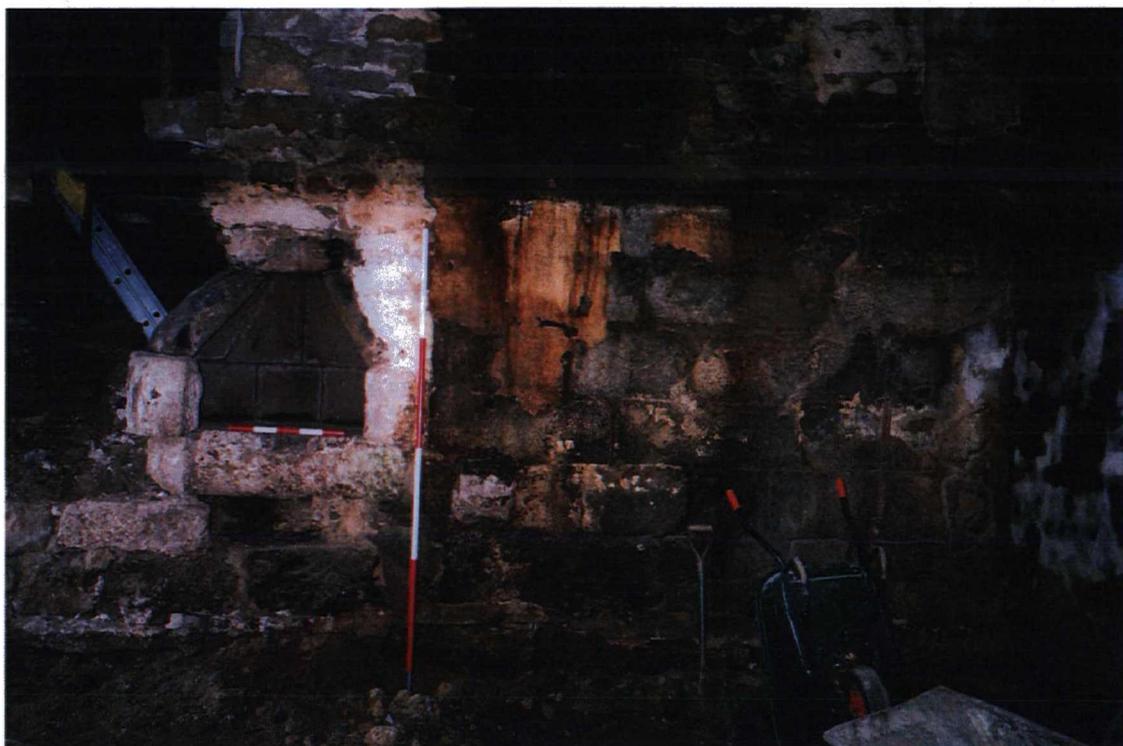
Fig 35. Brackenridge OF. The bread oven and the original 17<sup>th</sup> century hearth area. Note the lack of sooty on the stonework to the right of the bread oven, suggesting that this area had been rebuilt when the 19<sup>th</sup> century fireplace and a chimney had been inserted behind this area, in the west end of the building.

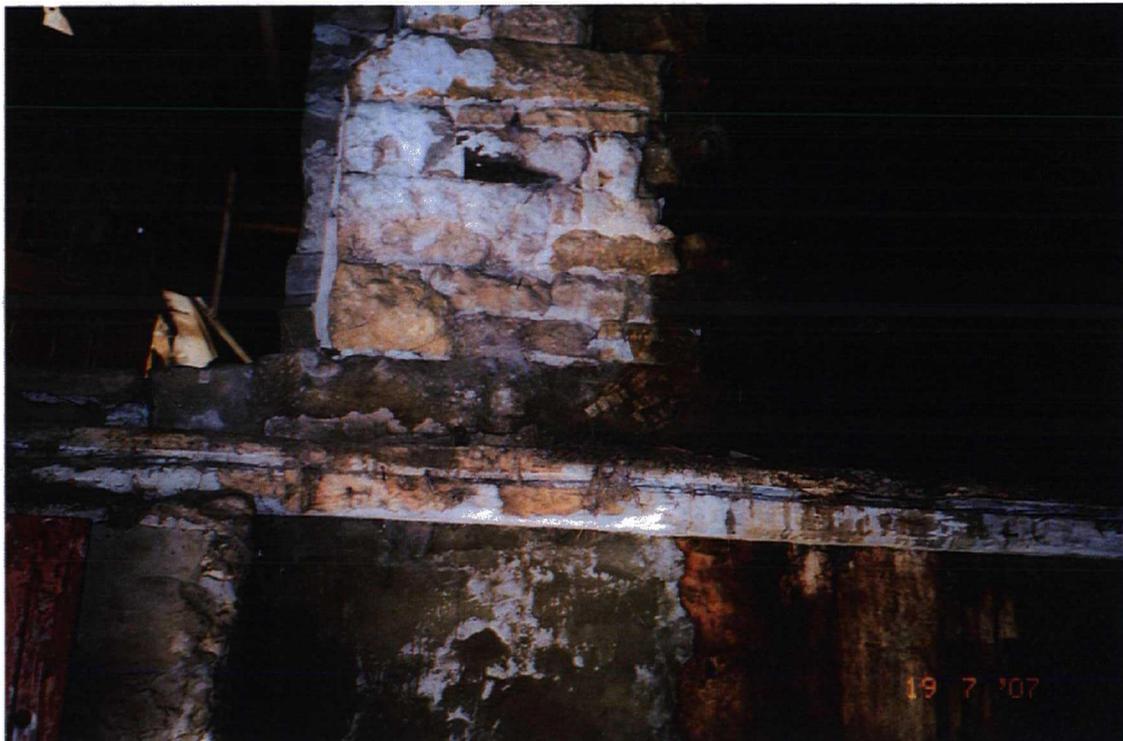
Fig 36, Brackenridge OF. The hearth area, before the opening of the sealed bread oven, showing the re-used beam inserted after the removal of the smoke hood and its supporting structure, to support the planks and joists from the first floor. Note the groove which would have held the top of a thin partition. It is not possible to suggest where this timber was originally used.
