Howgrave Hall
An Archaeological Assessment
of the Banqueting House,
with notes on the Hall
and Garden enclosure.

Peter F Ryder
Historic Buildings Consultant
2000/Revised October 2004

An Archaeological Assessment of the Banqueting House, with notes on the Hall and the Garden enclosure

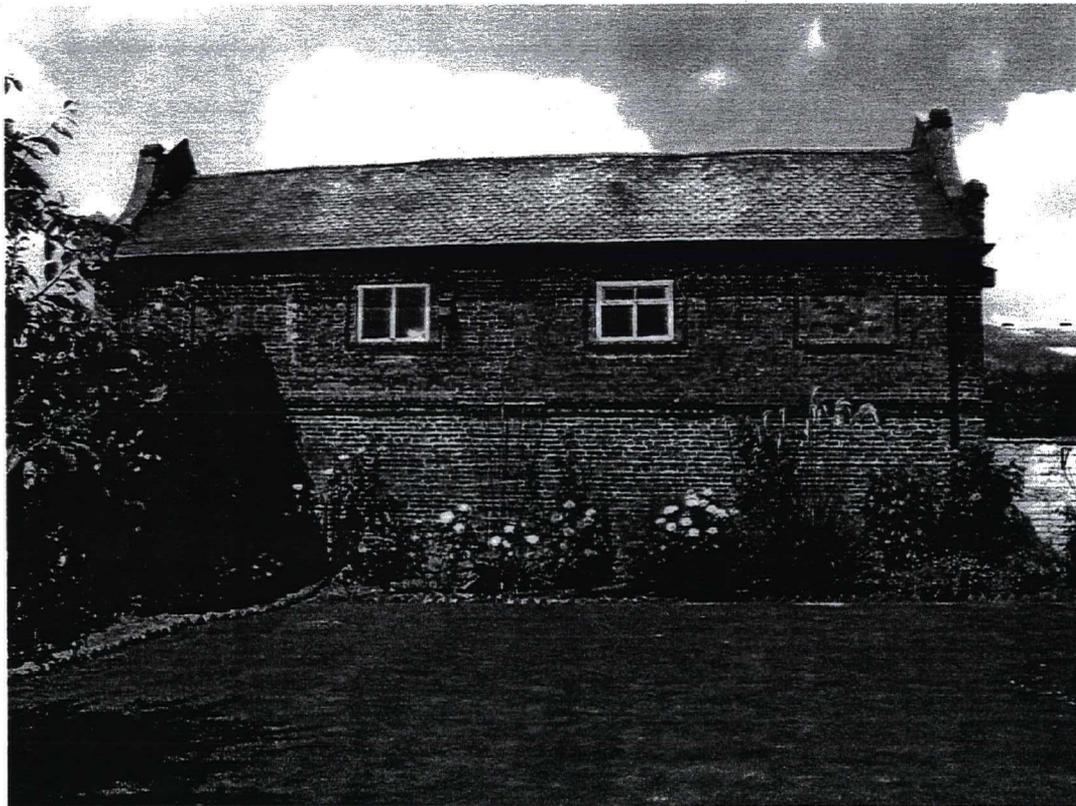
The Banqueting House from the South

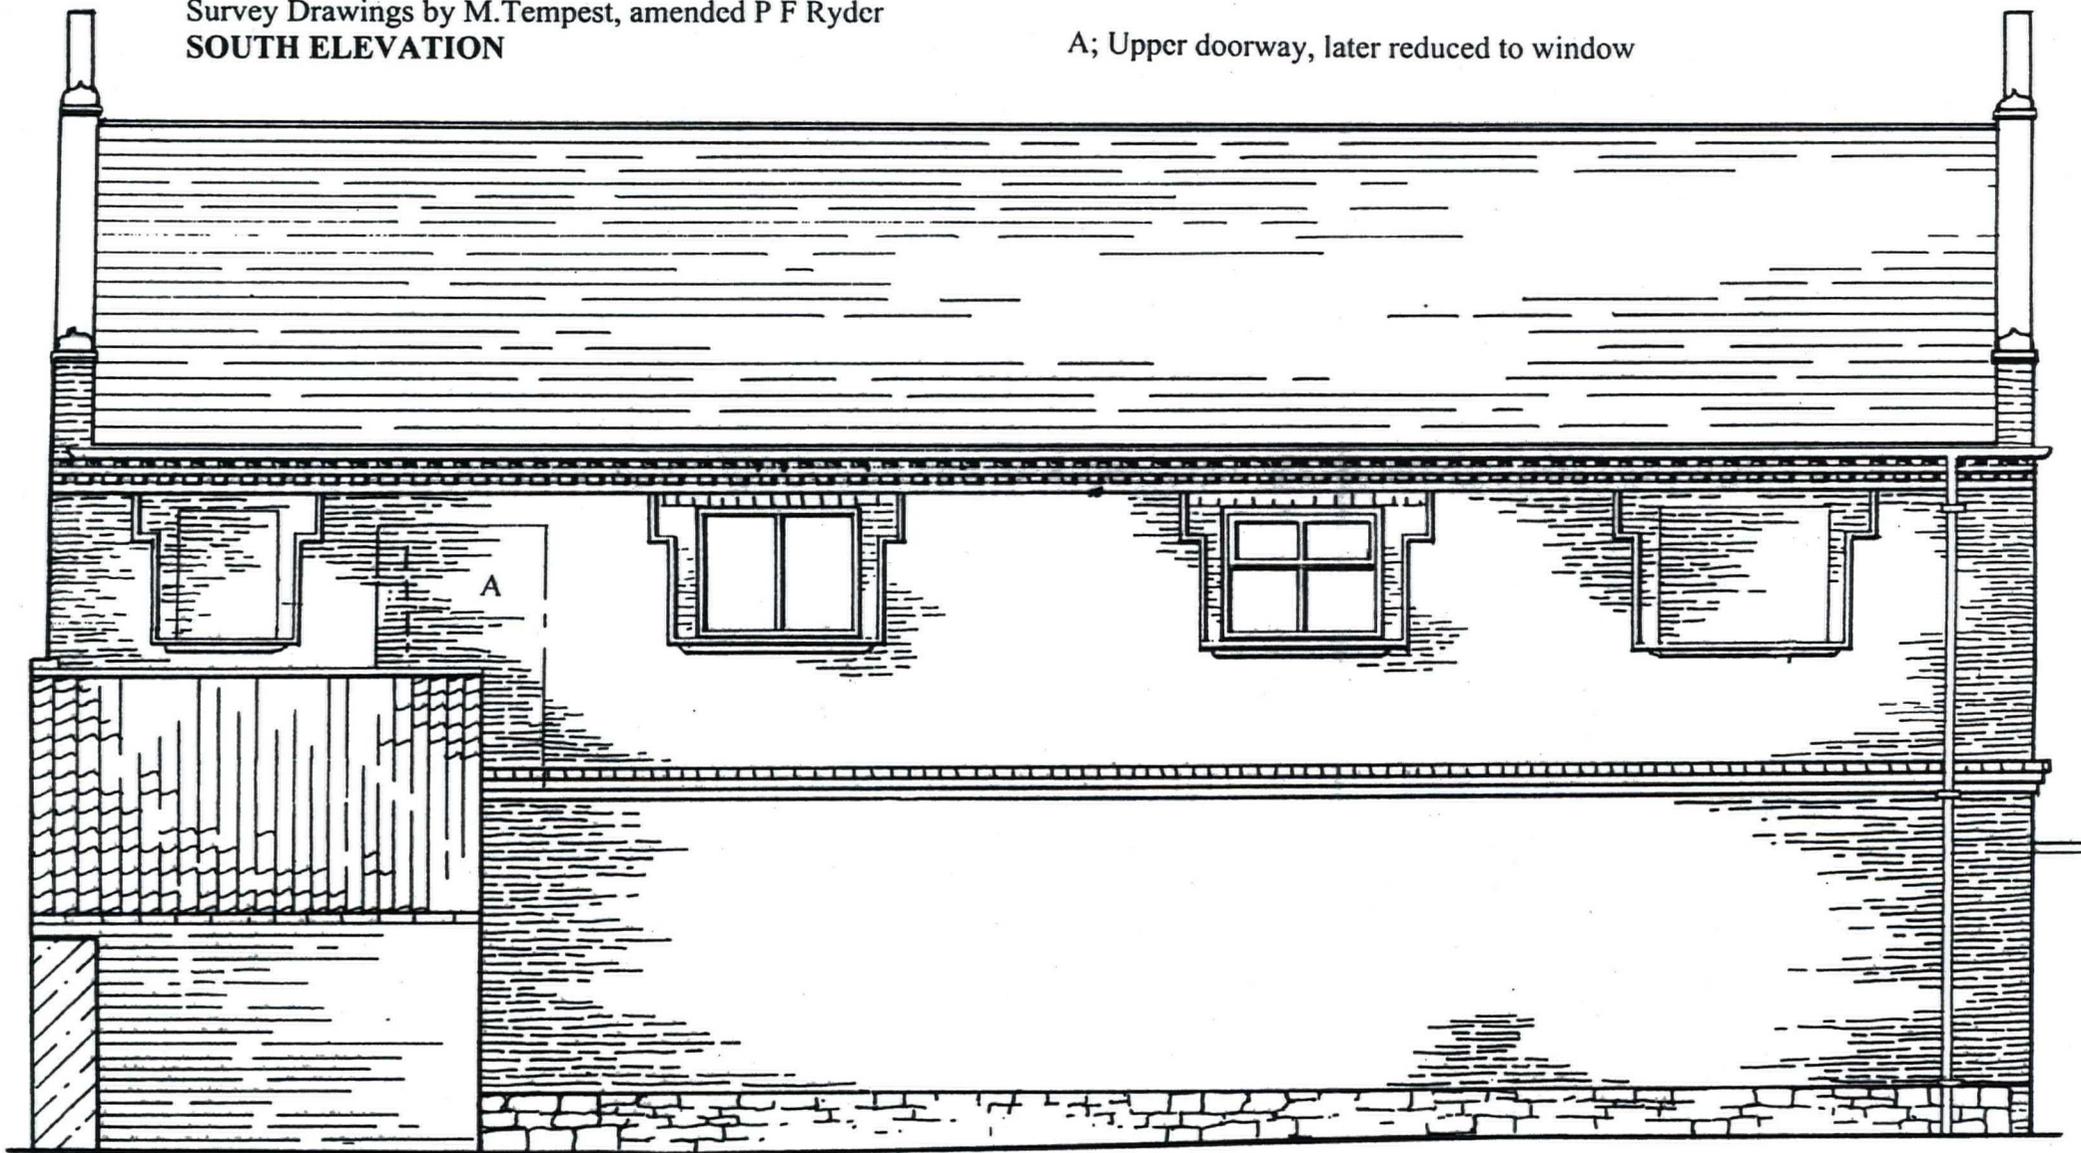
Survey Drawings by M. Tempest, amended P F Ryder
SOUTH ELEVATION

- 4.08 The south wall has a series of four further windows of this type; one that is set close to the west end of the wall being only half the width of the others; the two central ones now contain 20th-century casements, but the others are blocked¹. The upper members of their moulded surrounds interrupts the lowest course of the eaves cornice. Between the westernmost window and the first of the three wider ones are indications of a former doorway, which was apparently reduced to a window before being blocked; all the blockings are in 'old' brick. The sill of the doorway would seem to have cut down through the mid-height band, which has been restored when it was blocked. Internally the doorway, which has timber lintel, is blocked flush with the face of the wall, although the two blocked windows both form recesses, again with timber lintels. It is not clear whether this doorway is an original feature; the manner in which its sill cuts the band, and the lack of any evidence for an associated external stair would argue for its being secondary, but the positioning of a smaller window alongside (which does seem to be an original feature) would be easier to explain if both doorway and windows were all part of the same design.

A; Upper doorway, later reduced to window

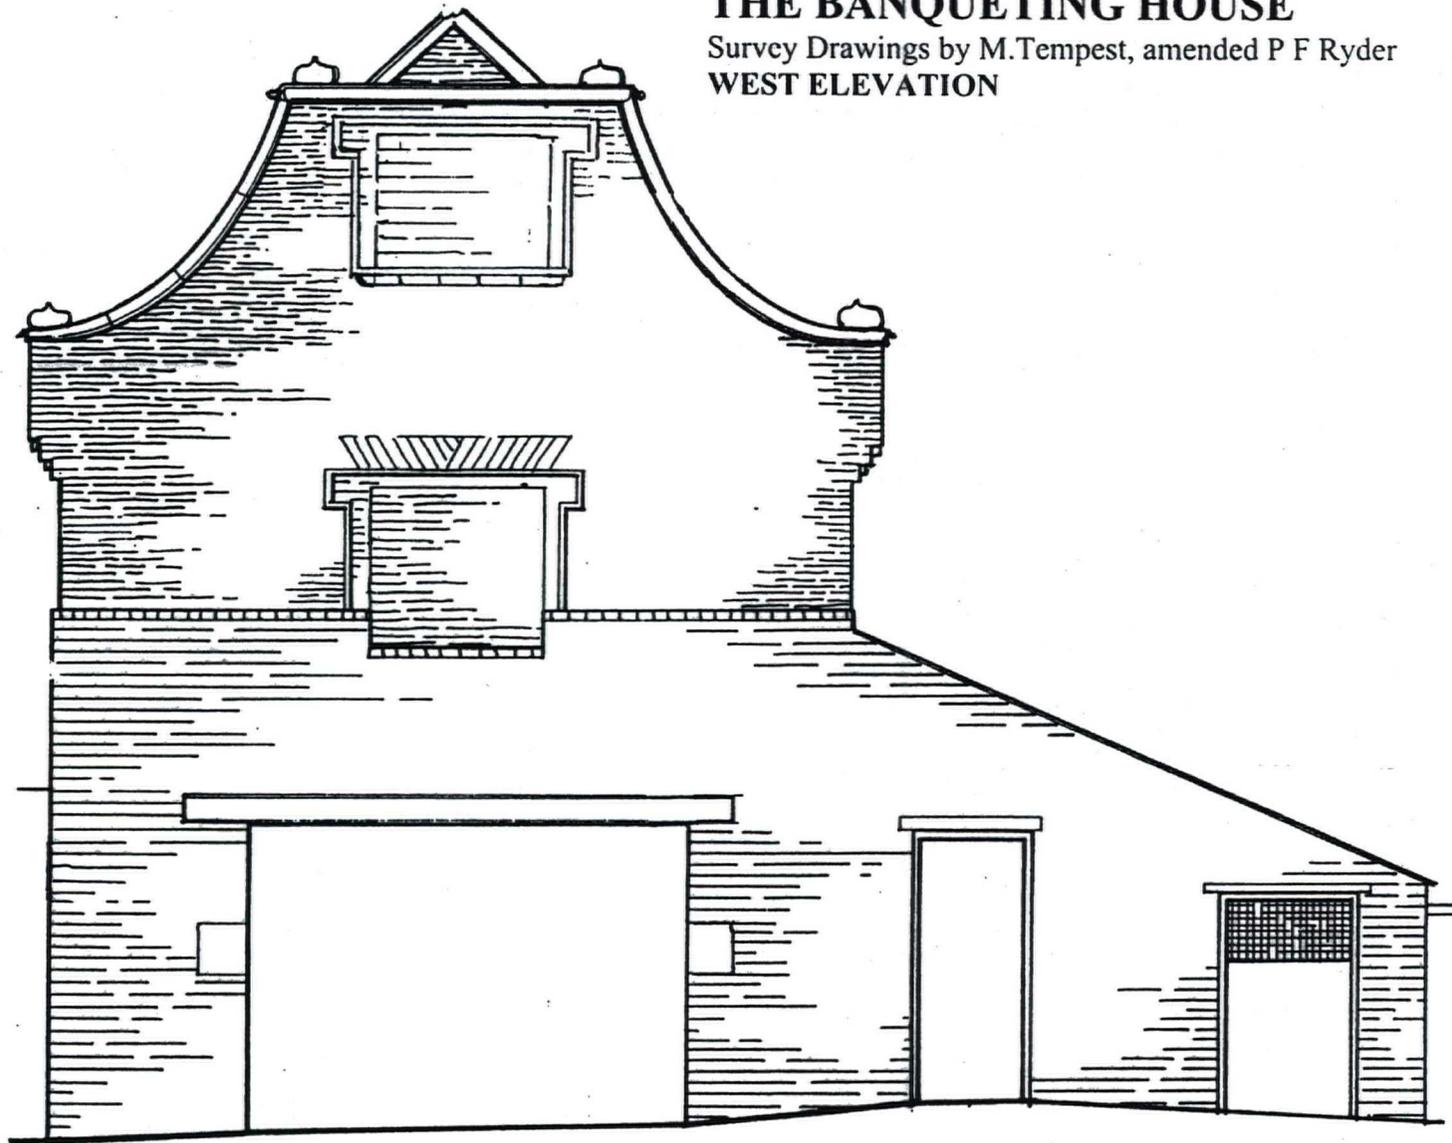
Survey Drawings by M. Tempest, amended P F Ryder
WEST ELEVATION

- 4.07 The west end and south wall of the buildings are clearly the 'show' elevations of the building. In the west end, above the refaced area, is a blocked window set within an architrave-like surround of 'lugged' form, outlined in quadrant-section moulded bricks, with a flat relieving arch (formed by bricks, including both stretchers and pairs of headers, set diagonally, meeting with one small V-shaped piece in the centre). The sill is concealed by the refaced section of walling. Internally this window shows as a recess, beneath a timber lintel; two courses above this is a flat arch of the same form as the external one. There is a second similar window, again blocked, directly above, its head set directly beneath the gable pediment; this one has a projecting brick sill carried on a corbel-like

course of quadrant-section bricks below. Internally this window is blocked up flush with the wall face, although straight joints appear to suggest that it was narrowed before being entirely blocked.

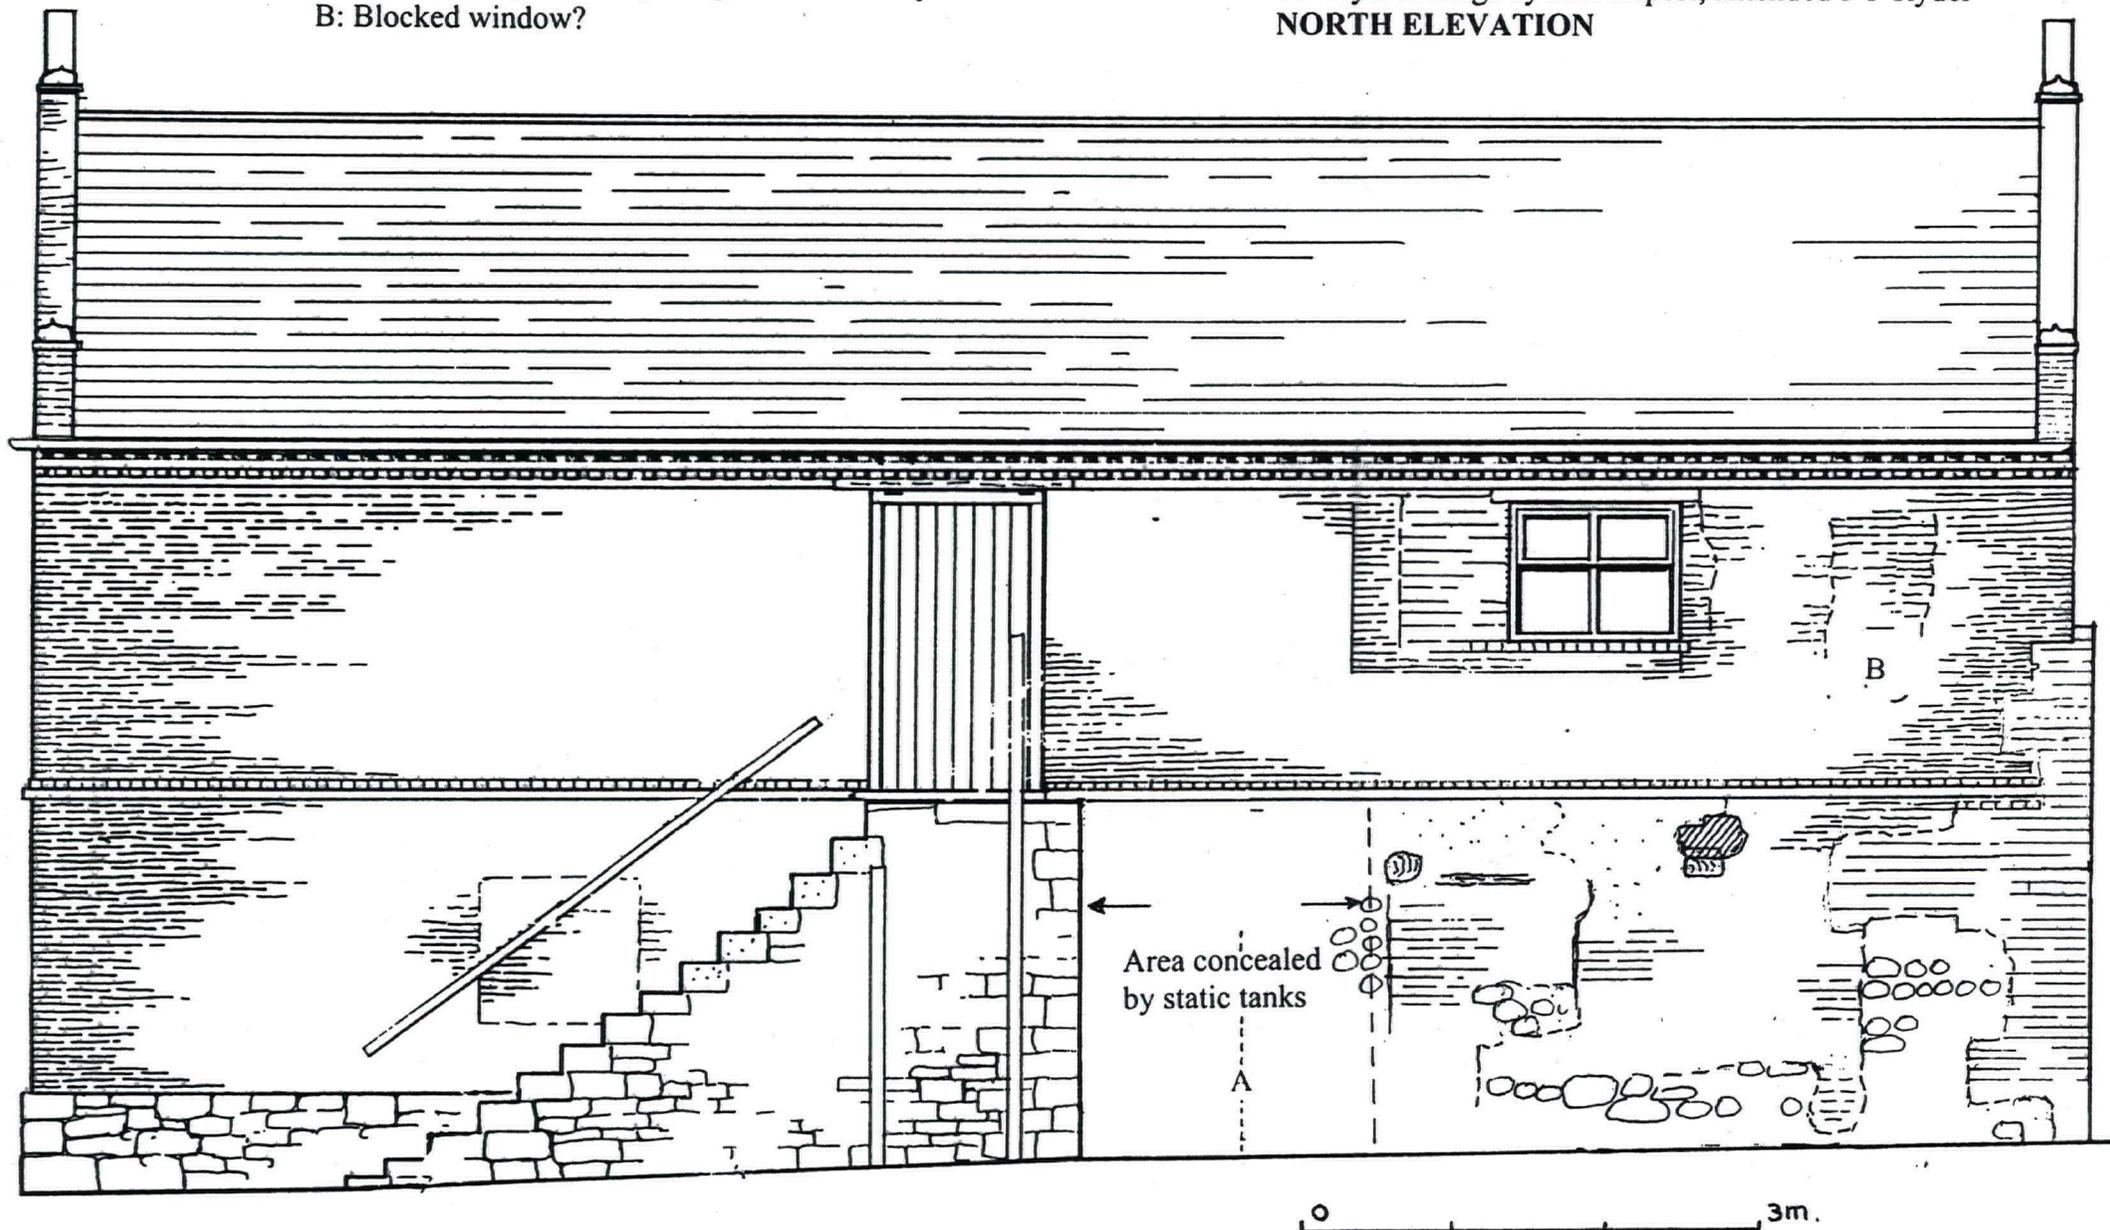
Survey Drawings by M. Tempest, amended P F Ryder
NORTH ELEVATION

- 4.05 The upper floor of the building is reached by an external stair, built of coursed roughly-squared stone, midway along the north wall. The stair rises westwards, and its upper steps have been replaced in brick (rendered over), probably within the last century. The doorway at the stair head is quite simple, with a renewed timber lintel; to the west of it is a 20th-century window set within an older opening that has clearly been reduced in size. External appearances suggest that the original opening was slightly reduced in width and its sill raised soon after its construction (to judge from the character of the brick infill), and then its east jamb narrowed further in 20th-century brick. To the west of the window is a feature which internally is a simple recess (which has no sign of ever having had a timber lintel) and externally shows as a rather irregular patch of secondary brickwork.

A: Line of east jamb of opening, seen internally
B: Blocked window?

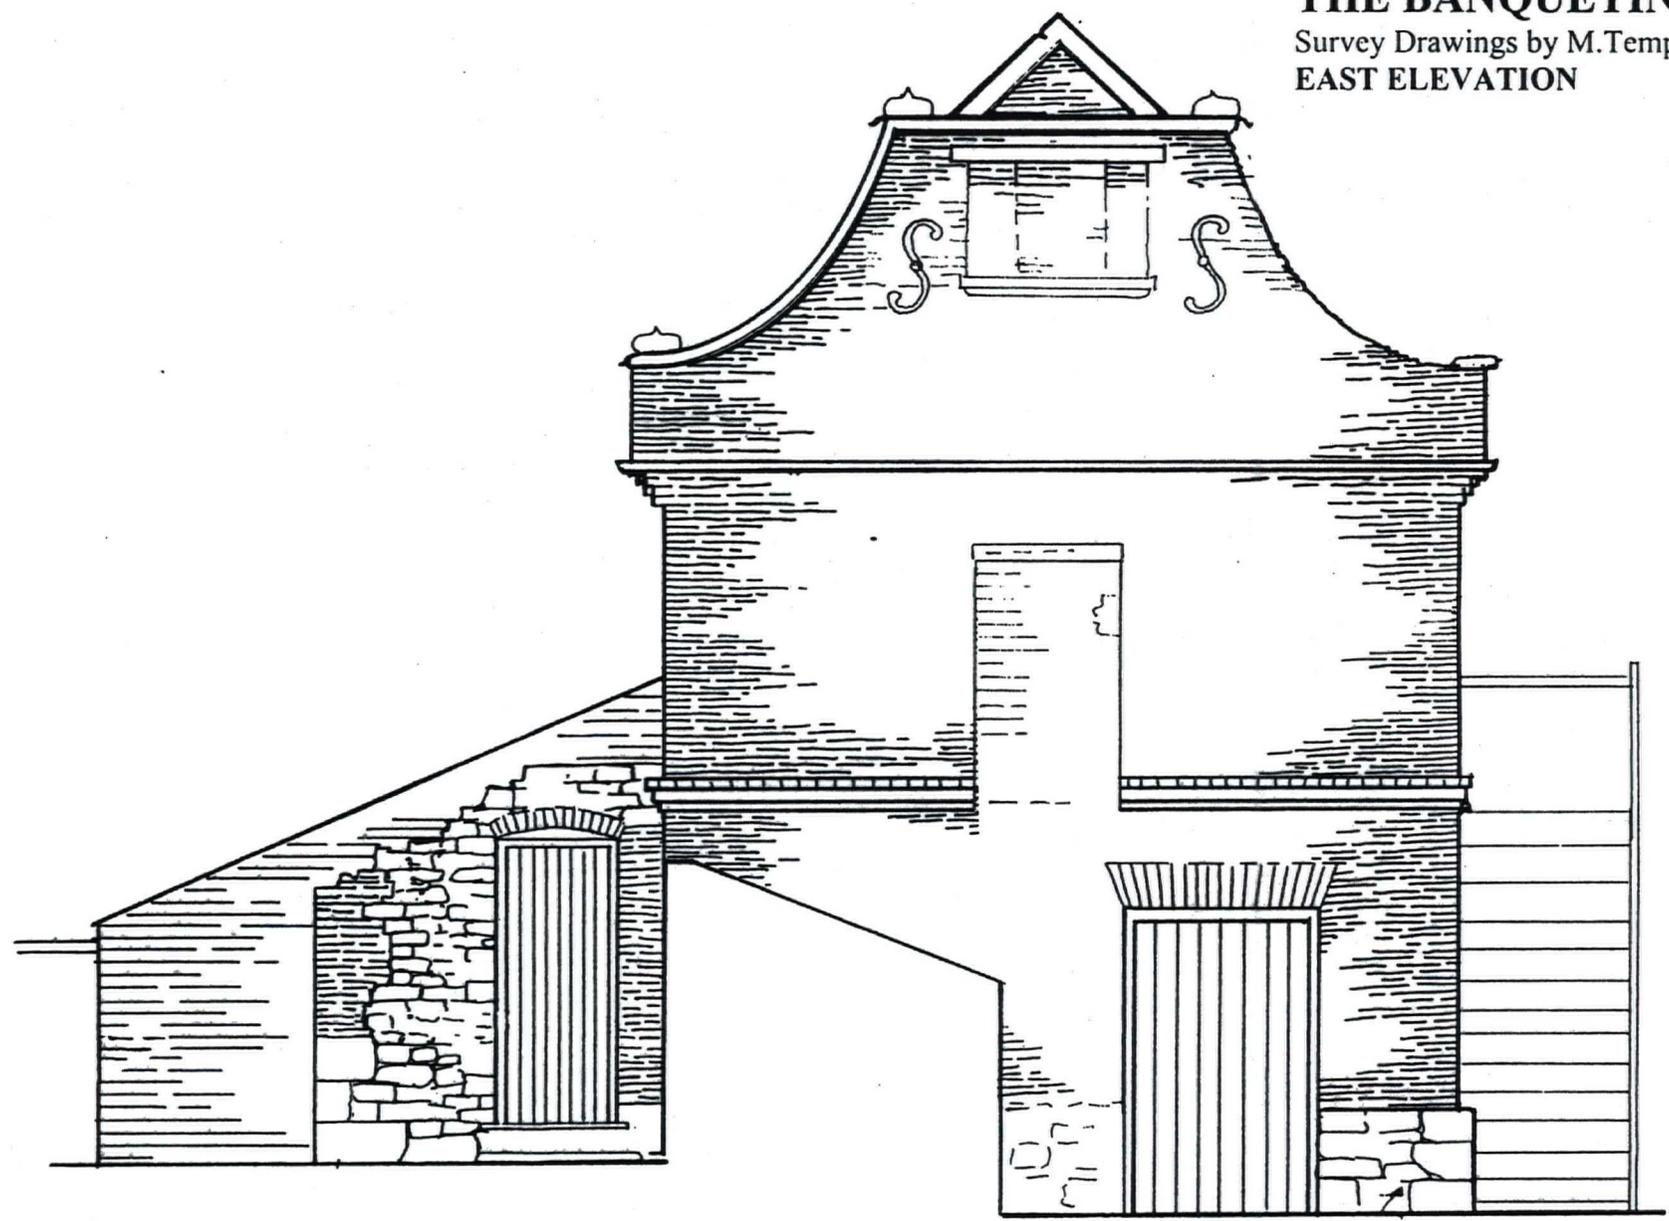
Survey Drawings by M. Tempest, amended P F Ryder
EAST ELEVATION

- 4.06 The east end of the building has a blocked opening at first-floor level, set just a little south of centre. It has a timber lintel, and its sill interrupts the mid-height band. Internally the upper part of this opening forms a recess, with a sloping sill, but the lower is blocked flush with the wall face. Above is a blocked window to the attic, with a timber lintel, and a projecting brick sill carried on a corbel-like course of quadrant-section bricks.

- 4.11 The fabric of the building is currently in rather poor condition, and in some parts, eg the upper parts of the east gable, close to collapse. Repair and restoration work are urgently needed if rapid deterioration is to be avoided. An excellent example of what can be achieved with a similar building is seen in the West Banqueting House at Chipping Campden (Gloucestershire), which has recently been restored from a similarly dilapidated condition, and is now a Landmark Trust property.
