Gunby Hall Icehouse Pond, Gunby, Spilsby, Lincolnshire
Archaeological Watching Brief
National Trust

Report Title: **Gunby Hall Icehouse Pond, Gunby, Spilsby, Lincolnshire –
Archaeological Watching Brief**

Revision: **Final**
Issue Date: **January 2014**
Report Ref: **4582**

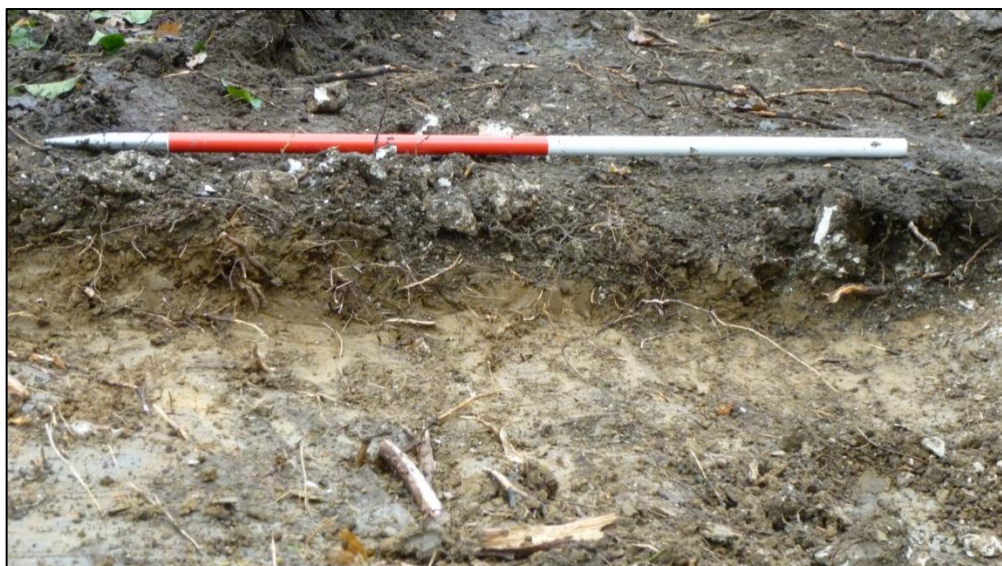
3.2.1 Topsoil **100** across the site was observed to comprise dark humic silty-clay, typically of 0.2 m in depth, overlying mid brown silty-clay subsoil **101** with a slight yellow hue in places. The remains of the pathway walk **102** are described in more detail below. Stiff grey clay **103** was encountered beneath the subsoil beyond the south-western corner of the pond (Plate 1), although the natural substrate was not encountered elsewhere.

Plate 1: Representative section through the walk to the southwest of the pond

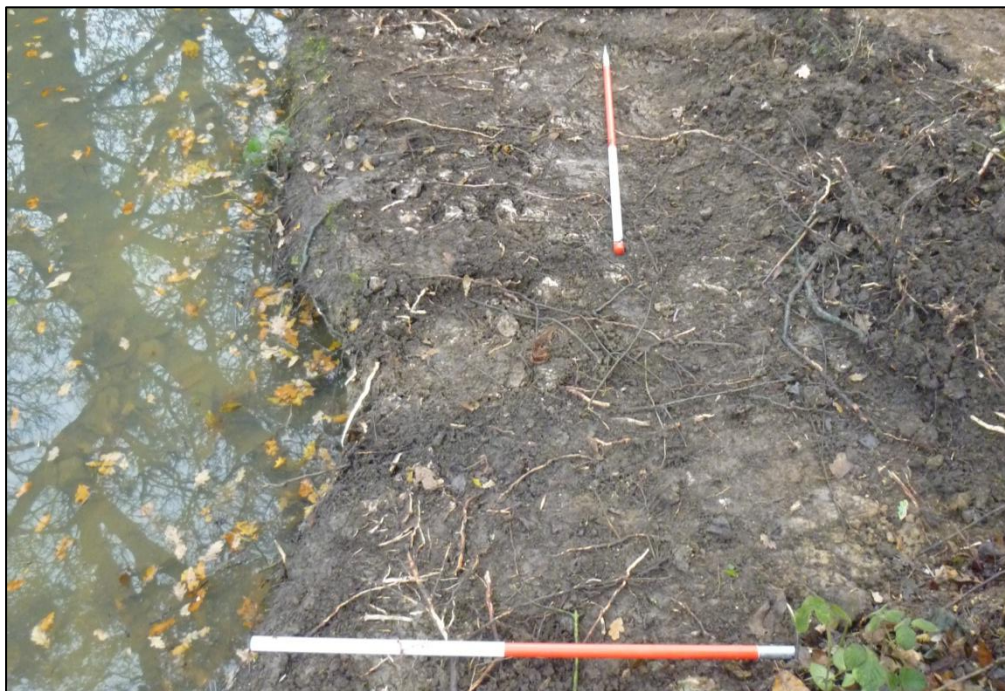
3.3.1 The remains of the path were encountered around a large proportion of the pond, although substantial areas to the south and east had evidently been lost to the pond through erosion (Plate 2).

Plate 2: Photo showing path **102** on the edge of the pond to the southeast, looking east

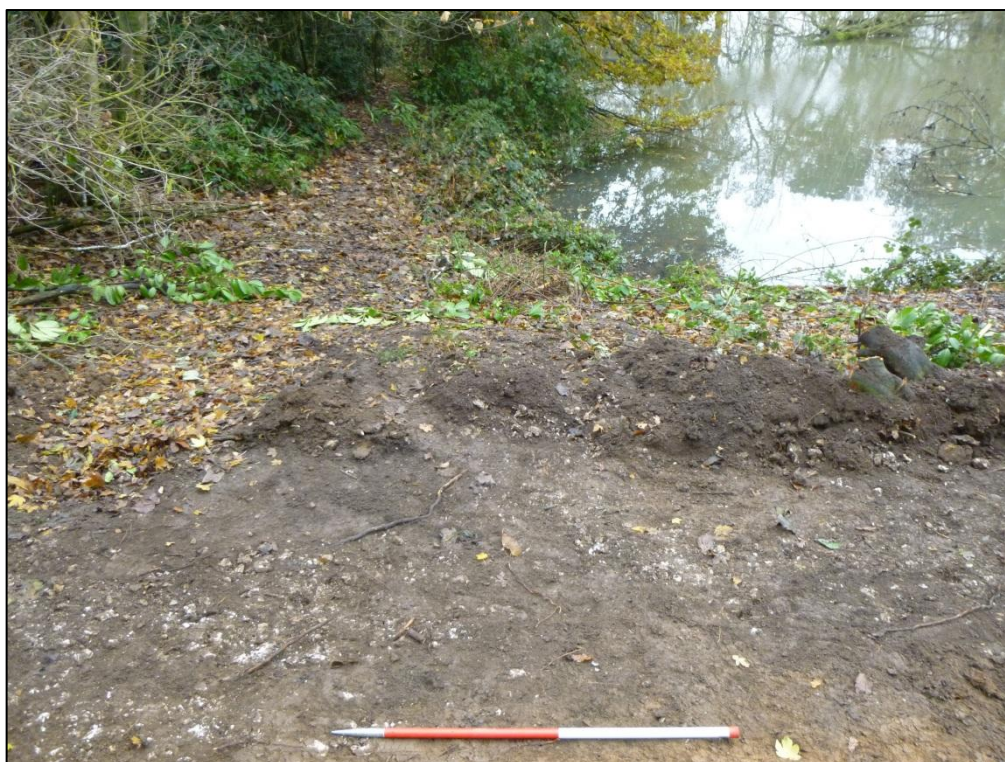
- 3.3.4 The junction between the western and northern sides of the walk was encountered (Plate 3), indicating that the crushed chalk surface had likely continued along the northern side. The western walk continued beyond the junction to the north, although appeared to end 8.0 m short of the current gateway (Plate 4). Whilst it was possible the shortfall to the gate represented the former edge of the woodland, the soil in the area was very loose and appeared to have been disturbed by a recent tree-throw and subsequent animal burrowing within the softened ground. However, little chalk was observed within the deposit to indicate the latter.

Plate 3: Junction of path **102** between the western and northern parts. Photo looking east along the north bank

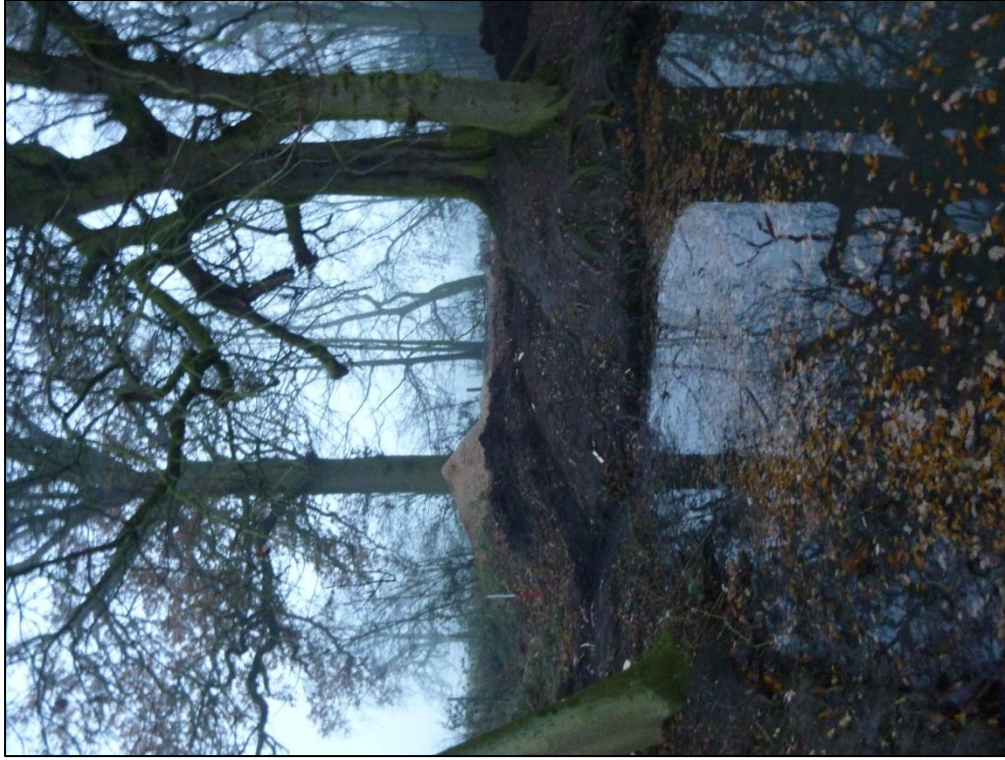
- 3.4.2 A ditch extended from the eastern side of the pond, curved towards the south along the edge of The Belt (Plate 5). Tracing the ditch it appeared to have been purposefully filled in south of the survey area. During the course of the work the ditch was scraped out at its western end, showing it to contain a depth of silt **104** that extended below the ponds current water level. The function of this ditch was problematic, with levels not clearly indicating whether it was an outlet, or inlet originally draining marshy land to the southeast.

Plate 4: View looking across the pond to the eastern drain

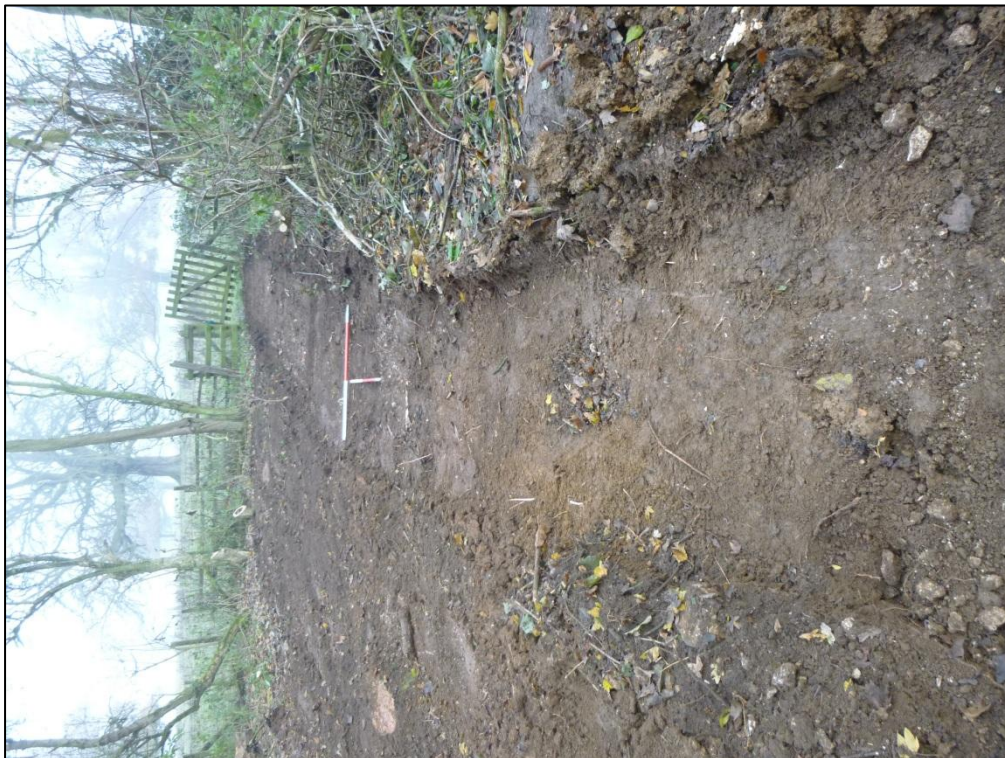
Plate 5: Excavation of west bank path looking north to north western field gate

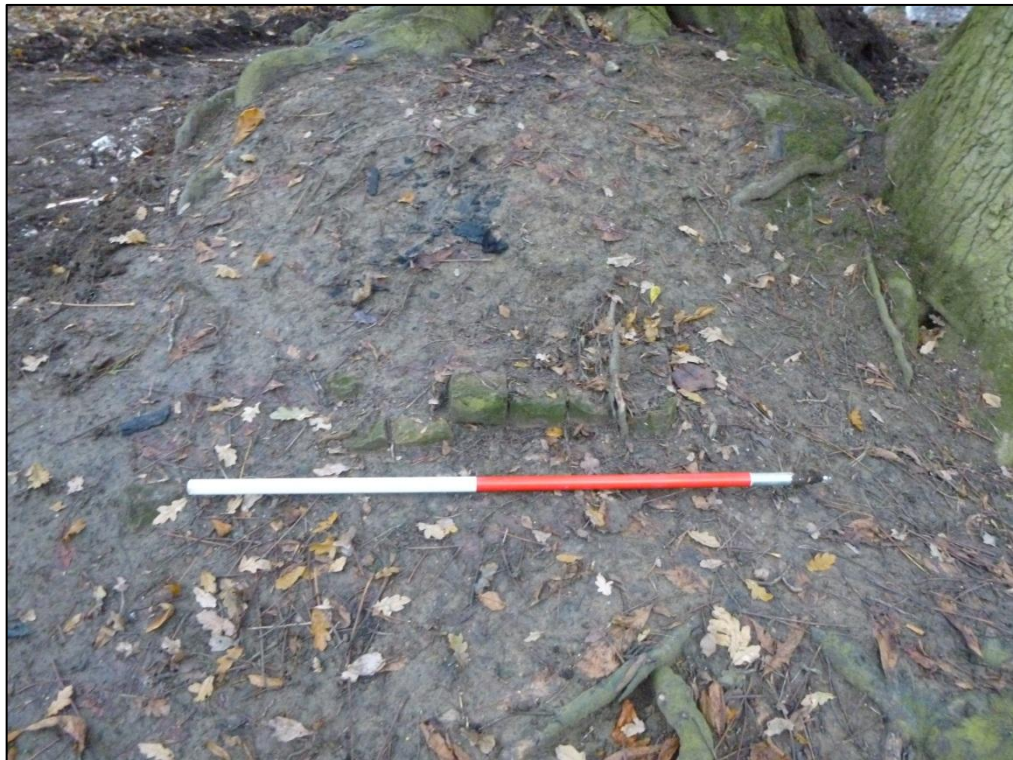
- 3.5.1 The upper course of a brick wall **106** was partially exposed between the excavated area and the southeast corner of the pond (Plate 6). This may have related to the structure depicted in the area on the 1889 OS map. A set of steps **105** are situated to the north of the excavated area. The steps comprised five brick treads laid on edge descending from the southeast to the northwest (Plate 7). In addition situated towards the centre of the pond there was a small island of broken brick of unknown function (Figure 2).

Plate 6: Exposed upper course of brick structure at the southeast corner of the pond

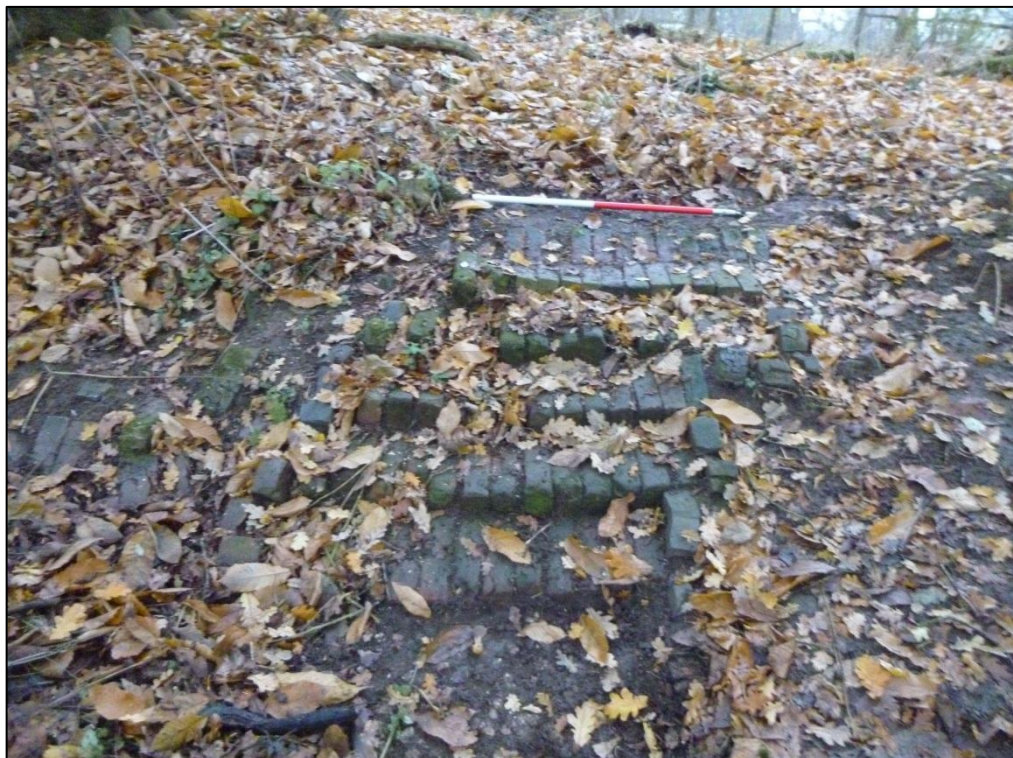
Plate 7: Exposed brick steps running east from the northeast corner of the pond
