**Abbeydale Industrial Hamlet Mill Pond –
Archaeological Watching Brief
Sheffield City Council**

Report Title: **Abbeydale Industrial Hamlet Mill Pond – Written Scheme of Investigation for Archaeological Monitoring**

Revision: **Version 1**
Issue Date: **December 2014**
Report Ref: **4763**

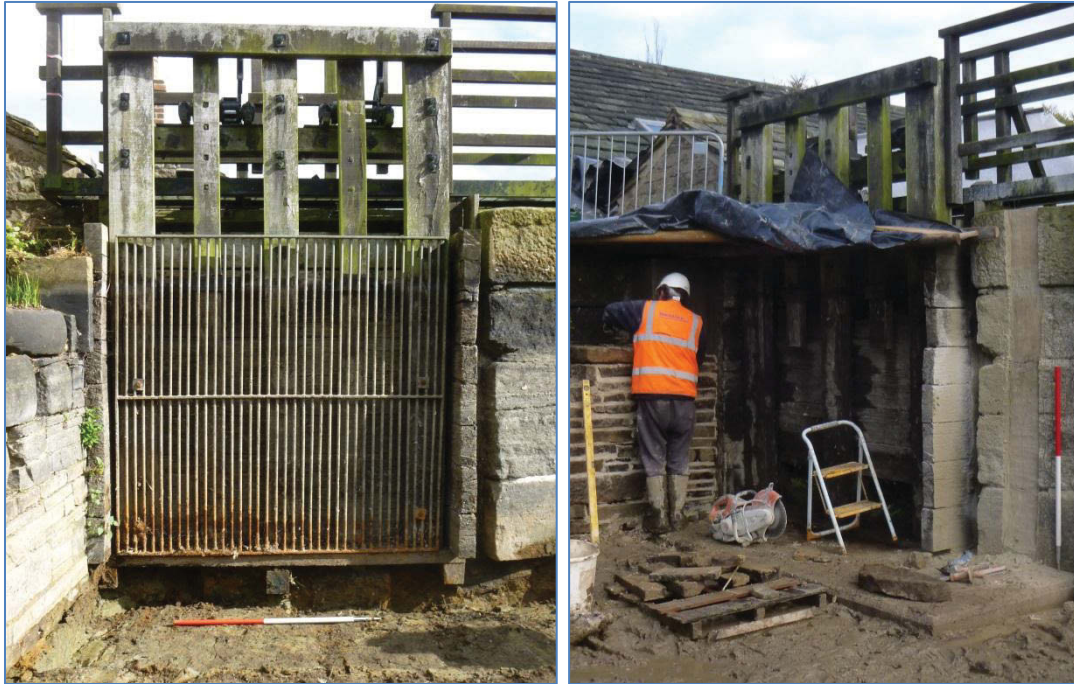
4.2.3 Grey clay **5002** was excavated from the base of the penstock within a 3.5 x 1.3 m wide and 0.25 m deep area to accommodate the creation of concrete foundations for the new penstock structure. The excavation revealed the penstock rested at its base on timber joists set within a stone sill (**Plate 1**).

4.2.5 The steps to the north of the gate were removed (having already been removed and rebuilt in 2001) and a concrete core was constructed behind them and the stairs rebuilt. To the south of the penstocks a channel was chased out 1.5-2.5 cm deep and 20-21 cm wide (**Plate 2**).

Plates 1-2: Detail of Penstock 1 as cleared and following pre-fit works

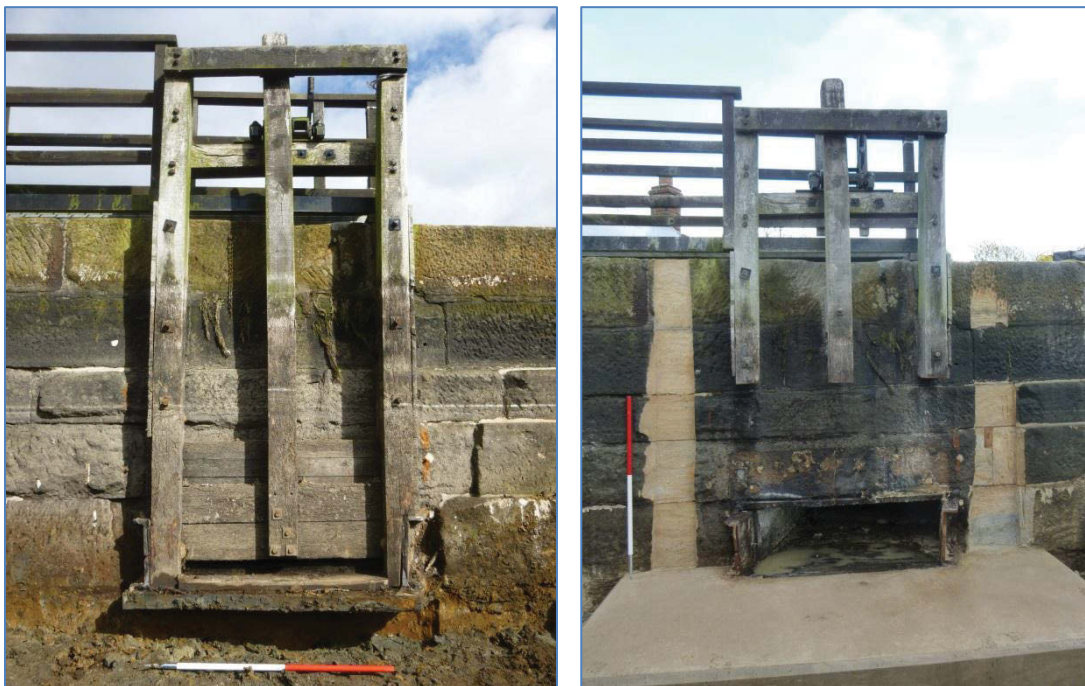
Plates 3-4: Detail of Penstock 2 as cleared and following pre-fit works

4.2.10 To either side of the penstock a channel was chased out 7.5-10 cm deep and 25-34 cm wide (**Plate 4**).

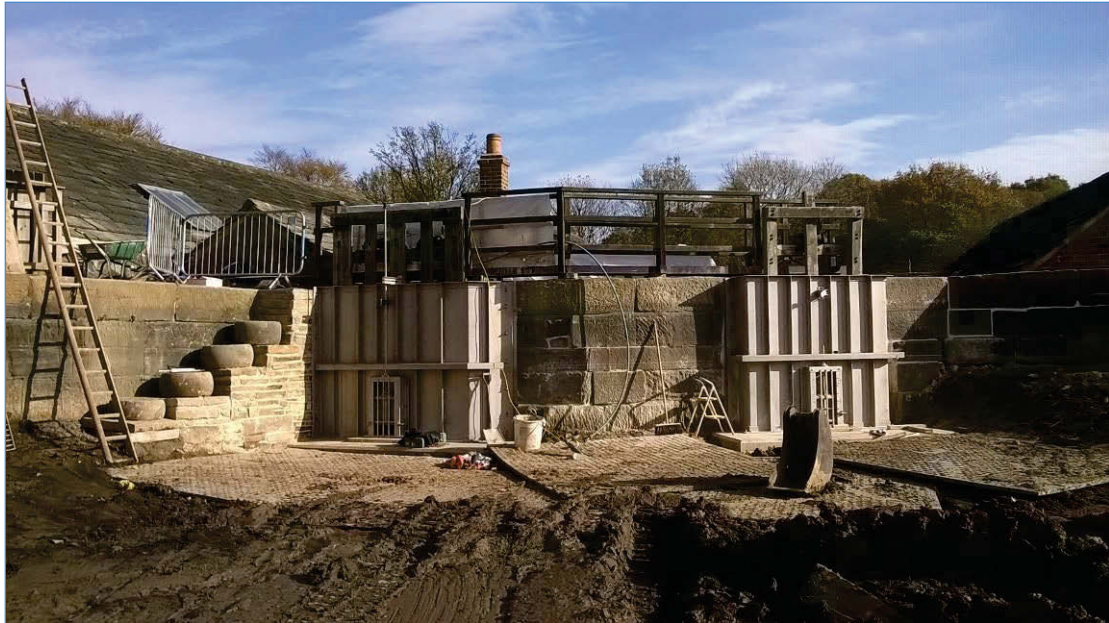
Plate 5: Penstocks following completion of works (image courtesy of J.N. Bentley)

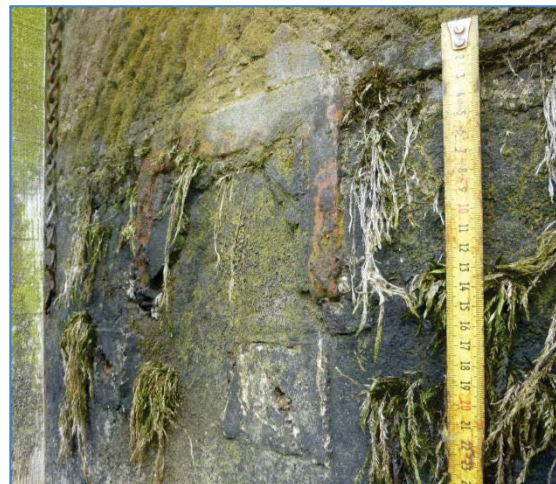
4.2.11 Several redundant fixtures were identified relating to an earlier penstock structure comprising six bolt holes, two chains and a central inverted 'C' section bar (**Plate 6**). The location of these features is illustrated on **Plate 7**.

Plate 6: Detail of truncated 'C' section bar and two bolt holes below.

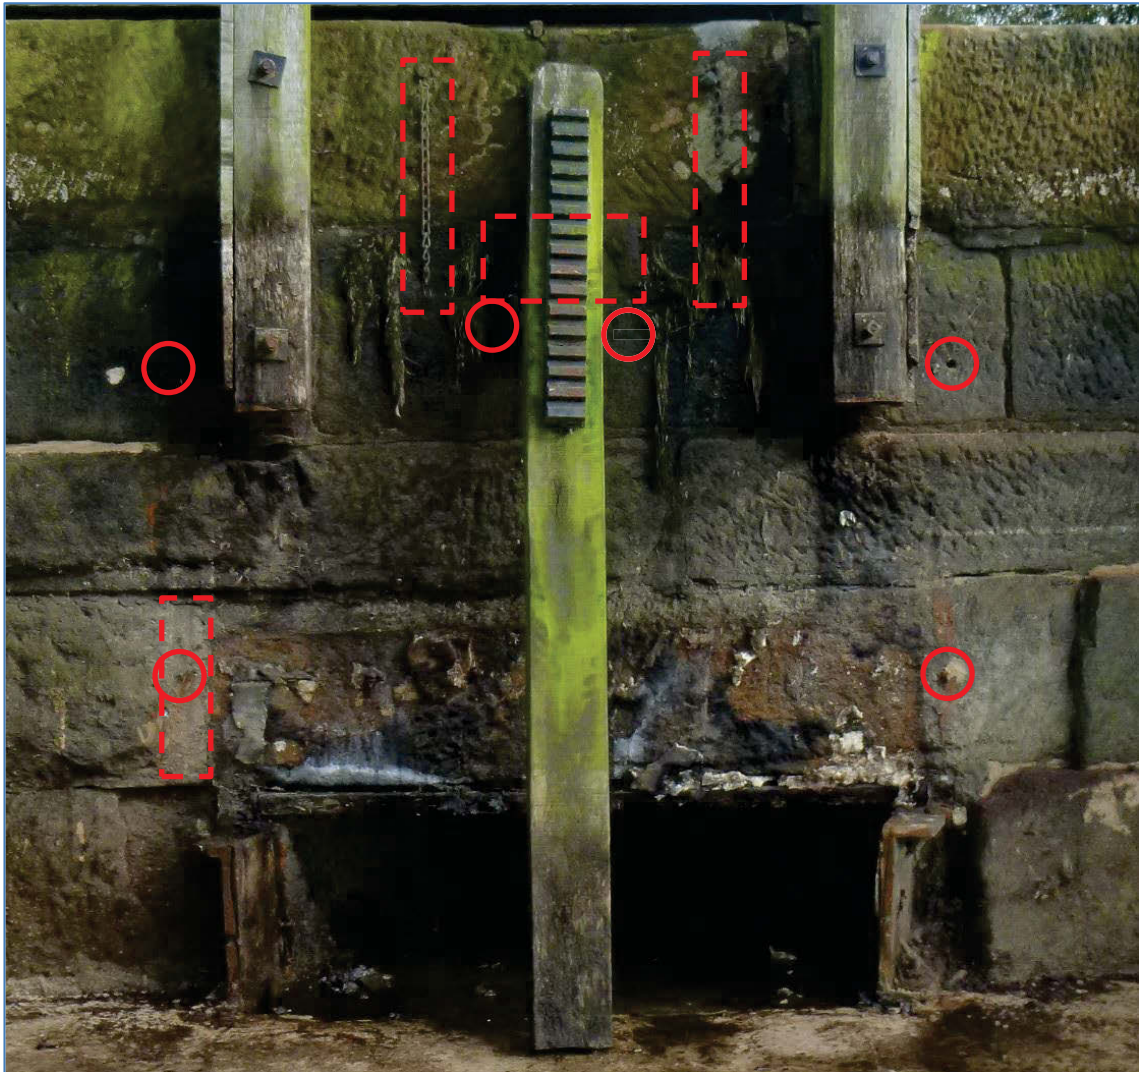
Plate 7: Detail of Penstock 2 showing former bolt holes (circled), chased out channel (lower left rectangle, chains (upper two narrow rectangles) and central truncated inverted 'C' section bar (central rectangle).

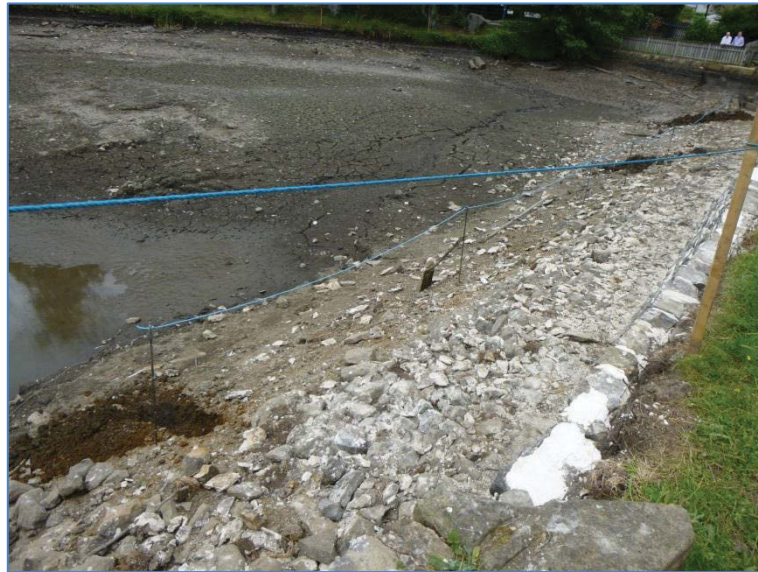
- 4.3.1 Test pits 1-3 (**Plate 8**) were excavated across the base of the bank to the south of the dam wall. The pits were excavated in error following a miscommunication regarding the excavation of test pit 4. Test pit 1 (**Plate 9**) was excavated to a depth of 0.95 m, whilst test pits 2 and 3 were aborted before reaching a similar level. The approximate location of these pits is shown on **Figure 1**.
- 4.3.2 An identical stratigraphic sequence was observed within each of test pits 1-3, comprising a sloping bank at the northern end of each pit formed of compact sand with a reddish hue **1000/2000/3000**. The slope of the bank steepened

Plate 8: General view of test pits 1-3 across bank of dam, looking north.

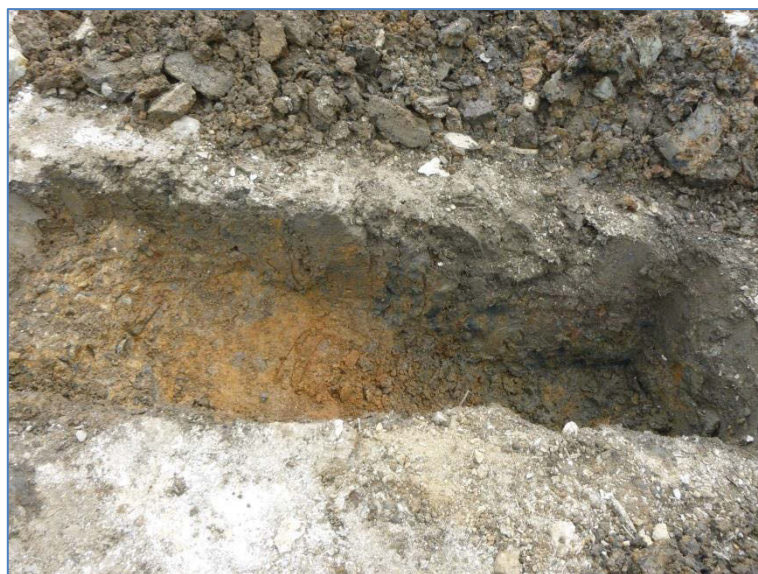
Plate 9: General view of test pit 1, looking south.

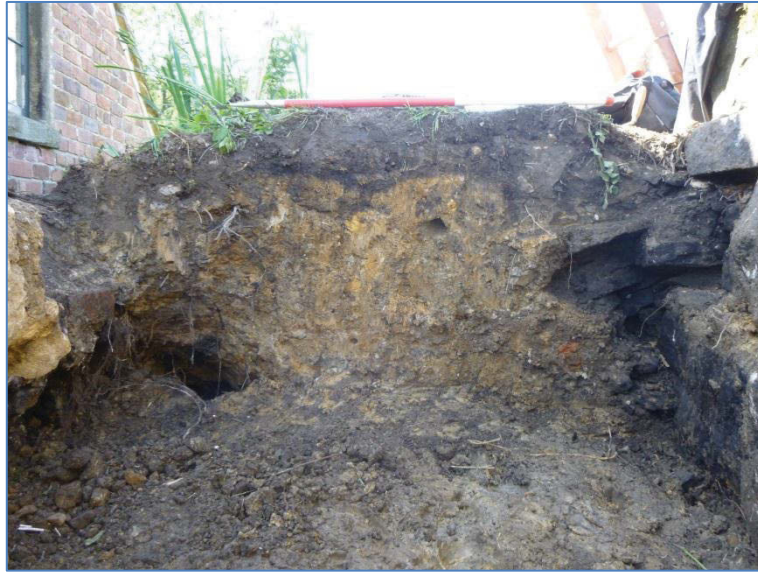
- 4.3.4 Test pit 4 (**Plates 10-11**), measuring 1.70 m wide by 2.00 m long by 0.93 m deep, was excavated between the dam wall and a rubble stone wall parallel to the south wall of the Forge. The purpose of the test pit was to investigate the depth of material above good quality puddling clay, and provide a suitable platform for replacing the material and repairing any potential points of leakage into the Forge. The location of the test pit is shown on **Figure 1** and a section through across the dam wall is reproduced as **Figure 2**.

- 4.3.8 Overlying the clay core was mottled clay deposit **4001** with occasional inclusions of unsorted sub-angular sandstone. The rubble backing of the dam wall to the south appeared contemporary with this layer; although the level of disturbance in the upper courses could indicate that the material had been removed and redeposited. Occasional voids were noted within this context suggesting water permeation through it from the dam.

Plate 10: Test pit 4, looking south.

- 5.1.3 Test pit 4 indicated that the southern stretch of dam wall from the penstocks was rubble backed, and that this backing had settled over the years into the clay bank creating a number of voids. Grouting was injected behind the wall along this stretch in an attempt to rectify this.

- 4.3.10 Grout was injected into the fabric of the wall beneath the level of the test pit, with the pit itself backfilled with puddling clay in an attempt to solve the leak from this area of the dam wall.

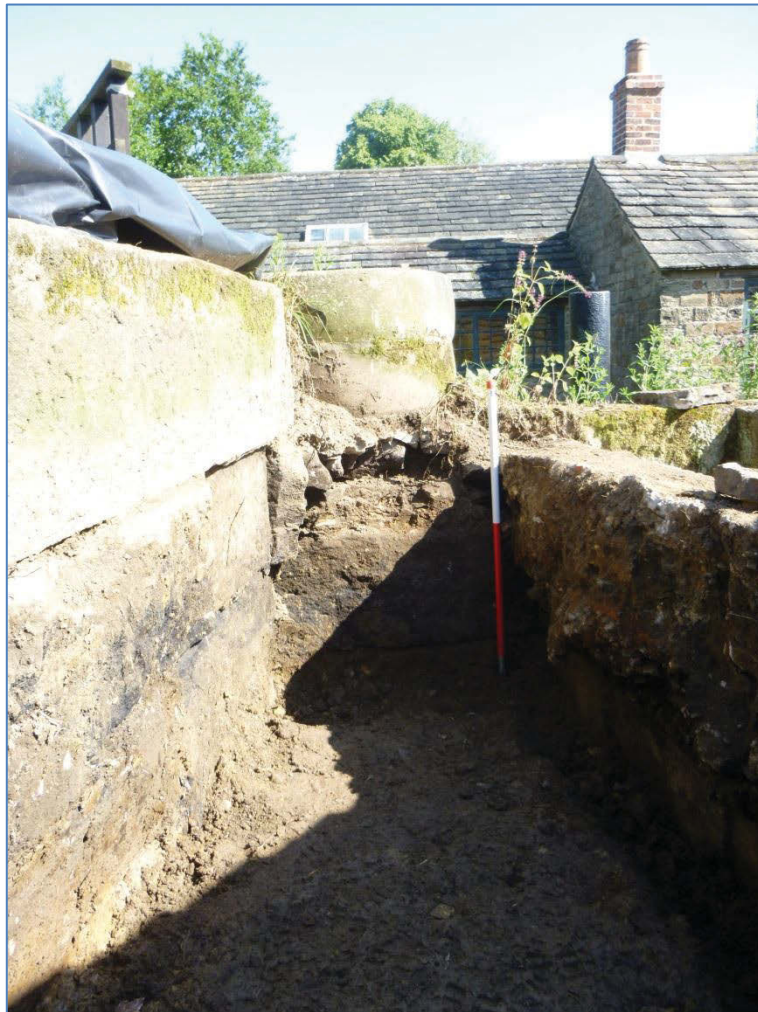
Plate 11: Test pit 4 looking north.

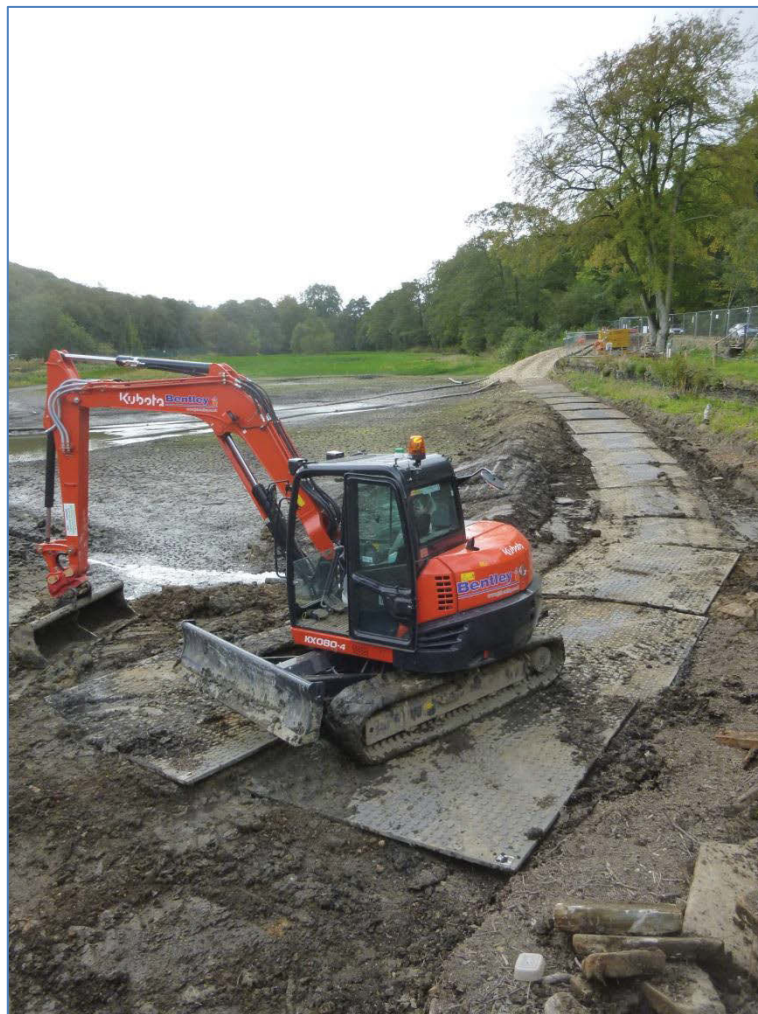
- 4.4.1 A level access track was created along the inside northwest edge of the pond, from the crane pad structure adjacent Abbeydale Road South round to the penstocks (**Plates 12-13**). The depth of the excavation varied, with a maximum depth of approximately 0.80 m in the northwest corner of the pond. The route and approximate extent of the works associated with the access track is shown on **Figure 1**.
- 4.4.2 In areas silt **5000** was removed to expose **5001**: a compact sand layer with red hue, similar to context **1002**. Towards the northwest corner the silt was excavated to reveal grey clay layer **5002** at a depth of between 0.2 and 1.0 m below ground level. Both 5001 and 5002 appeared to represent undisturbed layers, potentially representing the original base of the pond.

Plate 12: General view of the access track, looking south.

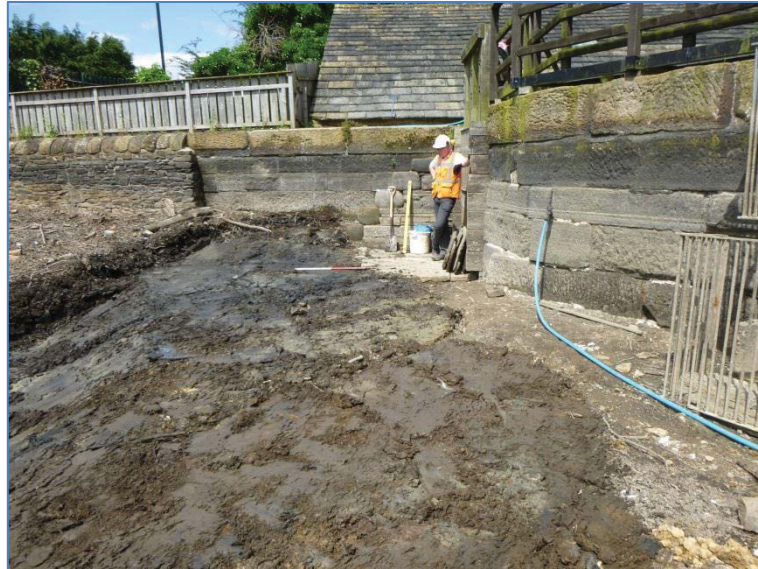
Plate 13: View of the exposed clay in front of the penstocks, looking north.

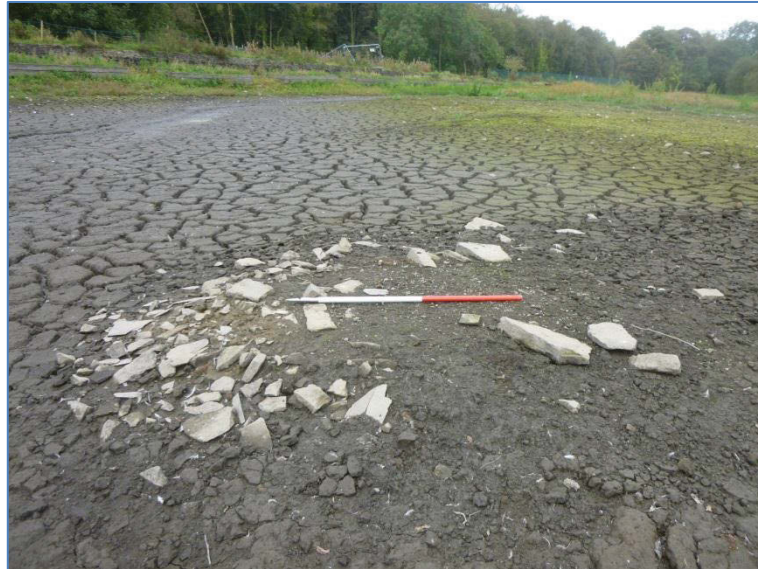
4.5.1 A rubble spread was observed in a raised area towards the centre of the pond. The rubble comprised unsorted angular narrow slabs of sandstone. Whilst no edges were discernible, two possible centres to the spread were recorded with a handheld GPS at:

Plate 14: View of the possible remains of a structure within the dam, looking east.

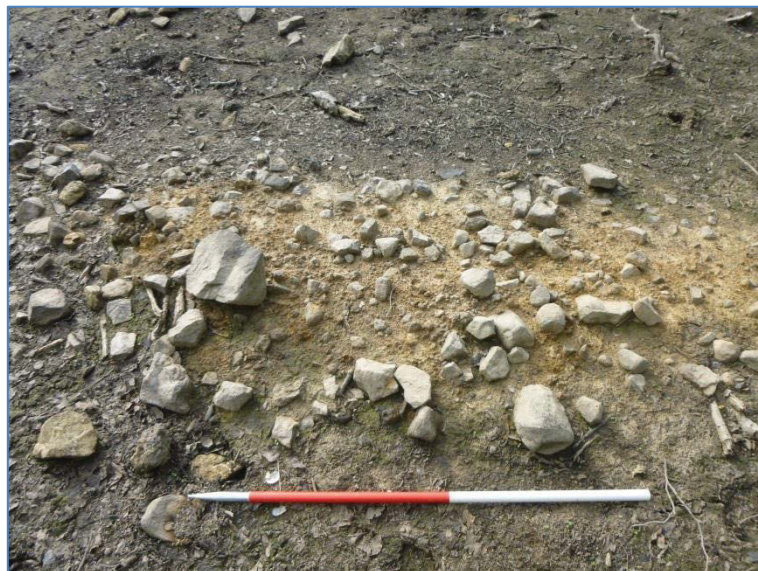
4.5.3 The remains of the former head goit structure feeding the mill pond was clearly evident as a linear spread of rubble extending out at an acute angle from the western bank of the pond (**Plate 15**). The location of the remains of the head goit structure is illustrated on **Figure 1**.

Plate 15: View of the remains of the head goit structure, looking east..

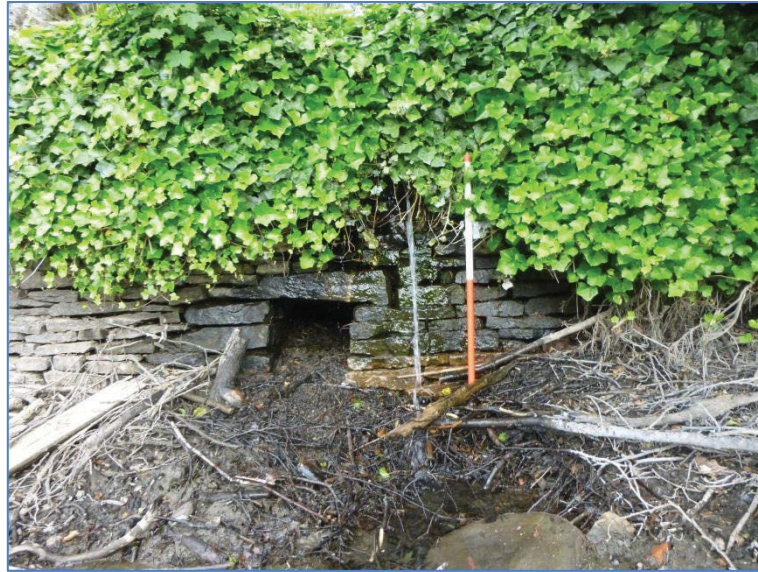
4.5.4 An inlet in the northwest corner of the dam that collects water from Ecclesall Woods is situated within the rubble built western dam wall (**Plate 16**). At this point there was a square opening with flat lintel that had silted up and likely represents the original inlet. Above it are two salt-glaze pipes from which water was running at time of survey. The location of the inlet is indicated on **Figure 1**.

Plate 16: View of an inlet within the northwest corner of the dam, looking west.
