**Archaeological Watching Brief  
River Nar Restoration Project  
at  
West Lexham**

**Heather Wallis  
March 2011**

**HW Report No. 106**

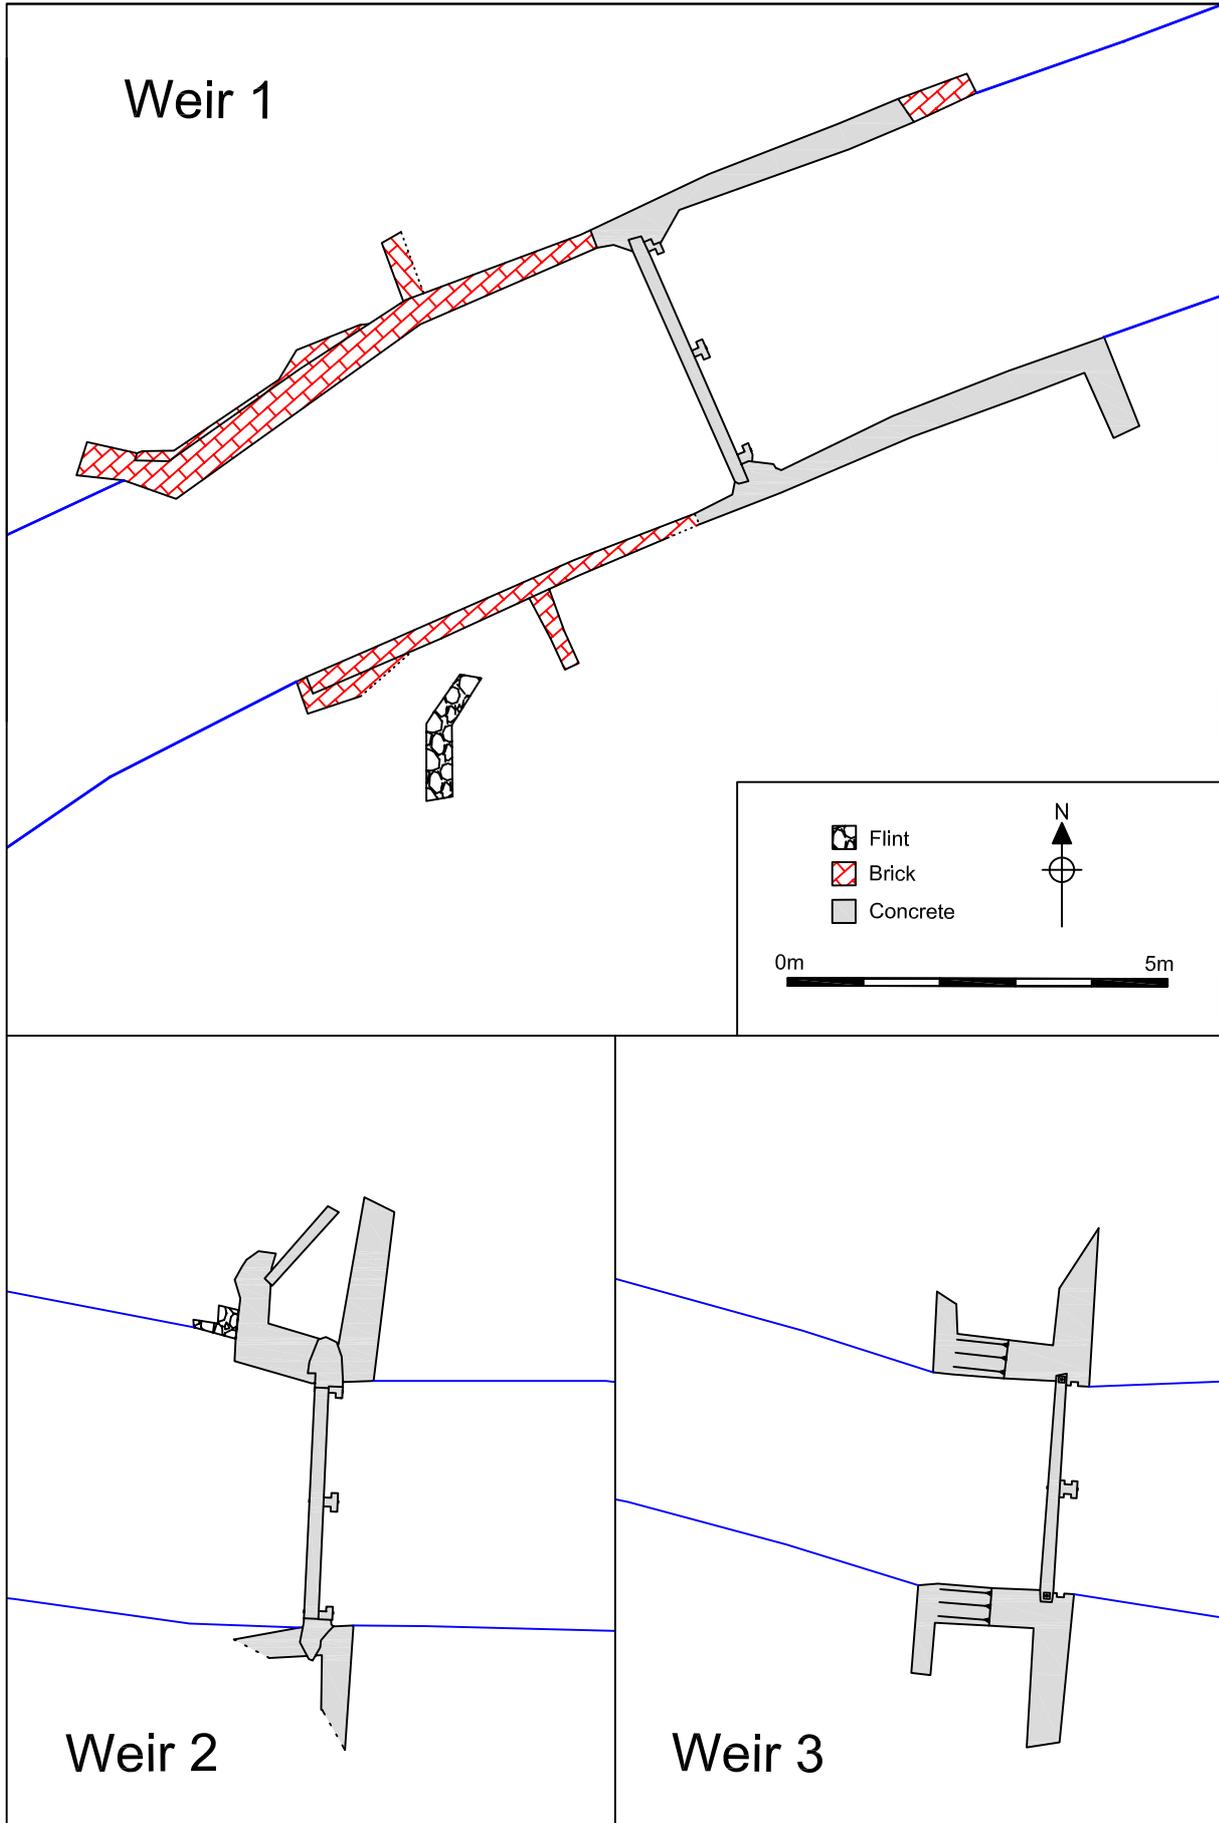
Fig. 2 Plans of weirs

Three phases of construction are apparent within the present visible structure, the first being of brick and mortar construction, which is later repaired with similar materials and finally consolidated and partially rebuilt using concrete. The original sides of the weir were c.12m long and do not appear to have been significantly extended during the repair/rebuild phases. Several of the bricks are in poor condition and this relates to scouring by the fast pooling water as it passes over the weir. The upper 3 courses of brickwork on both the north and south sides appear to be of a different type of brick and have been interpreted as a later repair.

This weir appears to be constructed entirely of concrete with a U-shaped bastion having been built to either side of the river. The arms of the bastions were of different lengths, that facing upstream being 2.3m long, and those downstream 1.5m. The top edges against the river are all sharp, while those facing 'inland' are gently rounded. Again this has three uprights, one L-shaped at each side and one central T-shaped, with slots to take the hatch boards. A cross strut or lintel ran between these with iron bolts holding the structure together. Where the horizontal meets the bastions an additional 'patch' of concrete had been added to each side.

The weir is made of concrete with a bastion on each side of the river. In plan these were a flat-based U-shape with arms of uneven length. Although similar in some ways to Weir 2 there are also very notable differences. The edges of the bastion were all very sharp. The side adjacent to the river had a very distinct slope so that the downstream arms on the bastions were 0.5m lower than the upstream elements.

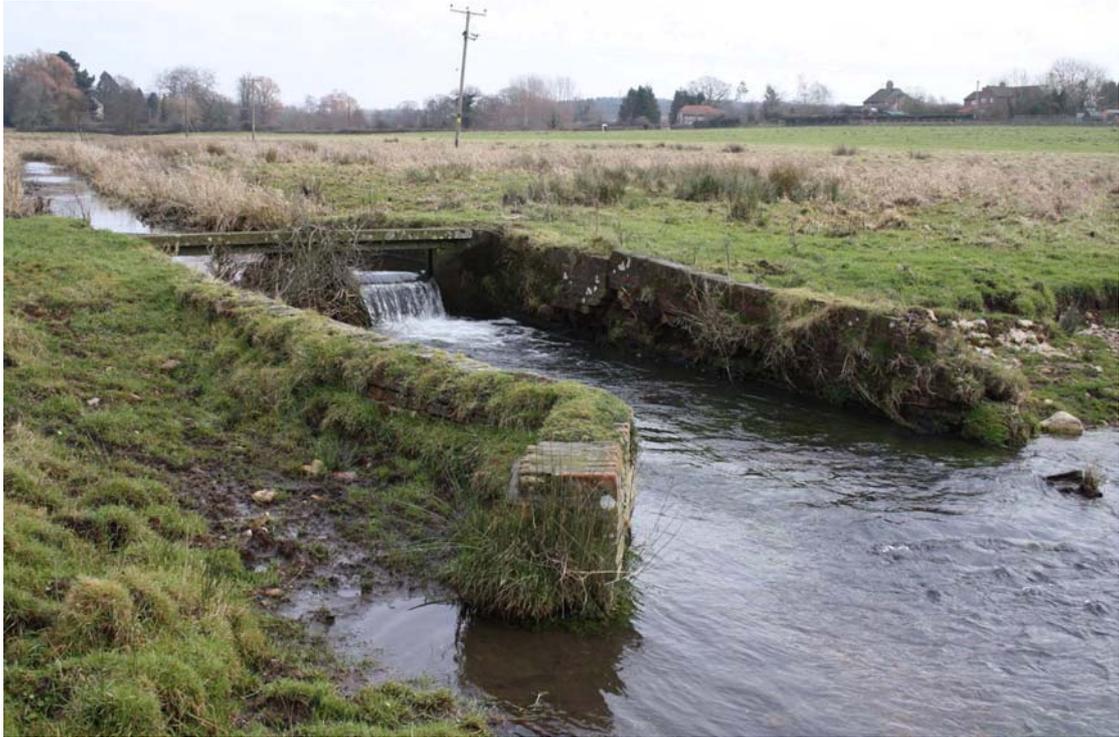
Concrete repair was mainly identified in the central section of the weir and particularly on the north side. A new crossing structure was built, comprised of uprights at each side and one central upright. Iron bolts were noted on the

central and southern upright, securing them in place. The central upright was T-shaped, the southern one L-shaped and the northern one Z-shaped. Running between them was a cross strut. Formed within these uprights were slots into which cross hatches could be placed to control the water flow. A steel plate, partially buried below the turf, was noted on the south bank, near to the weir. This may have been one of the (re-)moveable hatches.

Plate 1. Weir 1, before works.

In order to improve the flow of the river it was originally intended that all of the weir would be removed however, it was decided that the necessary results could probably be achieved by less drastic measures. Excavation within the channel removed three beams from either half of the weir. These were made of concrete with some iron reinforcement. It is possible that these were permanent features of the weir as there was no evidence for a lifting mechanism for these. Should the river need to be further controlled a more easily moveable hatch (such as one made of iron) could have been used. It should be noted that the use of this weir as a functioning part of the water meadow was long gone when these concrete elements of the weir were added.

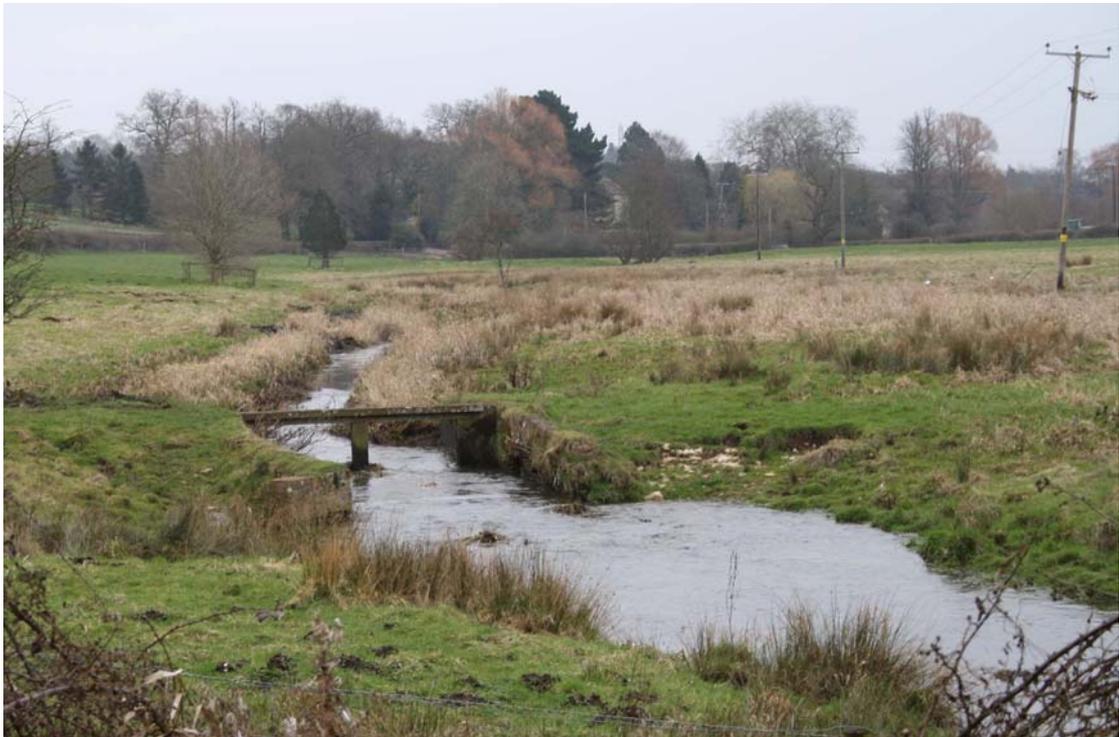
The remainder of the structure was not disturbed by the works and as all three of the uprights as well as the upper horizontal lintel remains in place it has not been weakened in any way. Further erosion to the flanking brickwork is also likely to be less as the river now flows at an even pace rather than into a swirling pool as it passed over the weir.

Plate 2. Weir 1, after works.

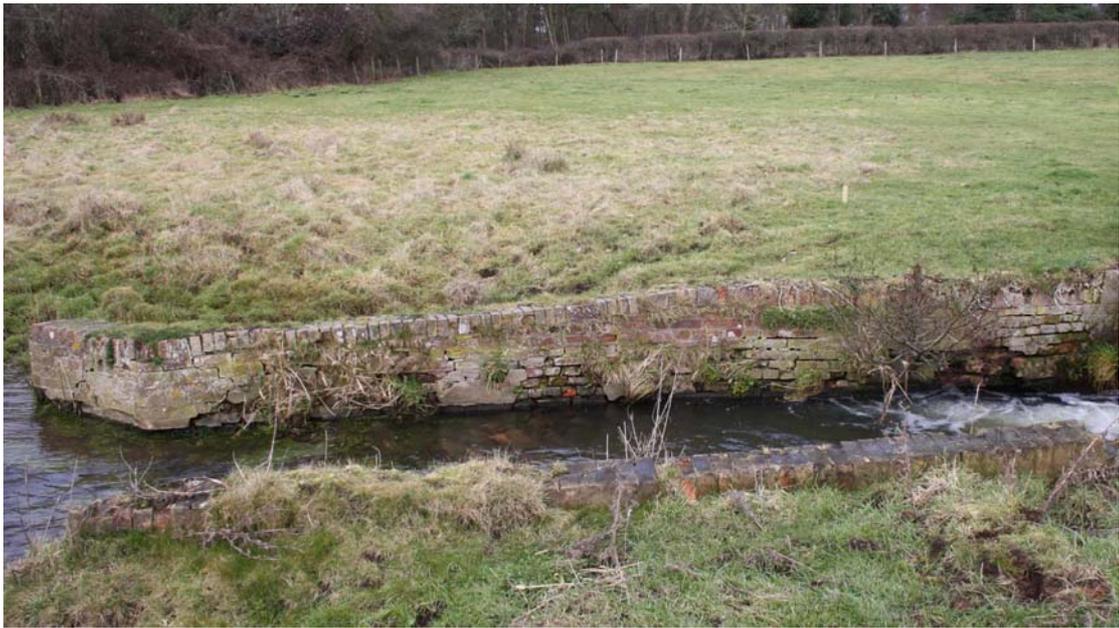
Further elements of the structure were apparent under the turf on both banks of the river. However as no disturbance to these was anticipated turf and topsoil was not removed to reveal them in any detail. These included short brick walls at right angles to the weir on both banks and a possible flint constructed wall on the south bank.

Plate 3. Weir 1, showing brick structure on North bank.

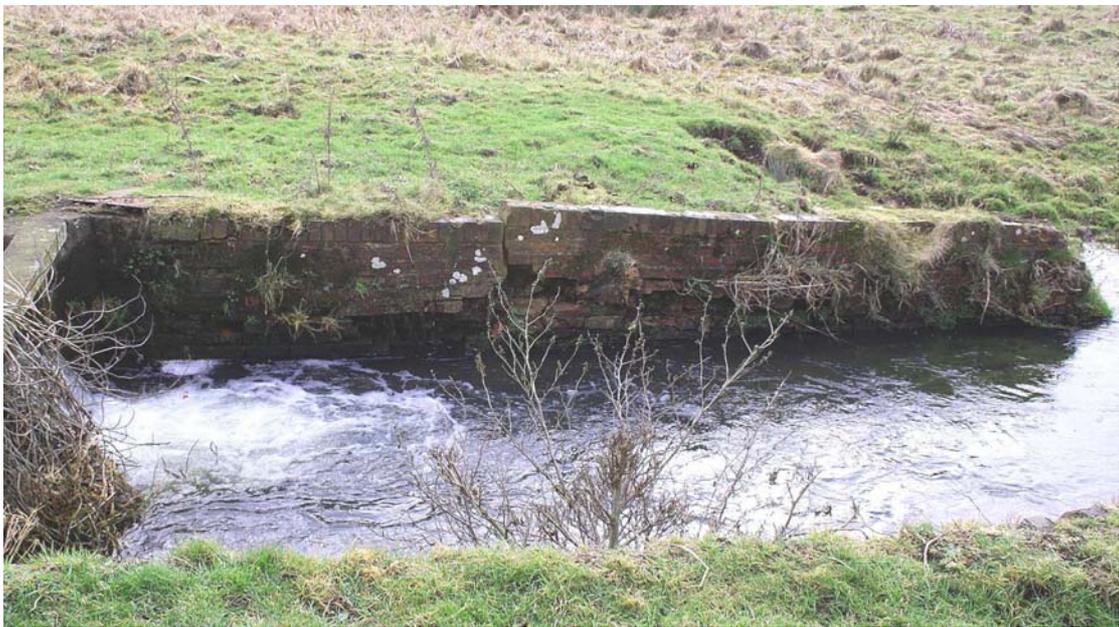
Plate 4. Weir 1, showing brick structure on South bank.

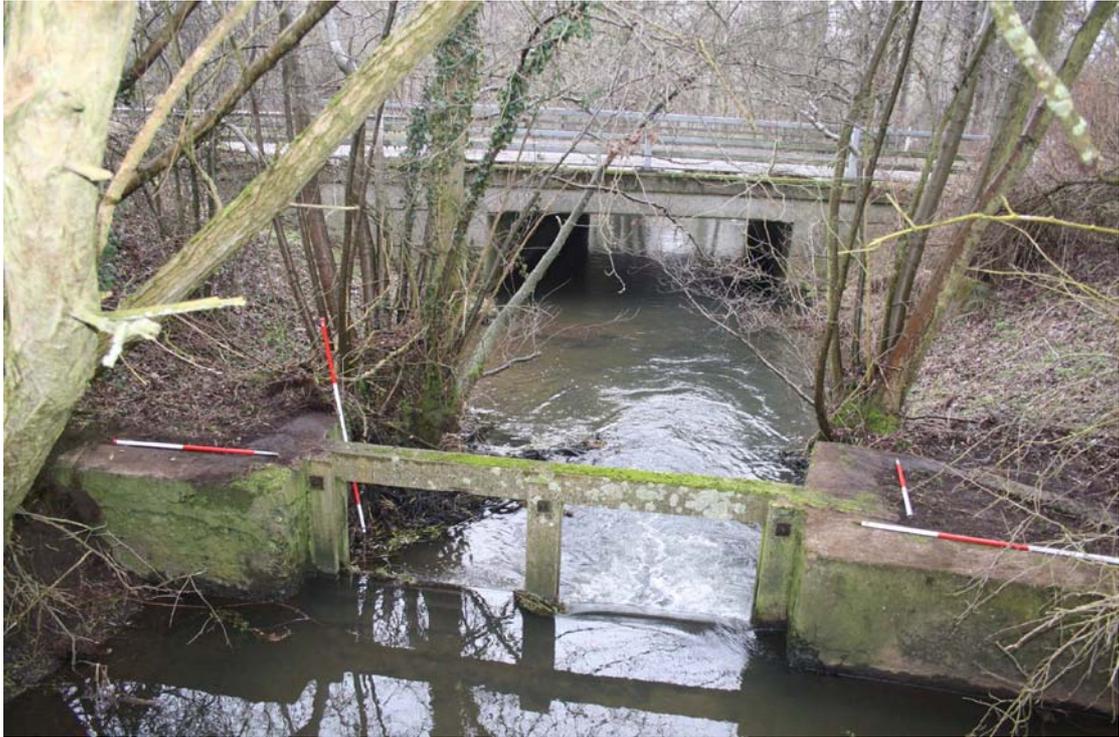
Plate 5. Weir 2, before works.

Lower cross beams were again made of reinforced concrete; one of which had previously been removed and lay next to the weir. The present works removed further concrete cross beams and the central upright so improving the flow of the river. There was no other impact on the structure.

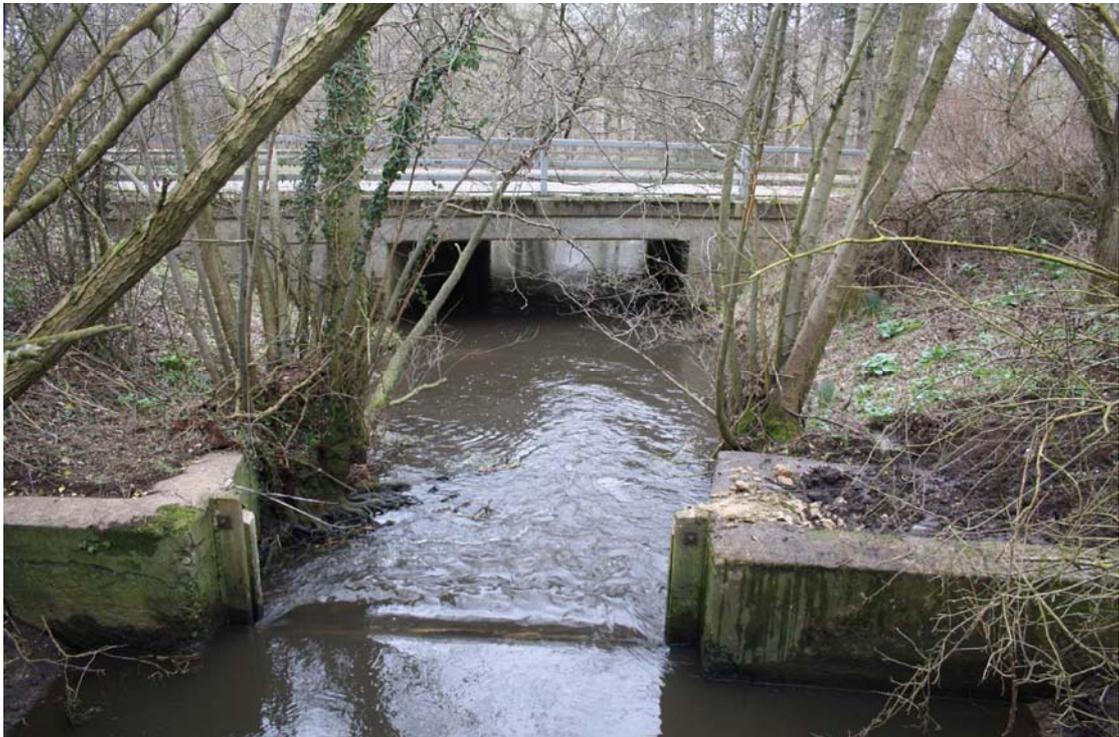
Plate 6. Weir 2, after works.

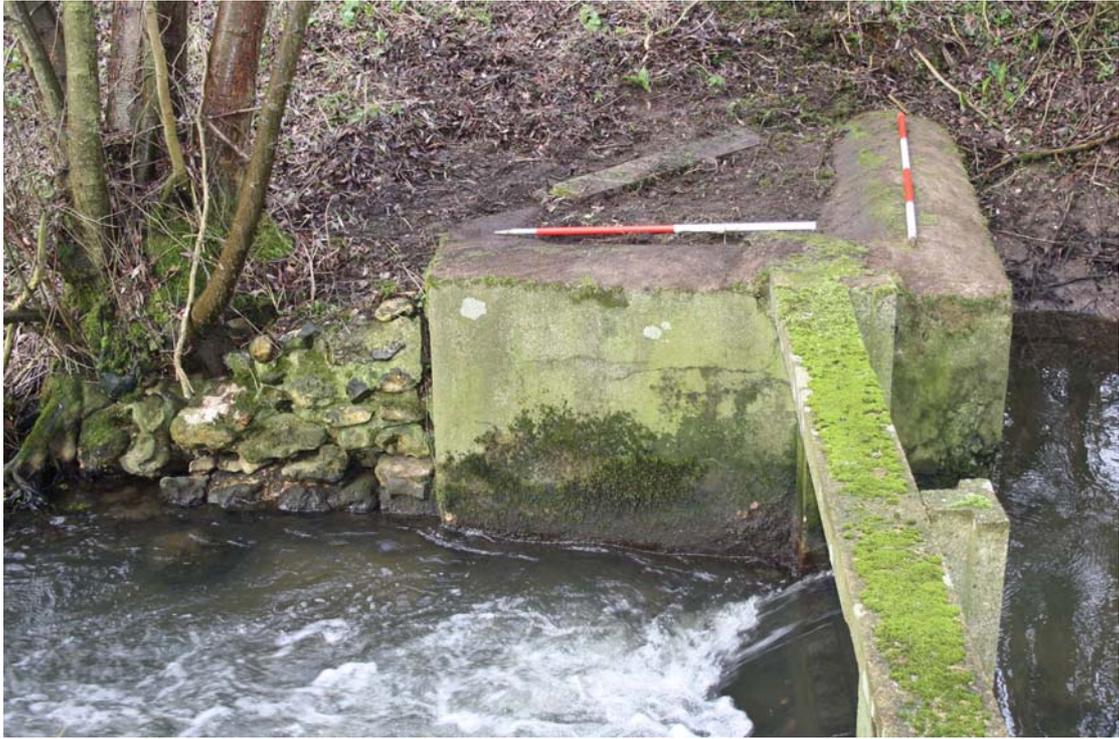
Adjacent to this on the north bank a short stretch of wall of different construction was noted. The lower levels were of brick, while the upper part was flint and mortar. Patchy concrete render was noted on its face.

The aim of the project to achieve a better water flow through this stretch of the Nar was achieved with minimal impact on the historic water meadows. It is not known if Weirs 2 and 3 were part of the original water meadow design but part of a brick and flint wall was recorded adjacent to Weir 2 which may indicate that an earlier structure once stood here.

Plate 7. Weir 2, showing flint and brick wall to west of weir

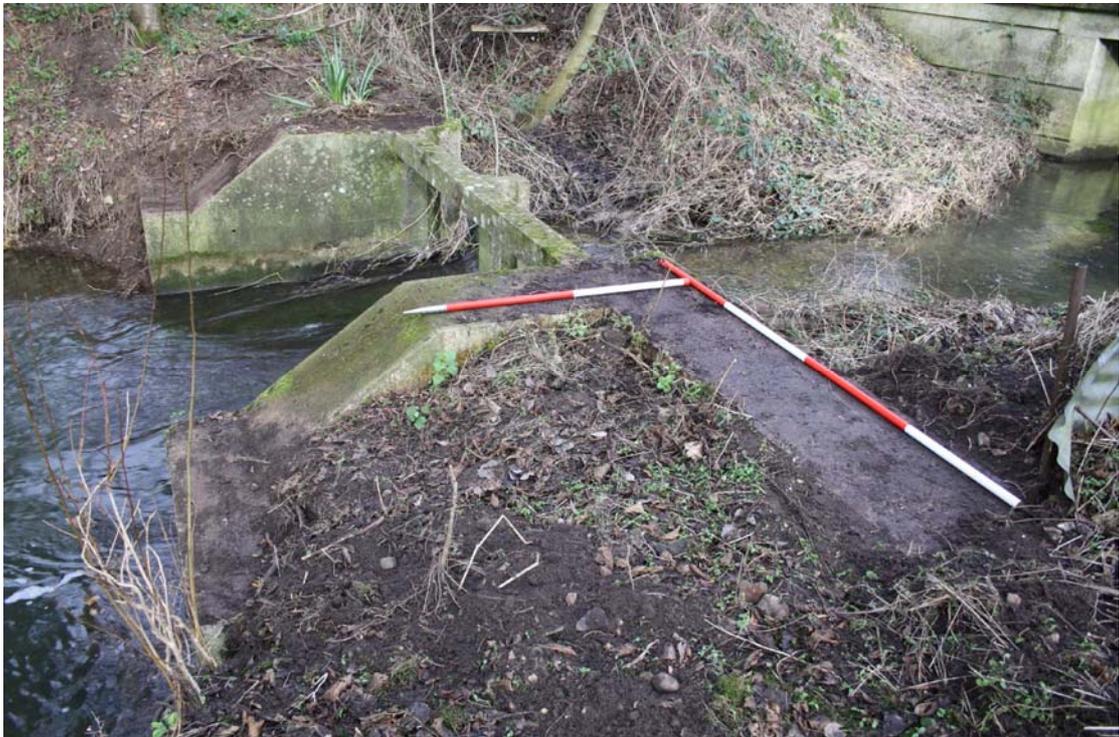
The slots for the cross hatches were constructed differently. The slots at each side were cast within construction of the bastions, while the central upright was H-shaped. An iron bolt connected this to the cross beam or lintel. Further bolts inserted from above connected the cross beam to the side bastions.

Plate 8. Weir 3.
