An Archaeological Evaluation through Test-Pitting at the Chapter House of Walsingham Greyfriars, Norfolk.

Prepared for David Watt of
Hutton & Rostron Environmental Investigations Ltd

Giles Emery
November 2013

Report No: 35

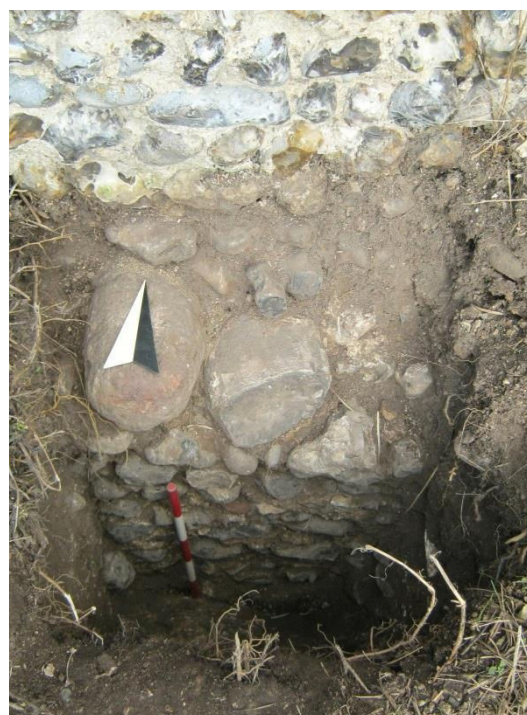
Plate 2: TP1 [1x0.5m scale]

Test Pit 1 was excavated against the external face of the southern wall of the Chapter House. The flint and mortar footings were partly exposed here, which revealed a stepped footing (by c. 0.25m) constructed of a solid, slightly splayed flint & mortar build with very rare inclusions of medieval brick fragments (06). The footing was constructed with fairly regular coursing with a fair face using a hard, off-white lime-rich mortar which has been left both unpointed and bleeding in places. Unlike the footings revealed on the northern side in Test Pits 2 and 3, the flint fabric here included several very large unstruck cobbles, particularly in the uppermost courses of the footings.

Part of the construction cut ([05]) for the footings was identified where it flared out from the wall and where it was infilled by silty-sand and construction debris (04). At greater depth the footings were constructed against a vertical cut into the natural geology (07).

Above the infill of the construction cut and abutting the wall footings was a medieval make-up layer (03) of redeposited clay-sand and soil flecked by residual chalk and mortar waste.

A layer of modern soil c.0.3m deep lay above the medieval deposits which shows that the base of the wall has been exposed previously (02). Above this soil and along the base of the wall at this location was a heap of loose soil and flint & mortar rubble (01) formed from the erosion of the wall above.

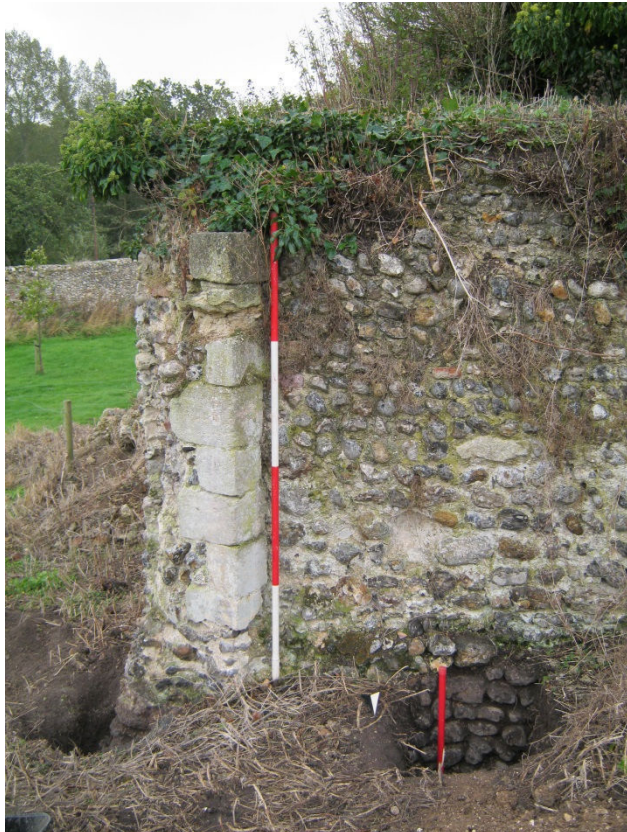
Plate 3: TP2 & TP3 [1x2m scale]

Test Pit 2 was excavated against the northern external wall face of the Chapter House. Several construction lifts can be identified within the footings which step out by c.0.2m and which also splay out slightly (13). The fabric made use of the same hard mortar as seen throughout the medieval construction of the Chapter House, although with variations in the flint sizes utilised for each lift. The uppermost foundation lift (b) made use of the largest flint cobbles laid in relatively regular courses with mostly recessed mortar only occasionally extruded or bleeding. The lowest two lifts (d and e) made use of smaller flints obscured by very rough mortar blinding, the result of a trench built method of construction dug vertically into the natural geology.

Above the natural was a firm layer of ?redeposited sandy-clay (11) from which two sherds of medieval pottery were recovered. This layer appeared to have been truncated by the construction of the Chapter House foundations. A well-mixed make-up layer of yellowish-brown silty-clay lay above this (10).

Above the medieval deposits was c.0.8m of modern soils, the lowest soil layer (09) contained moderate examples of flint cobbles and chalk pieces, along with fragments of late 19th to 20th century bottle glass. This appears to demonstrate that the wall footings have been partly exposed here before being reburied. Above this soil layer was a make-up layer of very soft loam containing modern tile fragments, glass, coal fragments and occasional building flints (08).

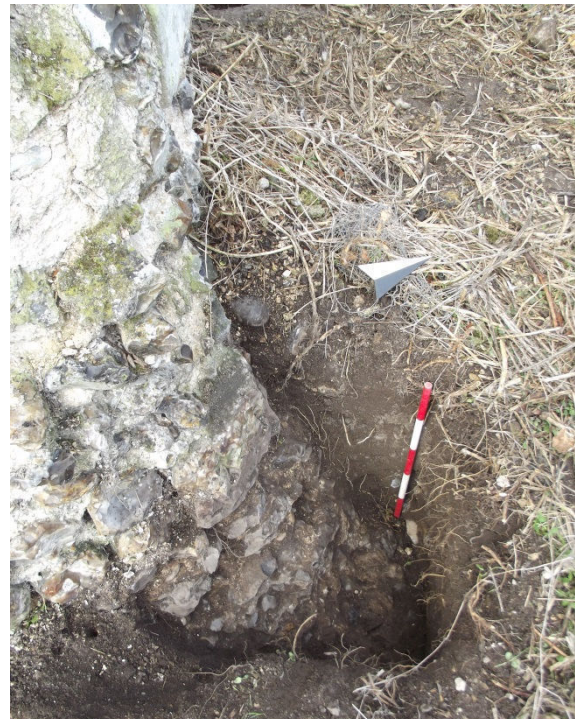
Plate 5: TP3 [1x0.5m scale]

Test Pit 3 was excavated at the north-east corner of the Chapter House, solely to determine if solid footings were likely to be present below the eastern wall. The test-pit could not be located along the east wall itself as the face-work there was in imminent danger of collapse.

The trench showed that solid footings extended out from the base of the eastern wall by at least 0.5m here, possibly to serve as a pad to accommodate a former medieval buttress at this location (15). The footings seemed to be artificially buttressed, either as a result of robbing or during consolidation and repair work. The footings were buried here only by modern soil (16) which again demonstrates that 20th century work also exposed the eastern wall footings and that the soils here are the result of subsequent landscaping.

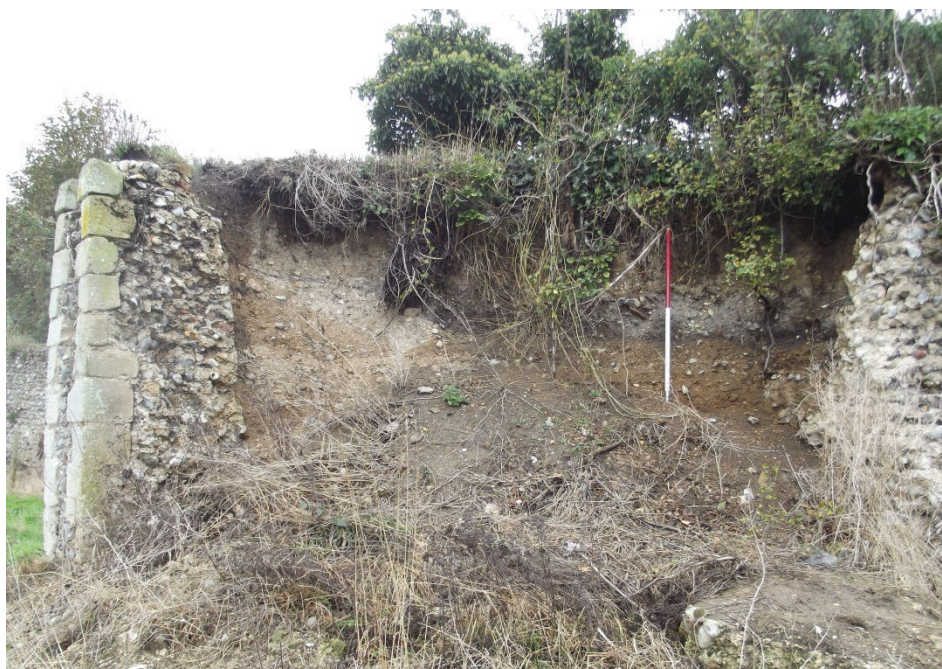
Plate 6: Partly Collapsed Eastern Wall [1x1m scale]

It should also be noted that the deposits exposed by the partial collapse of the eastern wall seem to share a similar sequence as that recorded within the test-pits; with a lower ?medieval compacted soil layer below demolition rich waste (see Plate 6). An ash rich layer or tip was also present at approximately the same horizon as that recorded by TP5 within which clay tobacco pipe and fragments of animal bone could be observed (at c. 0.5m below the vegetation covered surface).

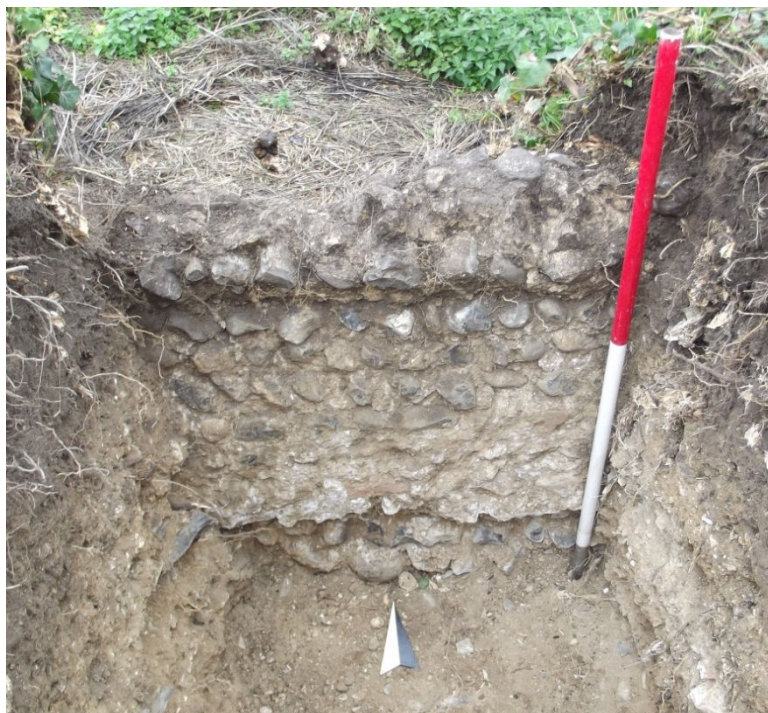
Plate 7: TP4 [1x1m scale]

The tops of both the northern and southern walls were capped by a weakly bonded modern stub wall just two courses thick (18 and 33). The fabric contained roughly sorted flints and occasional medieval bricks bonded with a pale whitish-yellow, degraded gritty mortar. This capping build was constructed on a thin layer of soil (35) rather than bonded directly to the medieval remains. This is evidence of modern repair and consolidation work to the Chapter House walls

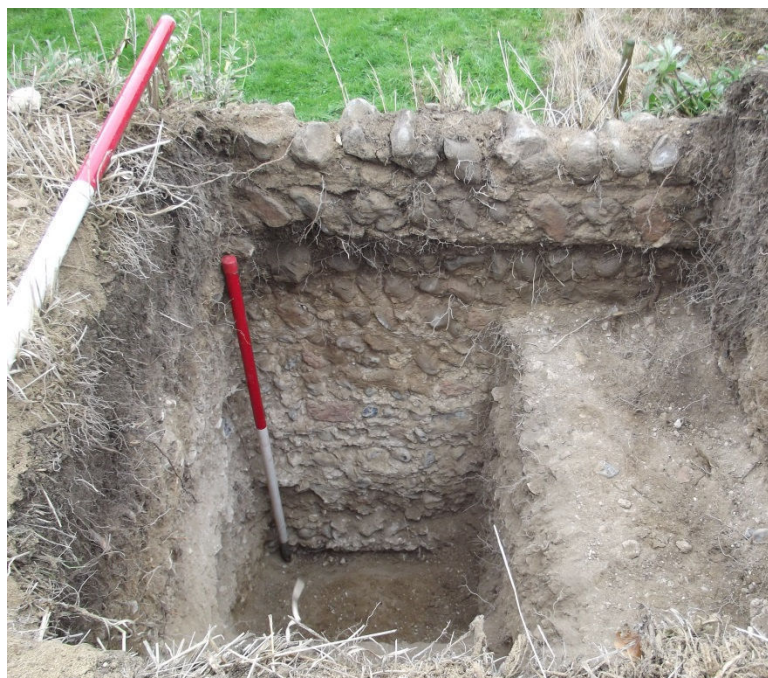
Plate 8: TP5 [2x1m scale]

Several construction lifts were identified within the fabric of the medieval walls; the two uppermost were seen in both of the test pits while Test Pit 5 revealed two deeper lifts. In general the construction method comprised of regular courses of well sorted flints with occasional fragments of medieval brick, bonded by a hard, gritty lime rich mortar. Only the uppermost lift was vertical and fair faced while lower lifts were markedly splayed with rough and bleeding mortar. The base of each lift was also seen to toe in slightly, where it may have overlapped onto a temporary surface. These observations have significance for the likely method of construction and the level of any original floor surface, which will be discussed below.

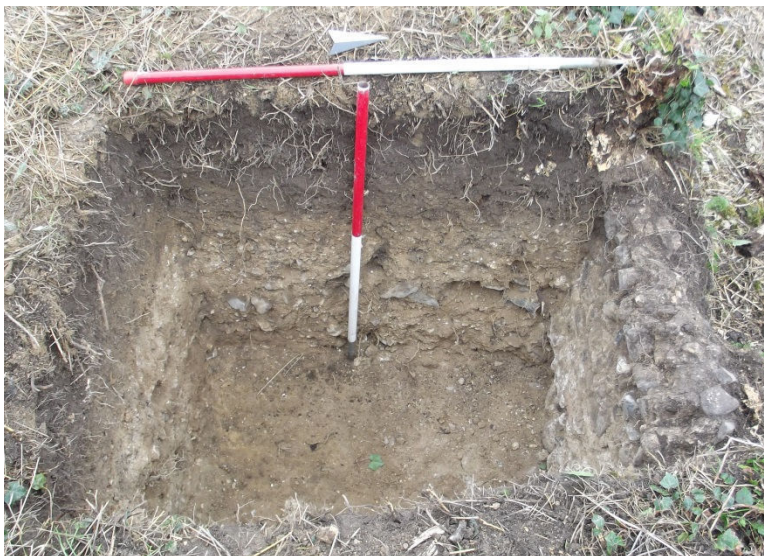
Plate 9: TP4 [2x1m scale]

A similar sequence of dumped demolition waste-rich deposits was recorded in TP4, where two main layers of demolition waste mixed with soils (19 & 20) were recorded to a depth of c. 0.65m above the fill of a possible robber cut along the wall ((22) within [34]).

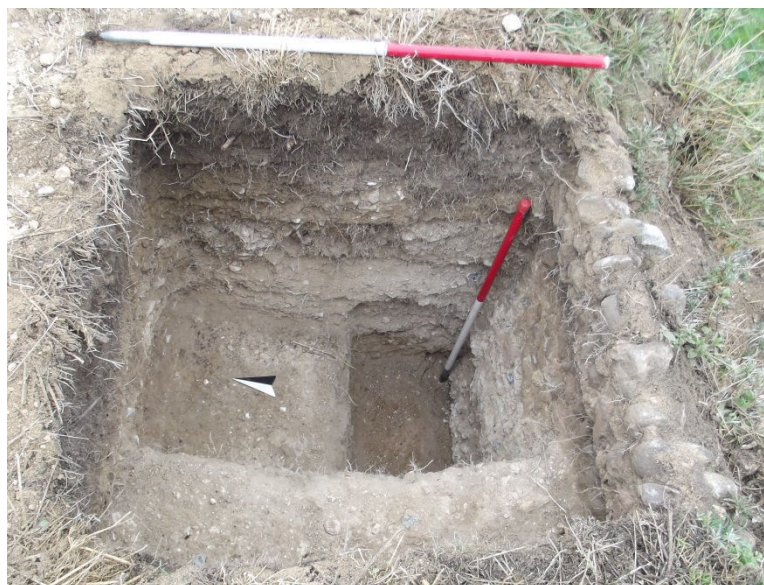
Plate 10: TP5 [2x1m scale]

A further 0.5m deep sequence of imported deposits of sorted demolition waste, rich in crushed mortar and lumps of mortar was dumped against the wall of TP5 (29 & 28), which may either be fills of the robber cut or later spreads of material. A lens of sooty, grey silty-sand containing a few small pieces of coal lay above this, from which tobacco pipe stem was retrieved (27).

Upper deposits in TP5 were subjected to frequent root disturbance and consisted of a well-mixed layer of soil and demolition/repair waste (26) below a spread of silty-clay make-up (25) which may coincide with the creation of the modern capping of the Chapter House wall.

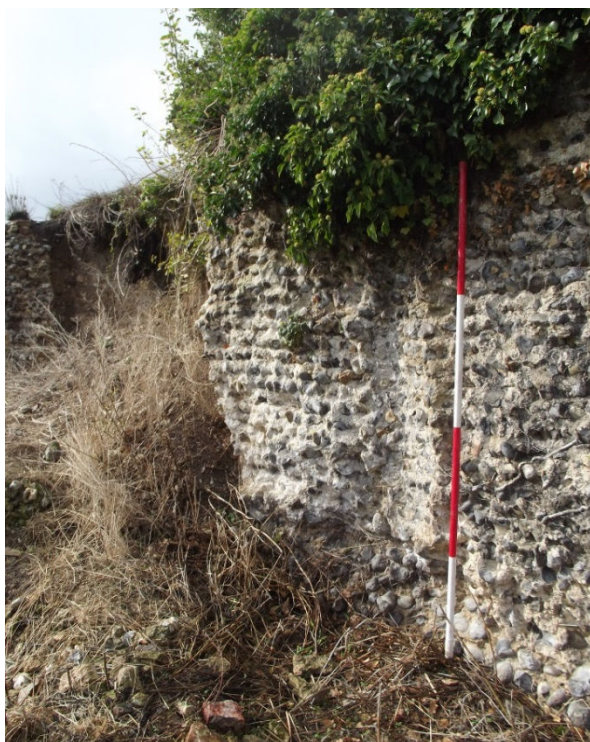
Plate 12: Vertical Scar (Looking SW) [1x2m scale]

Additional Observation: Vertical scar in the fabric of the eastern wall

A concave vertical ‘scar’ in the wall fabric of the external face of the remaining section of eastern wall was noted during the fieldwork. The flint and mortar here appears to have been constructed to receive some form of vertical shaft or respond. It is located off centre and could therefore be one of a pair of such features.
