Stours Farm, Lower Stokes Road, Ashen Sudbury Essex CO10 8JQ  
Description and analysis of the farmyard buildings at Stours Farm.  
Surveyed 14 02 2011.

## Descriptions of the Buildings.

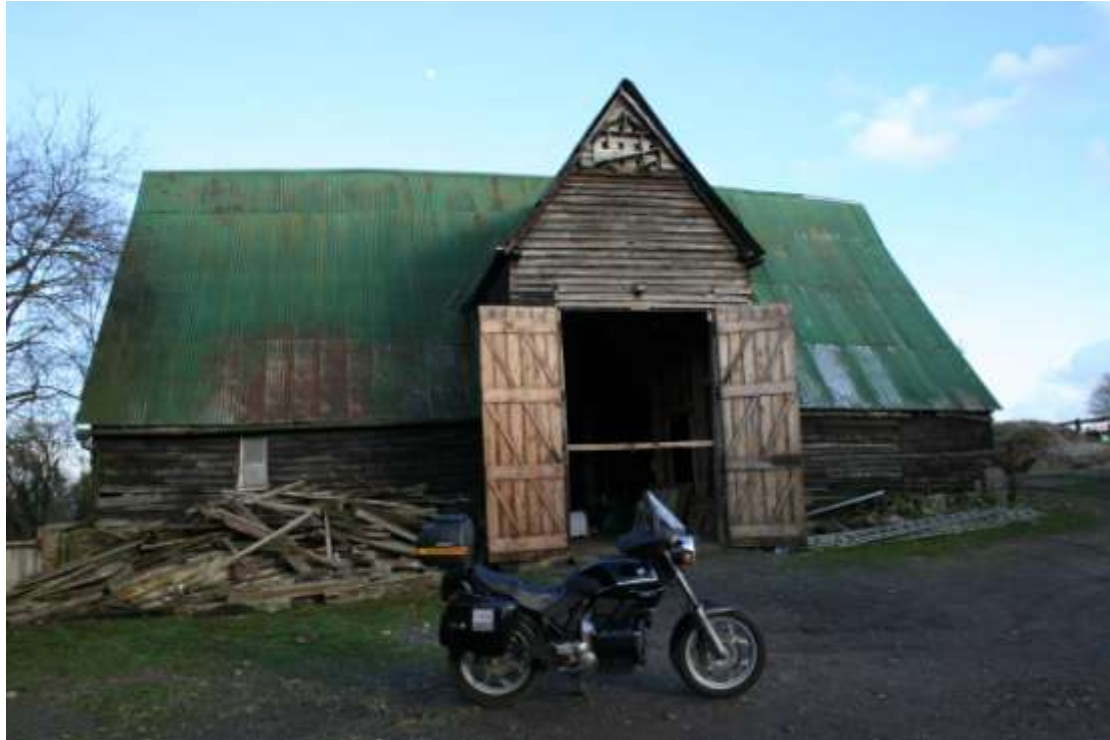
Western elevation looking east across the farmyard.

The roof has been clad in corrugated galvanised iron sheets, primed with red oxide and later painted green. The amount of wear suggests this was done over 40 years ago. The rainwater goods are all painted metal and in poor condition. The mean hopper head on the northern end does not look up to the job.

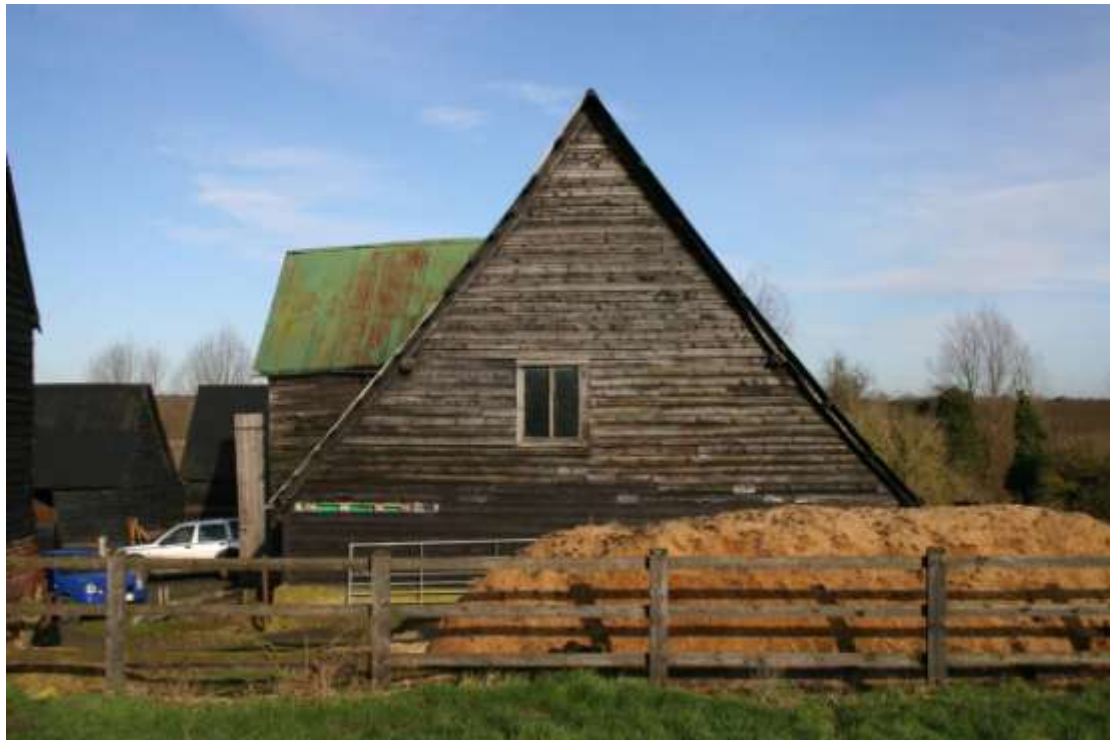
The southern elevation partially obscured by an enormous heap of stable waste.

Most of the barn stands on a plinth of red bricks but the northern elevation stands on shuttered concrete. The 7in weather-boards are all C20th fastened with French nails, most showing the vertical marks of a bandsaw. There are also some galvanised sheet metal patches.

Off -centre to the west there is two-pane modern plain glass casement with home-made frame. Below, a weather-board has fallen to reveal the aisle-tie and the vertical oak posts and studs of the western aisle. The ends of the arcade plates are visible under the eaves and there are applied bargeboards. The roof is heavy battened for the corrugated iron roof.

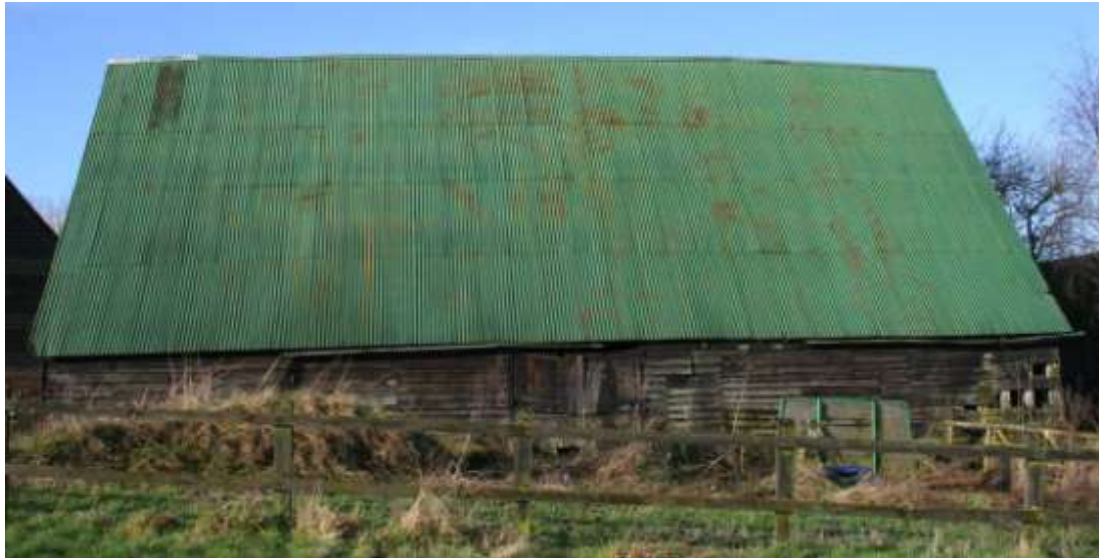
The eastern elevation looks out over the paddock which slopes to the road.

The eastern elevation is dominated by the blank corrugated iron roof. On this side the terrain slopes noticeably to the road and the brick plinth is sunk into the ground at the southern end and has been part replaced by shuttered concrete.

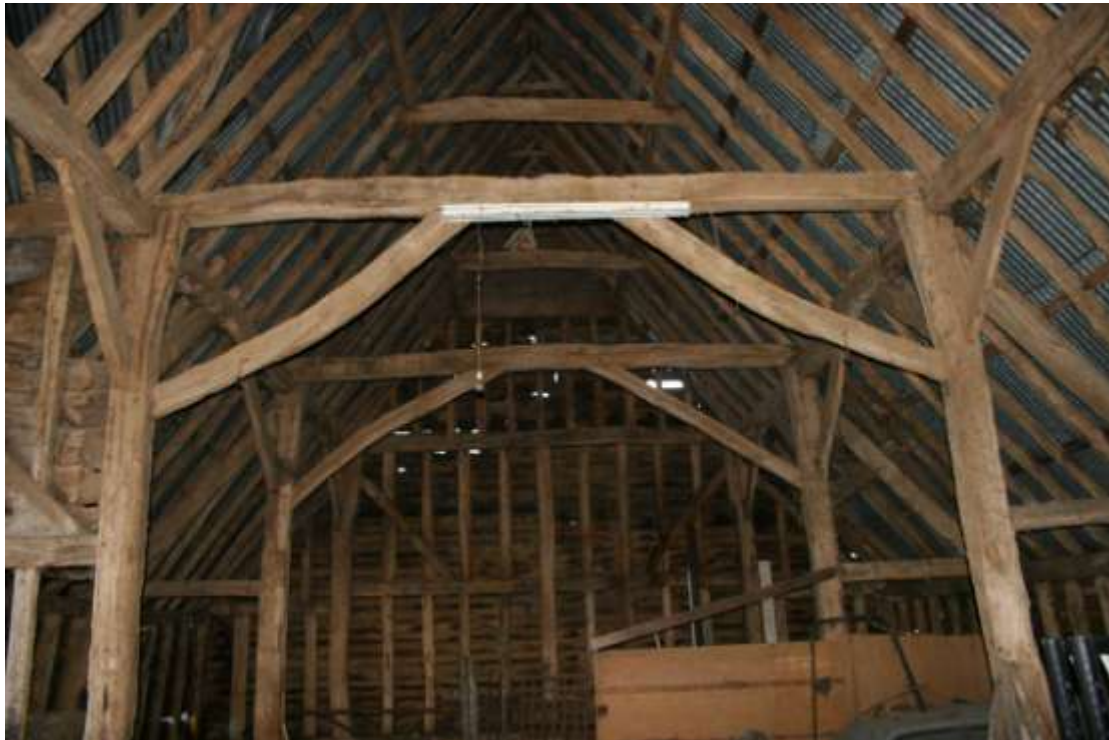
Inside the East Aisled Barn. Trusses 1 and 2 from N. Note unequal braces and lack of principal rafters. Also slender jowls on Truss 1. Looking N.

The shores were added later to the original design to counteract the enormous forces put on the arcade posts that have caused many of them to contort along their length.

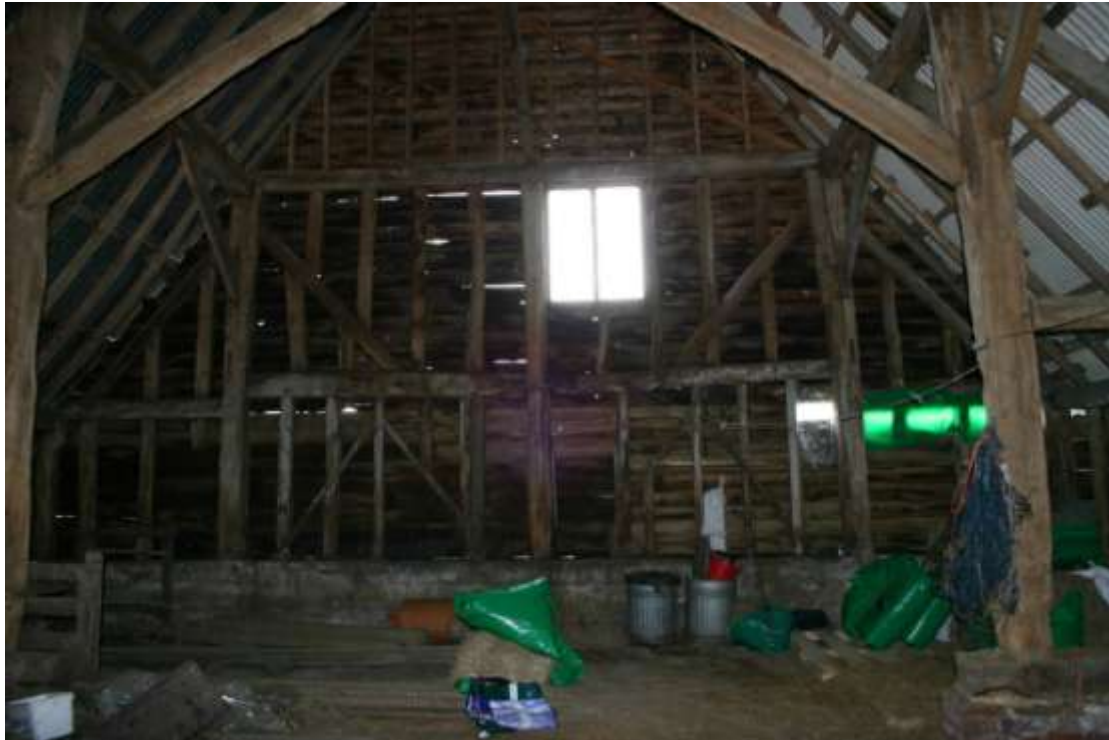
Most of the rafters are set on edge but since the roof has been clad with corrugated iron the re-used flat rafters have sagged under their own weight dropping away from the line of the battens.

Photo showing the sag of the rafters and the rebuilt south wall.

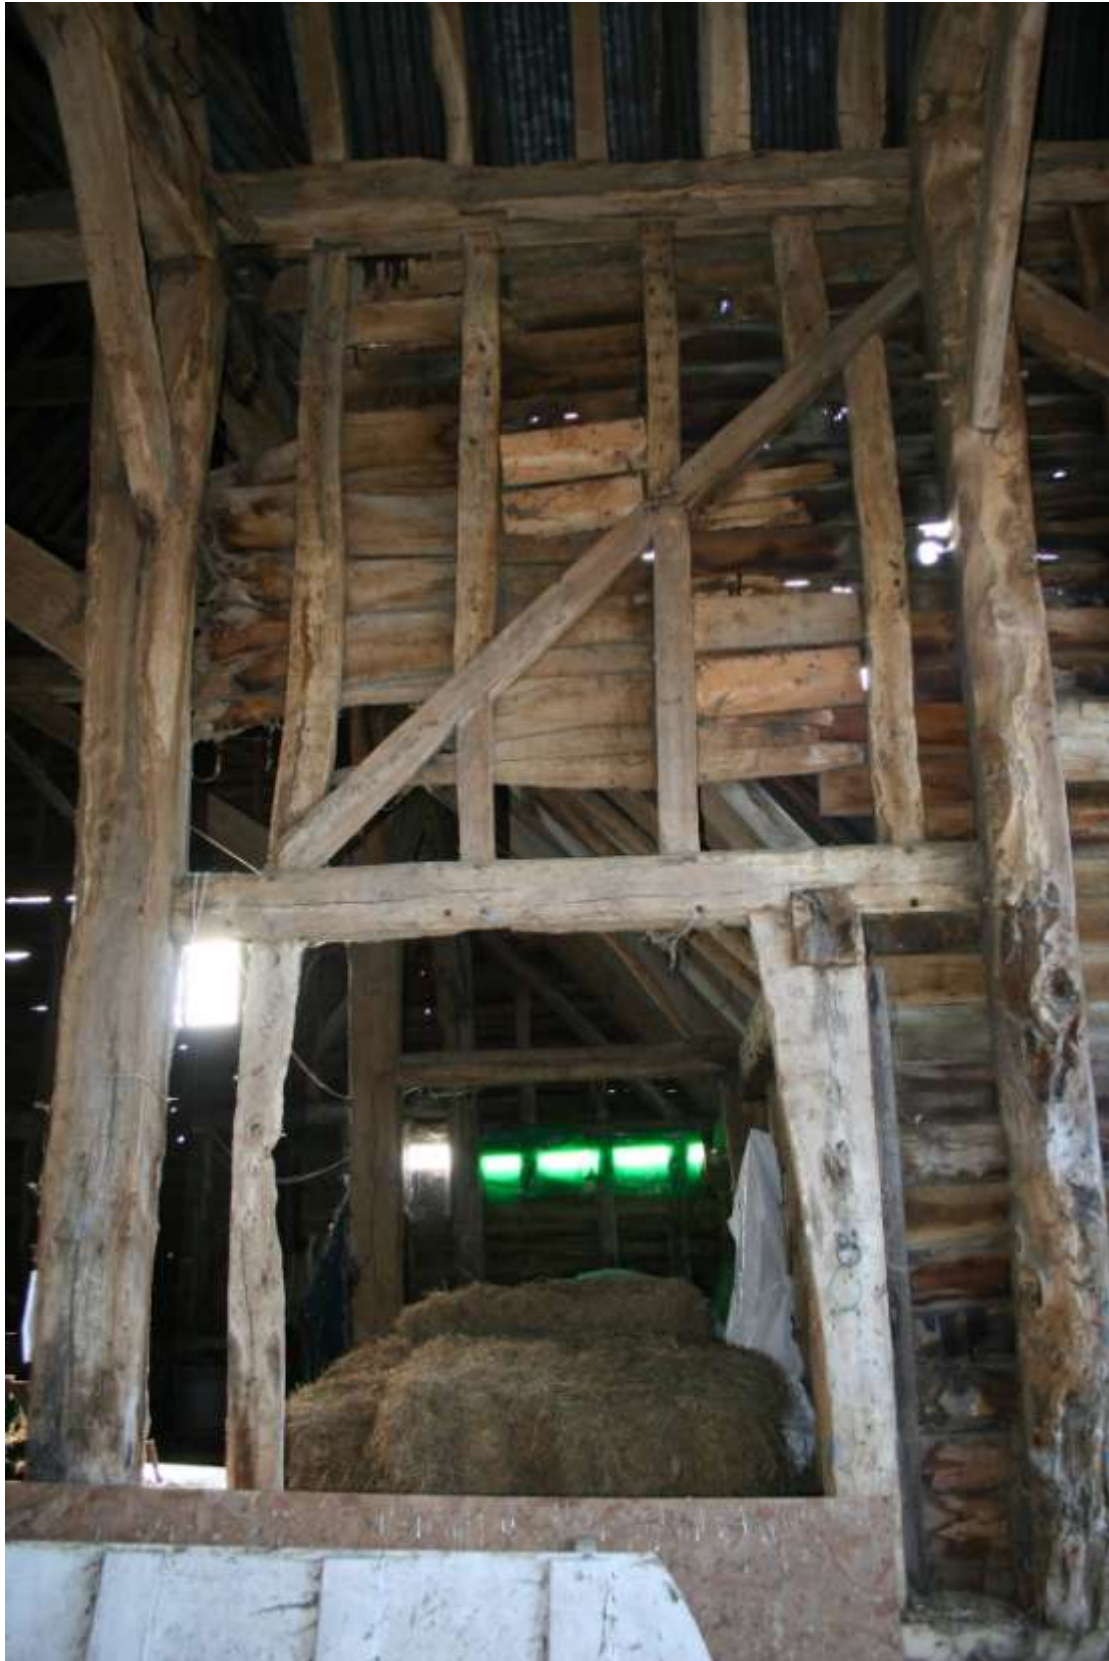
The least convincing posts are those either side of the midstrey whose form owes nothing to carpentry of c.1600 the date which is claimed for the barn in the Listing.

The southern side of the midstrey porch. Note scarf joint at top, interrupted studwork and unusual wall post. The midstrey post to the right is not oak. Initials WN are carved by the lashing ring.

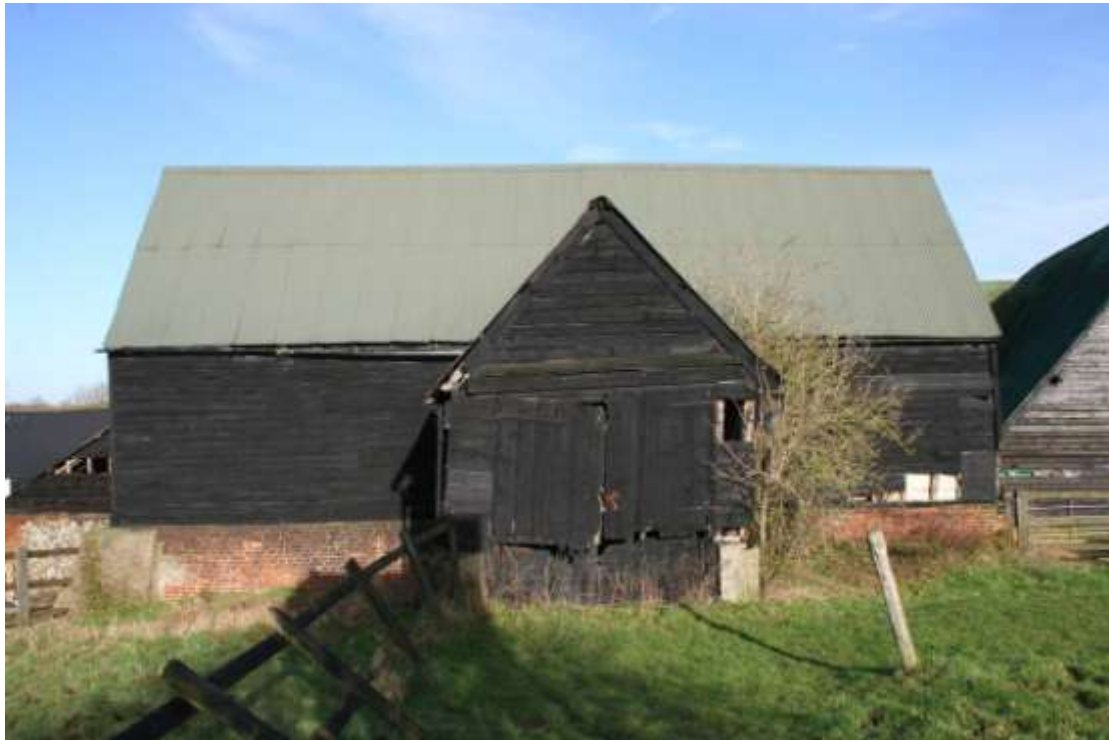
The South Barn from the south.

The 7in weather-boards are circular and bandsawn and secured with french nails. The boards were coated with cold brushing tar many years ago. The upper six runs of board are fastened with wrought iron nails and may have been hot-tarred. There are patch repairs and some boards missing. This applies for all the elevations.

The roof is corrugated iron painted green and the rainwater goods are painted metal in poor condition.

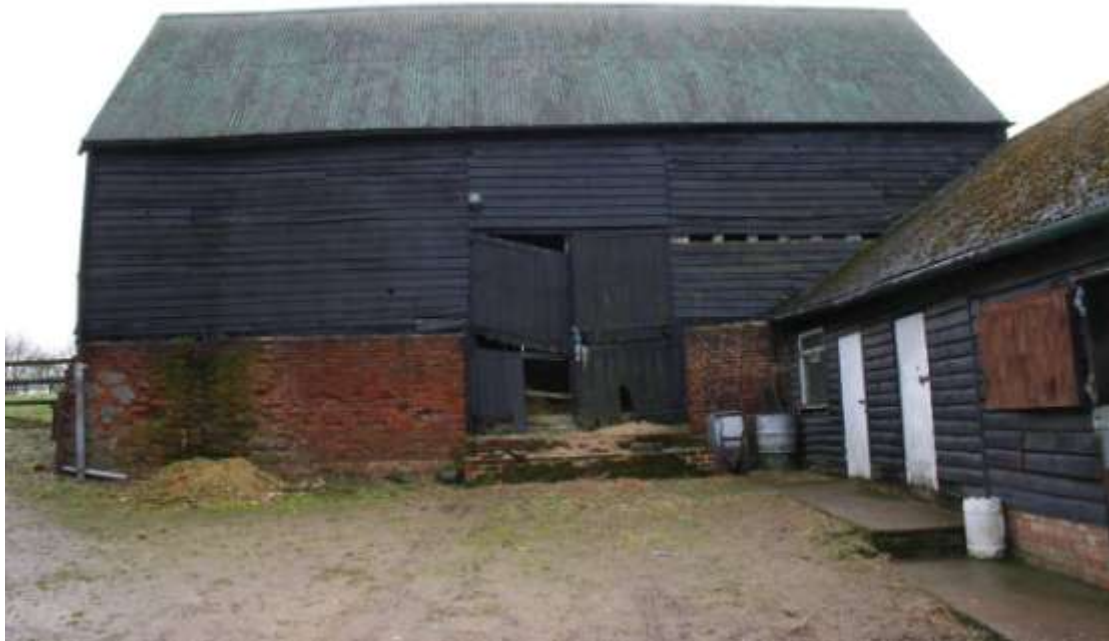
Test pit against the south wall reveals it has been rebuilt with a Fletton foundation.

The entire section of plinth east of the midstre doors has been rebuilt using Flettons to form a substantial foundation to 3 courses above the present surface level. The bricks above are reused and set in a cementitious mortar. This part of the plinth is properly finished with small closer bricks to the door jamb whereas the older section on the other side lacks this refinement.

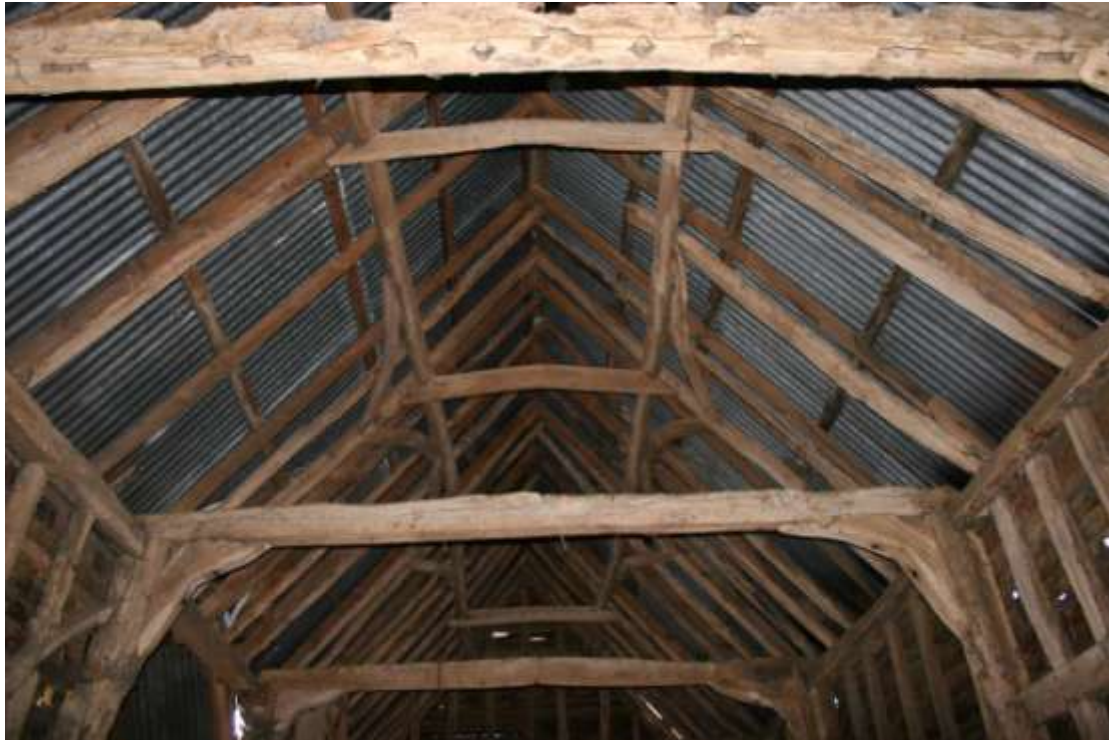
The roof structure looking east. Note curved windbraces and diamond mortices in tie-beam.

The roof has been much depleted when reconfiguring it to receive the corrugated iron cladding and about half the original rafters are missing. The roof is a simple but elegant clasped side purlin construction with curved or cranked flat windbraces from the main rafters to the purlins except in Bay 5. The collars are narrow and slightly cranked upwards.

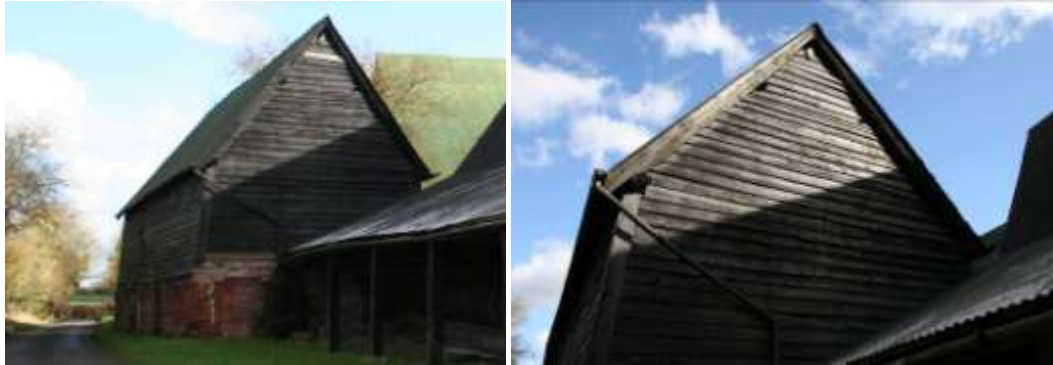
The western elevation is a plain reflection of the eastern.

The western elevation has a plain gabled C20th weatherboarded wall over a much repaired brick plinth. The upper few courses are inexpertly replaced with Flettons some set on edge.

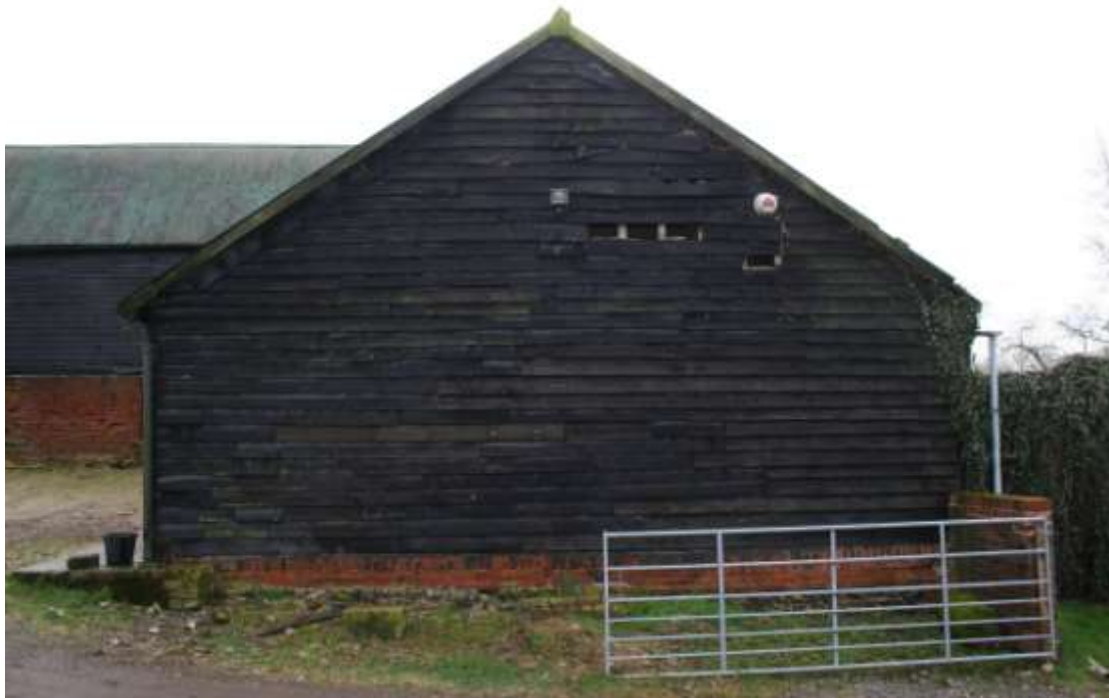
The northern elevation has a blank gable over a brick plinth.

The northern gable is weatherboarded with a mixture of older and replacement boards all French nailed. Some have traces of hot-tar but most are cold brushed and of inferior quality having split and buckled.
