Berwick Hall Farm, Park Lane, Toppesfield, Essex.
Description and analysis of farm buildings at the site.
Surveyed 15 09 2011. BDC 10/01438/FUL

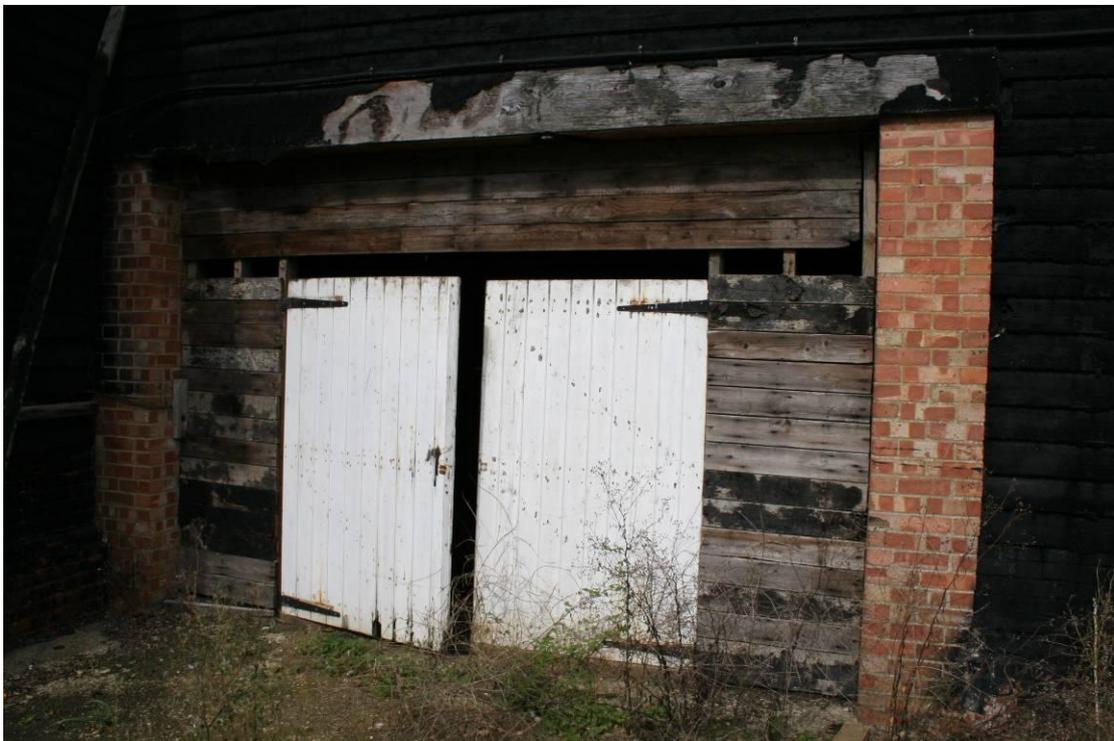
Inserted entrance for farm vehicles.

In the east half of the barn a large section has been opened up to insert an entrance reinforced with Fletton brick piers to allow vehicles to be driven in. The tracks are still there.

The opening corresponds in size with those on the modern barns but it has been subsequently reduced in size by inserted 2x4in softwood studs, plain boarded over and two LC20th gate and ledger softwood doors hung on mild steel T-straps secured with Pozidrive screws.

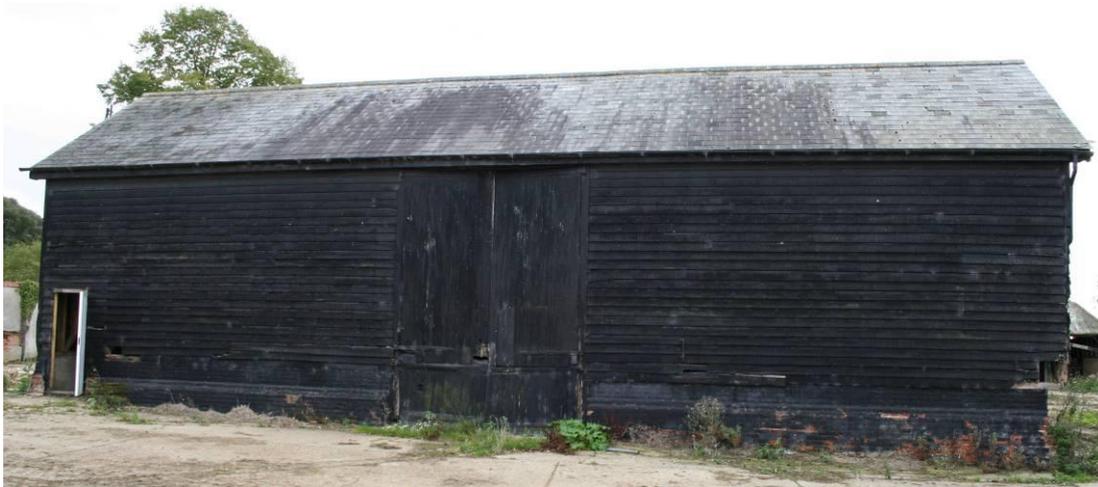
The northern elevation is plane with full height central doors and a C20th pedestrian door.

The northern elevation has the pairs of full height doors set in the centre and there is an inserted C20th pedestrian door in the NE corner. The NW corner has been damaged by traffic and the plinth can be seen to be 18in thick, narrowing to 9in and the bricks to have shallow frogs and set in a hard white lime mortar. The double coping is also cross-sectioned.

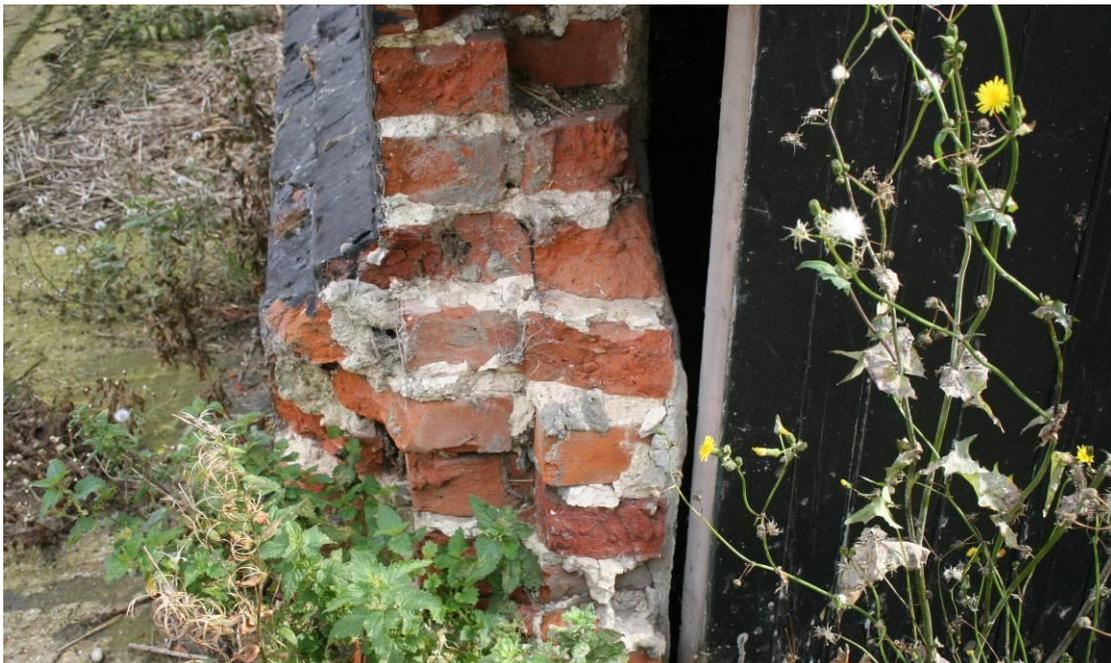
The smashed brickwork on the NW corner of the Timber Barn. Looking E.

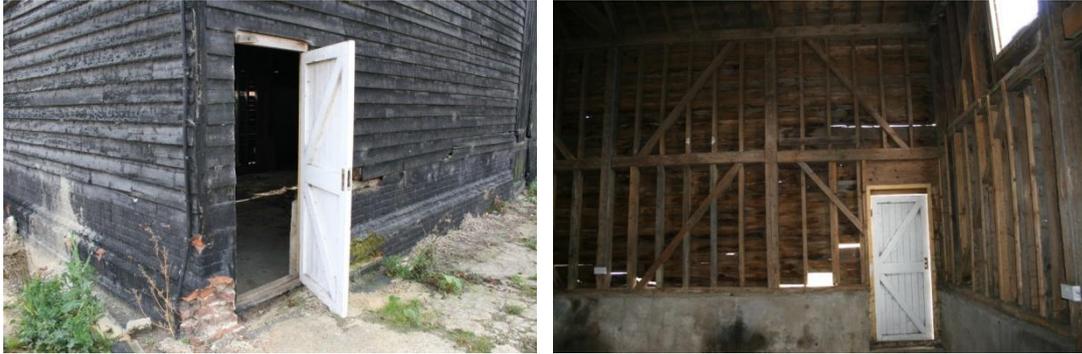
There is an inserted C20th doorway in the NE corner of the Timber Barn.

A LC20th timber gate and ledger door has been fitted in the NE corner in an inserted frame. Inside it can be seen the studs have been removed and the primary brace sawn through. Outside there are no closer bricks in the plinth.

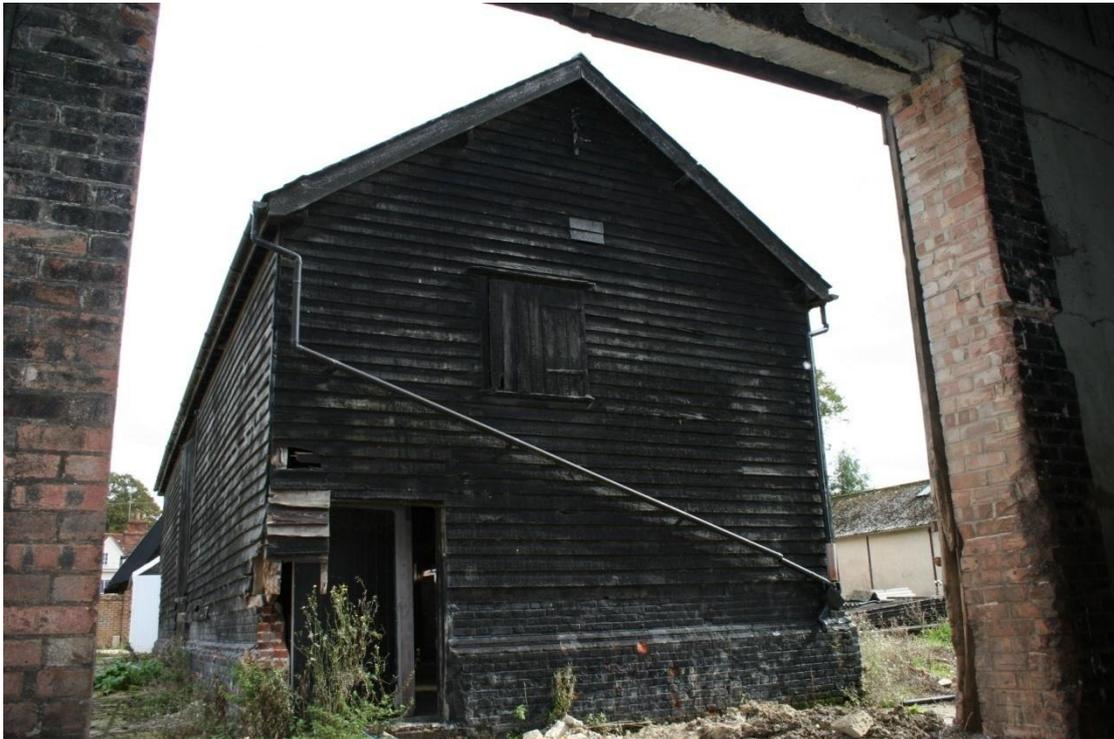
The western elevation seen from inside the C20th barn. Looking ESE.

The western gable end retains its original hatch door set just below the eaves line. This is a simple gate and ledger softwood boarded door hung on wrought iron pintles. Inside the wall is properly framed to receive it. Below is an inserted aperture for a sliding door manufactured by Aldam of London in poor condition and run off its rails.

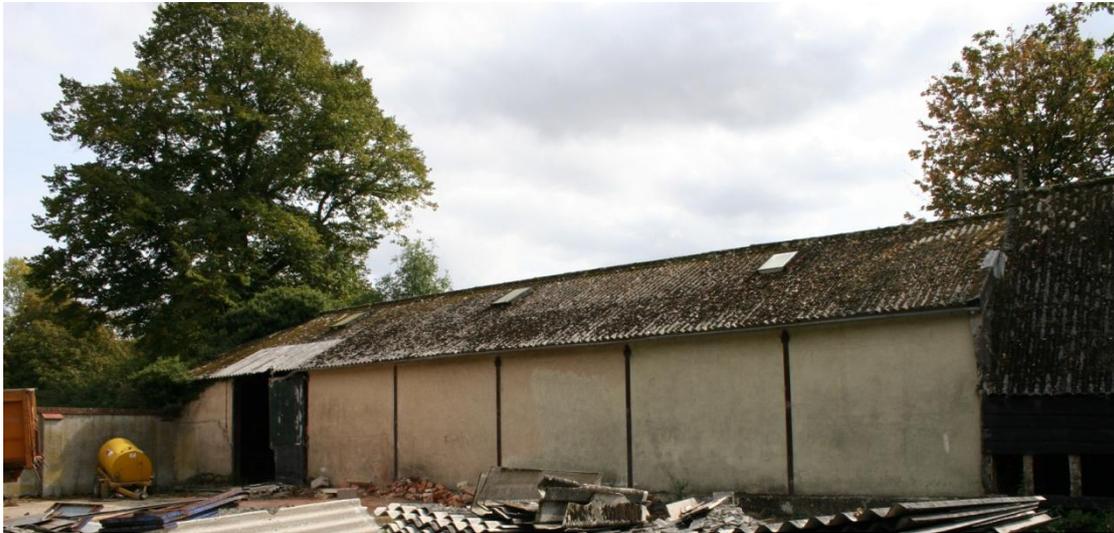
The Steel Barn has an infilled blockwork wall and asbestos roof.

The Steel barn has 7 bays defined by the steel uprights which are the principal posts for complete trusses. Originally the barn was open but the facade has been made up with recent high density 210x210x440mm blockwork set in grey cement. Bay 6 (from the west) has an opening for a rolling shutter door which has been removed leaving only a small part of the mechanism. Now there is one leaf of C20th timber, tongue and grooved, gate and ledger door hung on galvanised pintles. The roof is clad with corrugated asbestos sheets and the rainwater goods are grey plastic and badly broken.

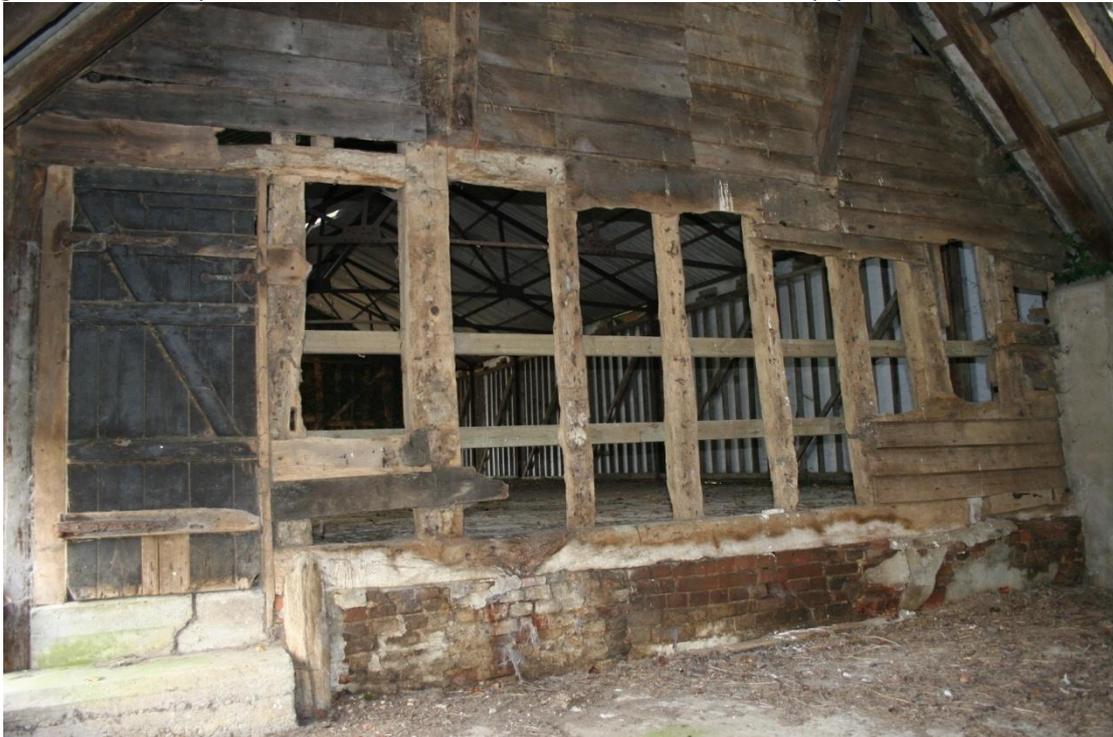
Exterior of the west gable end.

The exterior of the western gable end can be seen inside the Stable where it has been boarded in several episodes many of which have fallen off due to the failure of the fixings. Here the frame can be seen resting on a brick plinth of red 65x110x225mm poor quality bricks set in a beige sandy lime mortar and skimmed with grey cement. The plinth is disrupted and the sole plate is white with rot caused by water ingress from the concrete floor in the Steel Barn which is much higher than that of the Stable.

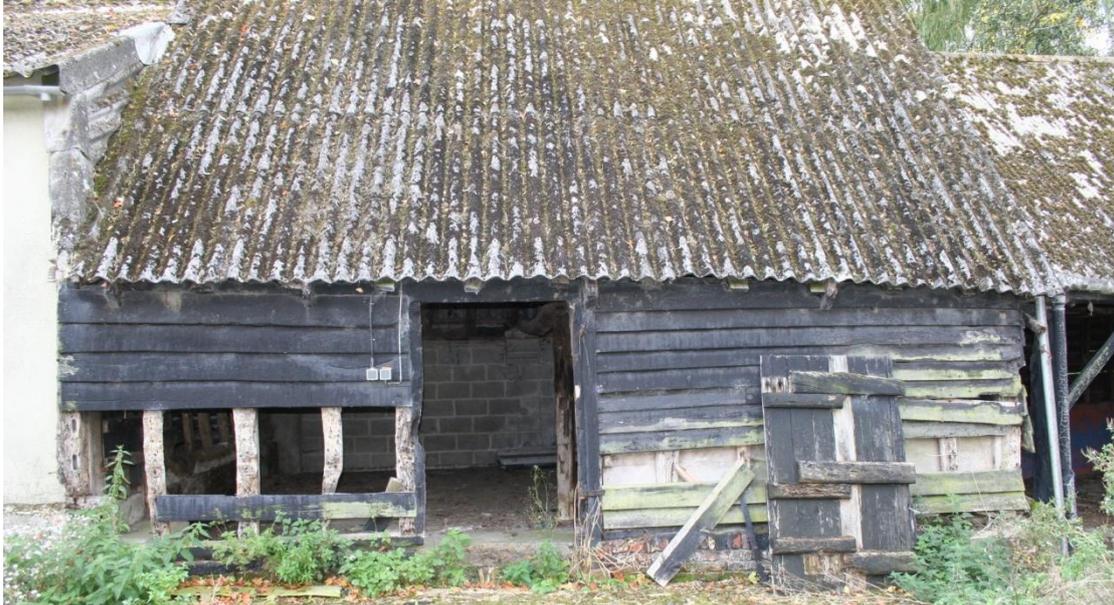
The Stable is set between the Steel Barn and the Shelter.

The north elevation has a poor quality scantling timber frame clad in waney weather-boards many of which have fallen off due to the failure of the wrought iron nails. The lower boards - highlighted a bright mouldy green - are C20th sawn softwood. The off-centre doorway has also lost its door which has fallen off its hinges and rests against the wall.

The door is a vertically boarded, tongue and grooved, edge moulded simple nailed ledger type which appears to have been widened by the addition of two boards. All the fixings are lost but the pintles and broken strap hinges remain in the frame.

The stud wall is stood on a red brick plinth of 65x110x225mm poor quality bricks. The wall is only 6ft tall so the sole plate has been cut through to insert the door. Inside the floor is of poured concrete which has broken away through the doorway.

The roof is clad with corrugated asbestos. The gutters are missing but were likely of the grey plastic type lent against the end of the building. The gutter brackets however are for a more heavy duty type.

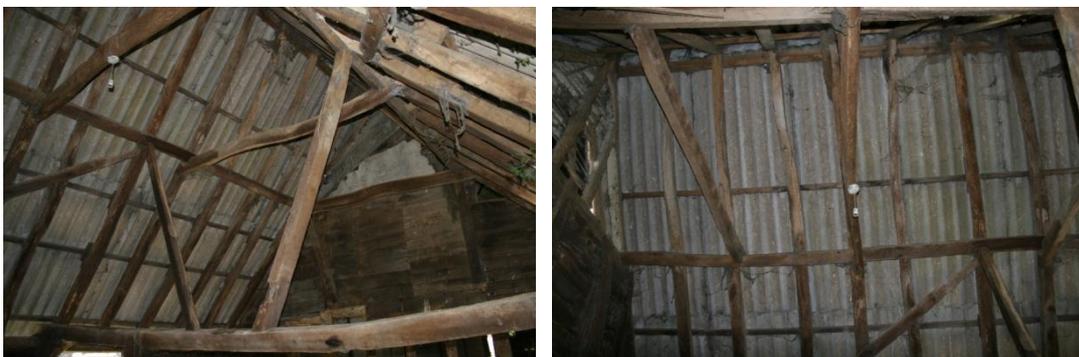
Poor quality scantling roof. Looking E and then S.

The roof is a poor quality clasped side purlin roof with raking queen struts cut from old collared rafters. Many of the rafters have the redundant collars lap joints from a collar purlin roof while the others are elm scantling. A few of the collars are probably original to the rafter pairs while the others are concomitant to the build. The roof is battened as clad with asbestos.

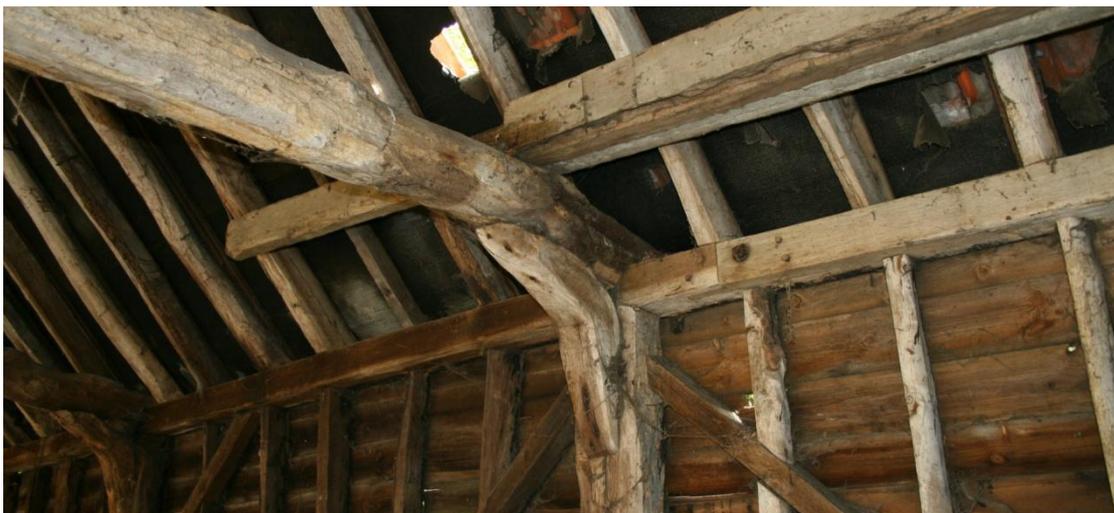
Many of the timbers are cut straight from the tree. Note bolt in scarf joint.

The halved and bladed scarf joint in the top-plate has four face pegs but has also been reinforced with a square headed nut and bolt. The top-plate is machine finished.

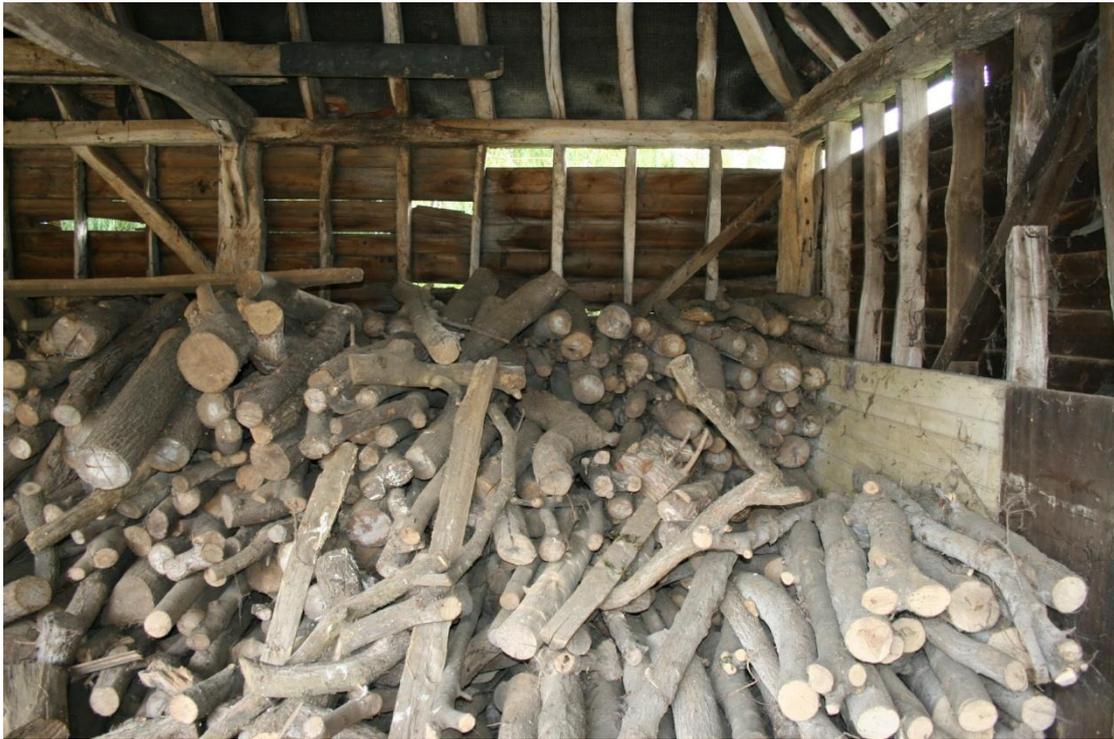
The SW corner of the Shelter. The walls have been boarded to contain the logs.

Like the south wall the exterior can only be seen from a private garden and is similarly clad in older, hot-tarred weather-boards. The frame is of the same interrupted nailed scantling studwork. The inside of the Shelter has been clad with a variety of LC20th boards, including plywood and doors. This has been done so the large pile of logs does not push the weather boards off the frame.
