Home Farm, Wadesmill, Youngsbury, Thundridge. Herts. SG11 1BP.
Description and analysis of the South Barn. Surveyed 06 11 2013. **3/13/0842/FP.**

Planning app. no: 3/13/0842/FP. Permission has been given to convert the former South Barn into a dwelling house. This report describes and analyses the building to English Heritage Level 3 to satisfy a planning condition for archaeological recording.

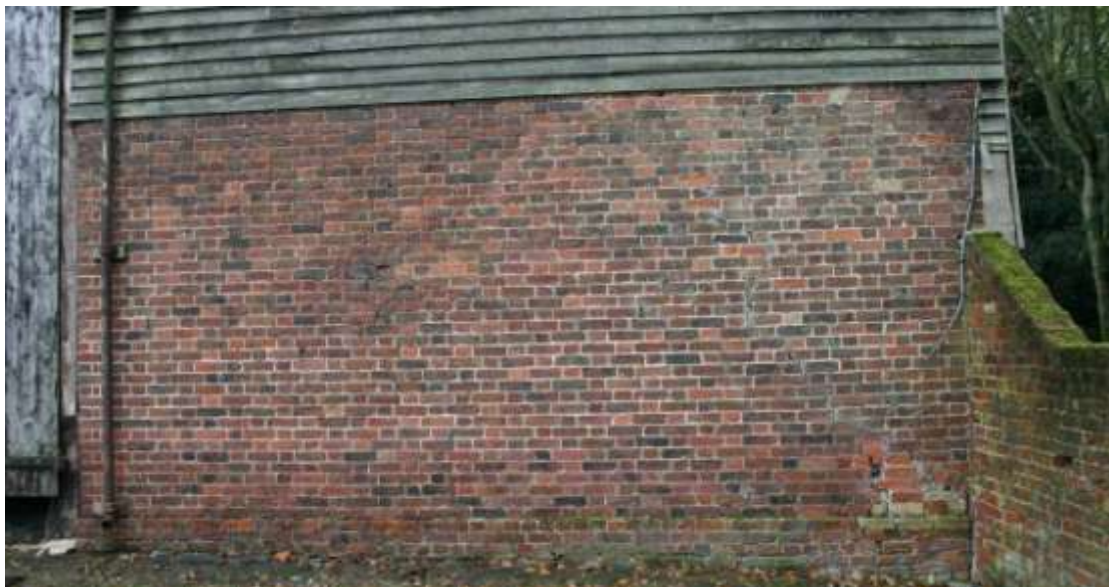
Shadow of a removed building on the western end of the elevation.

At the western end of the elevation there is a clear shadow in the brickwork to indicate a gabled building was once built against the barn wall. There is also a badly patched hole for former pipework close to the perimeter wall.

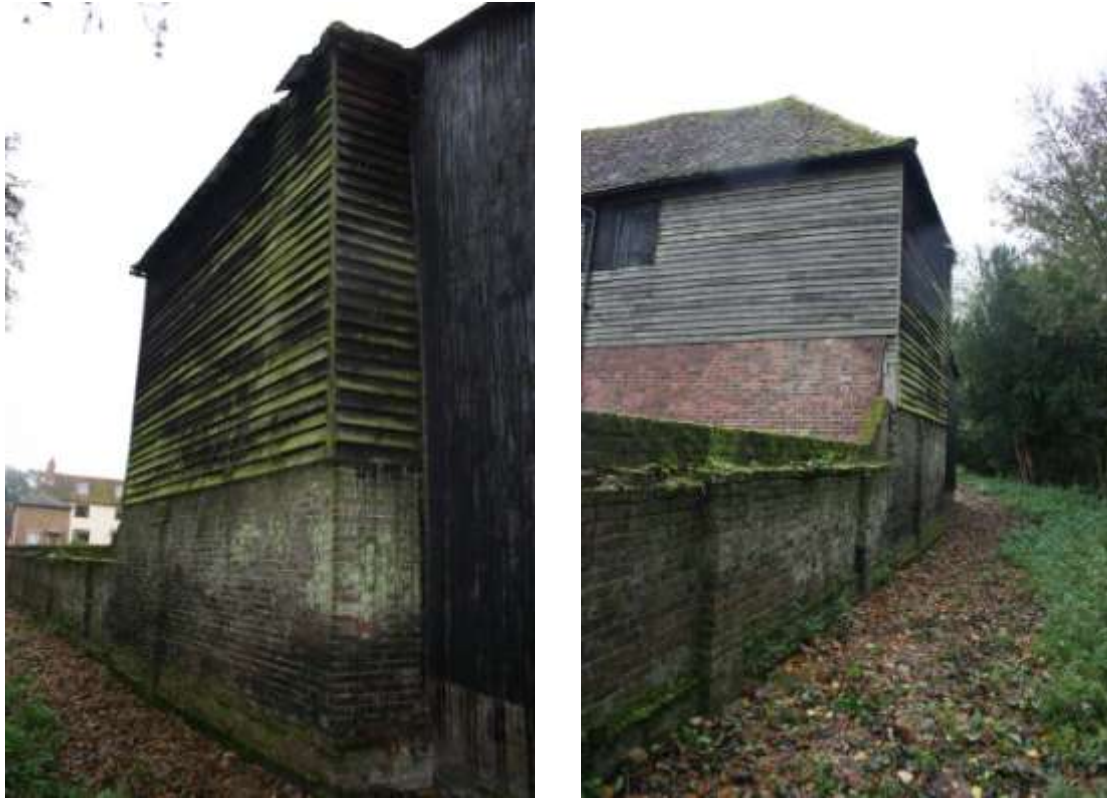
The western elevation looking N then S. The brick wall was originally a range of buildings.

The western elevation forms the boundary of the modern plot. It can be seen that the building is built with a tall brick wall that is later than the red facing brickwork on the northern elevation. Forming the end wall with a slight return on the southern side, the wall carries seamlessly on northwards where it formed the perimeter of the farmyard and buildings were sprung off it. The wall has brick buttresses at regular intervals and there is one in the end wall of the building. The perimeter wall has been reduced in height.

The junction of the two walls of the barn is awkward and the gap between the two builds has been masked with short sections of weather-board and a piece of marine ply. It is evident the perimeter wall is later. The brindled, orange and yellow bricks are similar to those used for much of the blocking work. Today they are discoloured green with algae which also coats the LC20th weather-boards above and incidentally is a sure sign that the boards are recent and poorly treated softwood.

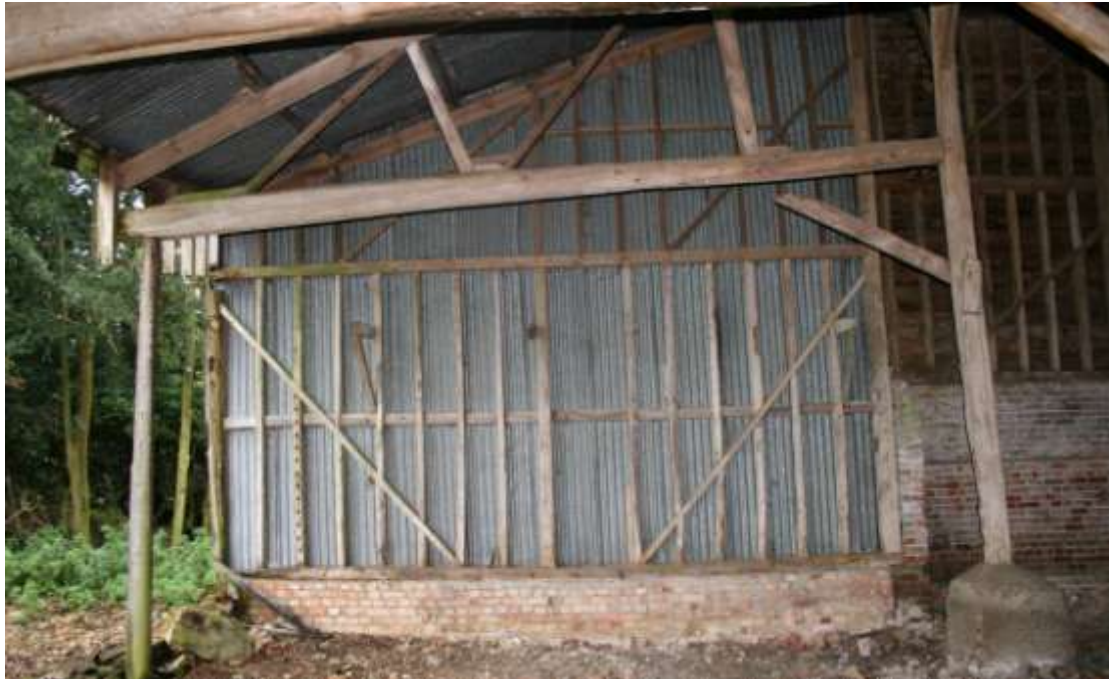
The interior of the western elevation of the lean-to.

Due to its proximity to the perimeter woodland it proved impossible to get a diagnostic photograph of the outside of the lean-to. Inside it can be seen that the end wall has been rebuilt using old, reused scantling in the LC20th – the owner saw it done in the 1960's.

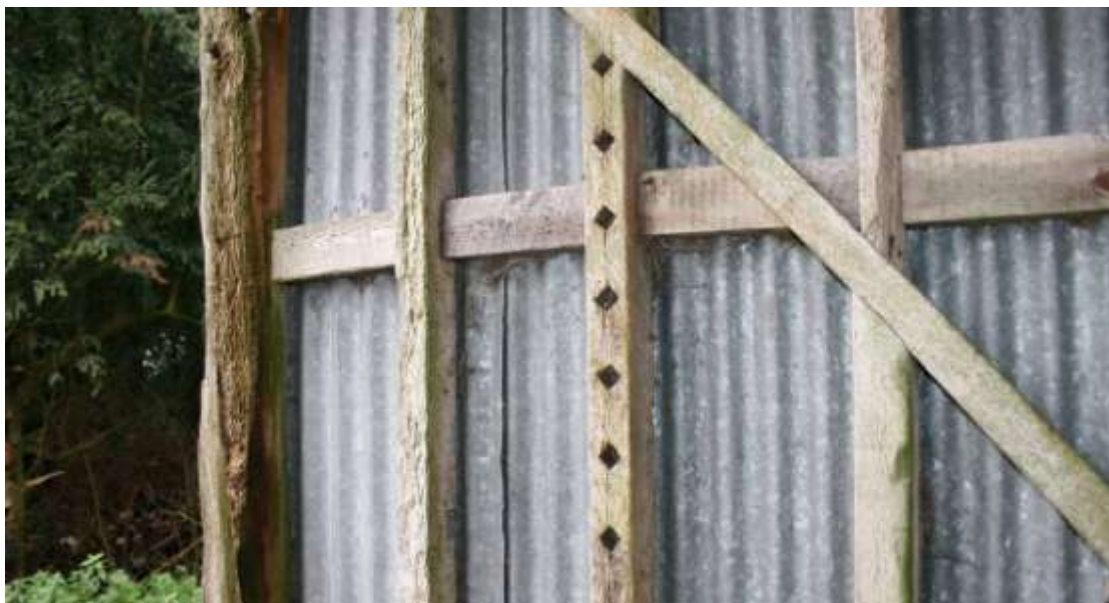
Detail of the repaired scantling frame.

The scantling frame stands on a plinth of LC20th Flettons and has been skinned with corrugated iron sheets. There is a mix of C19th/EC20th wrought iron and C20th French nails. One of the studs is a reused hayrack rail. The bandsawn softwood noggins have been skew nailed.

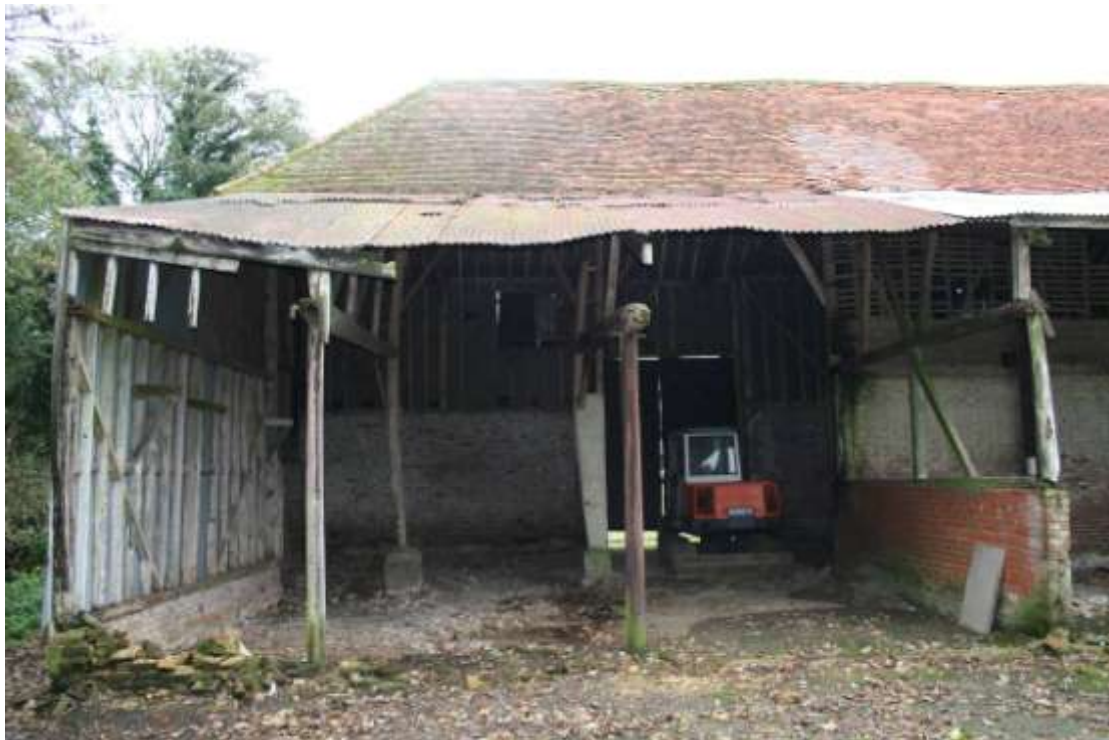
The southern elevation at the western end. Bays 1-3.

The south of the brick barn has a lean-to that originally ranged the whole length of the building. Some of it collapsed in the LC20th and was pulled away for safety reasons. The rest of it is in a very parlous state. The trusses retain some original timbers, now precariously pinned and cross-battened but most of the principal posts have been replaced with telephone poles or RSJ's (Rolled Steel Joists). It is evident from the concrete pillars that the posts rotted off at the base.

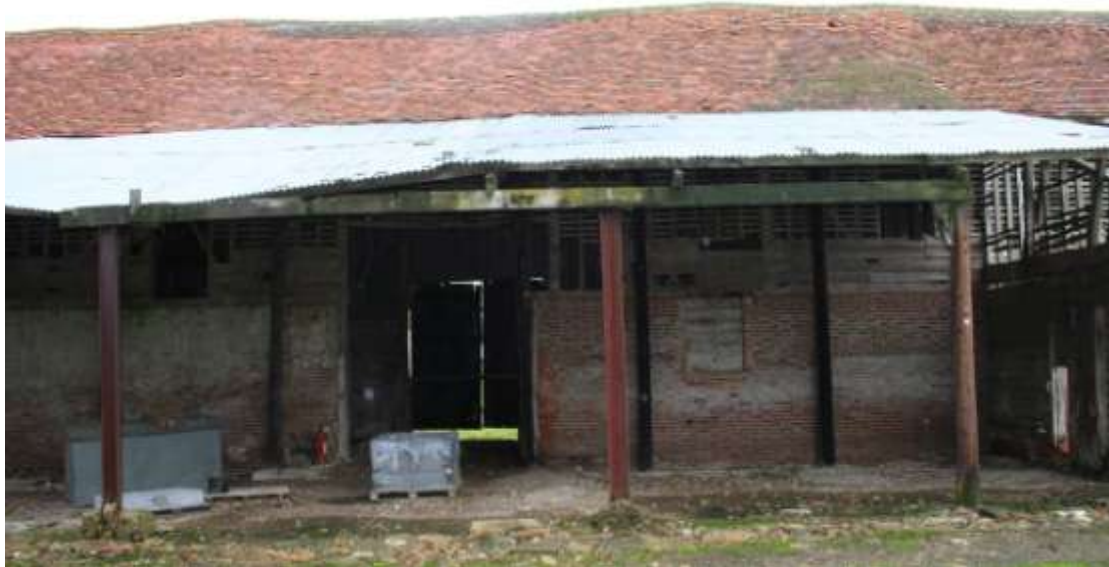
Southern elevation. Bays 5 and 6.

Only the trusses in Bays 1-3 retain any of the older frame. The other bays are rebuilt using LC20th machined softwood supported on telephone posts and RSJ's. There is a timber-framed partition completing the remaining Bay 7 but this is entirely C20th. The upper section reused some older scantling timber and the principal rafter indicates the former pitch of the roof. However the frame has been rebuilt with a new machined tie-beam and the 50x100mm softwood studs and weather-boards below it are all LC20th.

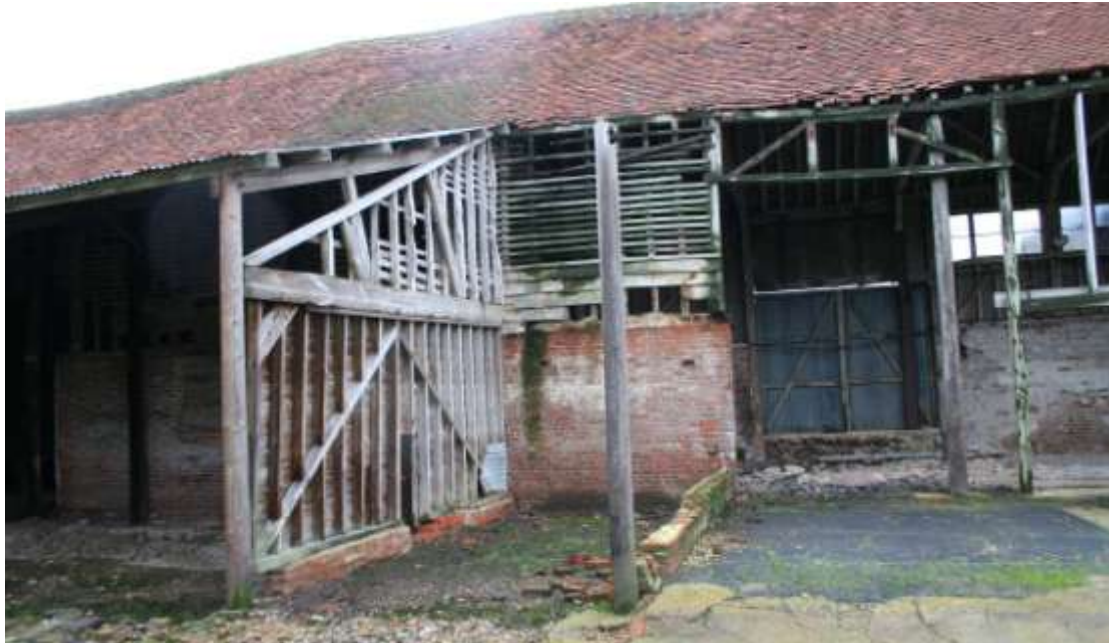
The partition wall ending Bay 7 is a LC20th rebuild.

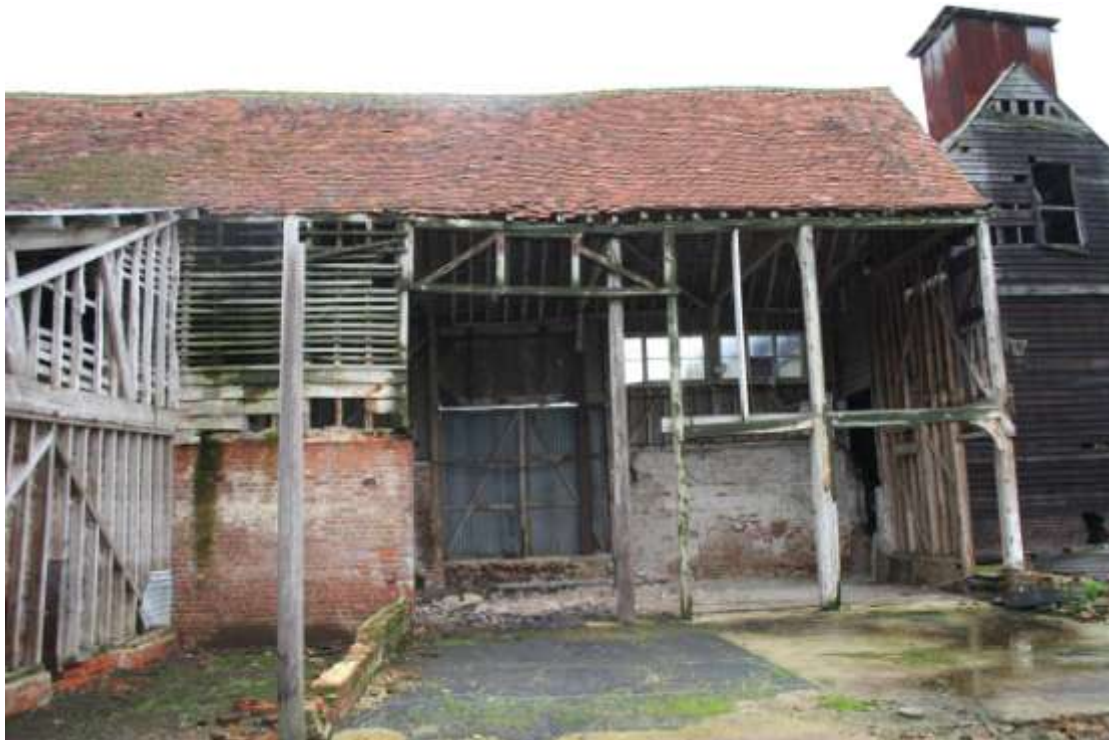
The eastern end of the brick barn range.

The eastern end of the building has lost the lean-to and it is evident that the brick wall range did not extend this far as the rest of the barn is made up of full height timber-framing of which only the principal posts and mid-rails remain. The joints were strengthened with hanging knees, nailed and broached (very large nails) rather than bolted.

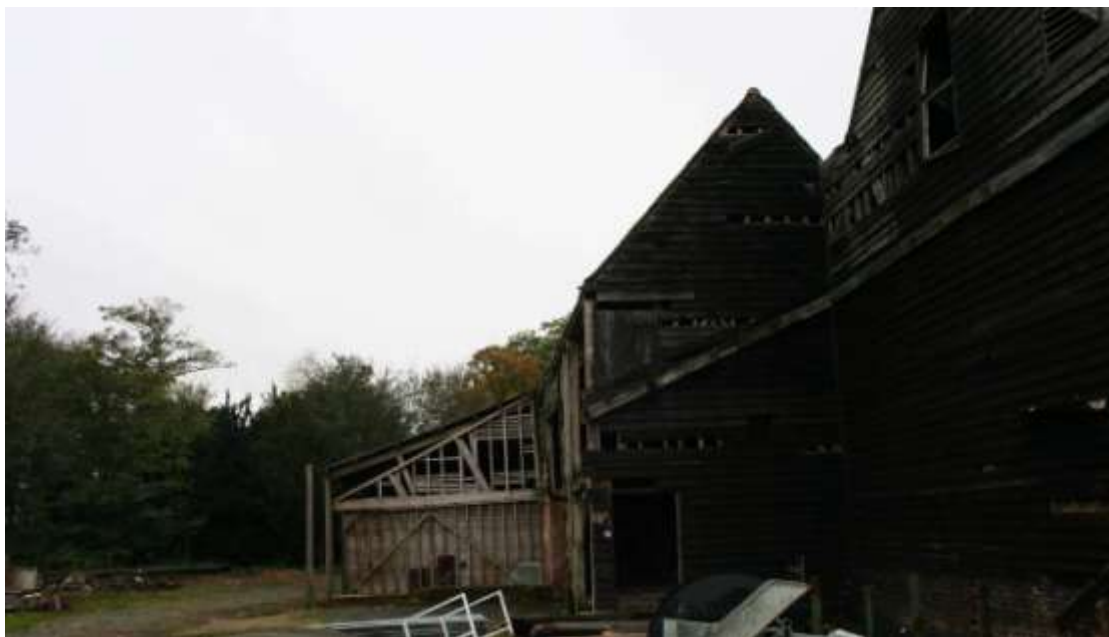
The eastern elevation.

The South barn has been built off the corner of the Threshing Barn. Most of the weatherboarding appears C20th. There is a large applied batten that shows there was previously another large building conjoined at the SE corner.

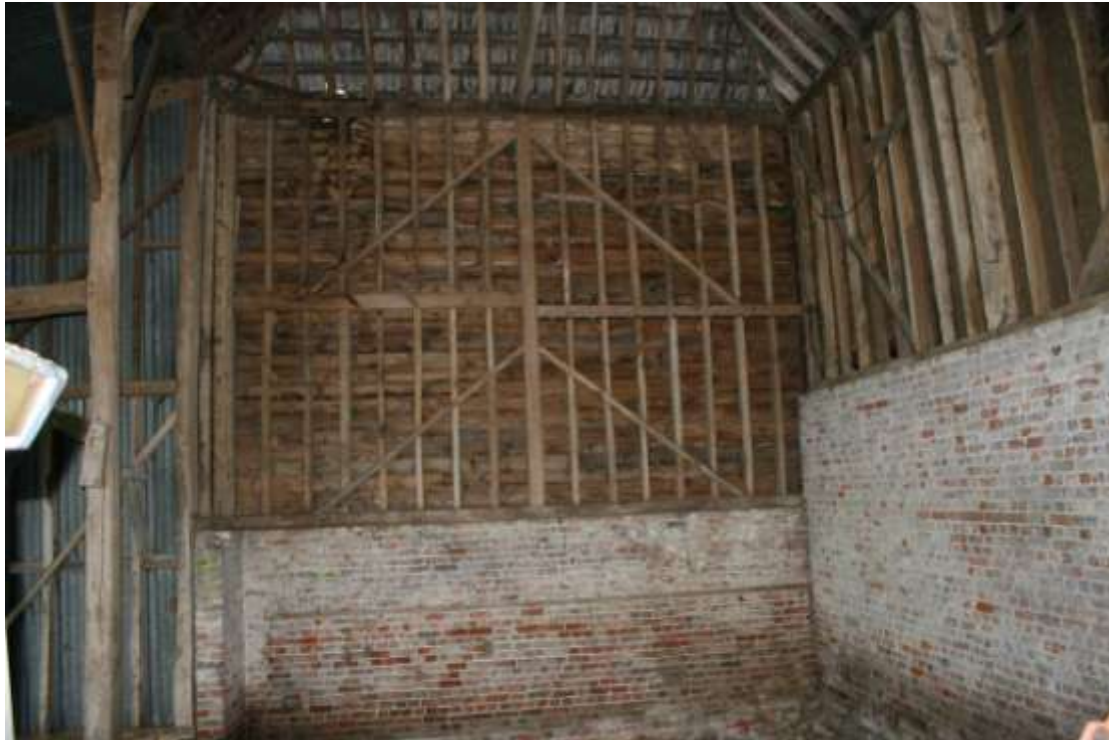
The western wall. Note the off-set mid-rail and reused floor joists.

Starting at the western end it can be seen that the plinth wall is butt jointed across the front wall. There is a timber strake at about 4ft above the original floor level suitable for applying battens for panelling to. The timber-frame appears to be pitsawn elm with 2.25-3in x 4in deep studs set at 14in centres. The straight primary braces are 3x4in and nailed to the interrupted studs.

The principal posts are 8x7in in section and reinforced with nailed and bolted hanging knees. The SW corner post and the principal post forming Truss1 are reused oak main floor joists each morticed for common joists. The mid-rails in the western wall are offset where they meet in the centre post.

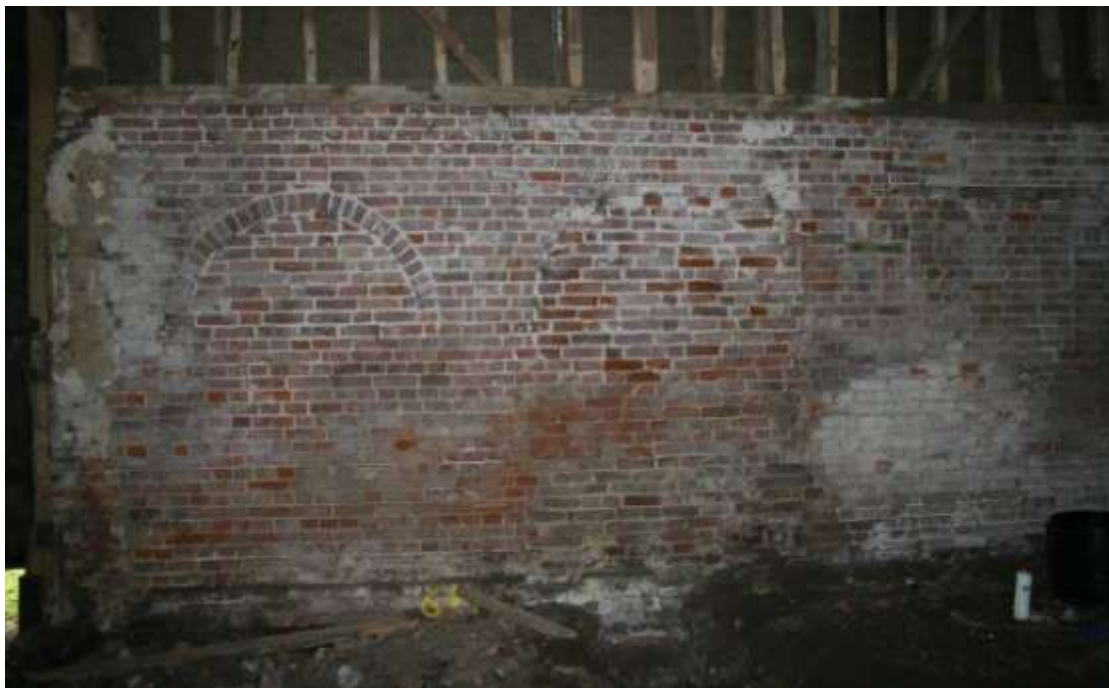
North wall Bays 4-5. The arch headed doorway and window have been blocked.

In both Bays 4 and 10 the arch headed openings have been blocked with very similar bricks. There are also blocked in rectangular openings with timber lintels in Bays 5,6,8 and 9. These broach timber-strakes under rowlock courses and the arrangement suggests there was originally one longer wall that was remodelled with square windows when the large barn doors were inserted.

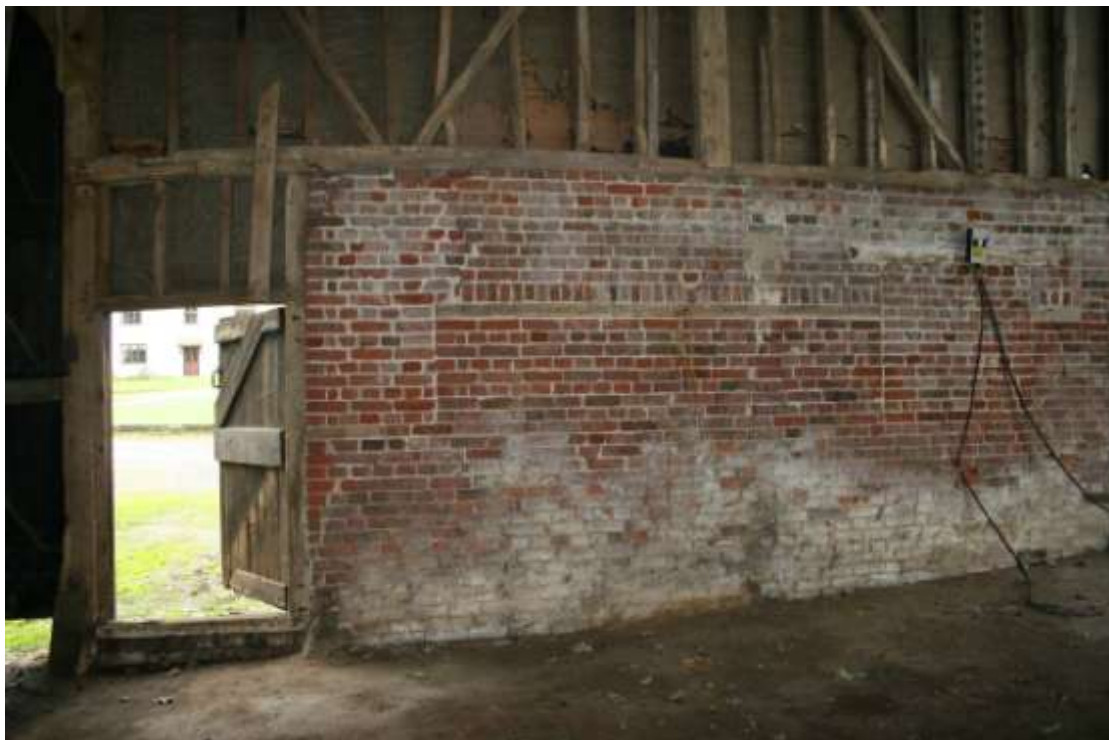
Two blocked openings in Bays 7 and 8. The LHS one has been altered for the doorway.

There are scars in the walls under Trusses 3 and 10 and also in the middle of Bays 4 and 9 that delineate the former design of the brick building. The footings are visible in the torn up floors.

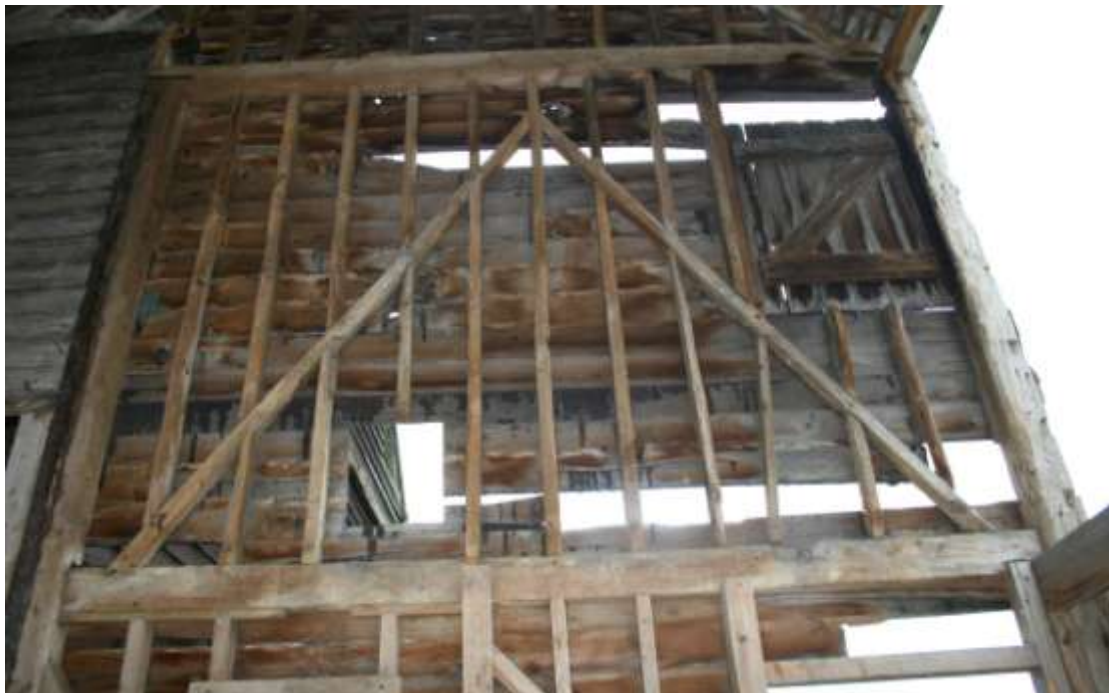
The upper part of the eastern elevation.

The eastern end of the South Barn has a full height timber-frame that has been built off the corner post of the adjacent Threshing Barn. The lower wall panel is a LC20th rebuild while the upper retains much of the scantling frame. There would have been raised machine platforms at this end and a set of MC20th casements has been fitted in the north wall to light the area. A small floodlight also remains.

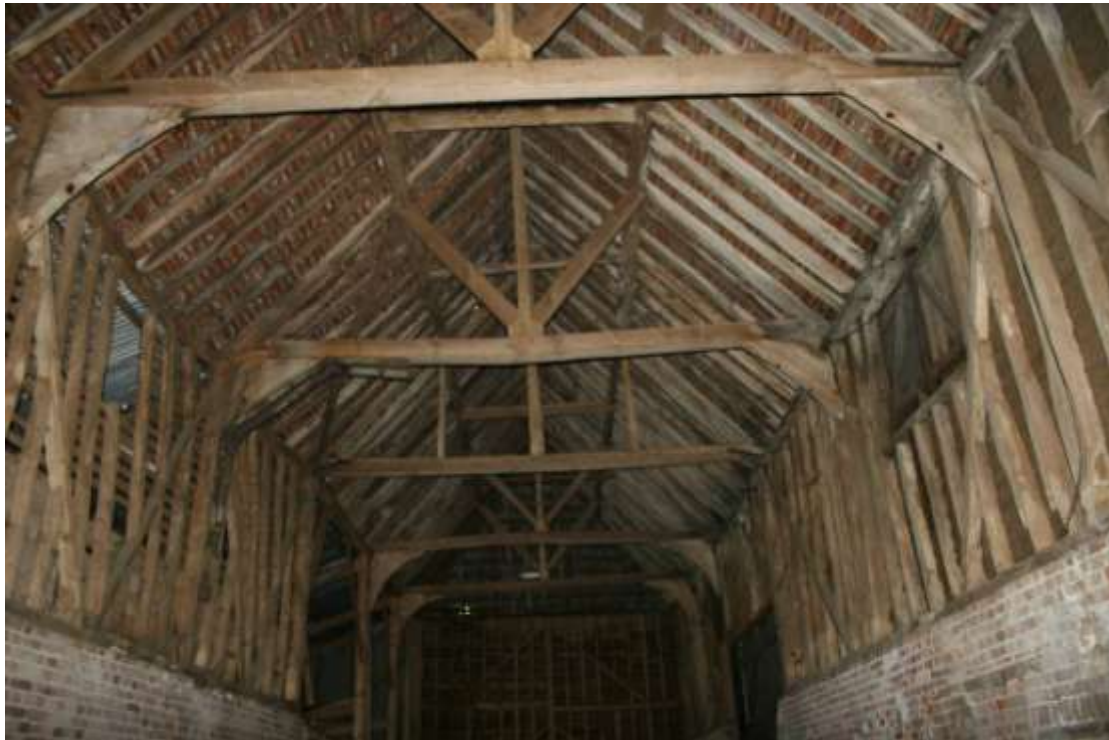
The roof over Bays 1-5 looking W. Note the hanging knees and steel reinforcement (LHS).

The roof is supported by 12 kingpost trusses each held with hanging knees to the unjowled principal posts. Truss 3 however has no hanging knees and a kingstrut with two scantling queen posts. The clasped side purlins are supported on the queen posts and raking struts on the kingpost trusses. The purlins are further retained with side-lapped collars and birdsmouthed struts in the centre of each bay (as defined by the trusses).

The roof is continuous in form but not in detail. The hanging knees for the central bays are solid triangular spandrels held with nails and square headed bolts while the 3 end bays have curved and chamfered hanging knees. Most of the joints are reinforced with wrought iron L-ties. Truss 4 also has a LC20th steel reinforcement across the spandrel on the south side.
