49 Swan Street, Sible Hedingham, Essex. CO9 3RA.
Description and analysis of the timber-framed house. Surveyed 03 02 2014.

Scope of this Report

This report records the fabric and analyses the building to EH/RCHME Level 3 to inform the proposed works and mitigate any necessary changes to restore the building. The building is a prominent landmark in the village and the current owner Mr Brian Day aims to sensitively repair the building to maintain its current appearance.

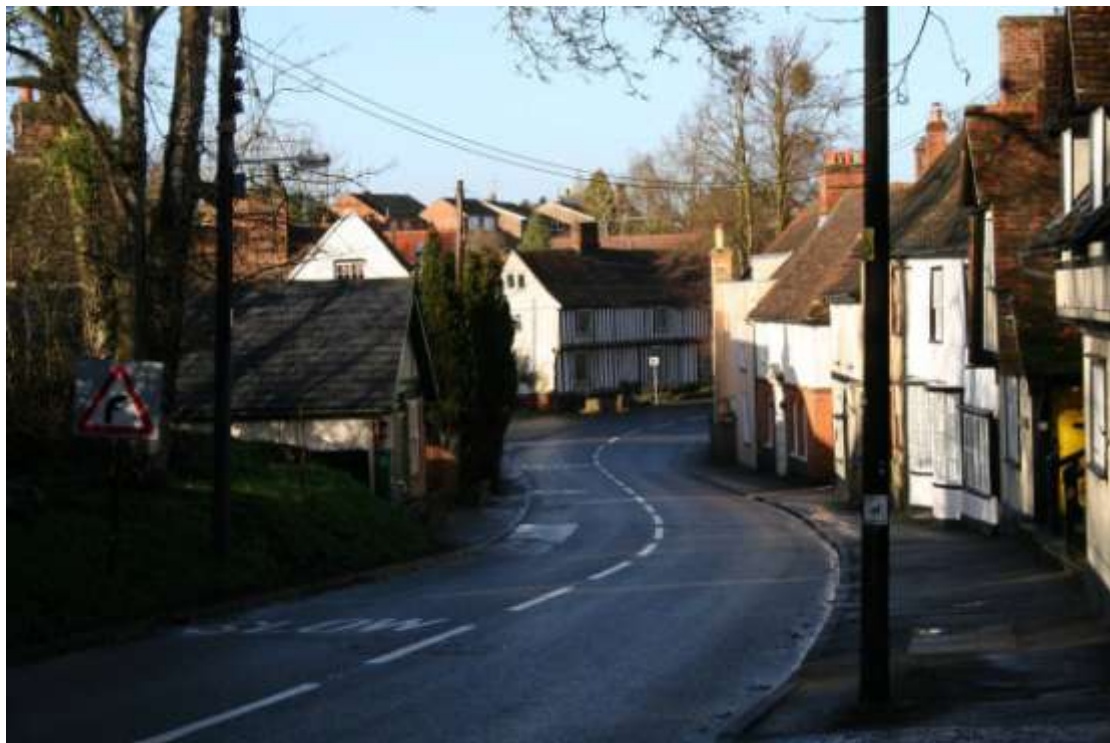
Looking N down the hill towards 49 Swan Street mimicking the view from many historic photos.

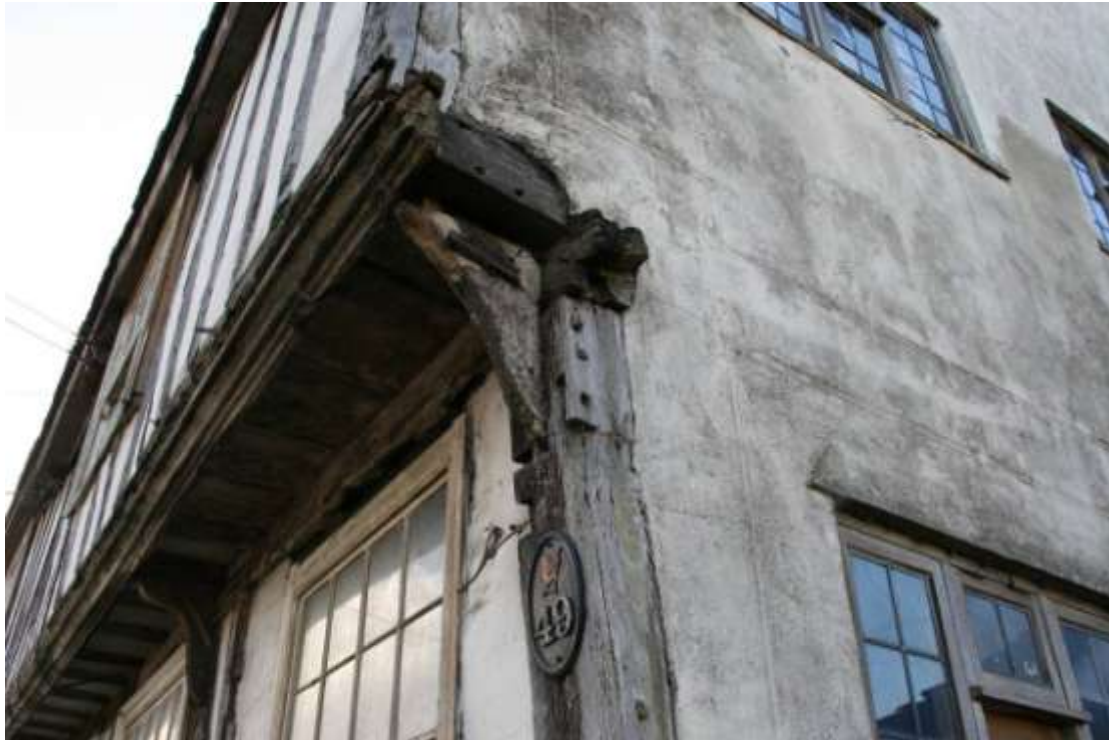
Detail of the bressummer and jetty brackets on the NE corner.

The bressummer for the jetty is moulded and is supported on small badly eroded brackets which all appear to be replacements (which is not uncommon). On the NE corner there are a number of mortices and chamfered rebates to indicate that other structures were attached in the past. Looking up at the jetty the underside of the floorboards can be seen scratch-coated with lime mortar.

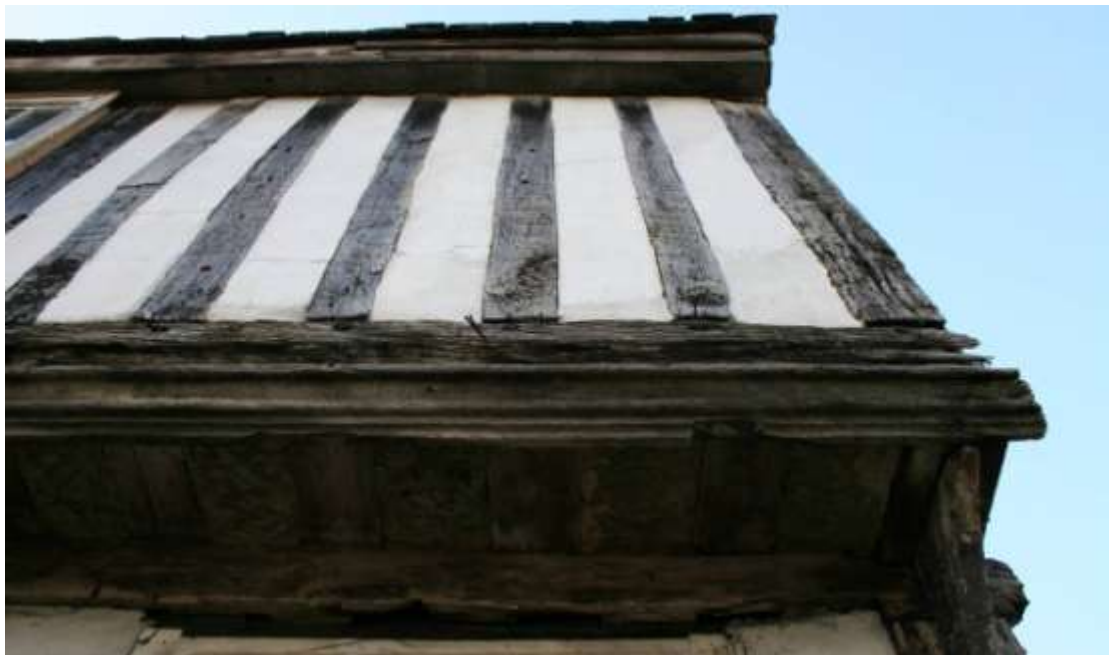
Looking at the underside of the jetty. Note the scratch coated lime render.

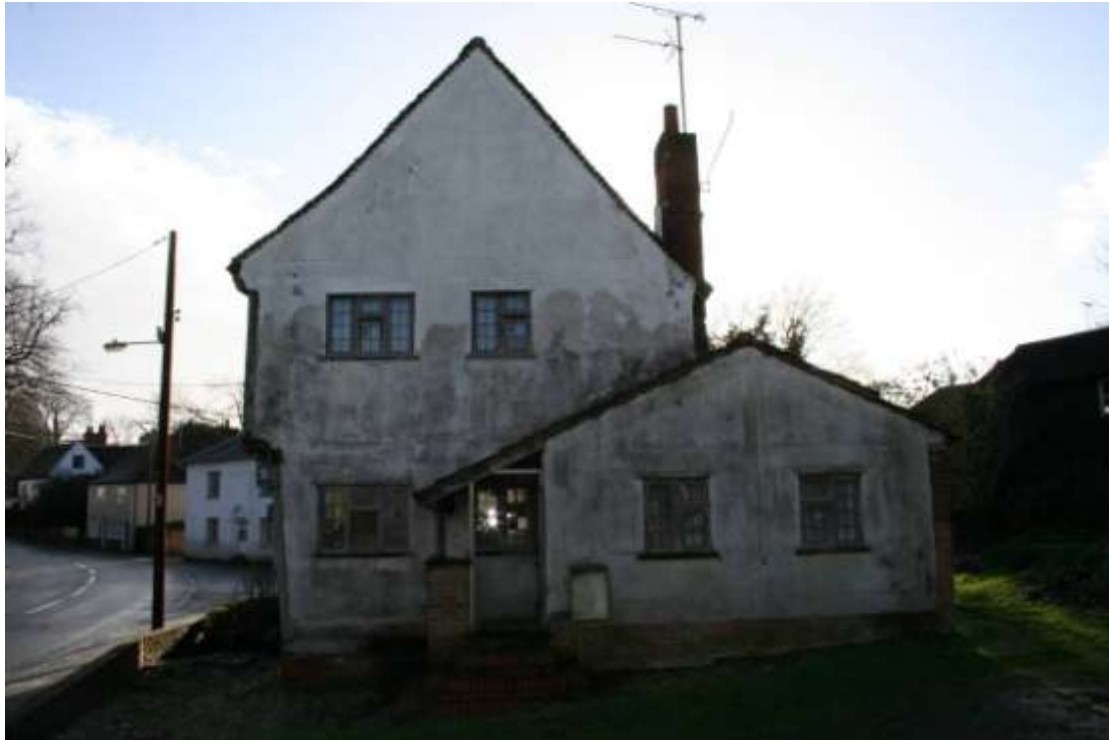
The northern elevation.

The northern elevation has the flank of the original house and the side of a later outshot. Both have been finished in a cementitious render with bell drip courses over the windows and plain pargetted fields. The windows are LC20th casements with leaded lights and almost certainly came from the Rippers (later Premdor) factory just down the road.

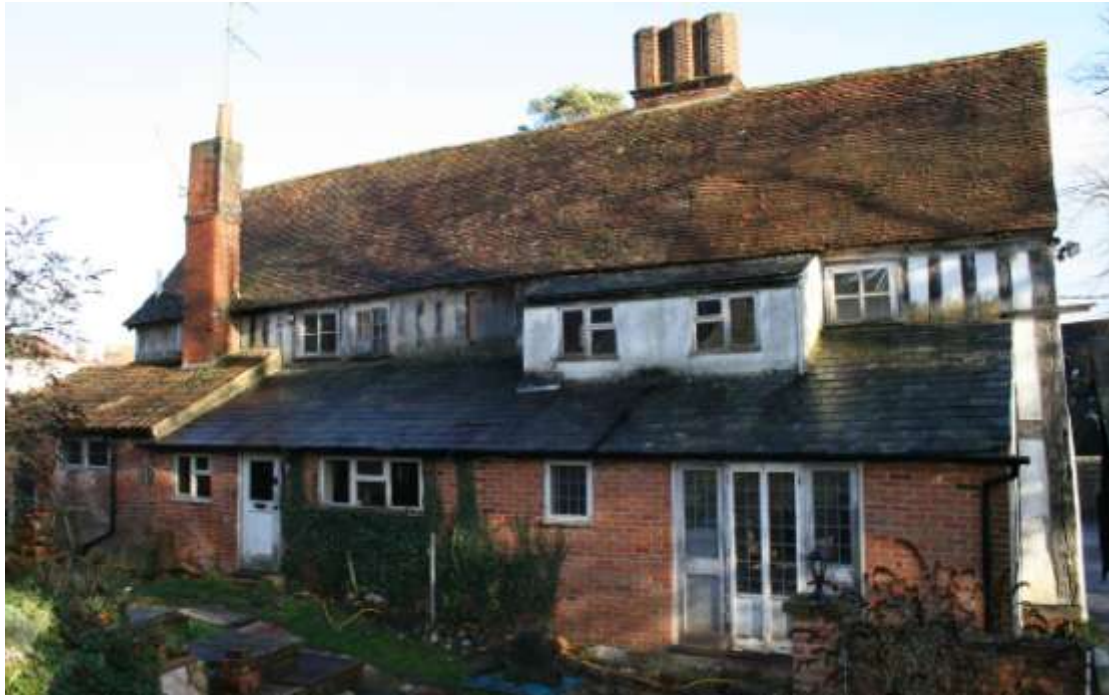
The rear of the house is the western elevation. Looking NE.

The western elevation is made up of a series of outshots from the original frame which is exposed above. The northernmost outshot contains the Laundry and is built of red 65x110x225-230mm red bricks pointed in grey cement. The exposed plinth is made of Flettons. The brickwork is M-LC20th in style. Laid in stretcher bond there are no closer bricks to the quoins or openings. The roof is laid with pantiles and had painted metal rainwater goods. There is a C19th style red brick chimney stack repointed in grey cement but bonded with lime mortar.

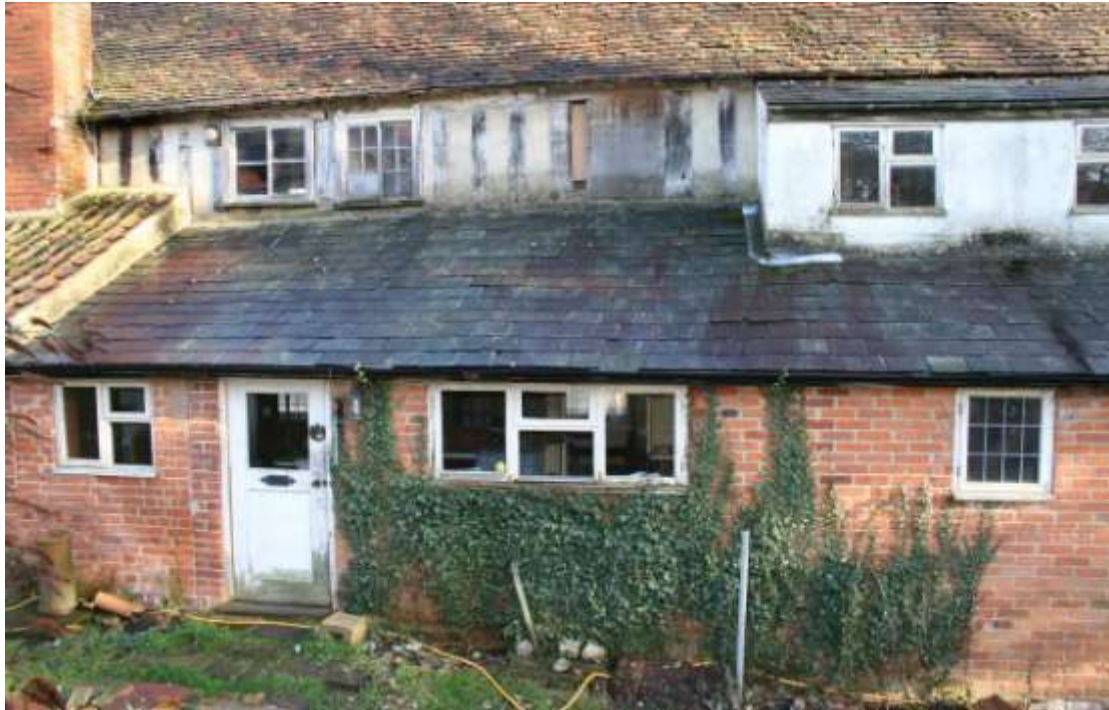
Detail of the central section of the rear of the house.

A small section of the close studded frame is visible above the outshots. There are two horizontally sliding sash windows (often called Yorkshire sashes) and a blanked off mullioned window. While the 6/6 window looks authentic the other appears to be a large pane sash lain on its side. It was not until the 1920's that windows incorporated landscape oriented panes.

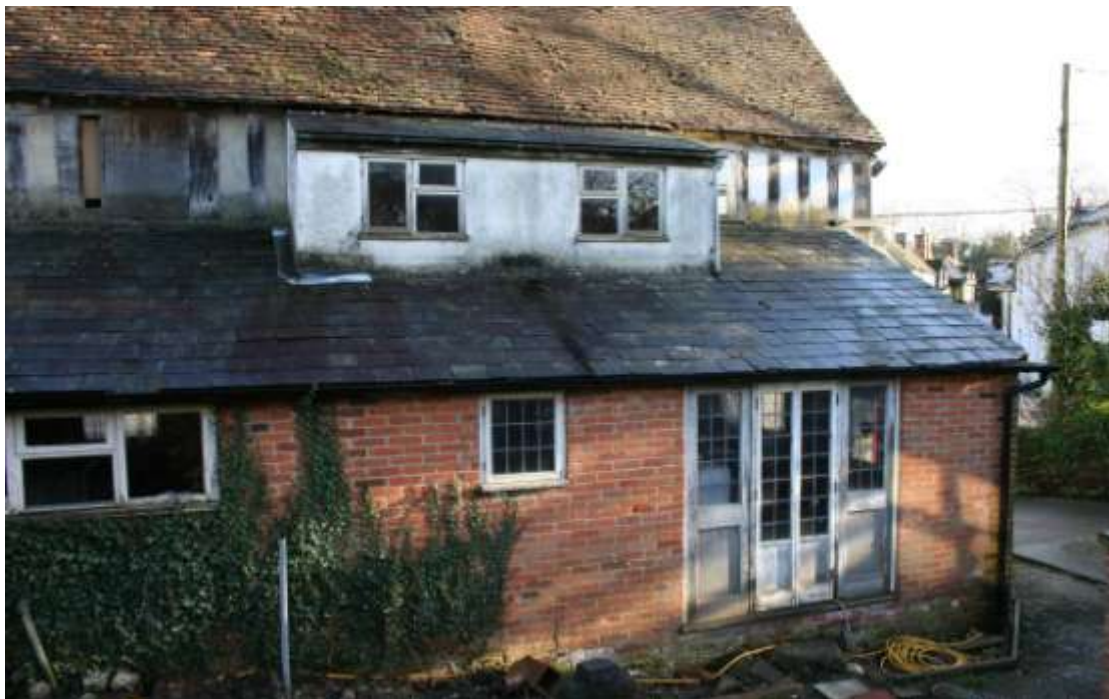
Detail of the stair-tower and C20th French windows. Looking SE.

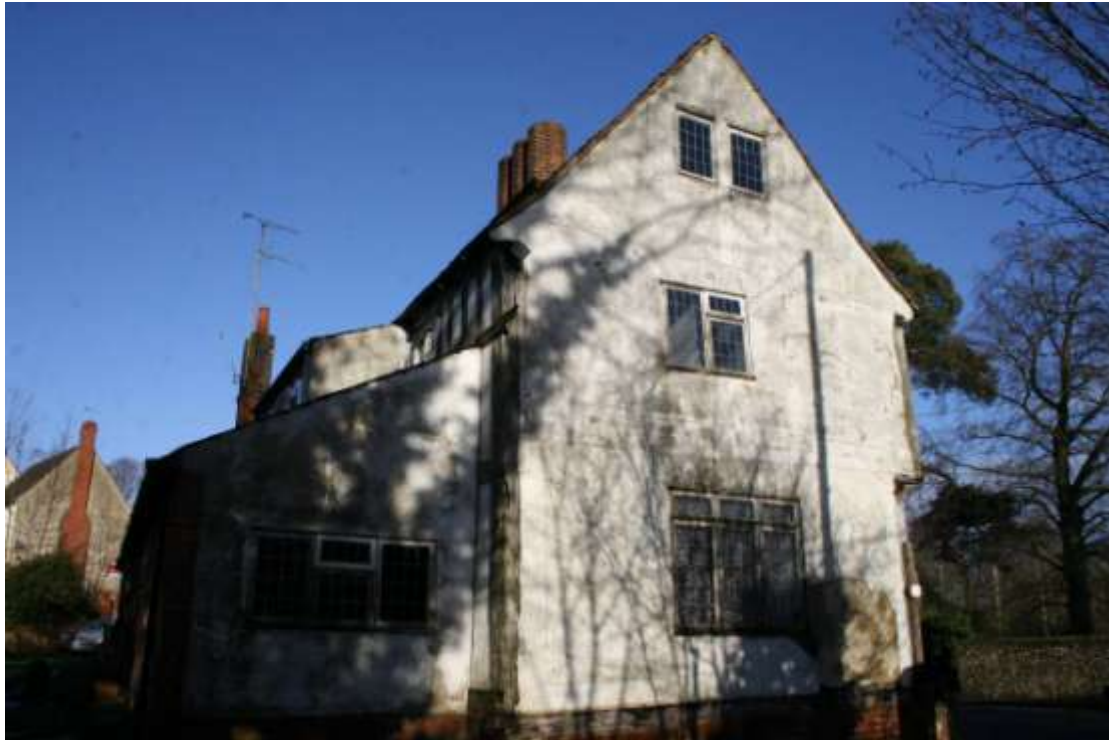
The southern elevation.

The southern elevation maximises the natural light and has windows for both floors and the attic room. The windows are E- MC20th leaded light casements. The wall is rendered in lath and plaster which photographs shows was undertaken by Mr Brooks post 1966.

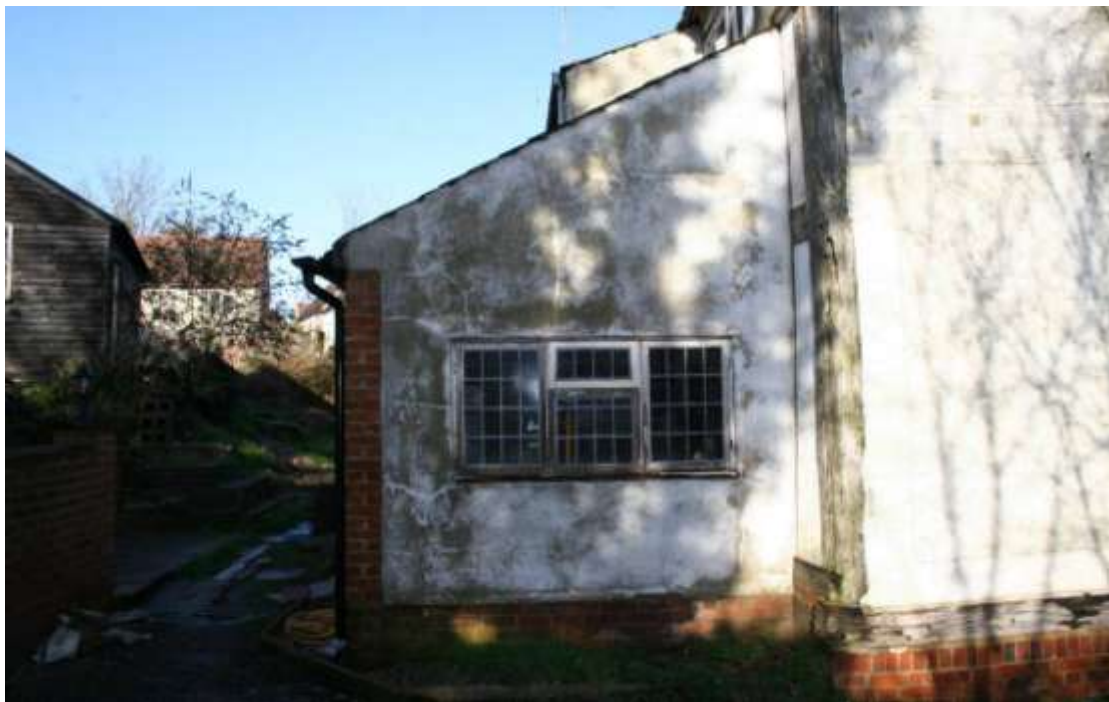
Detail of the rear outshot built by Mr Brooks.

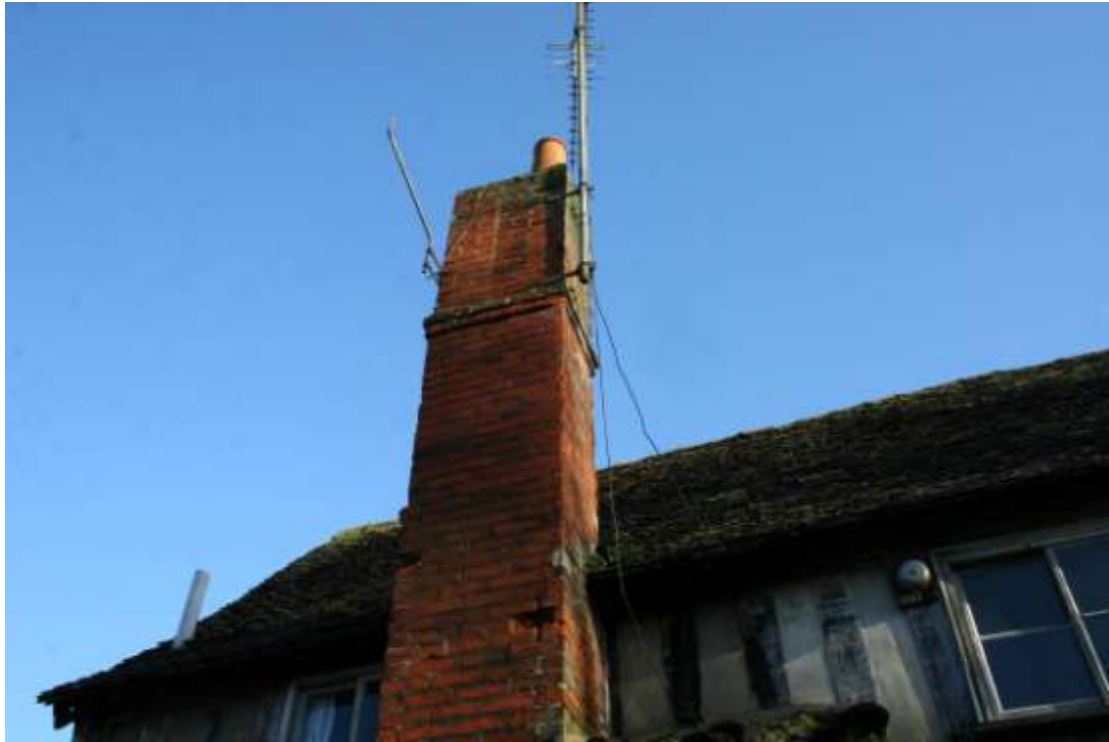
Detail of the C19th chimney.

The House has two substantial brick chimney stacks. That to the rear, now in the Laundry is of red 65x110x225mm red bricks set in lime mortar and of a pattern common in the C19th. It retains a single EC20th cannon barrel type chimney pot. The main stack has three axial linked octagonal shafts of thin red and purple bricks heavily buttered with grey cement. Originally they would have been taller with decorative caps but they have been rebuilt in the LC20th.

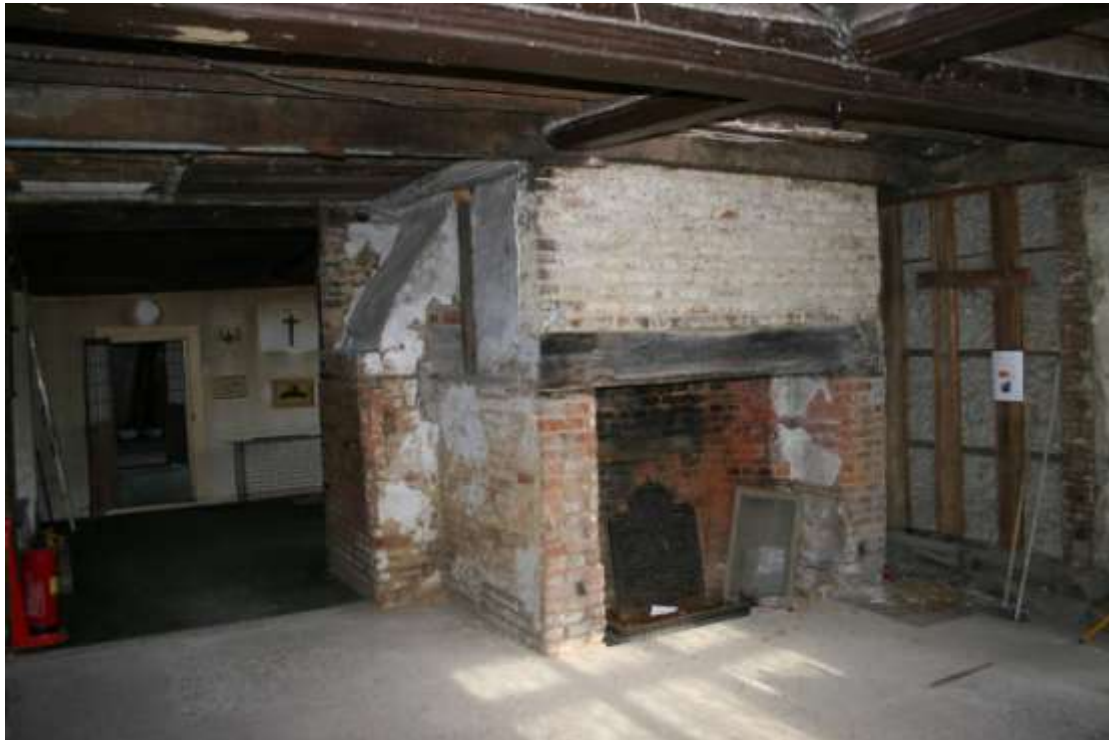
Room 1 looking NW. Note the two phases of firestack.

Room 1 displays the remains of the original timber-frame in each wall and houses a large firestack in the NE corner. The frame is correctly pegged and framed with axe finished close studwork of 6.5-7in x 3.5x4in oak studs set at 16in centres. The northern dividing wall has been removed and the sawn off mortices indicate this was done quite some time ago.

In the SE wall, facing the roadside, is a large section of rebuilt wall adjacent to the firestack. Close inspection shows the top-plate is not pegged here and the sole plate is a later insertion. The studs are a modern infill using battens and EML (Expanded Metal Lath) concrete render. It is likely that originally there was an entrance porch.

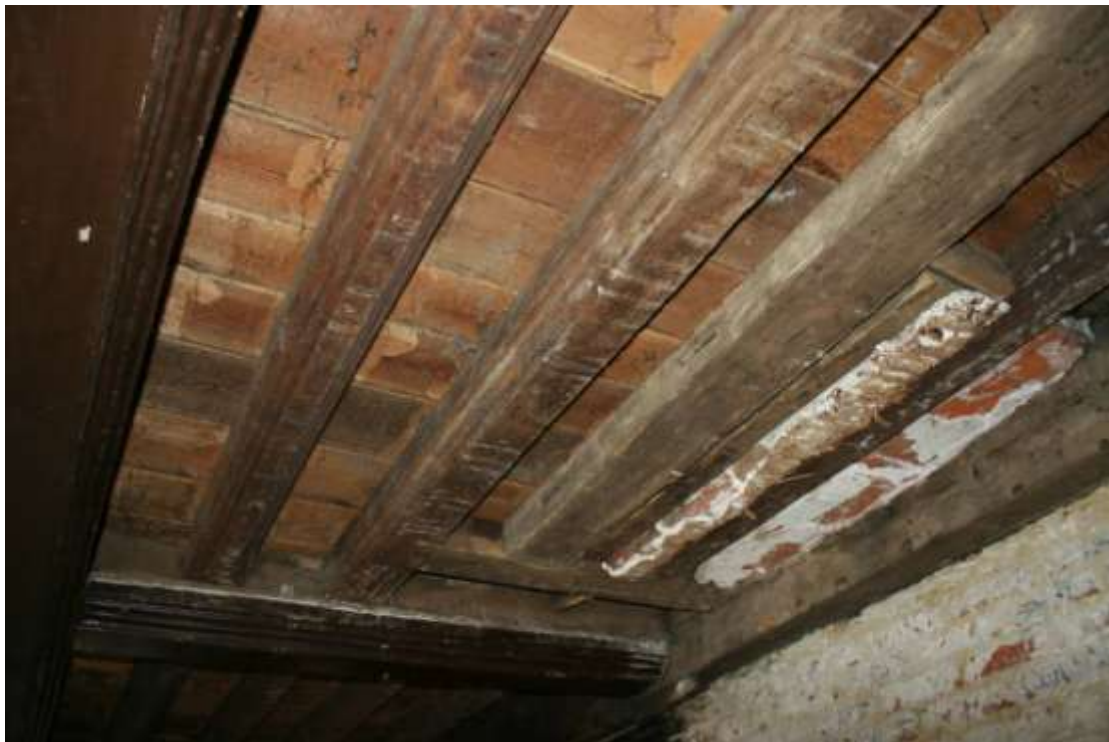
The timber-framed floor above the fireplace. Looking NNW.

The ceiling above the fireplace has been altered to install a small hearth for the bedroom above. The original trimmer beam, moulded on only one side remains and other dissimilar joists have been placed in to support the granite hearth that has been further packed with roof tiles. One is a shortened original moulded joist but another is clearly a reused stud with wattle darts in its flank.

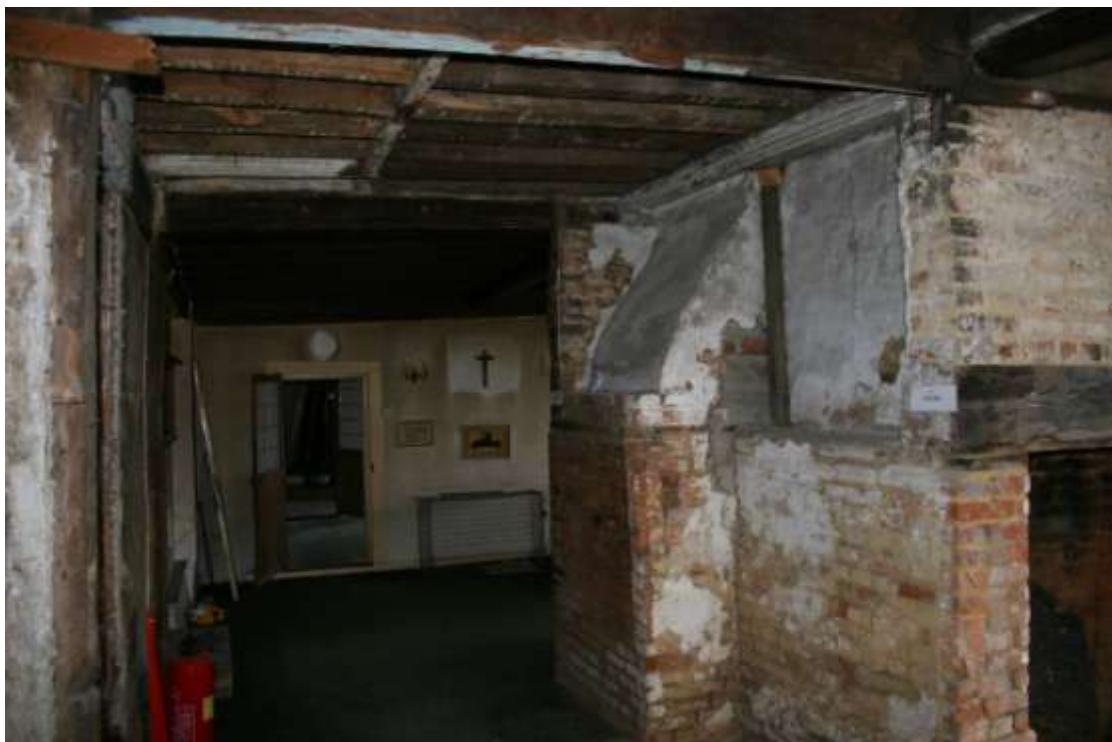
The area besides the two firestacks has a stair-trap later filled in.

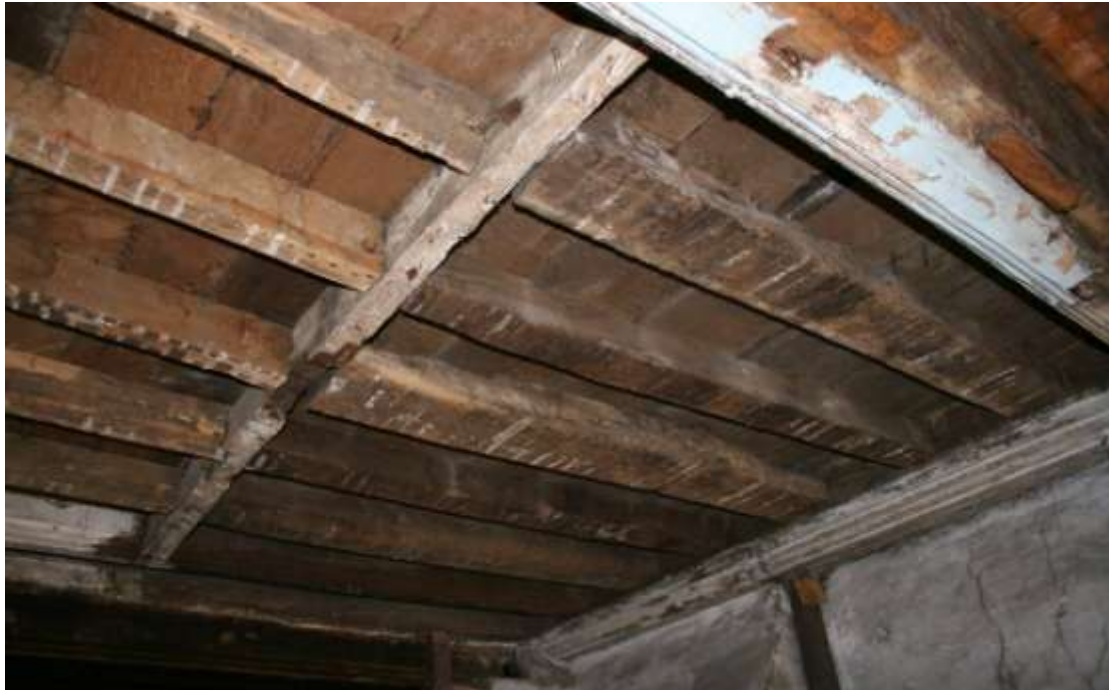
Looking N, up at the ceiling besides the firestacks.

The dividing partition wall between Room 1 and Room 2 has had its studs sawn off but previously to that the moulded face of the main transverse joist has been hacked back. This would have been done in the Georgian era to allow lath and plaster finishes to be added to the stud walls and ceilings. The area created has a trimmer beam for a stair trap which has been later filled back in. The earlier floor is rebuilt from original wall studs (denoted by wattle darts) and the older section has oak floorboards while the later section has narrow pine joists and pine floorboards. One reused stud is painted in a similar way to the firebreast and is also chamfered as a door jamb would be.

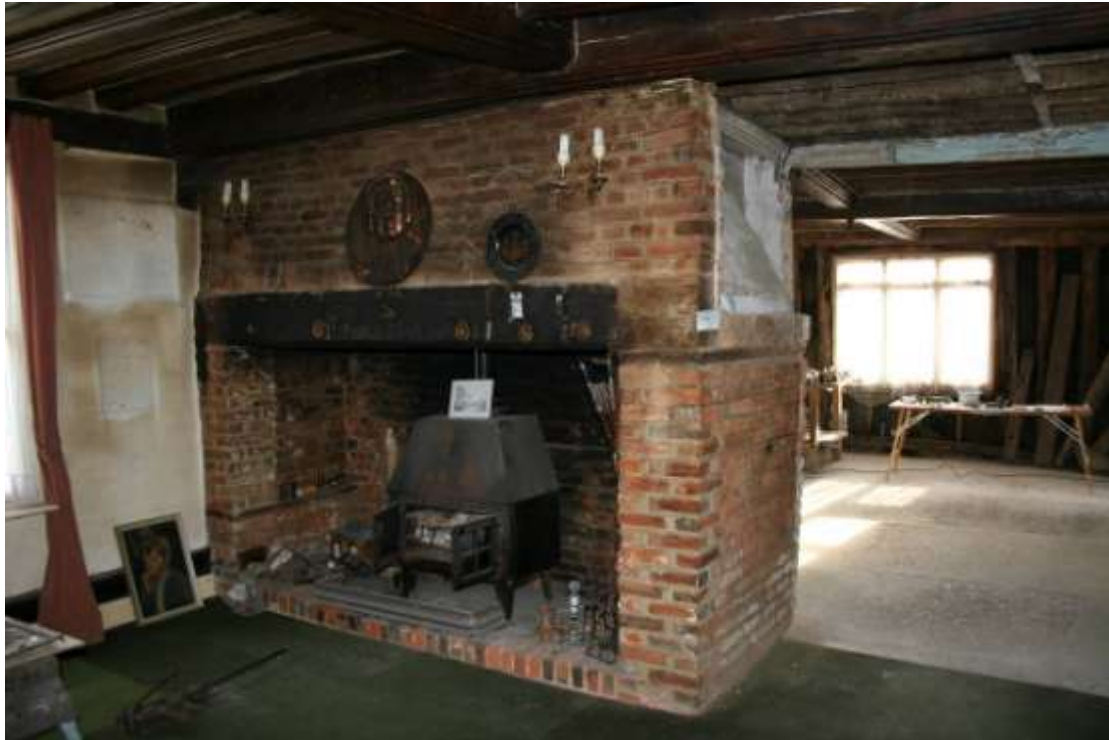
Looking S in Room 2 at the later fireplace.

The walls of Room 2 are concealed inside by lath and plaster but the ceiling structure is displayed and is a continuance of that in Room 1 and has the same features and dimensions. Again the room is dominated by a large brick firestack that is later and larger than the other. The bressummer is 10ft long by 11in deep and 9in wide and chamfered on the inner face. The fireplace is 8x4x5ft high and incorporates a wooded inglenook seat which appears original. The stack is built of orange and purple 60x110x240-50mm handmade bricks which have been repointed in modern grey cement.

The firestack although wider in the room has a chimney of the same size as the other that cants inwards so that the framed ceiling did have to be cut through. The NW flank has been lime plastered but the other end, as mentioned is unpointed and unplastered. It seems likely it has been built in the original entrance passage.

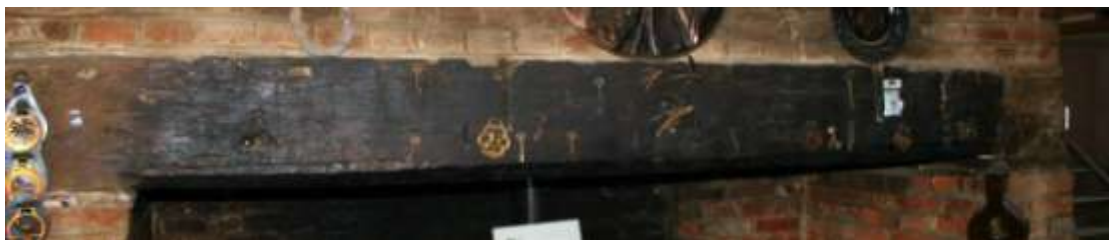
The bressummer has apotropaic marks and taper burns.

The bressummer has a number of apotropaic marks in the form of W or IXI and several taper burn marks. At the NW end (RHS) there are holes drilled for a turning mechanism.

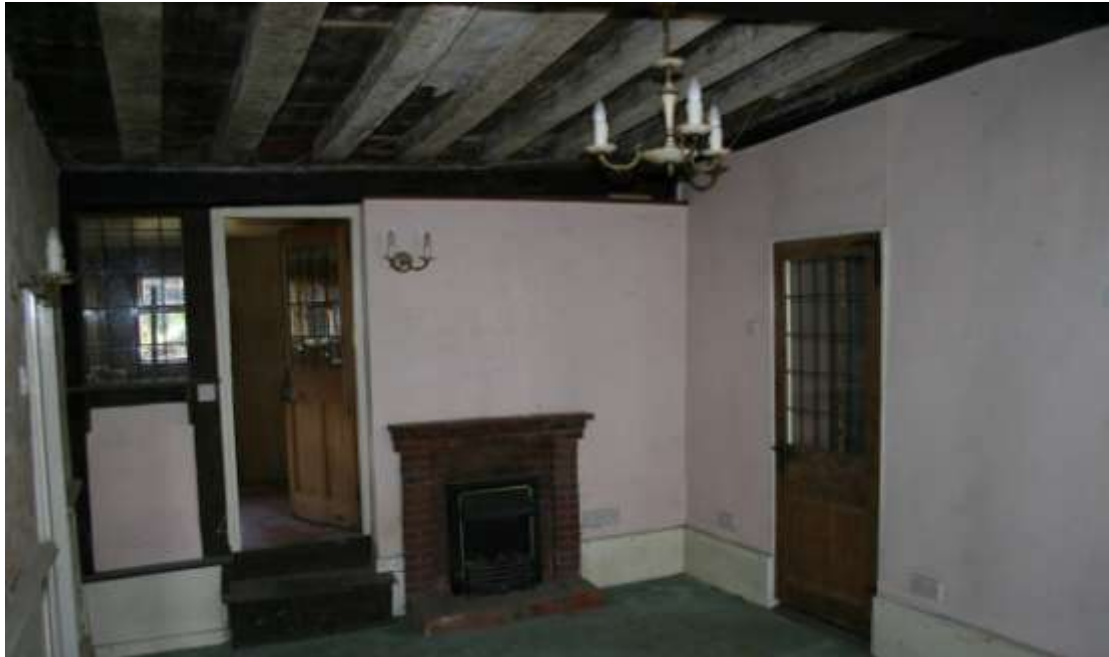
Room 3 looking SE towards the Kitchen.

Room 3 has lath and plastered and wallpapered walls with some modern wainscoting. There is a small EC20th brick fireplace that vents into the C19th chimney on the back of the house. The exposed ceiling show heavy, plain 6-7in wide joists set at 16-17in centres. The larger axial joist is 10in square and chamfered. The paucity of detail suggests this is the service end of the house. There is a former blocked doorway in the front wall.

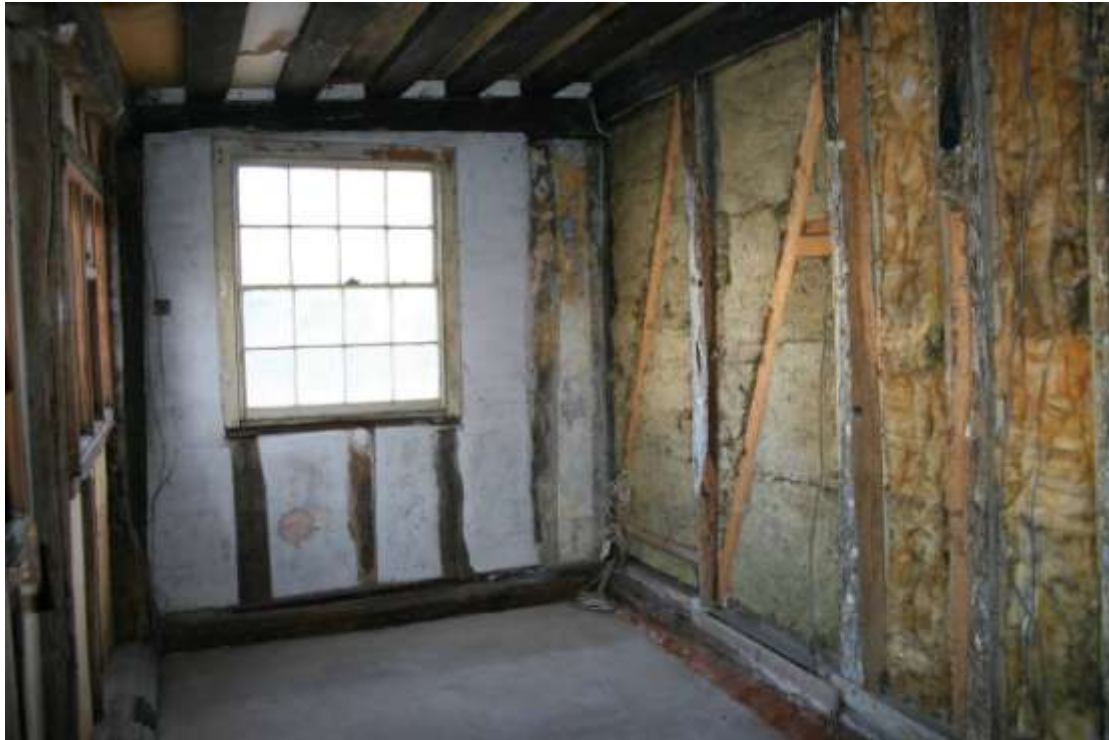
Looking E in Room 4. The walls have been much altered.

The frame is exposed in the walls in Room 4 and it has been much altered and abused. There is a doorway with a pegged lintel but the jamb is clearly reused.

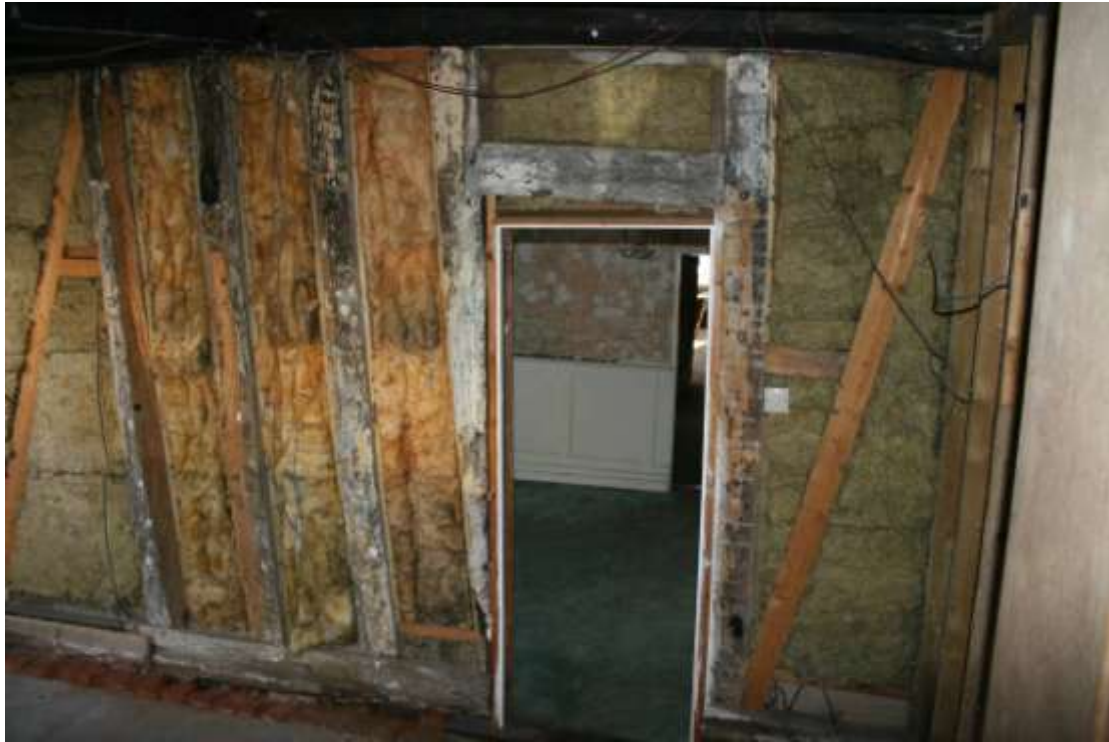
The pegged doorway looking into Room 3. Note the tapered door jamb.

Only half of the 6-7in studs appear correctly seated and there is a series of fixture holes that run across for shelves or counters. The doorway has been inserted or altered. The lintel has no peg for a central stud and the jamb has been radically sawn down. There are applied timbers to hold in the Rockwool insulation which is also held in with fencing wire strung across. The wall has been rebuilt in the LC20th and it appears there were two phases of doorway at the other end of the partition wall. There are some burn marks which appear electrical.

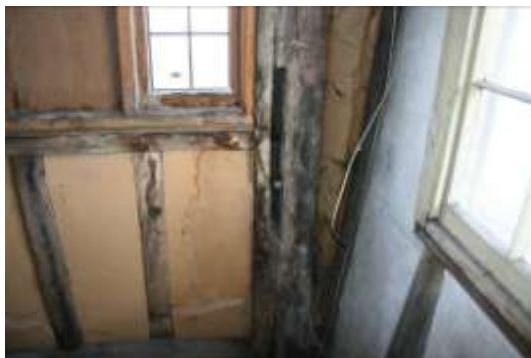
The mortice for the corner brace.

The principal corner post has a slot mortice for a curving brace set to the back of the post. This indicates the front wall has been rebuilt to house the sash window. There is a doorway broken through the outer wall to connect to a small lobby to access the downstairs shower room. The studs have been removed and a nailed timber bracket put in place. Like much of the house this area has been left unfinished.

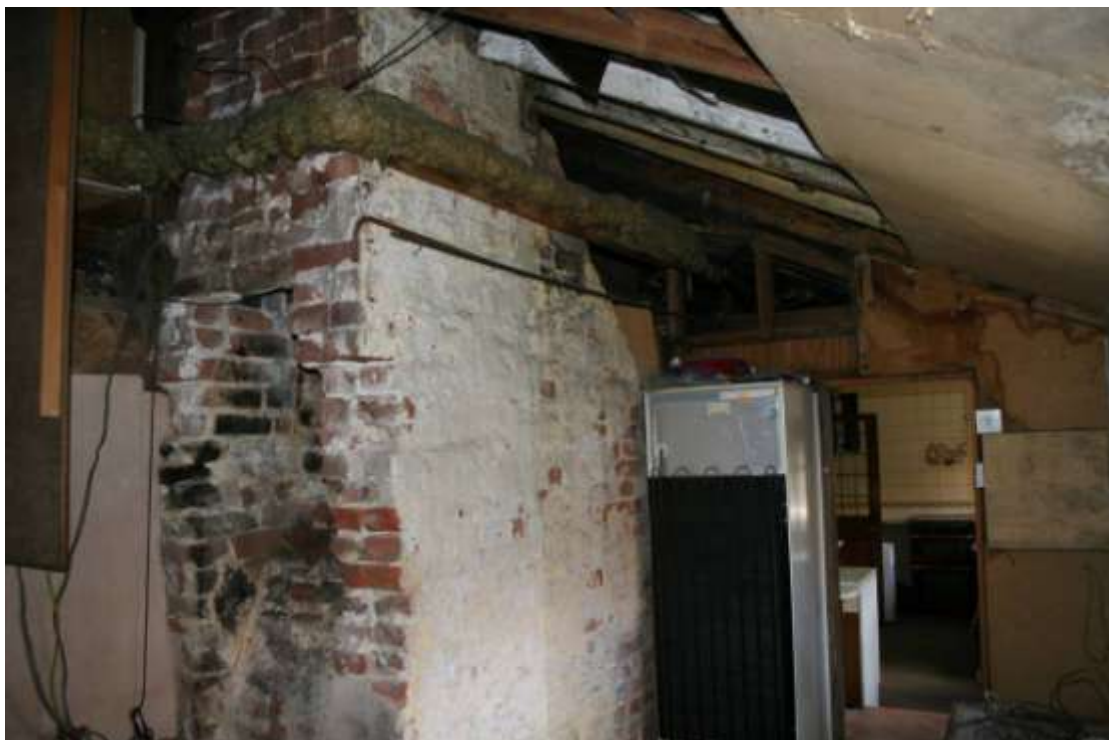
Looking SE in the Laundry. The bread oven or copper has been smashed out.

The Laundry is housed in the rear extension and from inside the roof can be seen to be recent. The walls are panelled with hardboard. The brick chimney stack has been hacked back and it is likely that a bread oven or copper was removed.

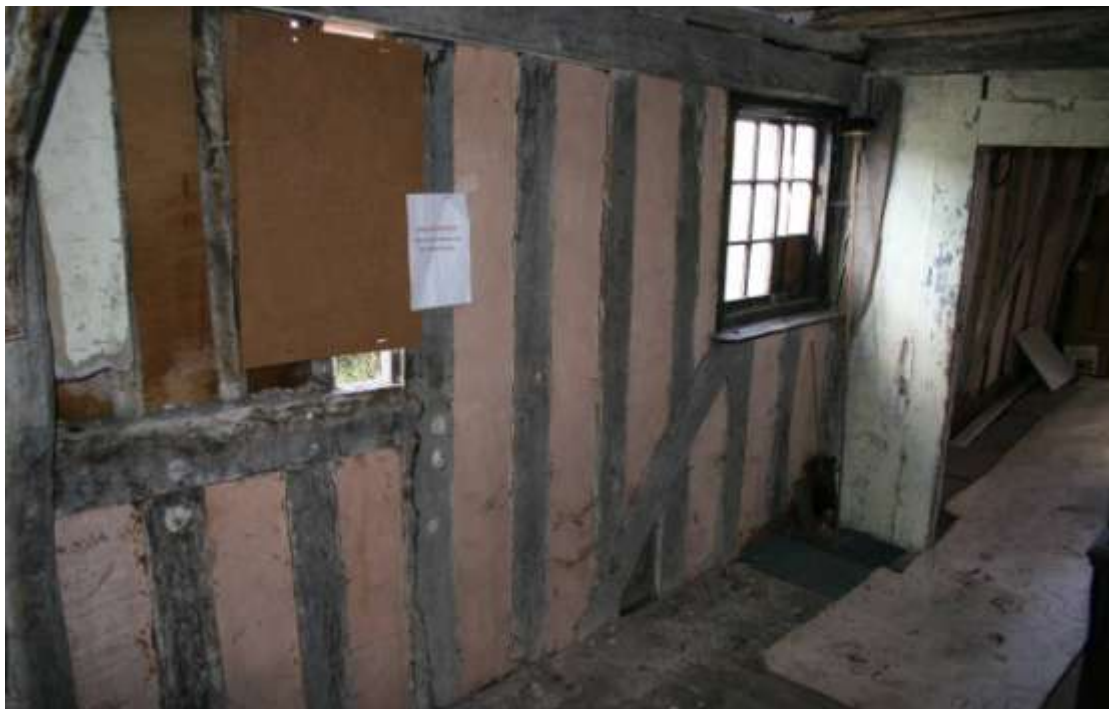
The NW wall of the house in the corridor. Note the mullioned window and severed brace.

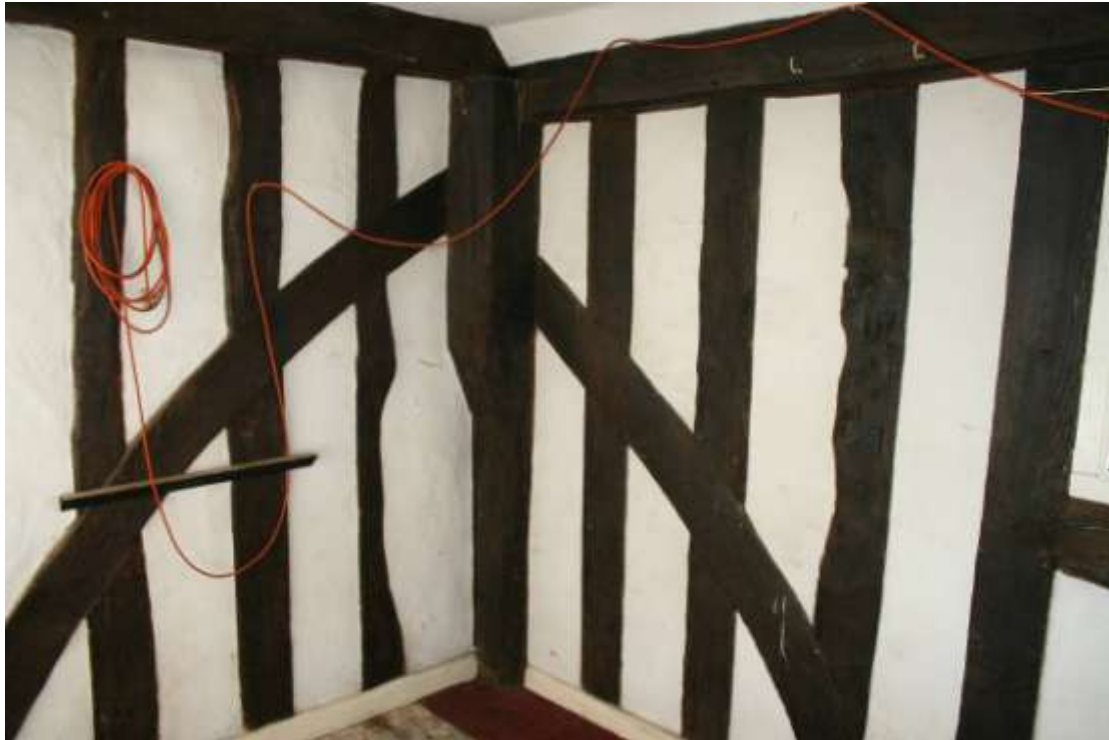
The frame in the SW corner of Bedroom 1.

The frame is exposed in Bedroom 1 and the heavy brace of the tie-beam can be seen. Secured with four pegs in the tie-beam and three in the jowled post, there was a series of spandrels on each truss stiffening the frame. A number have been removed causing the frame to rack slightly.

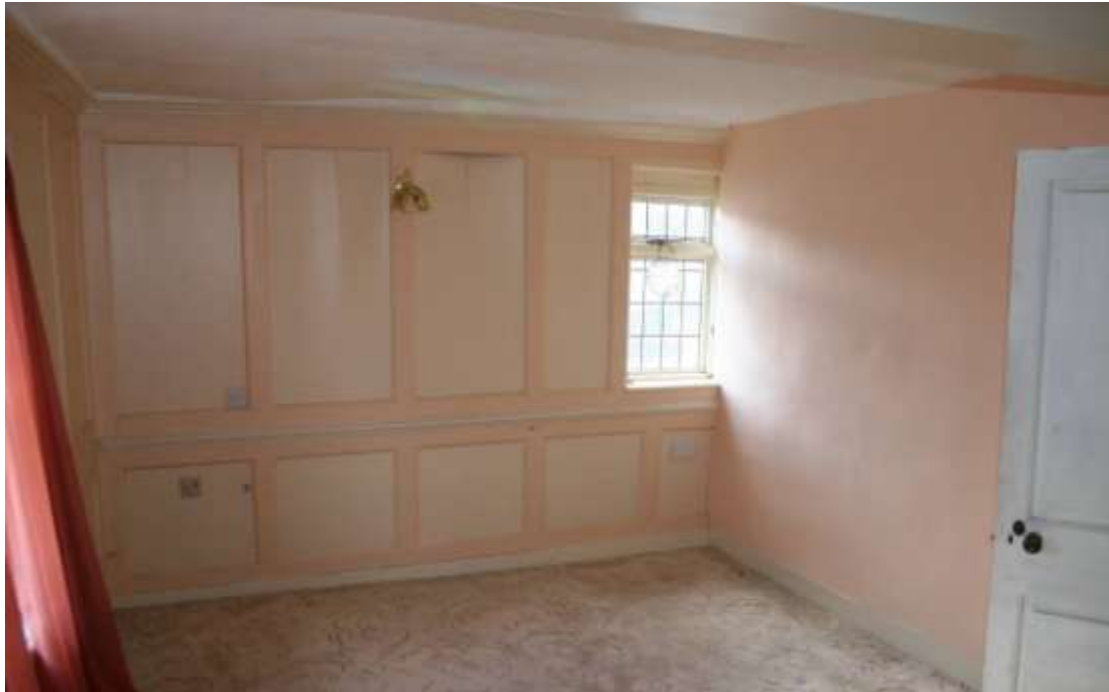
Looking SW in Bedroom 2. Note the window bisected by the inserted wall.

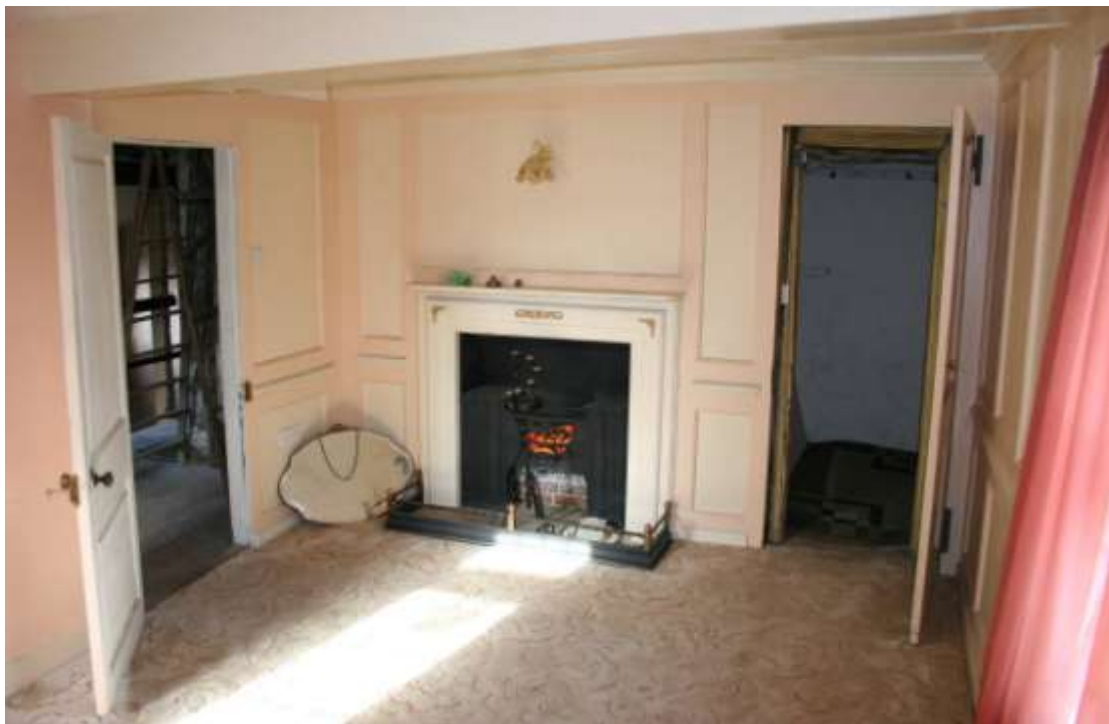
Looking N in Bedroom 2. The hobgrate appears genuine. Note the racked ceiling.

Bedroom 2 has authentic C18th or EC19th pine or oak wall panelling painted pink. An earlier scheme visible in the door frame to the closet indicates it was arsenic green. The fireplace is a hobgrate decorated in the Adams style and appears genuine.

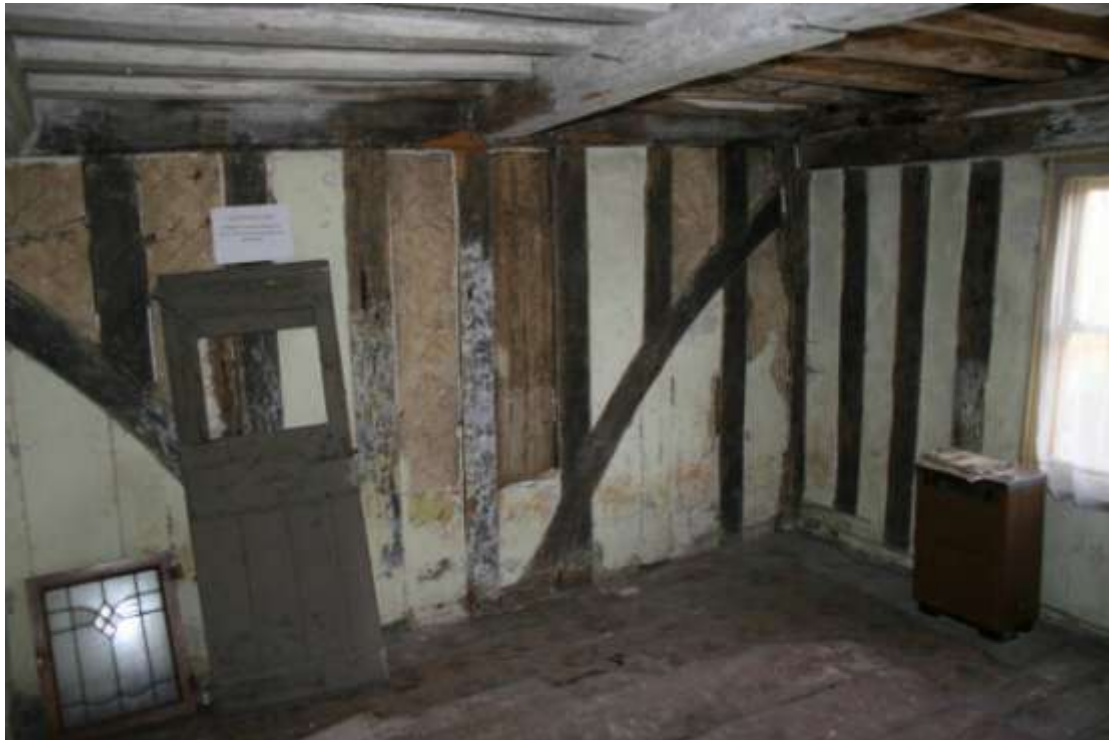
Looking NE in Bedroom 3. The walls retain their wattle and daub.

The scantling partition is lath and plastered on both sides but the original oak frame is exposed in the northern partition wall and still retains the wattle and daub panels which exhibit their structure. Horizontal ledgers split from branches are wedged in to the darts cut in the flanks of the studs. Vertical riven wattles are wedged in the grooves cut in the top and cill plates and then bound to the ledgers with bark withies. The panel was then packed with daub made from chalky boulder clay dug out of the garden and mixed with chopped straw and other organic material. This was then floated to a smooth finish and scribed with a diamond pattern to receive a lime render.
