49 Swan Street, Sible Hedingham, Essex. CO9 3RA.
Description and analysis of the timber-framed house. Surveyed 03 02 2014.

Scope of this Report

This report records the fabric and analyses the building to EH/RCHME Level 3 to inform the proposed works and mitigate any necessary changes to restore the building. The building is a prominent landmark in the village and the current owner Mr Brian Day aims to sensitively repair the building to maintain its current appearance.

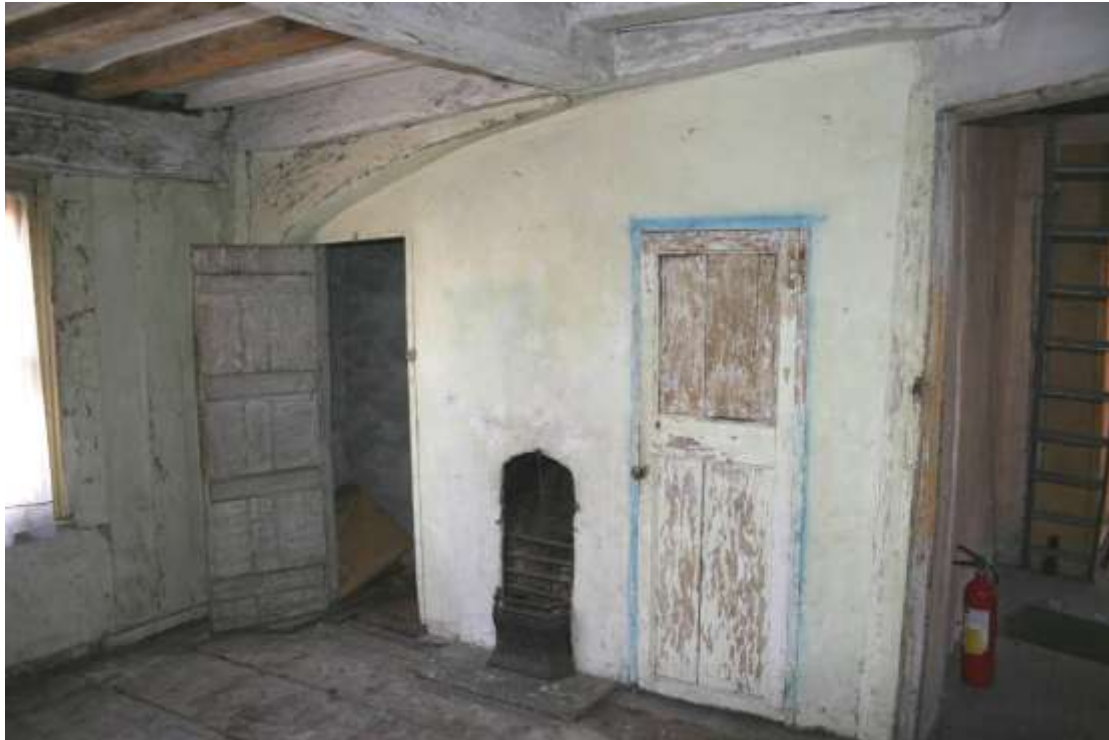
The fireplace has been altered in the C18th or EC19th.

By contrast the other end of the room has been rebuilt to incorporate a small bedroom fireplace (that has lost its surround and original grate) and a pair of closets. The whole has been plastered over. The closet doors are C18th in style and have H hinges nailed to the frames.

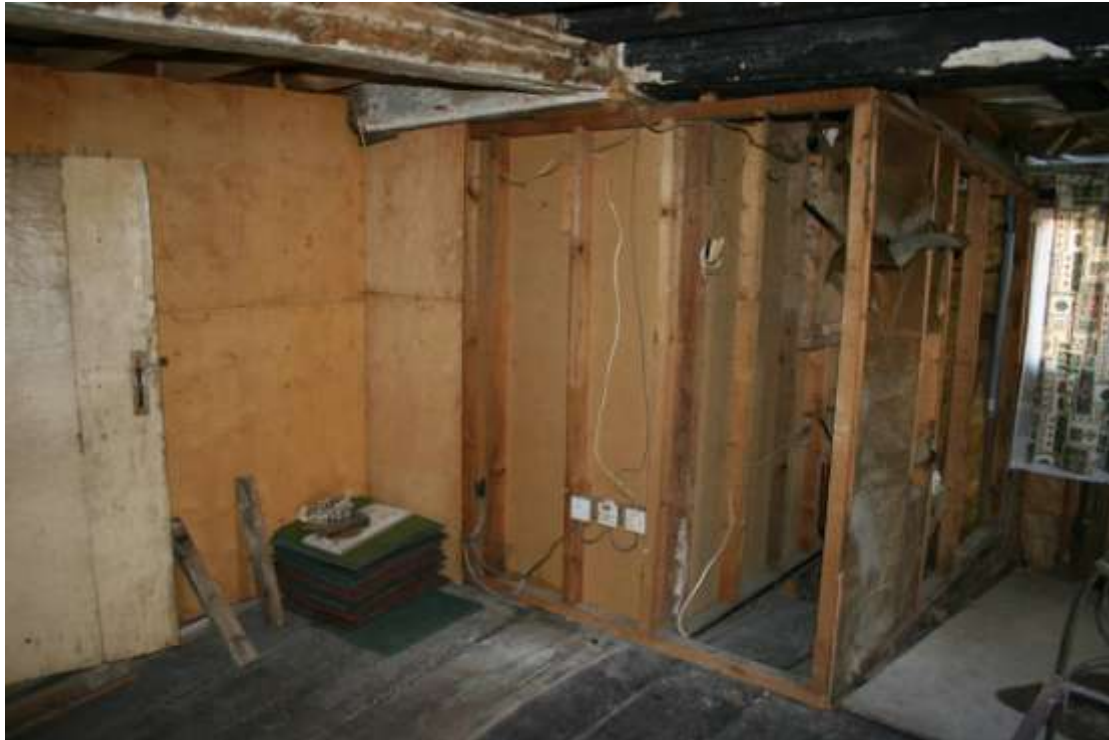
The axial beam and floorboards have mortices for earlier partition wall.

The bathroom was most likely constructed in the 1960's or early 1970's by Mr Brookes and later partly dismantled for redecoration. There is a series of small mortices in the floorboards and two larger ones in the axial joist of the ceiling to indicate the room was previously subdivided into smaller cells. The style of the design indicates this was done in the LC19th or EC20th when the house was divided into three dwellings. The decor of the room, part painted black part original implies the layout was retained at least until Mr Brookes ownership in the 1960's. The unpainted timbers are clearly axe finished and ceilings appear correctly framed.

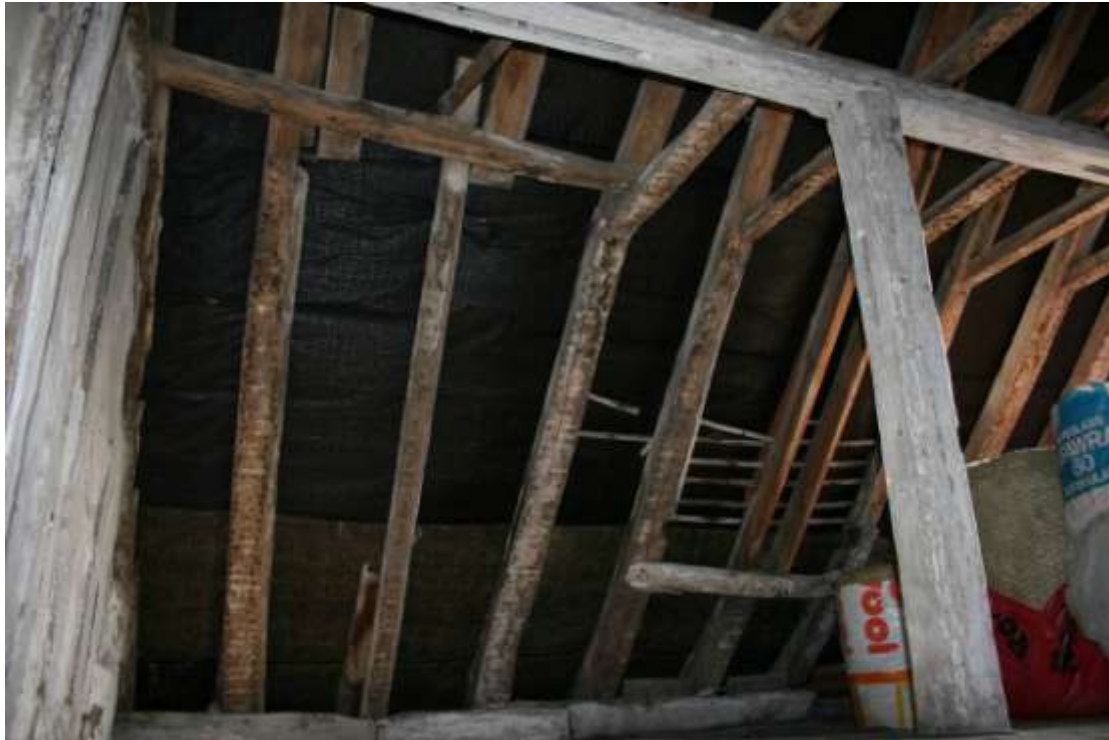
Looking SE at the roof structure in the South Attic. Note the trimmer beam for a window.

The roof is a collar purlin roof with a central purlin supported on a king post with two curving braces. In the South Attic the braces have been removed but they remain elsewhere. The collars are side lapped and pegged and the rafters paired and numbered.

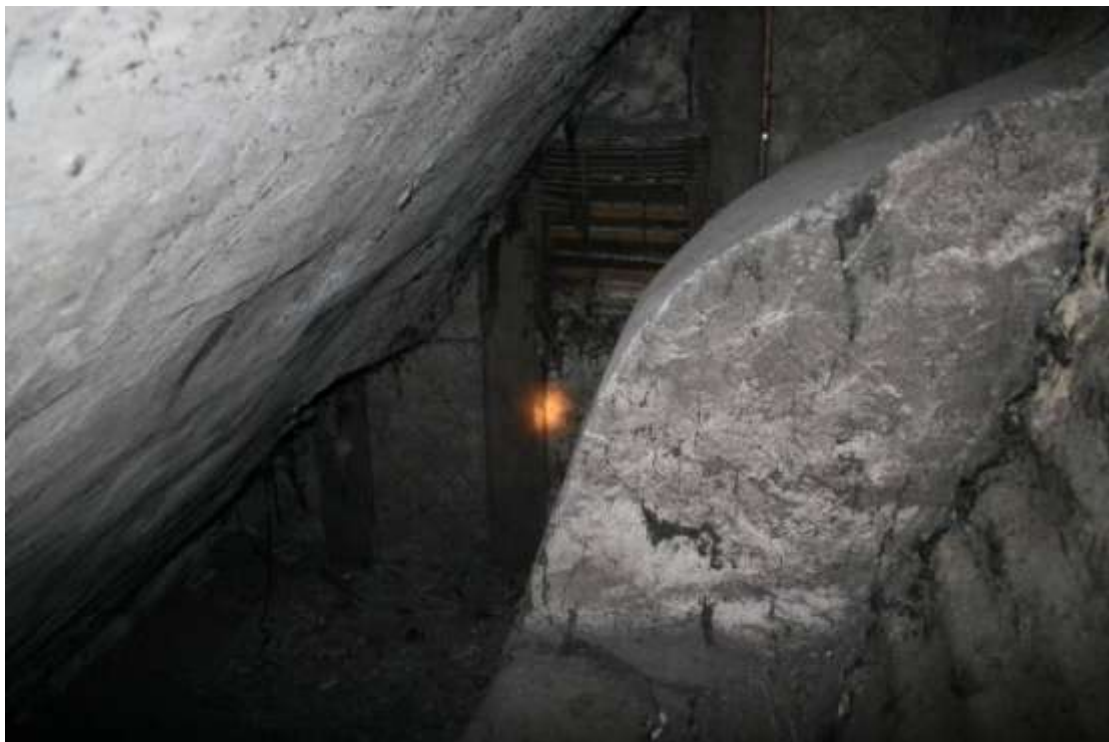
The SE side of the firestack. Note the two builds.

The two builds of the firestack can be seen in the bay between the attics. Also noted was the scratch coated wattle panels which are likely original to the house.

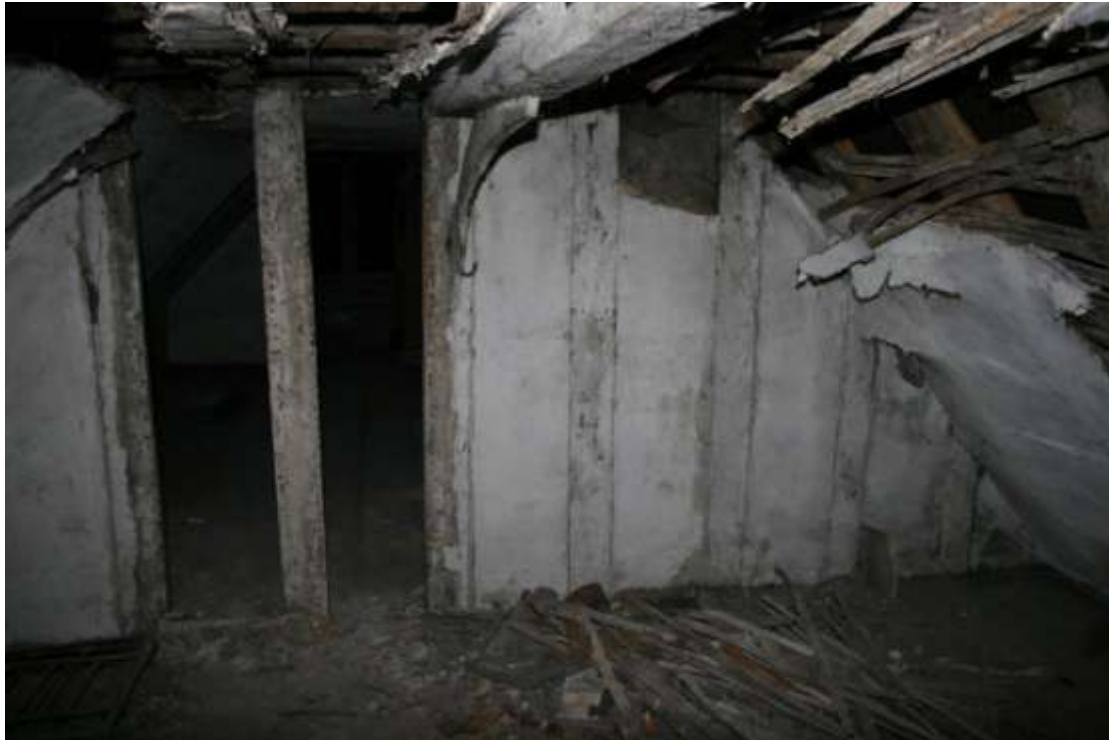
Looking N in the Central Attic. The lath and plaster has failed due to rusty nails.
