Creeksea Place Farm Barn, Ferry Road, Creeksea, Essex.
Description and analysis of a timber-framed barn at Creeksea Place Farm.
Surveyed 03 07 2009.

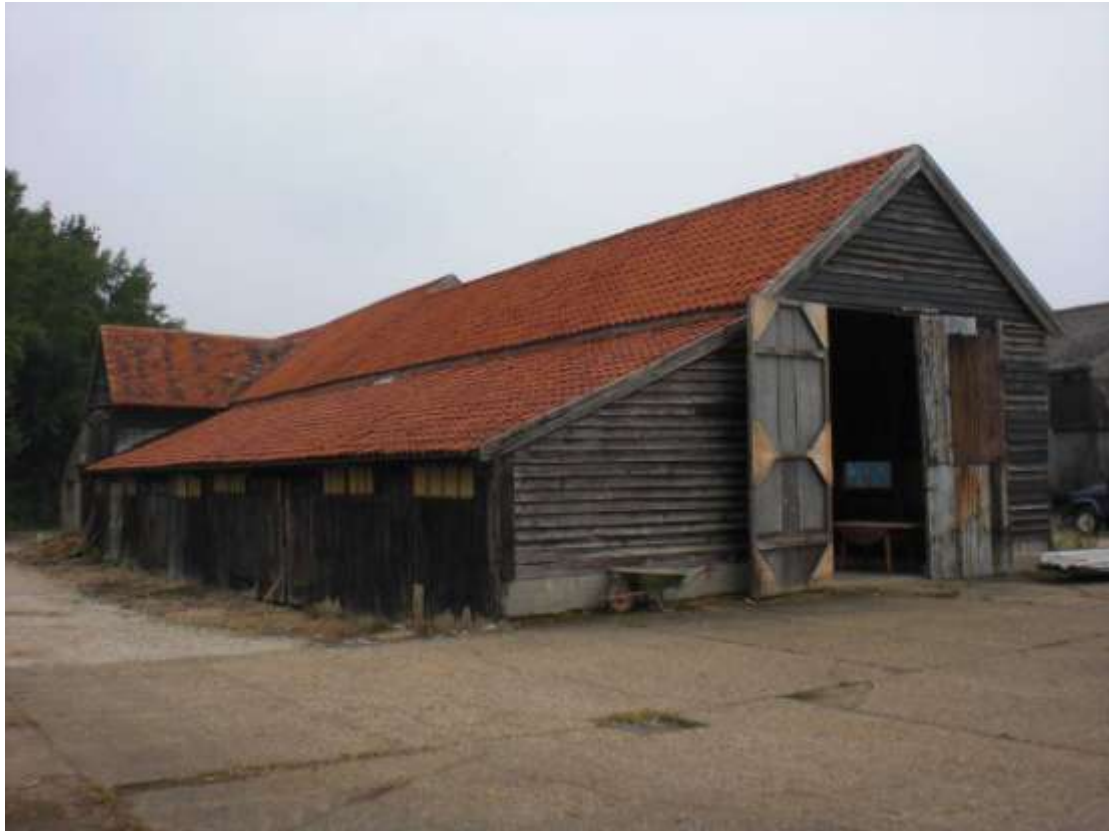
The Barn from the SE. Behind is an earlier timber barn. The Outshot is more modern.

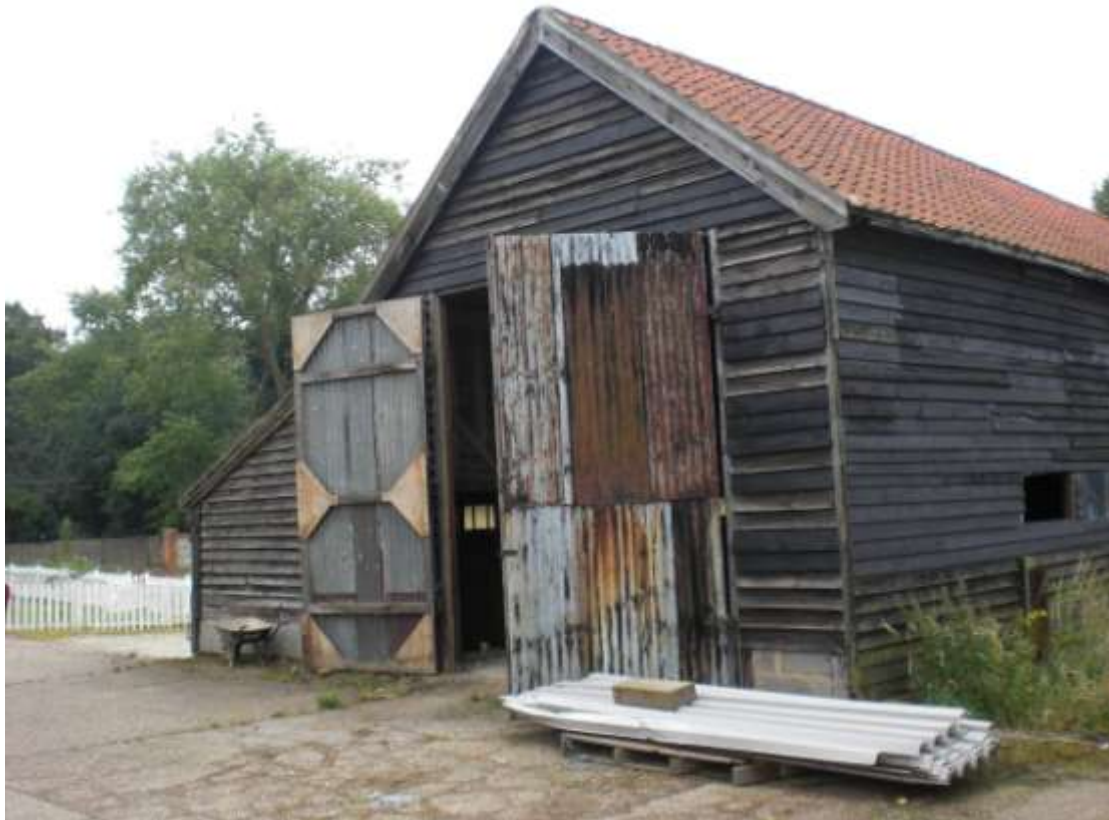
Eastern Elevation

Eastern elevation showing the C20th homemade doors. The cladding on the pallet lined the interior.

The eastern elevation comprises the Outshot flank and the gable end of the Barn which has been opened up to accommodate two 3.65m (12ft) tall barn doors made from corrugated iron sheets and marine ply in the past 20 or so years. The weather-boarding has been repaired recently but with only the newer feather-edged boards being cold tarred. The base of the walls has some modern blockwork inserted. The barge boards are C20th softwood.

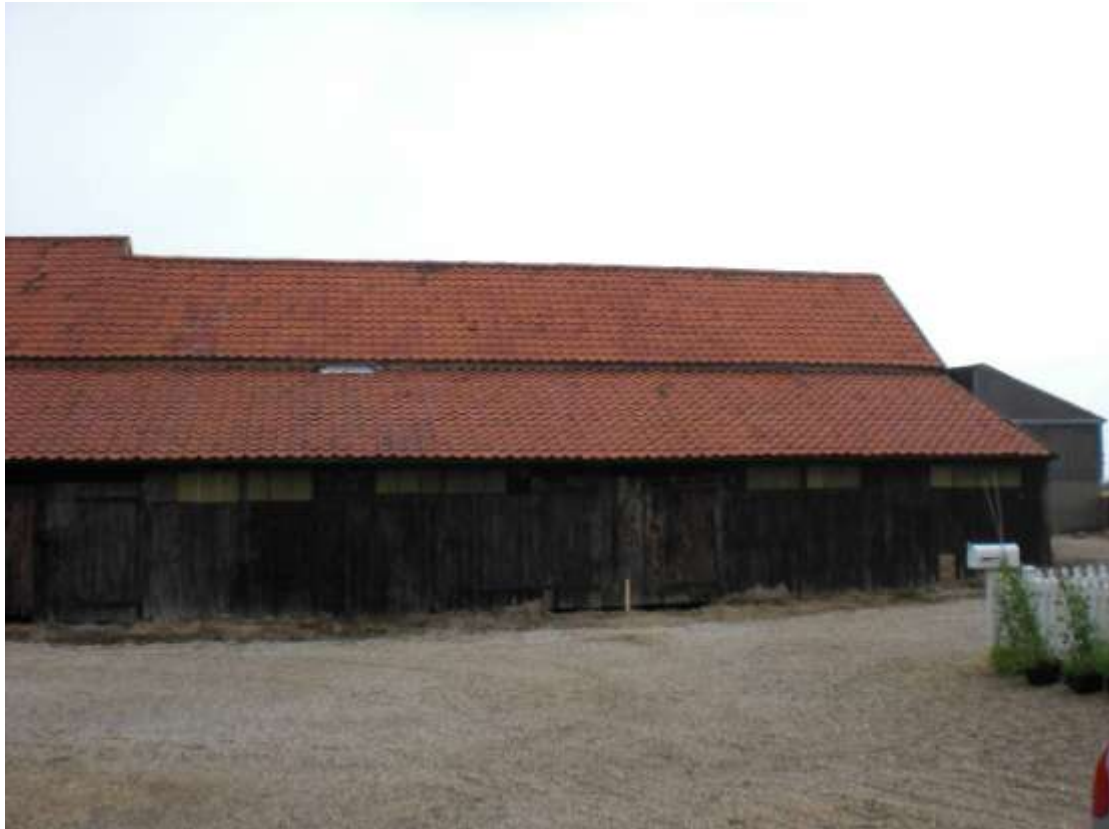
Southern Elevation

The southern elevation comprises an Outshot with vertically panelled walls.

The entire length of the southern elevation is taken up with a low-eaved Outshot with vertically boarded walls and simple C20th casement windows. The outshot has 7 bays with double doors in Bays 2 and 5 from the west. These are much altered late C19th or early C20th gate and ledger doors which have been dismantled and rehung on C20th door furniture. Bay 1 has a single C20th gate and ledger door that led into the Older Barn through a single bay lobby for which the partition wall has now been removed.

The Outshot was originally open between the posts and has been closed in with C20th timberwork and the vertical boards used as cladding. The guttering is plastic leading into square cast iron downpipes.

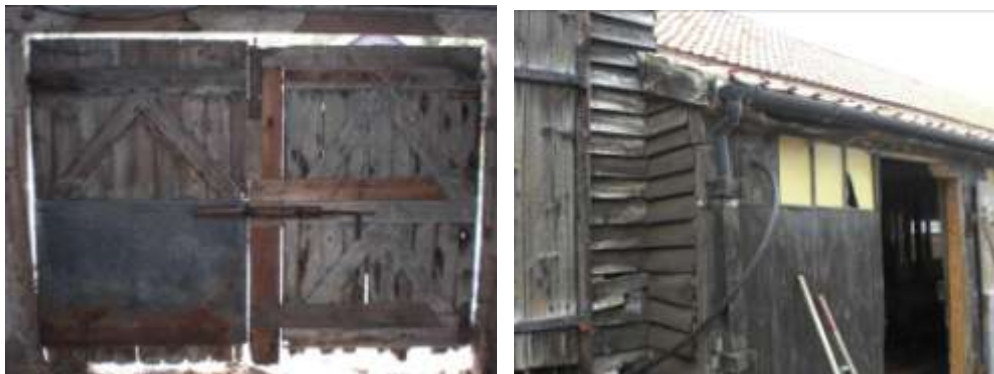
Reused doors and plastic C20th guttering with square downpipes on the SW corner of the Outshot.

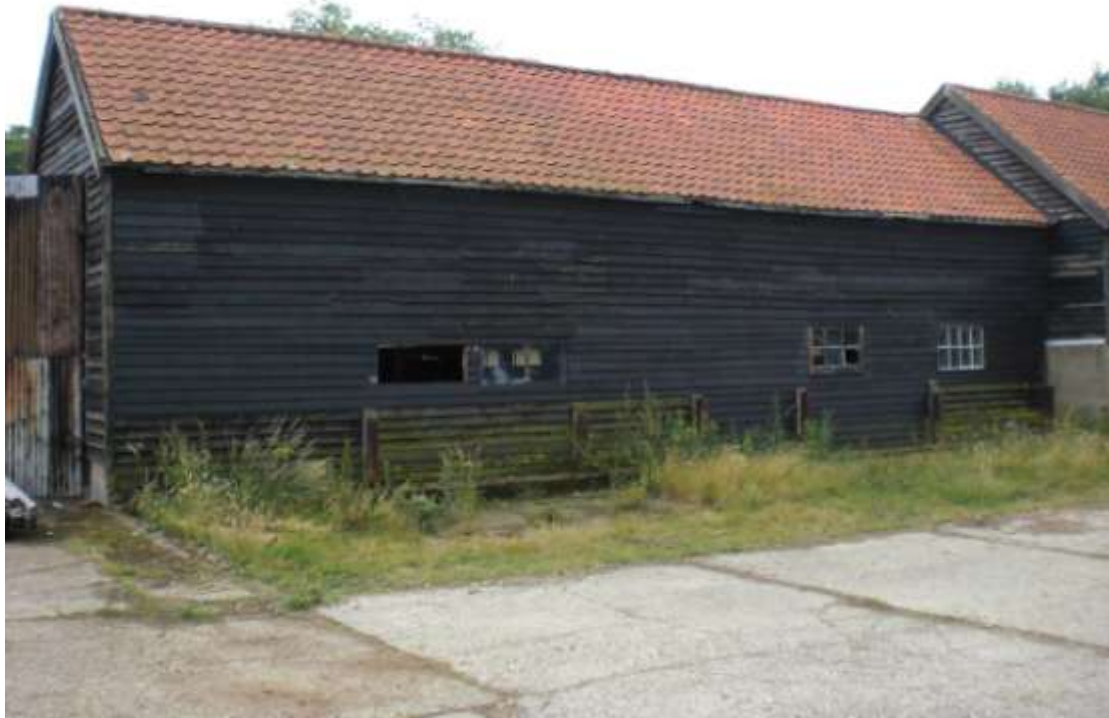
Northern Elevation.

The northern elevation has been recently reclad in feather edge boarding and the doorways blocked.

The northern elevation has been recently reboarded with new 7in feather-edge boards and cold tarred. On the inside it is more evident where the fresh wood has been left untreated. There is a section in the centre bay which indicates that there was a set of doors which have been removed and the void boarded over.

There are three sets of windows. That to the east is a simple modern effort made of nailed in softwood with plastic sheeting. The other two are made from reused frames from old windows, one of six lights from a casement set on its side and the other of 8 lights from a sash window. They are both set in recent frames.

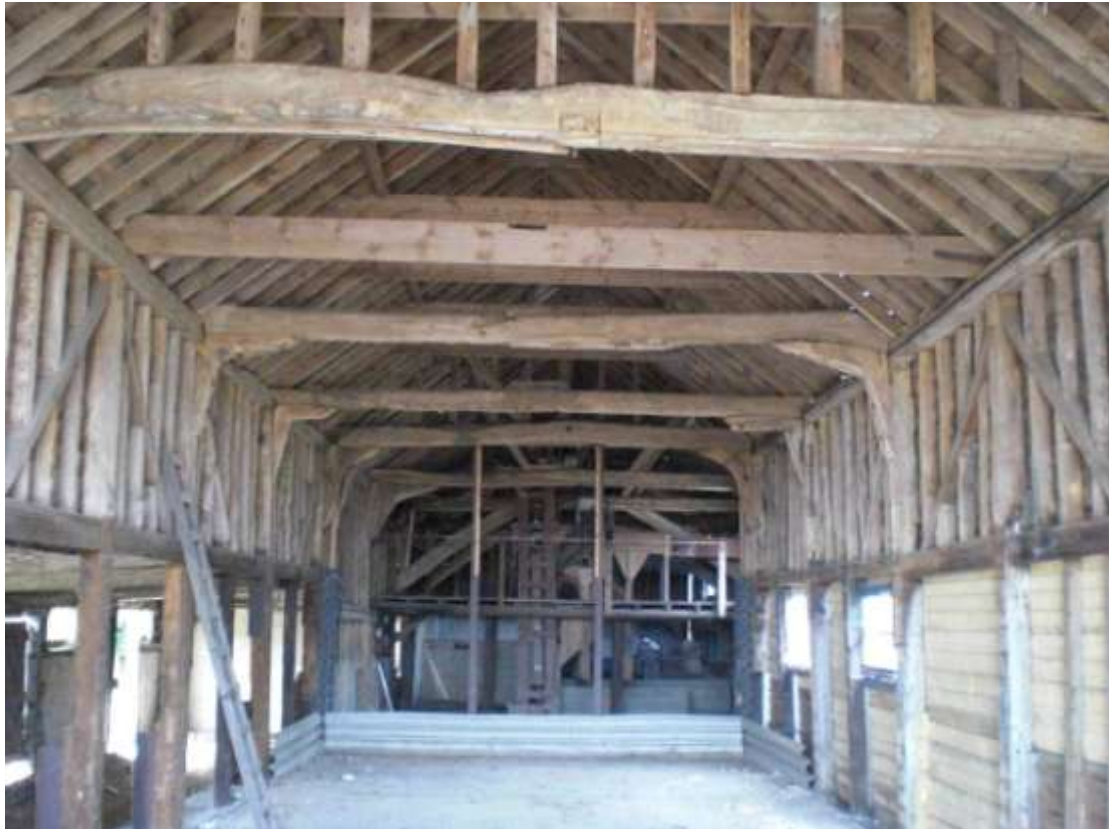
Western Elevation.

The western elevation can only be seen from inside the barn and has been largely removed.

The western elevation conjoins the Older Barn and the two buildings are bolted together through the tie beams and storey posts with wrought iron screw threaded bolts with flat square nuts typical of the turn of the C19th. Both tie beams have mortices for stud walls but all the timbers have been removed. A pair of steel joists have been inserted beneath the tie-beams. Until very recently the inside was clad with crenellated grain store panels fixed to steel angle irons which closed off the lower part of the barn.

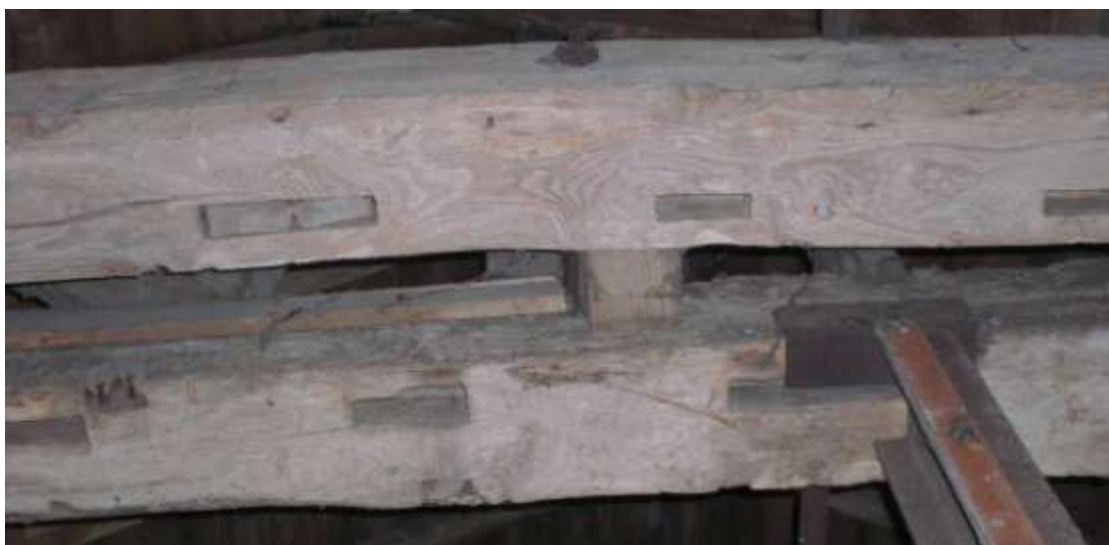
Underside of the tie-beams showing sawn off studs and wrought iron bolt with spacer. Looking W.

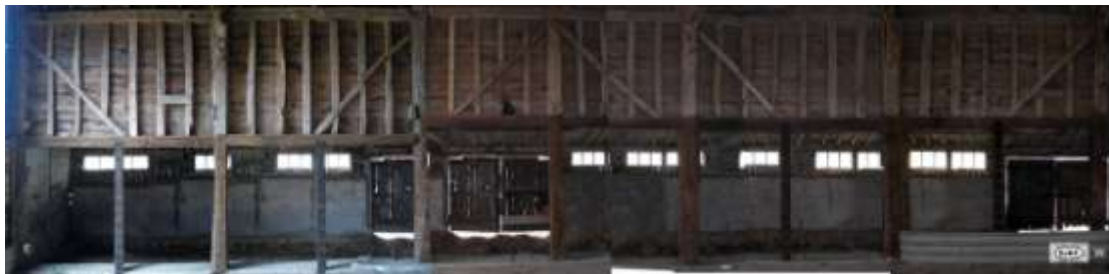
Composite photograph of the south side showing the raised midrails in darker coloured timber.

The mid-rail is not contiguous and it can be seen that it has been raised on the southern side in Bays 1-3. The line of the previous rails being demarcated by the original pegholes. As a result the panels above have been modelled with shorter studwork. The newer rails are red softwood and significantly, the mortices are marked out in pencil. In Bay 3 there is a door frame with a pentice board above on the outside of the barn. It is likely this section was once open for a midstrete porch or processing house.

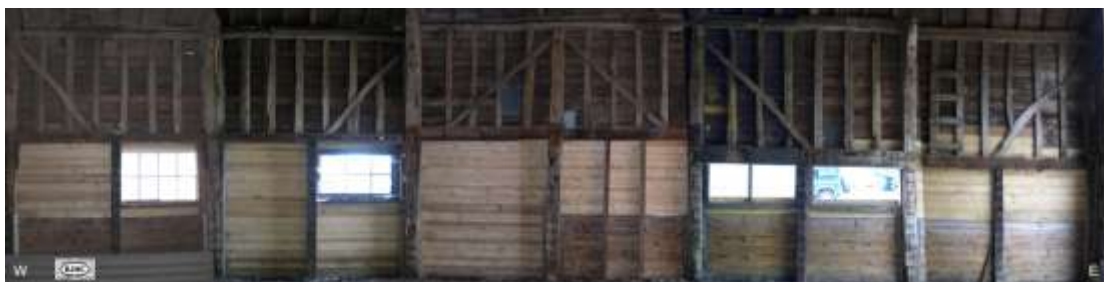
Composite photograph of the north side showing the raised midrail in the midstrete (Bay 3).

The mid-rail is also raised in Bay 3 on the northern side and it seem likely that there were also doors in this section although there is no easy evidence of fixings. This is because in common with all the posts the timbers are reused and have many earlier joints and holes cut in them. The raising of the top-plate indicates an effort to improve head height.

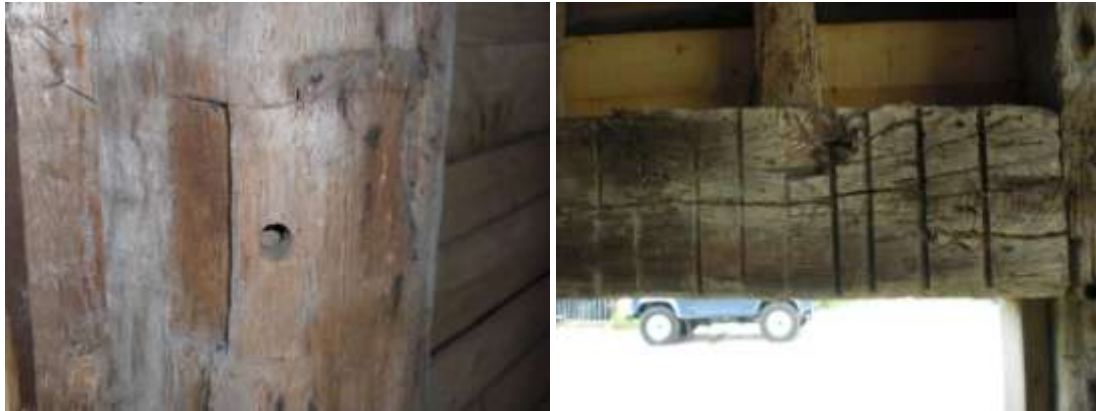
Storey post with pegged birdsmouth and oak beam reduced in section by sawing down.

Several posts are obviously top plates from earlier buildings with dovetails for tie-beams and birdsmouthed and pegged joints for rafters.

There is an interesting conversion of one of the timbers to form a mid-rail in Bay 3 north side. Evidently the oak beam was too thick in section so it has been reduced by sawing down many times at regular intervals and the excess wood chiselled roughly off.

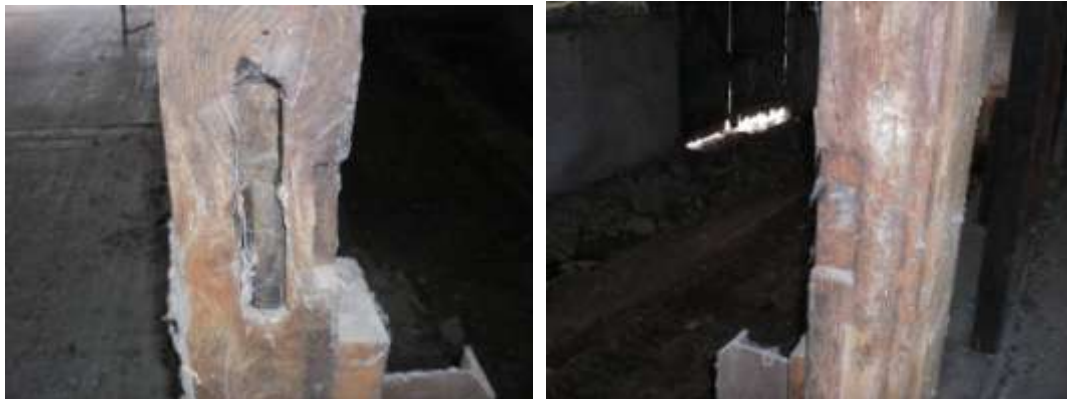
C19th bottle trapped inside the empty mortice (left) and the housing for a door bolt.

The posts in Bay 3 which form the doorframe on the southern side have mortices for the bolt and drop bar. Inside an empty mortice was trapped a late C19th style hexagonal glass medicine bottle with the instructions on the label to take 4 teaspoonfuls. The label was fragmentary so whether it was for human or animal consumption is unknown.

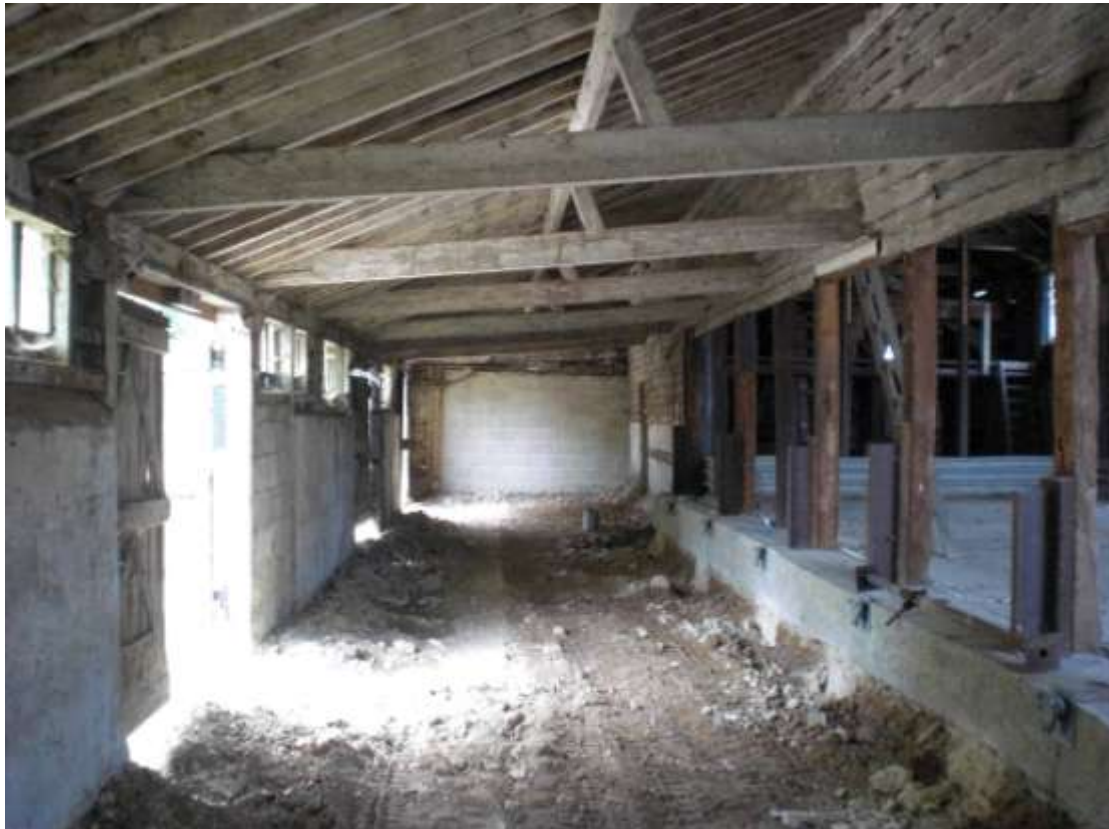
Roof structure of the Outshot looking west. Tie-beams support the simple purlin roof.

There are seven rafters in each of the eight bays measuring 2x4in (50 x 100mm) with the central ones being 3x4in (76 x 100mm). They rest on a central purlin 3x5in (76 x 127mm) which is held in position by short raking struts off the tie-beams.

Two of the tie-beams have merchants marks 'MAS' made in red paint visible on their northernmost ends. All the timbers including the internal weatherboarding have been limewashed several times.
