Coleraines, North Hill, Little Baddow, Chelmsford, Essex.

Description and analysis of the timber-framed Stables.

Surveyed 22 01 2010 by Barry Hillman-Crouch MSt PA DipFA BSc HND.

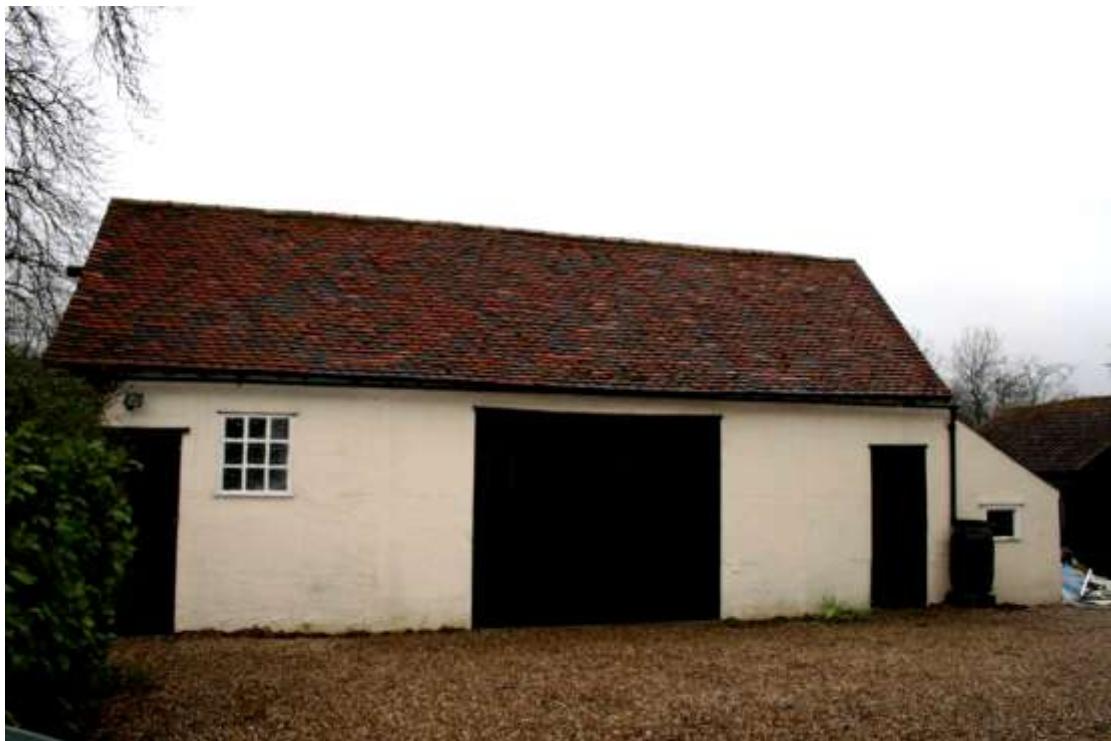
Southern Elevation

Southern elevation facing the house has two stable doors and central coach doors.

The southern elevation is asymmetrical about the central coach doors. There are stable doors positioned at each end to serve the horse stalls. The western stalls have an 8 light fixed window with heavy moulded timber astragals clearly visible on the inside but plastered over with putty on the outside. The glass appears old but is not crown glass. There is a small C20th fixed casement in the Outshot. There are drip courses in the pargetting over each door and window.

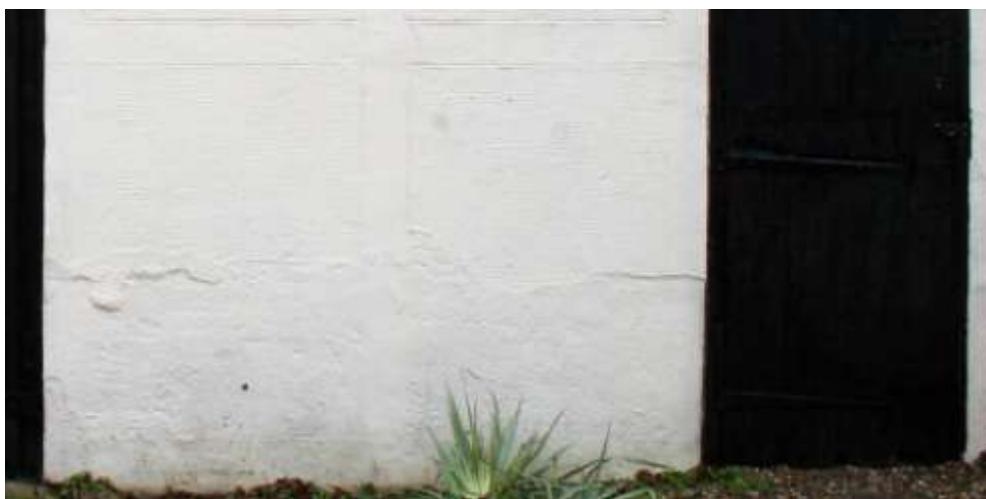
Two styles of pargetting are present on the wall between the coach and eastern stable doors.

From the inside it can be seen that the elevation is in fact weather-boarded and then pargetted over in two episodes. Most of the elevation is covered in a cementitious lime render, probably from when 10% white cement was a proscribed mix in the late C20th. However there is a section between the coach doors and the eastern stalls doors which is evidently earlier and to a different pattern. The later work is fielded in scribed panels and then dotted with a pointed roller in definite vertical strips. The earlier section is randomly imprinted using the end of a small cylinder leaving dozens of little circles.

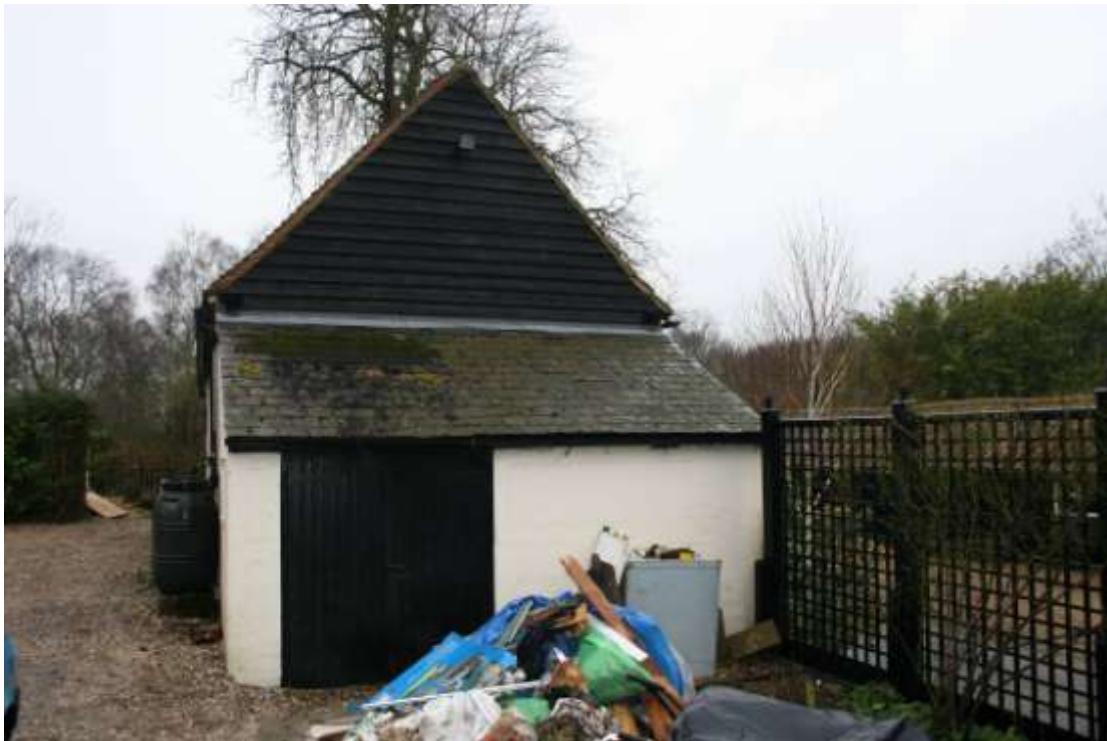
Eastern Elevation.

Eastern elevation showing the Outshot.

The eastern elevation displays the plain, weather-boarded gable end of the Stables above the simple grey slated pent roof of the Outshot. The mortar bedded verge looks fresh and in good condition. The boards are cold brushed, in good condition and the lead work is modern.

The double doors into the Outshot are late C20th softwood gate and ledger design. The brickwork is pargetted in fields with rollered dots to match the southern elevation. The grey slate roof is covered in moss and there are a number of broken and slipped slates. The rainwater gutter is painted metal and appears to vent onto the ground without a pipe.

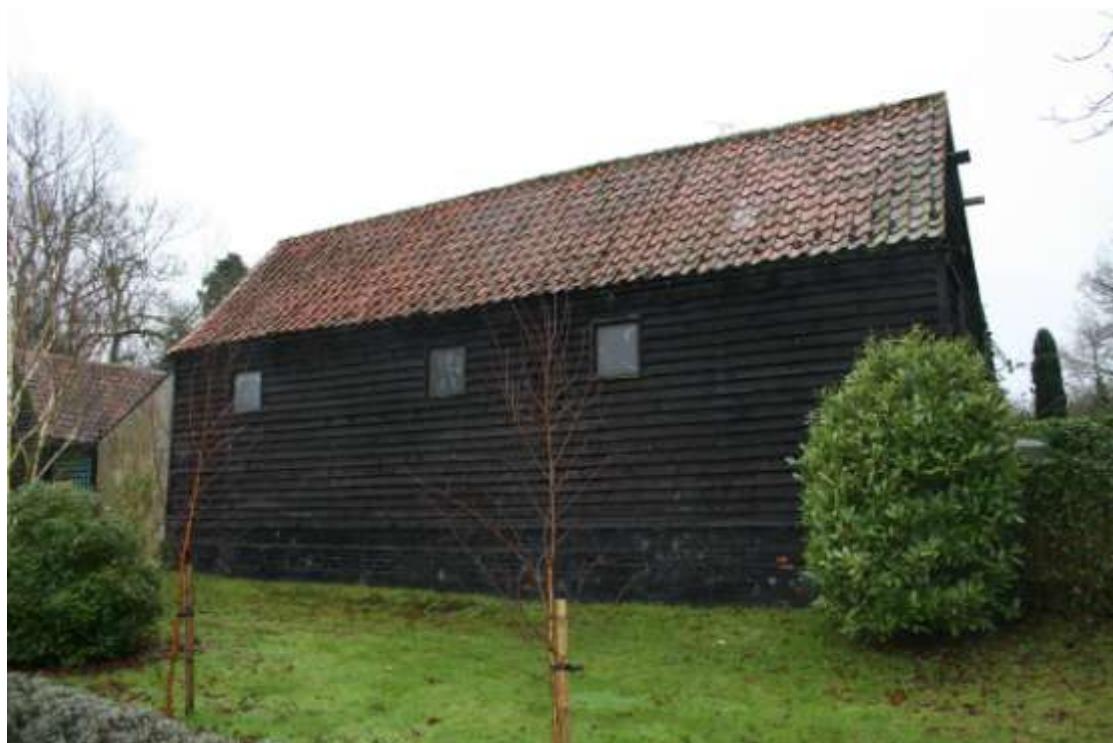
The Northern Elevation

The northern elevation has a pantiled roof and C20th/C21st cladding.

The northern elevation can only be viewed from the road or the neighbouring property. The timber-framed building is stood on an orange brick plinth heavily coated in hot tar. There are 8 lower courses of brick then a small step and 4 further courses. The bricks measure 55x110x220mm matching those in the plinths for the internal dividing walls. They are laid generally all as stretchers but there are a large number of bats giving a slightly random, vernacular appearance.

There are three plane, C20th square windows with softwood frames to light each bay. The weather-boarding is entirely late C20th or even early C21st and is marked up internally with BS numbers. It is fastened with modern French nails and has been cold tar brushed which has now worn thin.

The Outshot wall can be seen to be pargetted in the same manner as the rest but the paint has worn off indicating that the other elevations have been more recently decorated (probably to sell the house).

In contrast to the northern elevation the roof is clad in orange pantiles. The rainwater gutter is of painted metal and has been recently repaired with bright galvanised brackets.

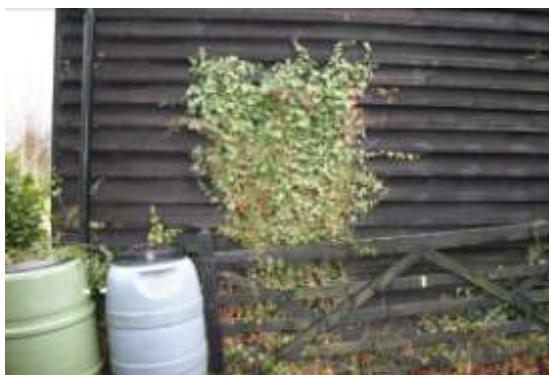
The ivy covered door and water butts.

The door has been completely covered by ivy on the outside. There is a broken gate that has been laid across the doorway. The rainwater pipe is in painted metal and feeds into two water butts.

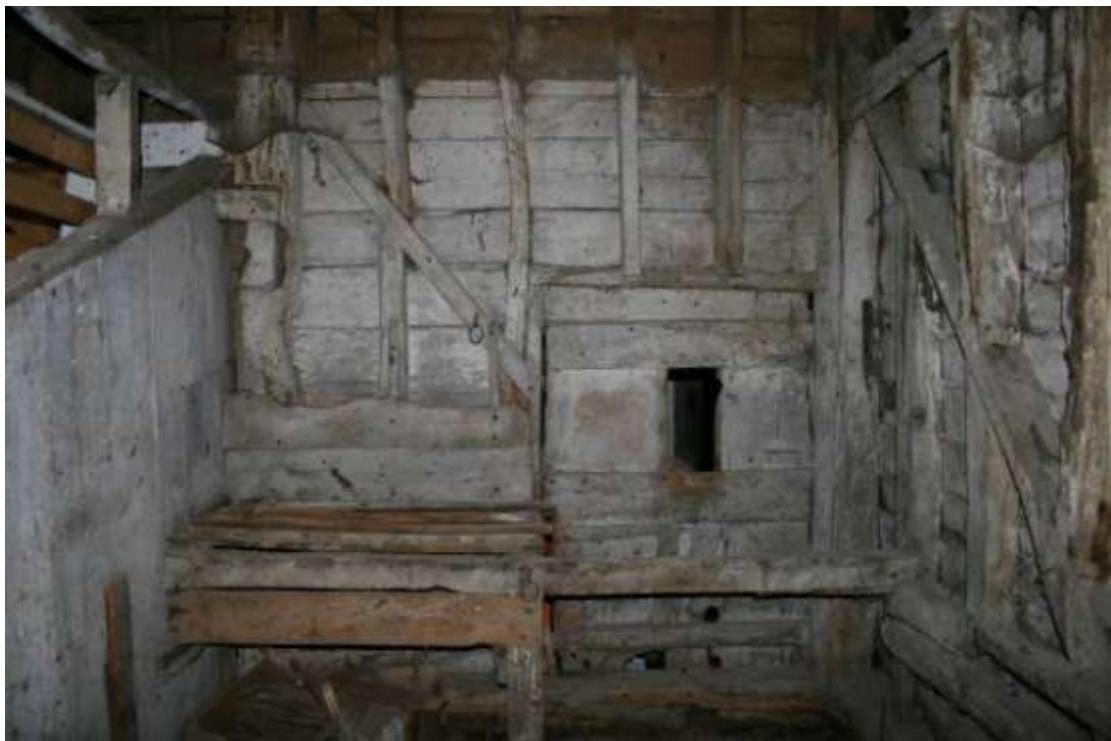
The southernmost of the two horse standings in the western stalls. Feed trough and rail. Looking east.

The carpentry in the Western Stalls typifies the whole building. All the principal timbers, the posts and plates are of reused timber from earlier buildings. The joints are unjowled. They are strengthened with primary bracing to which the interrupted studwork is fastened with wrought iron nails. Some of the studs are cut from reused timber but in the main they are fresh scantling that has been squared in the saw mill although some still bear the marks of the pit saw. There are quite a few quarter poles squared only on two sides.

On the inside of the frame are nailed half tree-trunks and various strakes to act as kick boarding for the horses. The room is divided down the centre with a large studwork partition clad in vertical one inch thick oak boards of up to 11 inches wide. On either side of the partition are the remains of two feed troughs which appear to have originally stretched right across the width of each stall. However each one has been modified so that only half of the trough remains although the front rail continues across the stall.

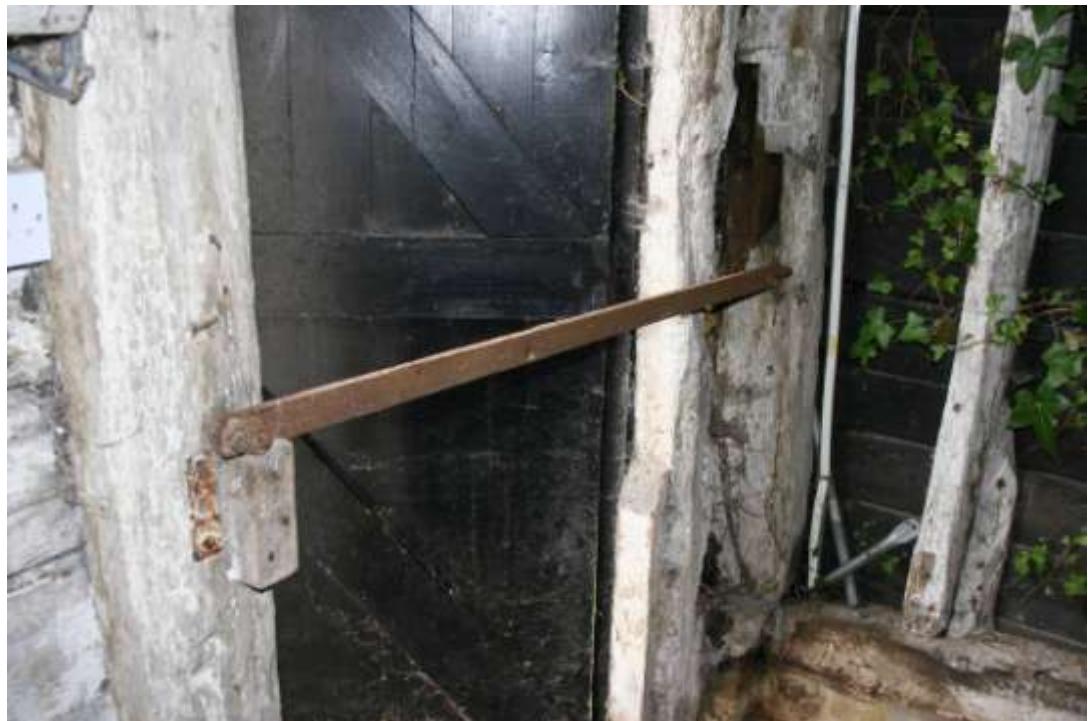
The iron drop bar originally screwed into a fitting on the door jamb which has now pulled out.
Looking SW.

The reason for putting this in can be surmised by looking at the main door which has a large iron drop bar fastened with a large staple into the corner post. The drop bar was originally fastened with a screw thread into a socket on the door jamb. It would be very difficult to screw this in using a socket wrench from the outside so it seems more likely the door was barred from the inside and the ostler left the stalls through the coach bay door.

When the post pulled out and the bar could no longer be screwed in place a makeshift drop socket made out of wood was nailed in place. The bar itself is made of two strips of milled iron but is so corroded that it could be mild steel which would date it to after 1856.

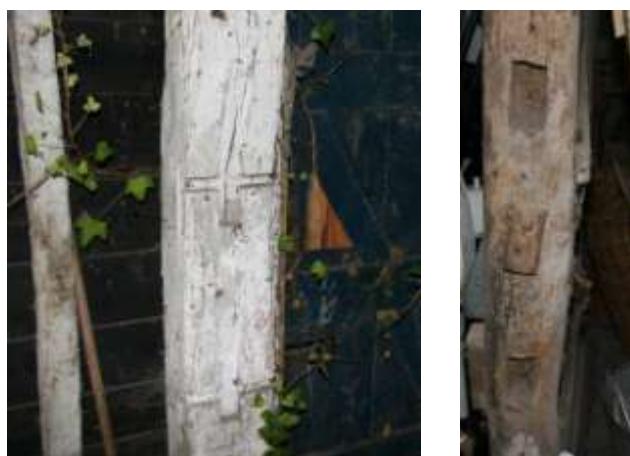
Cut-outs for the drop bars in the principal post (left) and the partition post to divide the stalls.

The stalls were not only divided by the planked partition but also by two timber-drop bars now missing. The sockets for the bars are evident in the end post of the partition and also in the principal post in the middle of the western wall. Here it can be seen that the bars were dropped in on an arc and then secured with a strap or plate through slots cut horizontally in the timber. This allowed one of the horses to be walked into the rear stall and then secured from walking out again.

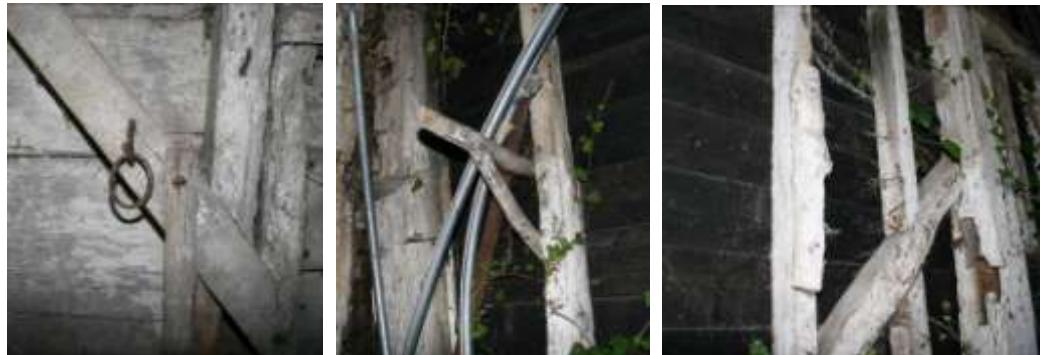
Tie ring (left) over the feed trough and harness trees on the western wall.

There are a number of iron tie rings made of slender round section iron, much worn from constant chafing. Their small size suggests that small horses were kept here. On the southern wall there is a vernacular harness tree made of quite thin sticks would have only supported lightweight tack. There is also however the lower part of a much more robust harness tree nailed to the centre of the wall and this may have held the collar for a plough horse. It is too high to put a saddle on. There is no sign of the bespoke hangers, bridle rests, whip reels and the like beloved of the Victorian equestrians.

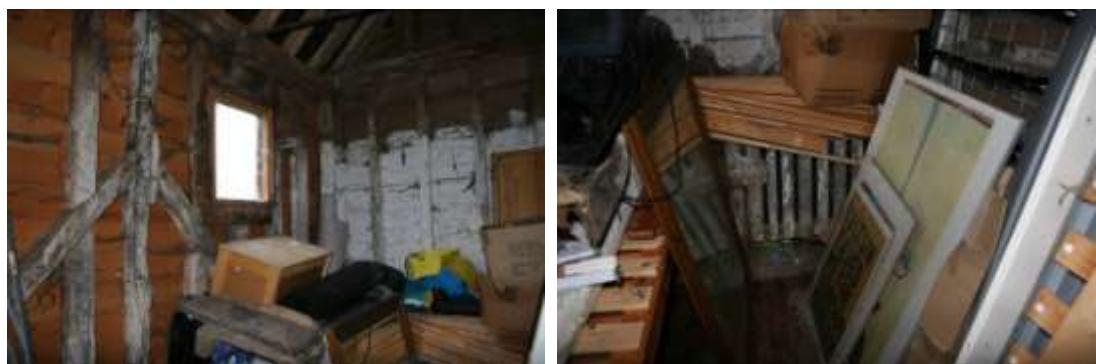
The northern stall was being used as a store but the half feed trough (right) could be seen.

At the time of the survey the northernmost stall was being used to store private possessions and the feed trough was buried under boxes and everyday items. It was however possible to excavate the feed trough to note that it was the reflection of the other one with a rail that spanned the bay. There was also the addition of a series of vertical battens on the front to prevent the horse getting its hooves under the trough. Unlike the other side there was no sign of a door into the coach house and on the other side of the wall the boarding could be seen to carry right across.

It is likely that in latter years there was a water trough inserted into the empty halves of the feed troughs. In the SE corner there is a galvanised water pipe which has been blocked off with a modern screw fitting which could have supplied them.

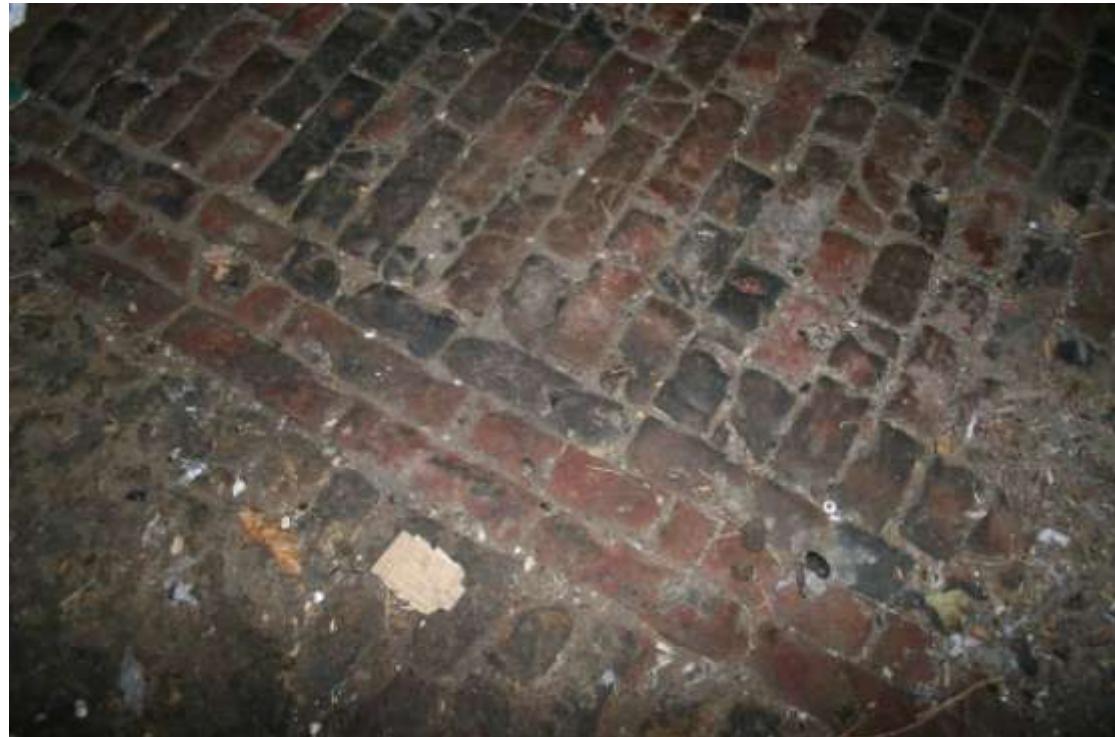
Well made brick floor with built in gulley. Note patchy concrete to the left.

The floor of the stalls is carefully laid with 60x100x210mm hard red and purple paving bricks on edge arranged to drain into a gulley that passes across the floor from the entrance door to the northern wall. The vent for the gulley has been lost when the building was repaired in the C20th. Concrete has been spread over the bricks near the door and has subsequently worn away.

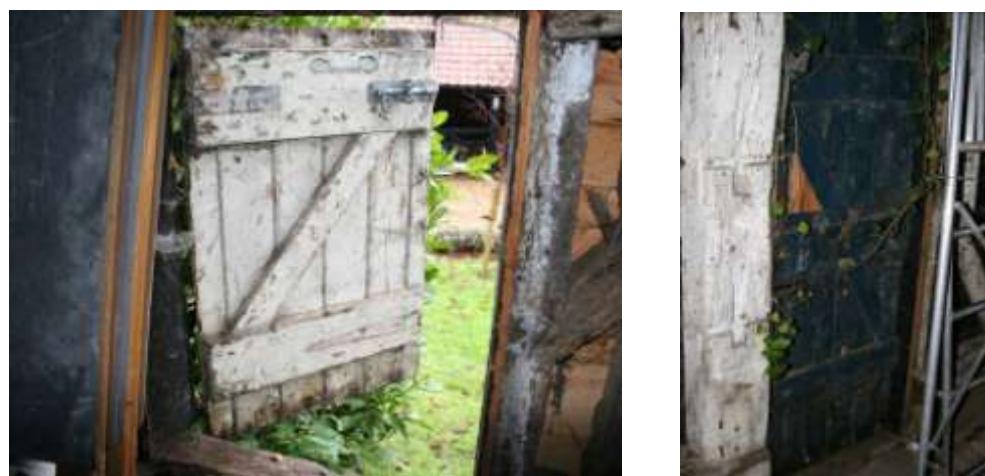
Small hatch door in the north wall (left) and gate and ledger door in the west wall. Both C20th.

Adjacent to where the gulley should pass out of the building is a small C20th gate and ledger hatch door with vertical softwood boards. The modern hinges and lock have been reversed. In the western wall there is a C20th gate and ledger door with vertical softwood boards. The mild steel fittings are fastened with Phillips head screws and the small nailed on drop box is made of C20th scrap wood. The outside of the door is engulfed in ivy and evidently hasn't been opened for some years.

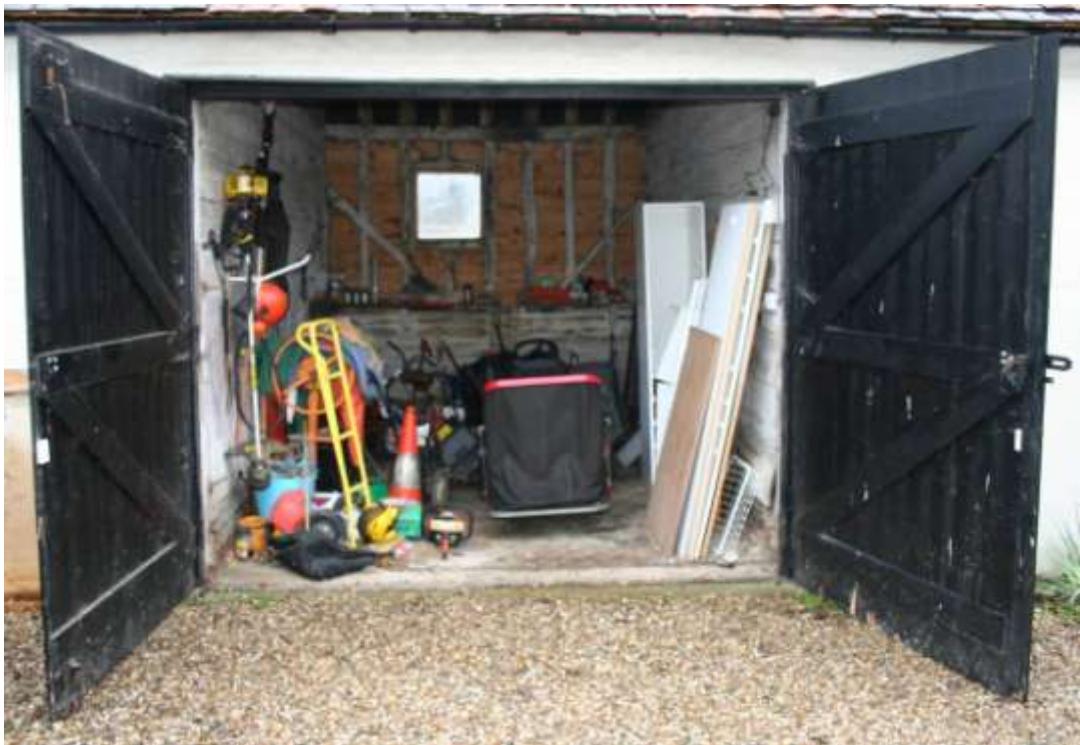
The Coach Bay is currently used as an equipment store.

The centre bay was evidently used to store the coach. This can be confidently stated because of the wide double doors and the fact that there are no fittings whatsoever inside. The interrupted studwork can be clearly seen in the north wall where the exterior cladding has been replaced in the late C20th and a C20th plain glass light is set in the original frame position. The lower part of the north wall is clad inside with C20th tongue and groove fastened with French nails and there are two makeshift shelves similarly nailed. Most likely this was put in when the Coach Bay became a garage.

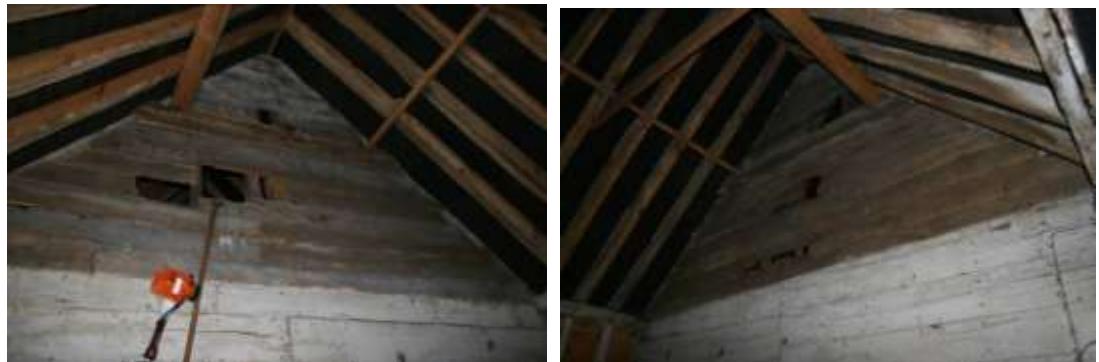
The west (left) and east walls of the Coach Bay clad in mill sawn boards and whitewashed to the eaves.

The east and west walls are clad to the apex with heavy, mill sawn variable width plain boarding fastened with rose headed wrought iron nails. Mostly 11 to 12in wide the boards are edge-butted up to eaves height where they are then overlapped like feather edge boards. Coincidentally the room is white washed to eaves height all round on the original boards - a feature common to all the bays.

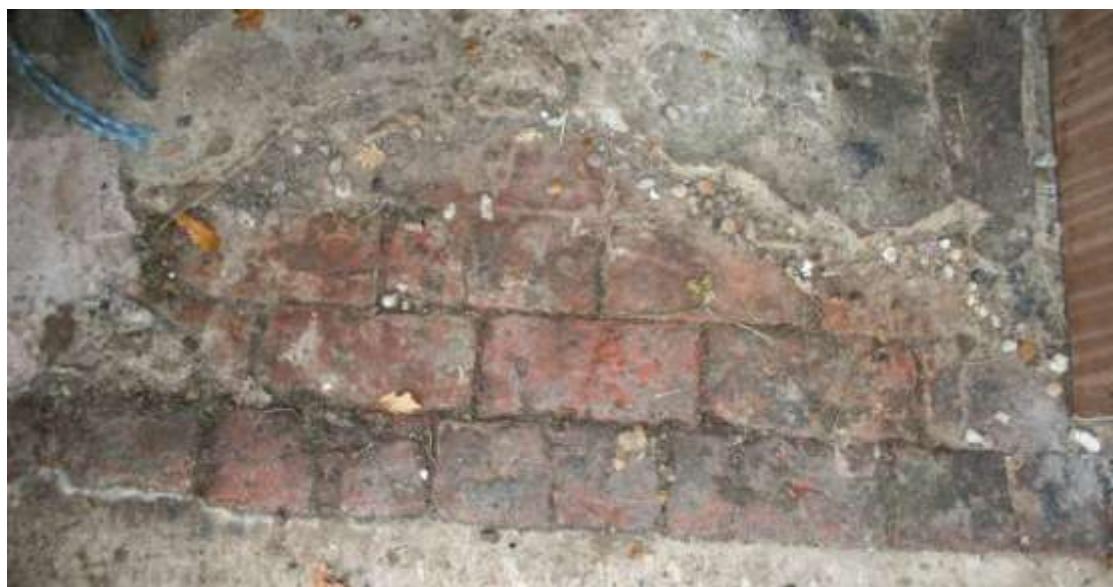
The brick floor is mostly covered in cement.

The floor is mostly washed over with a thin layer of cement but some of the original brick floor is visible at the threshold. The bricks are similar hard red and purples to those in the stalls but are slightly larger at 110x220mm (the thickness could not be measured). The bricks are laid on their flats rather than their edges as in the other bays.

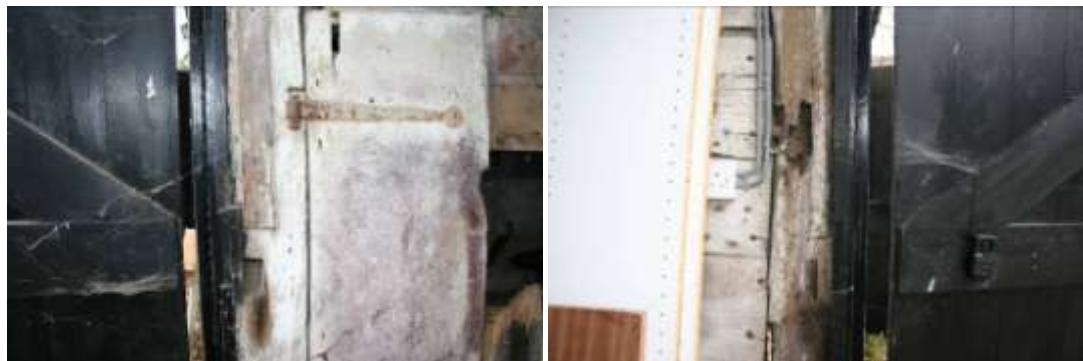
The door jambs to the coach bay have sockets for drop bars.

The Coach Bay doors are late C20th softwood replacements hung on the original hand wrought iron pintle hinges. In the door jambs can be seen the sockets for the drop bar to secure the doors against the wind. There are also some redundant mortices from the original use of the timber.

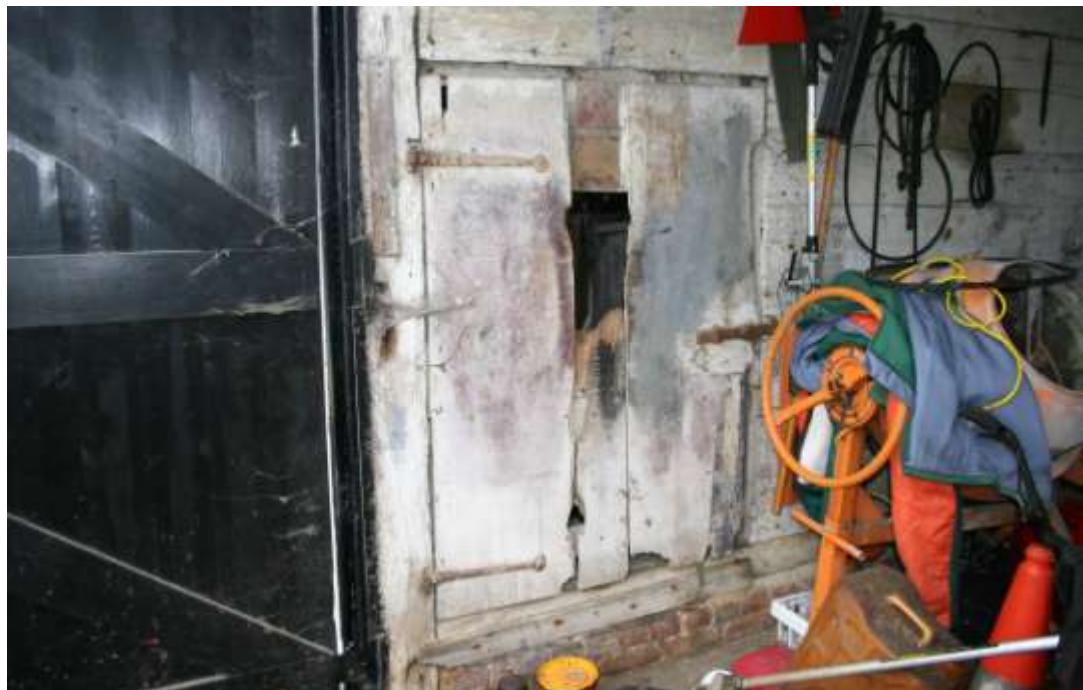
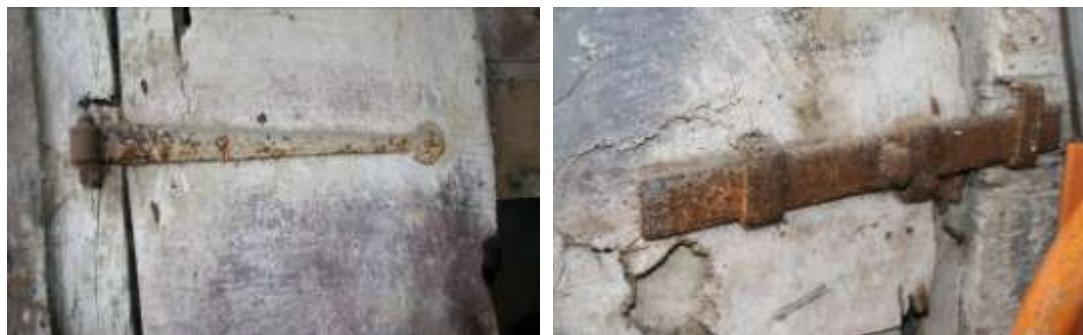
The small door into the Western Stalls from the Coach Bay.

Hand wrought strap hinges (left) and flat bar bolt on the small internal door. NTS.

In the western wall is the small door into the Western Stalls. It is made of very wide 16-18in boards and hung on pintles with hand wrought iron straps with spooned terminals. There is a milled iron flat bolt fastened with square sectioned staples which is so rusty it may very well be mild steel. The door is smeared with oil paint and it is likely that it was used as a testing palette before the paint was applied to the coach or other machinery.

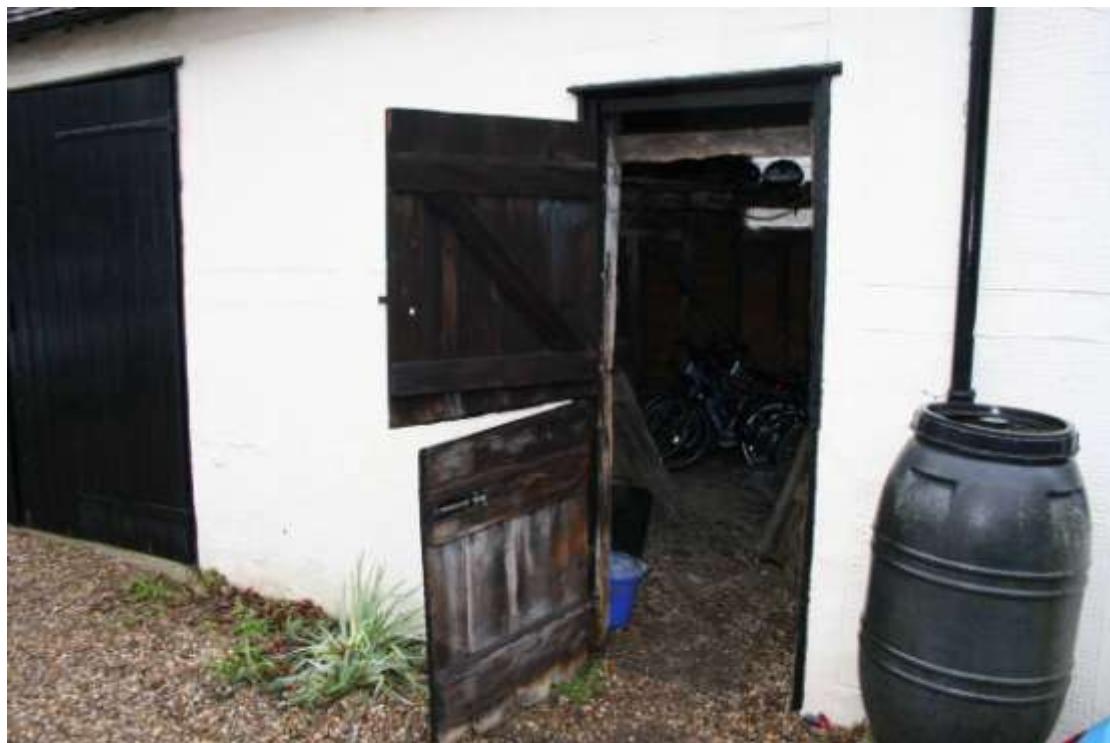
The Eastern Stalls are currently used as a wood store and bike shed.

The Eastern Stalls is markedly different in interior layout and materials used in its construction from the Western Stalls. There was an inserted floor of which the axial joist and only the four edge joists remain. This was supported on nailed in cheek pieces and afterwards reinforced off an unusual timber structure made of machined softwood.

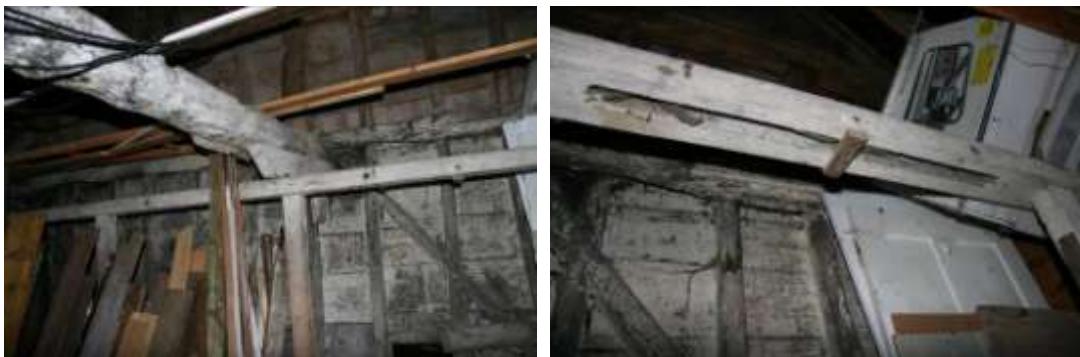
The axial joist for the inserted floor is then later supported on a slotted (right) softwood frame.

The axial joist is a rustic pole that was rebated to accept the waney joists which were then nailed in. The machined frame formed a kind of large cabinet in which two long, round ended slots must have allowed sliding shutters to have been moved up and down. It has since been dismantled but it does resemble a hen coop. The removed floor is a little over head height and was reached by a rather vernacular ladder composed of rungs nailed to the eastern wall near the door.

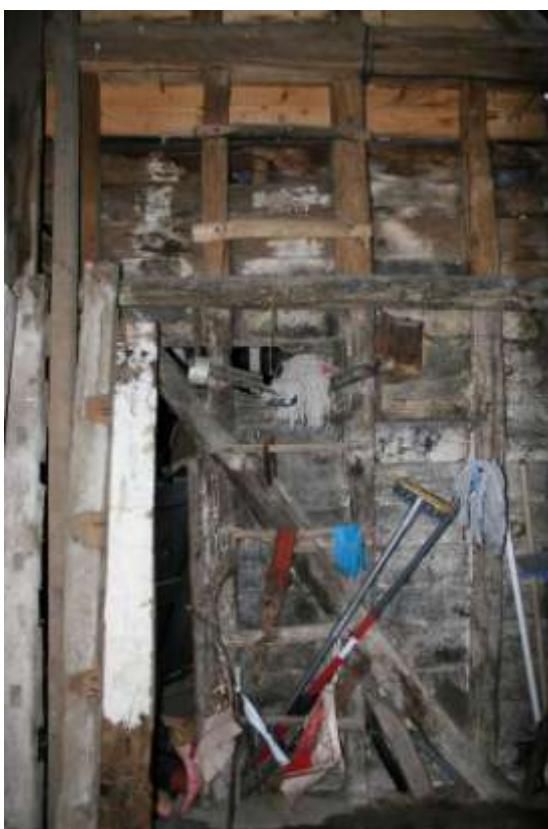
Loft floor ladder nailed to the studs of the eastern wall now used as rack.

The two upper most rungs are likely original being wide, hand hewn half poles nailed with wrought iron nails. The others are later additions and two are the narrow rails from a manger, scarcely able to bear weight and have been put in to hang things on. These are fastened with French nails. Adjacent is a very old electrical isolator switch with wooden backing plate.

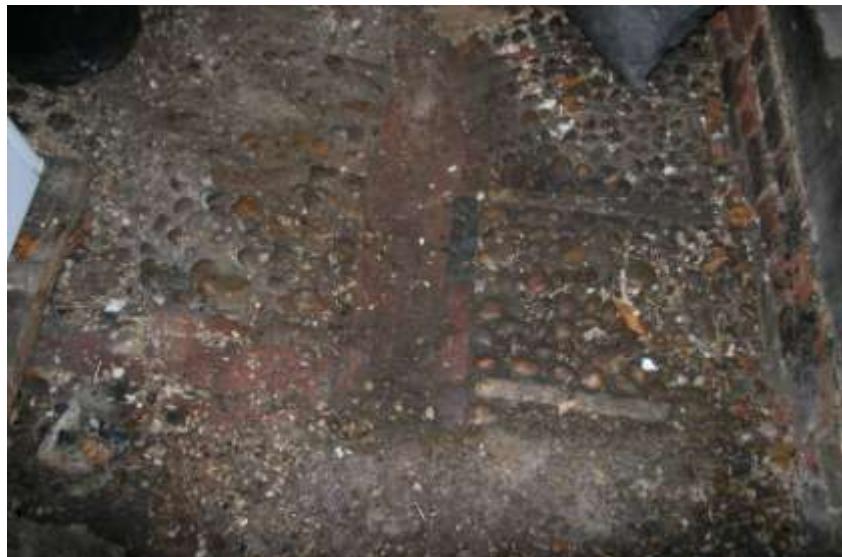
The floor is made up of panels of pebbles divided by brickwork.

A drainage gully is made up of the same 60x100x210mm hard red and purple paving bricks on edge as elsewhere. The pebble fields are divided by white gault bricks of the same dimensions. The pebbles range in size from about 30mm to 100mm and appear to be set in asphalt. It must be assumed only the tips of the pebbles can be seen on the surface otherwise they would soon be displaced.

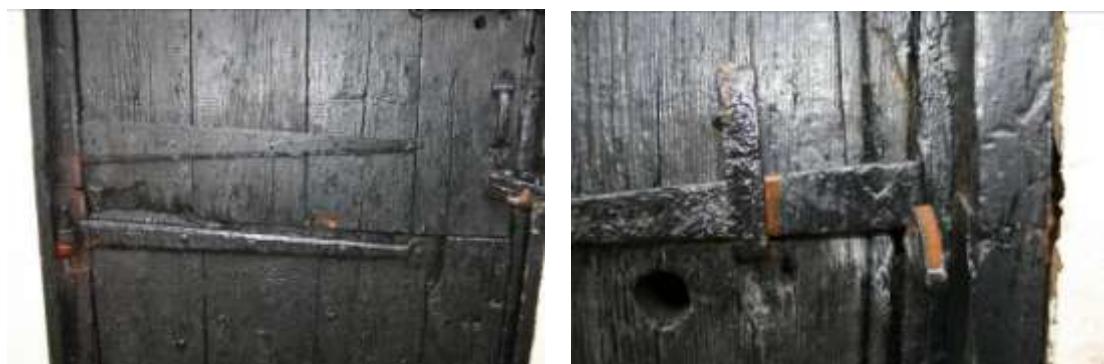
The eastern stalls doors. The lower leaf is original with its fittings. The latch is also early.

The eastern stalls door is the split stable type with the upper leaf being a C20th softwood replacement with screwed on mild steel T-strap hinges and padlock hasp. However the pull handle and drop latch and catch are probably the originals reused. The latch has the saltire cross stamped into it to ward off evil.

The lower leaf is original and retains its hand wrought iron strap pintle hinges with spooned terminals. The lower leaf is coated in hot tar whereas the rest of the doors are painted in modern cold brushing tar. The window is a C20th plain glass casement set in the original frame position.

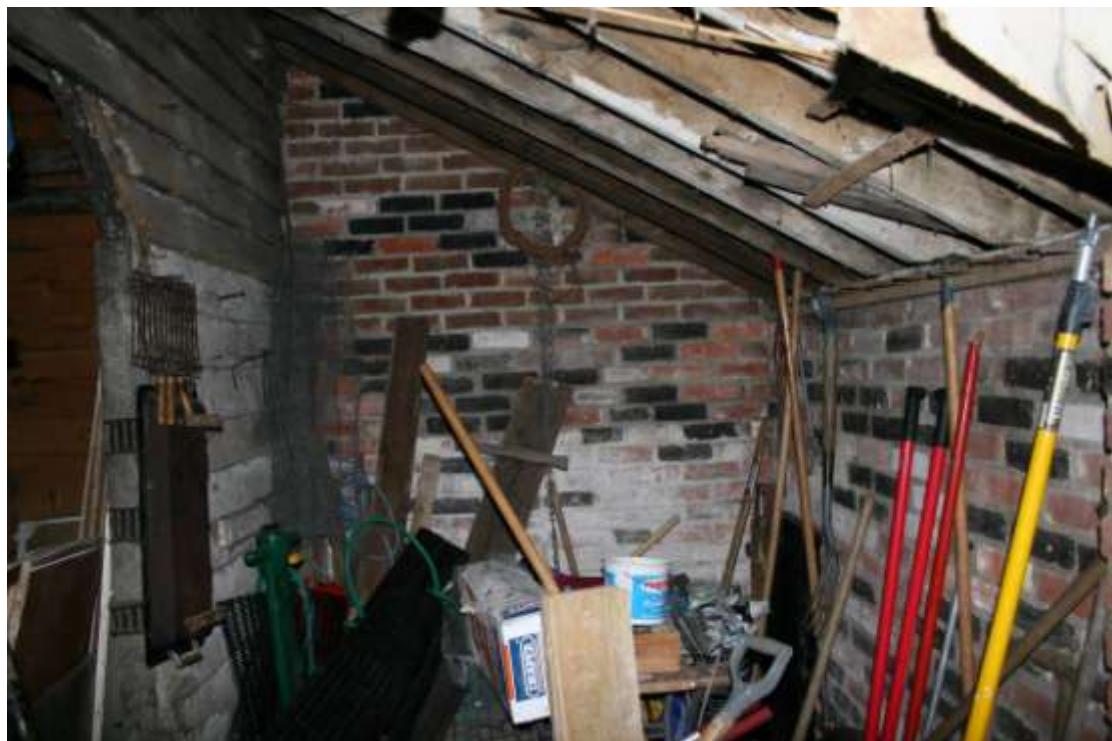
Interior of the Outshot used as a garden store. Bricks are reused in the late C20th.

The Outshot is built of reused bricks set in a 20mm thick grey cement bed. The bricks are variously painted, tarred or whitewashed and measure 65x110x220. The simple pent roof is composed of reused machine sawn 125 x 50mm (5 x 2 in) softwood rafters. There are no purlins.

The dividing wall with the Eastern Stalls is partly whitewashed and part bare wood showing that there has always been an outshot here because the weather boarding was not tarred for external use. The softwood gate and ledger double doors and windows are late C20th.

The brickwork of the plinth is also visible and is composed of 55x110x220mm orange reds in a 15mm lime mortar bed. The floor is washed over with concrete and buried in gravel from the drive.

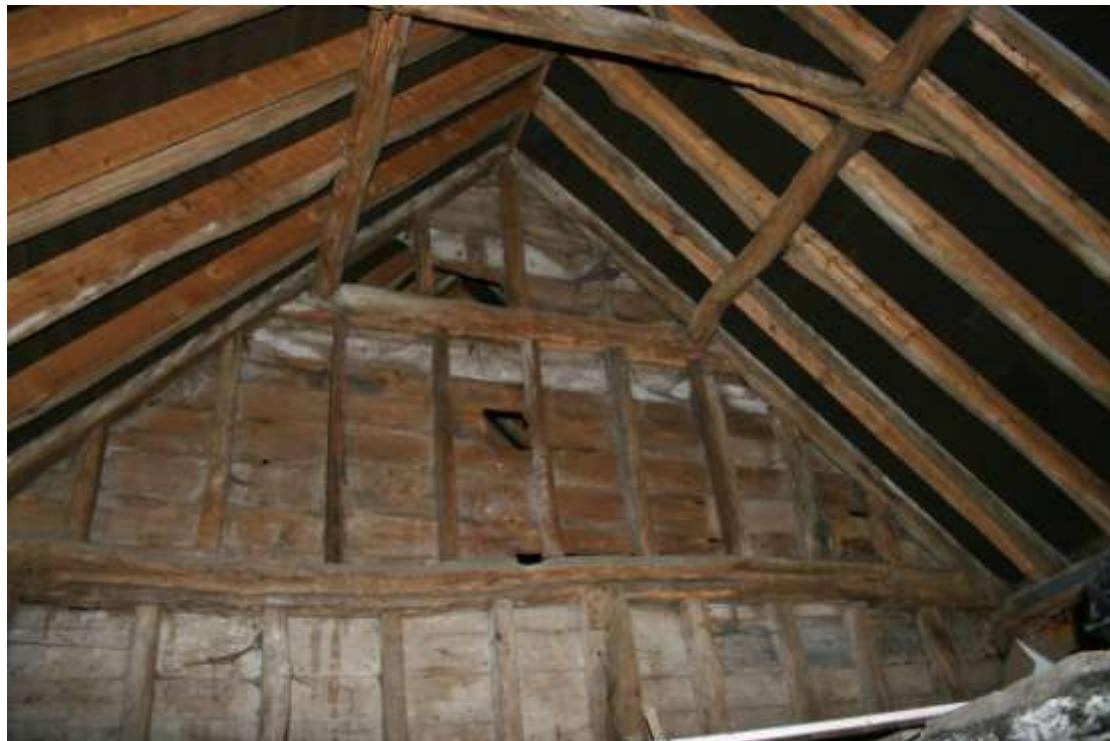
The roof structure is best expressed in the wall of the Eastern Stalls.

The roof has been almost entirely replaced in C20th machined softwood. In the Eastern Stalls there are some original rafters paired with new ones and the original collars for the side purlin roof. The purlins here are also original but are replacements throughout the rest of the building. The roof construction is entirely nailed together.

There are three mild steel tie-rods spanning the building passing through the top-plates. These are actually steel tubes which are threaded at either end and secured with hexagonal headed C20th nuts against small square mild steel pattress plates. The only other ironwork repair visible is a mild steel strap across the failed scarf joint in the top-plate of the north wall of the Eastern Stalls which is painted with grey primer and secured with hex headed bolts. (See photo for roof structure extreme right).

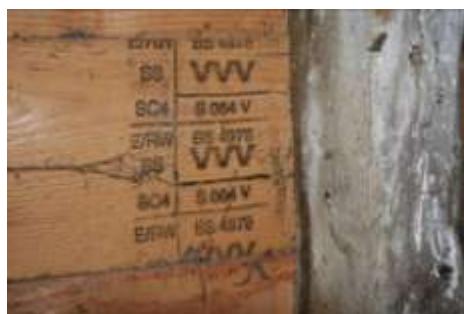
C20th British Standard marks on the cladding.

There were no frame assembly marks discovered but this is not a surprise. On late buildings (post 1700) the carpenter's marks are nearly always on the outside of the frame. There was a British Standard stamp on the cladding inside the Western Stalls.
