Norton Hall Barn, St Stephen's Road, Cold Norton, Essex
Description and analysis of a brick and timber-framed barn adjacent to Norton Hall.
Surveyed 30 04 2010.

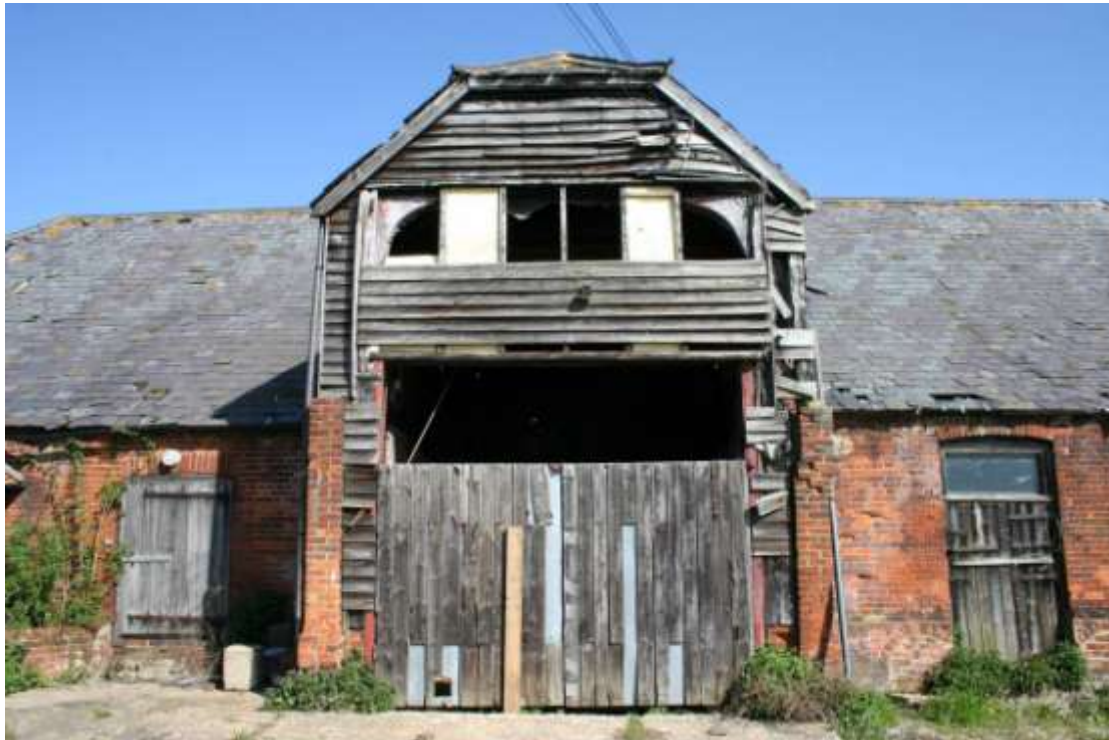
The southern elevation is dominated by the full height porch.

The section above the doors was boarded over in the later C20th as shown in the Images of England photograph taken in 1999 but since then many of the boards have fallen off revealing the machine sawn softwood battens. Towards the top, modern insulation panels are visible as are the two hanging knees that connect the top-plate to the original door posts. These are numbered I and II with a wide chisel. In general the weather-boarding is in poor condition and is all C20th being machine sawn softwood fastened with galvanised wire nails and cold tar brushed black which has badly faded.

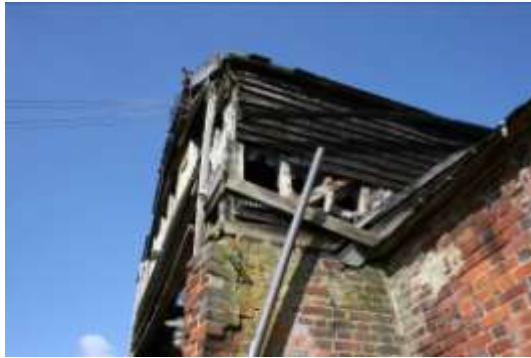
The flanks of the porch are constructed in hard red, orange and over fired purple bricks 60-65x110x220mm set in a 10-15mm bed of hard white mortar with a flint chip aggregate. These bricks are consistent throughout the barn but differ slightly in size in the Outshut walls where most of the bricks measure narrower at 65x105x220mm. However all the walls are 330mm (13in) wide. The eastern flank is failing and the brickwork damaged.

Failing eastern flank of the porch and (right) the side entrance to the porch.

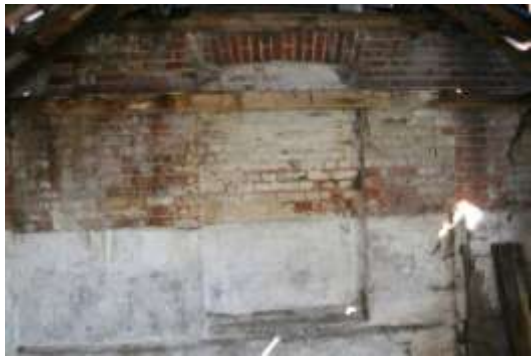
Bricked in doorway visible in the Stables. Mortar is markedly different.

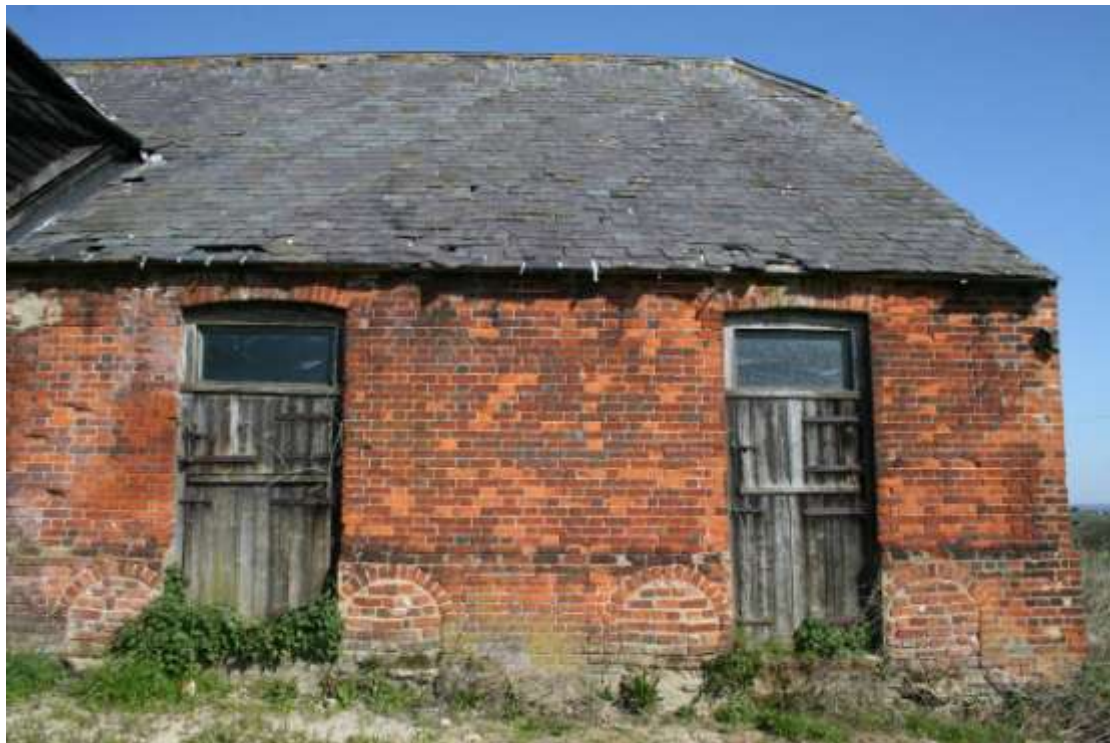
Southern elevation of the Eastern Outshut. Note semi-circular tunnels.

The Eastern Outshut has two full height C20th vertically boarded stable doors with wire reinforced glass lights above. Looking at the brickwork it can be seen that the openings are properly finished with closer bricks down to the level of the plinth. In the plinth either side of each door there are bricked up semi-circular tunnel mouths which the Listing describes as 'dunging passages'.

In each case they have all been truncated to drop the doors to the exterior ground level and then bricked in with cement bonding. In the base of each can be seen a layer of poured concrete corresponding to the current floor inside. The westernmost tunnel has a round

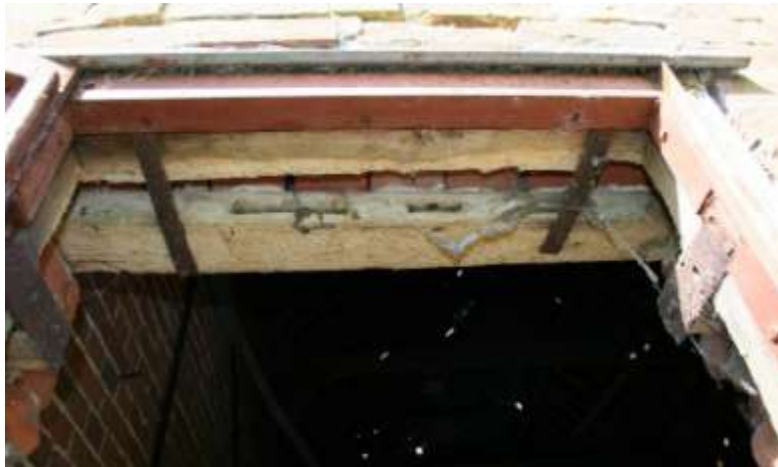
The 13in walls are laid in Flemish bond set in a 10-15mm bed of hard white mortar with a flint chip aggregate. A door has been inserted into the SE corner of the barn resulting in the failure of the brickwork above it.

Detail of the inserted door into the eastern elevation.

A door has been crudely inserted into the eastern elevation of the Barn. There is a steel door frame similar to that in the porch with a steel C20th door. The opening is also framed with a timber frame with a double timber lintel held with crude iron straps nailed into place. The lintels are made of reused timber and the iron is very likely to be mild steel as it is so rusty. The C20th steel frame has been cut to accommodate it.

The brickwork above the lintel is failing and there are no closers to suggest the doorway is original to the build. About two thirds of the way up the door there is a line of whitewash across the width of the Barn and outshut that suggests there was once another building or structure built against the eastern wall. This is confirmed by the substantial 13in brick footing seen in the ground some metres away which is contiguous with the northern wall of the Barn.

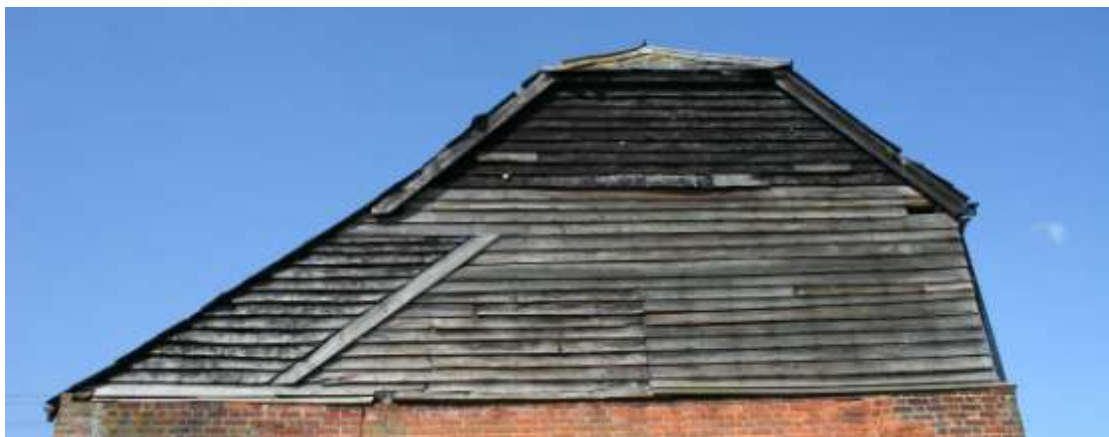
The weatherboarding is in three distinct sections with local repairs.

The weather boarding consists of a heavily tarred section at the top of the gable fastened with wrought iron nails which is likely original. Below is a large section of C20th machined softwood boards fixed with wire nails with a square inserted section that suggests there was an opening. However this is not borne out by the frame and it is more likely caused by a shortage of materials at the time it was reclad.

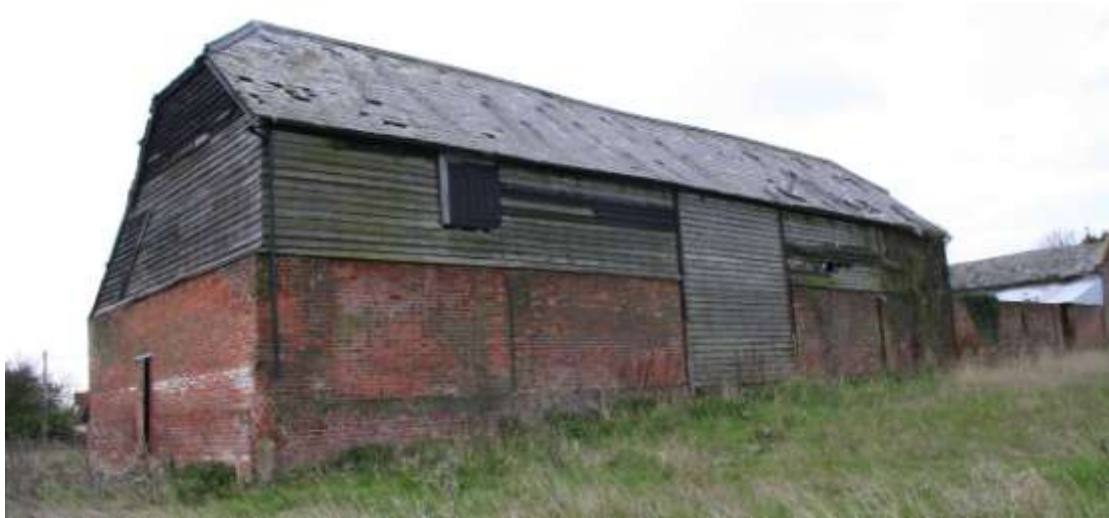
The rear of the barn from the NE emphasises the slope of the ground. Note the loft door.

The northern elevation is centred on the full height opening for the barn doors which have been removed and the void boarded over with C20th weatherboarding. The brick walls have a plinth whose visible height diminishes as the ground slopes upwards to the west. Above this the brick wall is reinforced with full height piasters. Most of the timber-frame has been reclad in machine sawn softwood boards. Some are older and some are missing.

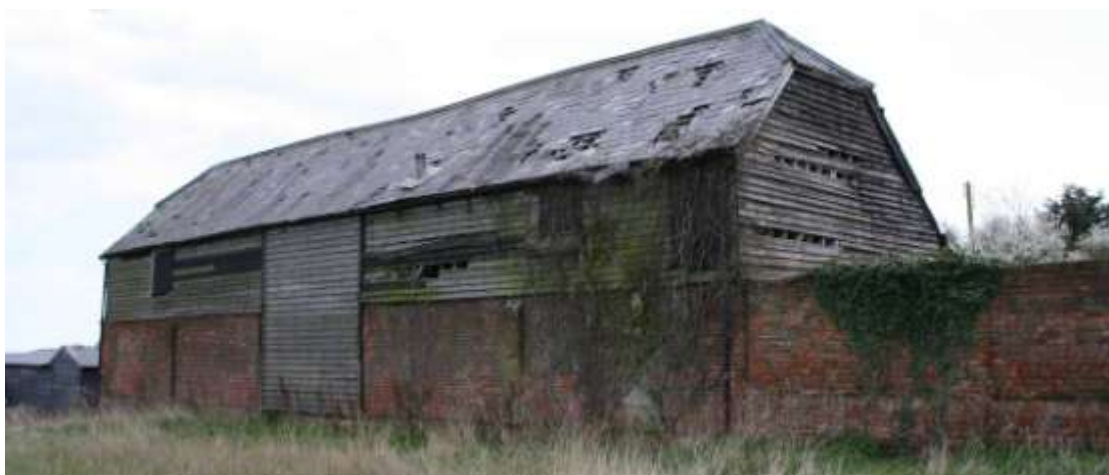
Rear of the barn from the NW showing high level door in western end.

To the east and west there are square loft doors of wide vertical boards with wrought iron strap hinges. At the western end there is also a full height door hidden behind the plant growth. The three doors are coated in hot tar in contrast to the rest of the timber.

The roof is in poor condition and many of the tiles appear to be asbestos copies rather than the original grey slate with its distinctive chipped edges. There is a stainless steel flue left hanging in mid-air from its sealing plate.

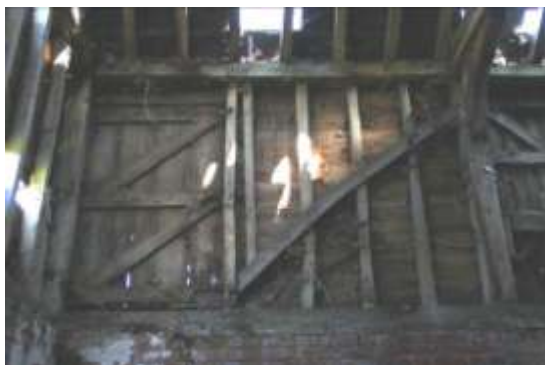
Inserted door in the NW corner of Bay 1.

The full height door in Bay 1 on the north side is inserted. The curving down brace has been cut through and a reused stud serving as a door frame added. Above the gate and ledger, edge moulded board door two studs have been sawn off. The hinges are fastened with wrought iron bolts with flat, square nuts. Again the door fastens from the inside to a round section staple on the corner post and implies that there was a floor in use at this end of the barn.
