Yardley Hall, Yardley Hall Lane, Walden Road, Thaxted, Essex.
Description and analysis of a timber-framed barn and outhouses at
Yardley Hall Farm.
Surveyed 10 01 2011.

The Barn is Listed: 1. THAXTED Barn at Yardley Hall TL 53SE: 1/5 II 2. C17 barn, timber framed and weatherboarded barn, with red plain tile hipped roof. 3 bays long. Hipped midstrete to west. IoE Number: 122266.

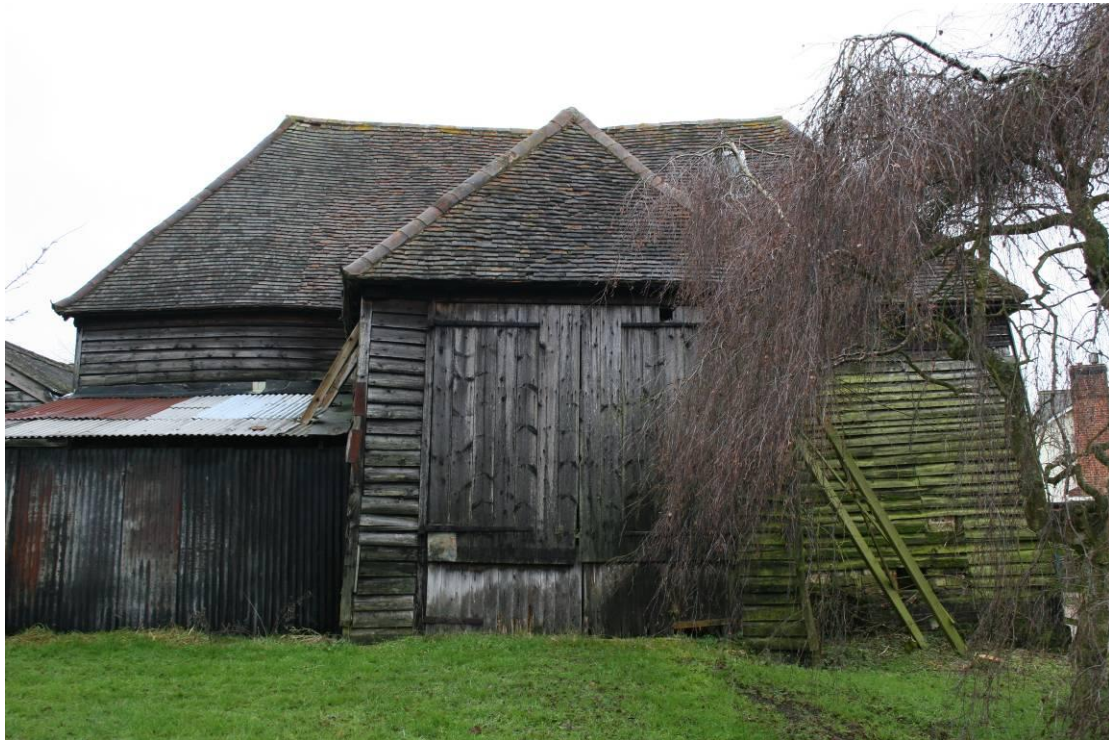
The western elevation from the lane. Looking east.

Much of the boarding was at one time hot-tarred. Inside the lean-to, which has protected the boards they have also been treated with cold brushing tar. Nowadays the boards are neglected and many are green with mould, the fixings have failed and the boards have split.

The Barn suffered a calamitous failure of the frame as result of a freak high wind in the year 2000. Since then it has been supported with a scaffolding armature, props and many internal timber braces. On the western elevation the porch has been propped with timber shores and the SW corner is badly racked. Some of the boards have fallen off to reveal internal brick noggin and a raised brick plinth which is more evident in the southern elevation.

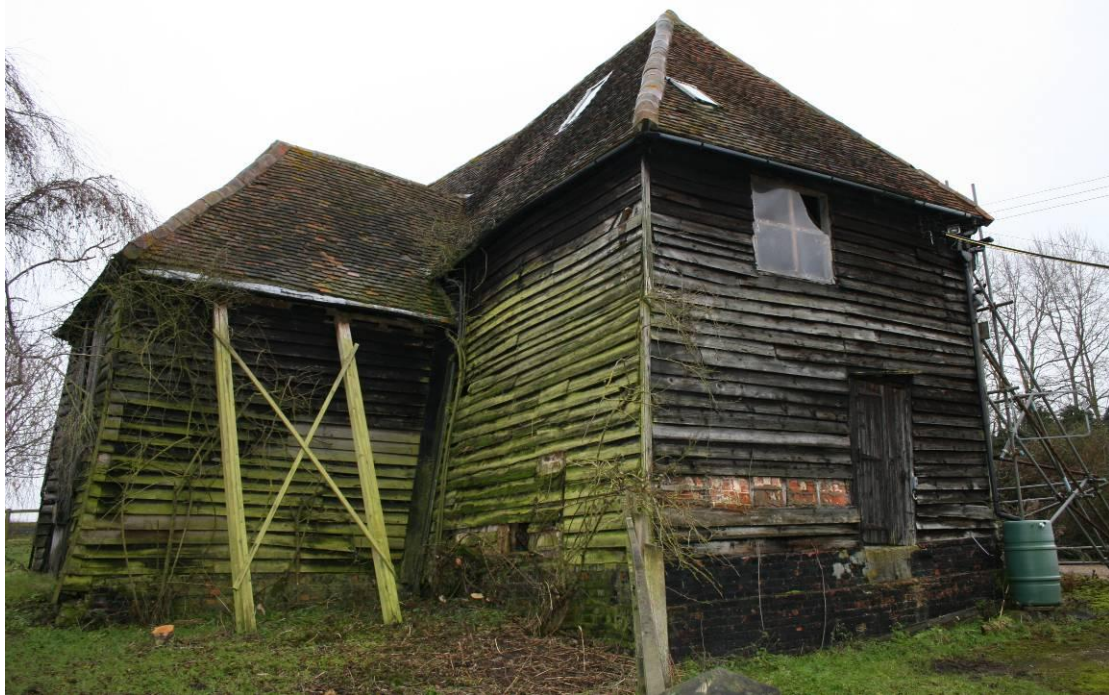
This oblique view of the southern elevation shows how badly the building is racked.

The southern elevation consists of the side of the midstrete porch and the south wall of the Barn. The barn is badly racked towards the east and this can easily be seen in an oblique photograph from the SW.

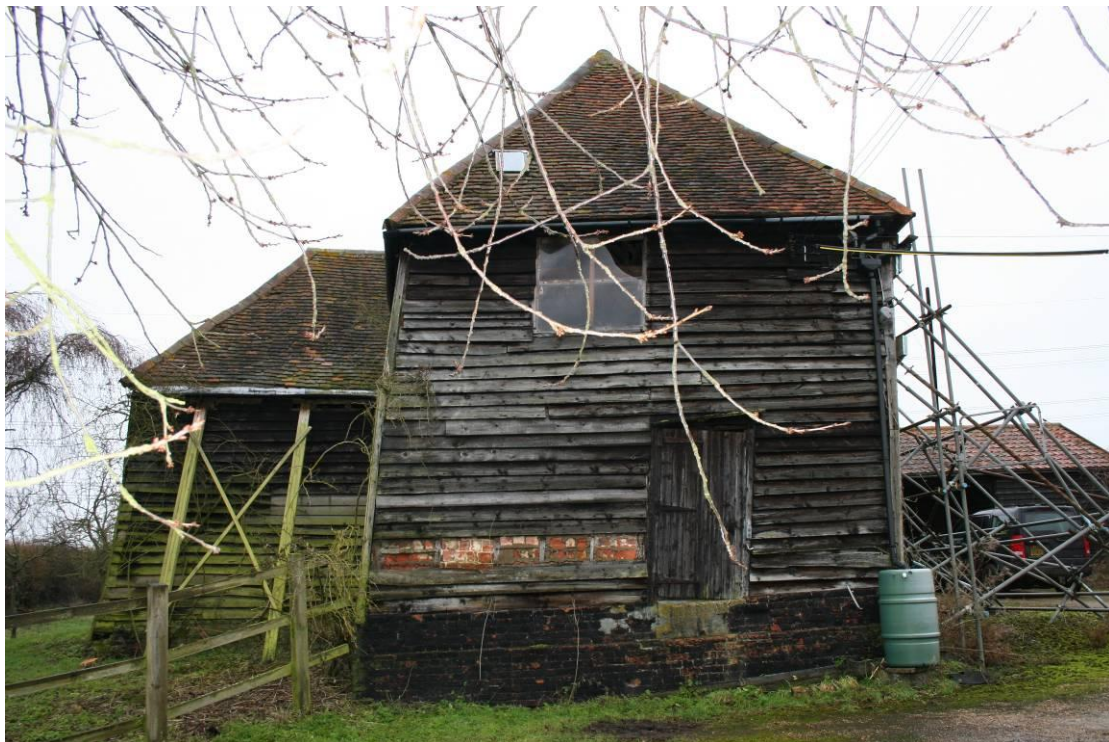
The southern elevation with inserted door and window.

The flank of the midstrey is clad in original boards with a few being replaced near the junction with the Barn. Inside the corner post has been severed and propped with a sleeper and heavily reinforced with steel ties. This was done by the current owners.

The southern wall has many later boards characterised by clear circular saw marks which the original boards lack. They are also more silvery in colour. There are some C20th band sawn replacements. Many have been refastened with galvanised nails.

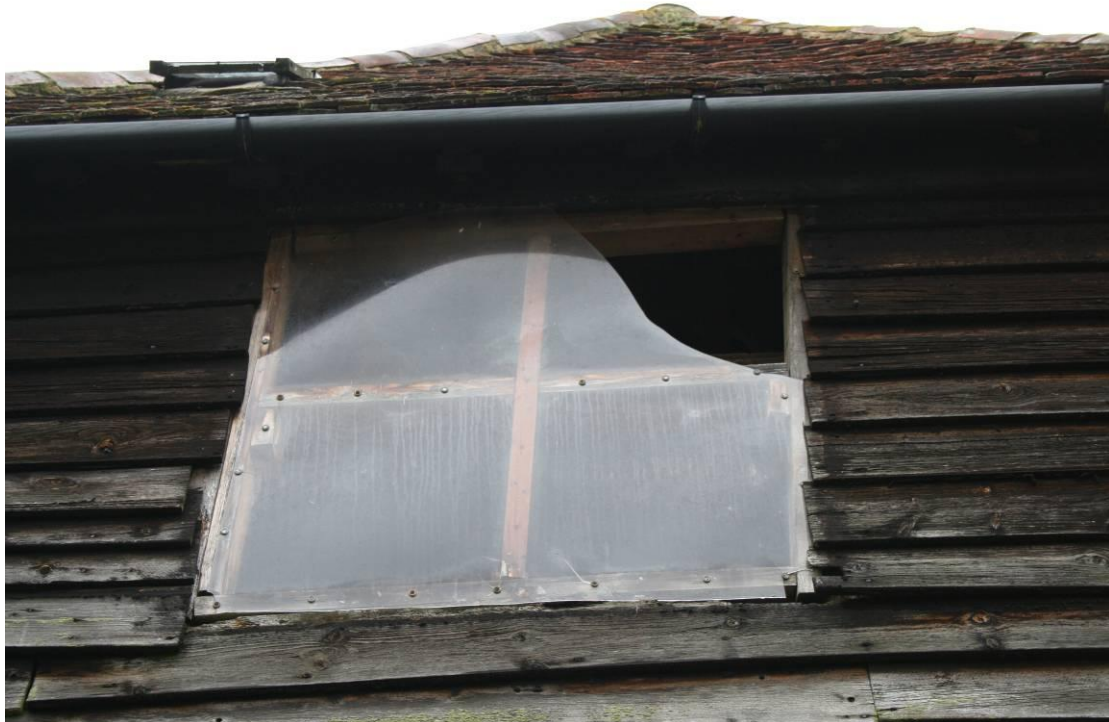
Inserted window in the south elevation. Small roof light in the hip of the roof to the left.

Below is an inserted door which is now badly racked and impossible to open. It is built in the same style as the midstrey doors. It is a softwood gate and ledger door with vertical edge moulded boards. Inside there is a Woodstock box for the working lock. Crucially however the door is C20th. It is nailed with galvanised French nails and the three T-strap hinges are badly corroded mild steel fastened with screws. The lock has a large old key which must be reused from another door. There is also another key hole with modern escutcheon but no lock.

Some of the boards have been sprung off as a result of the racking suffered and they reveal the back of the brick noggin applied to the inside of the barn. This is useful as it reveals that the bricks have shallow frogs.

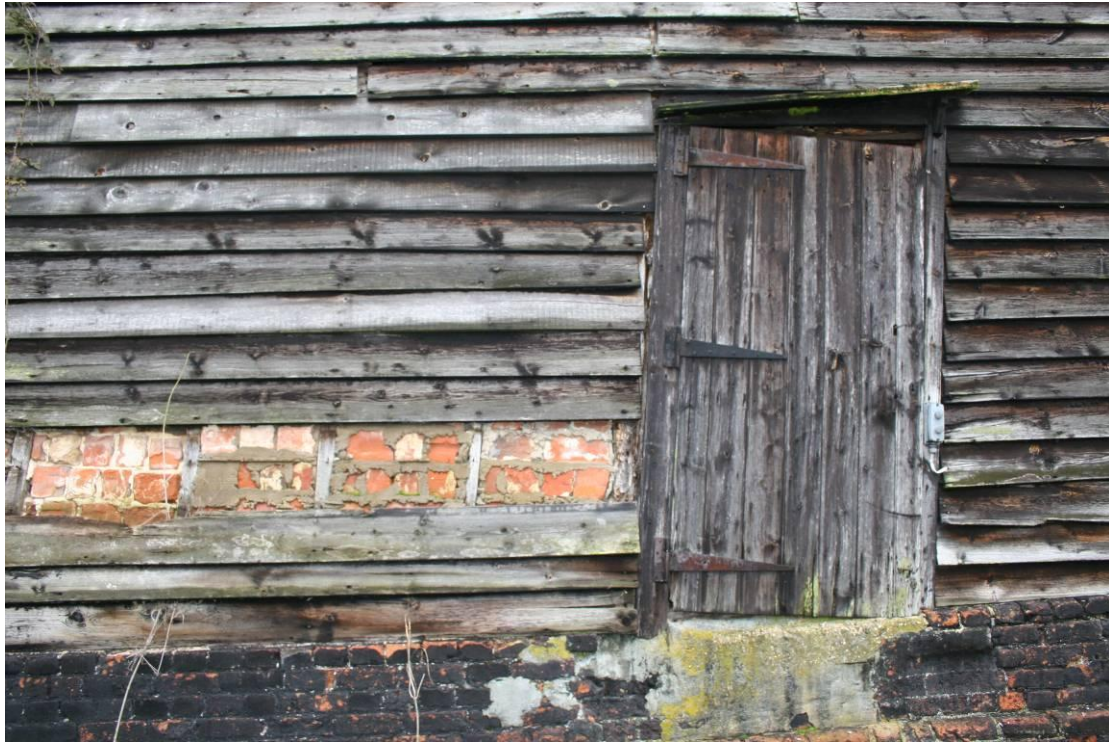
The inserted C20th door and the exposed brick noggin and plinth.

The brick noggin is composed of red/orange frogged bricks, 60x110x225mm, with creased faces, wiped soffits and soft arrises. They are bedded in a white crumbly mortar except where they have been reset using hard grey cement. They are identical to the bricks used in the plinth below of which a maximum of 15 courses is visible. The plinth also contains shorter bricks down to 205mm in length and it can be assumed the plinth was built of second grade bricks.

The plinth has been hot-tarred on the outside and contains a step out at five courses down from the sole plate. The area below the door has been remade in concrete. The exposed studs appear to be machined 2x4in softwood replacements.

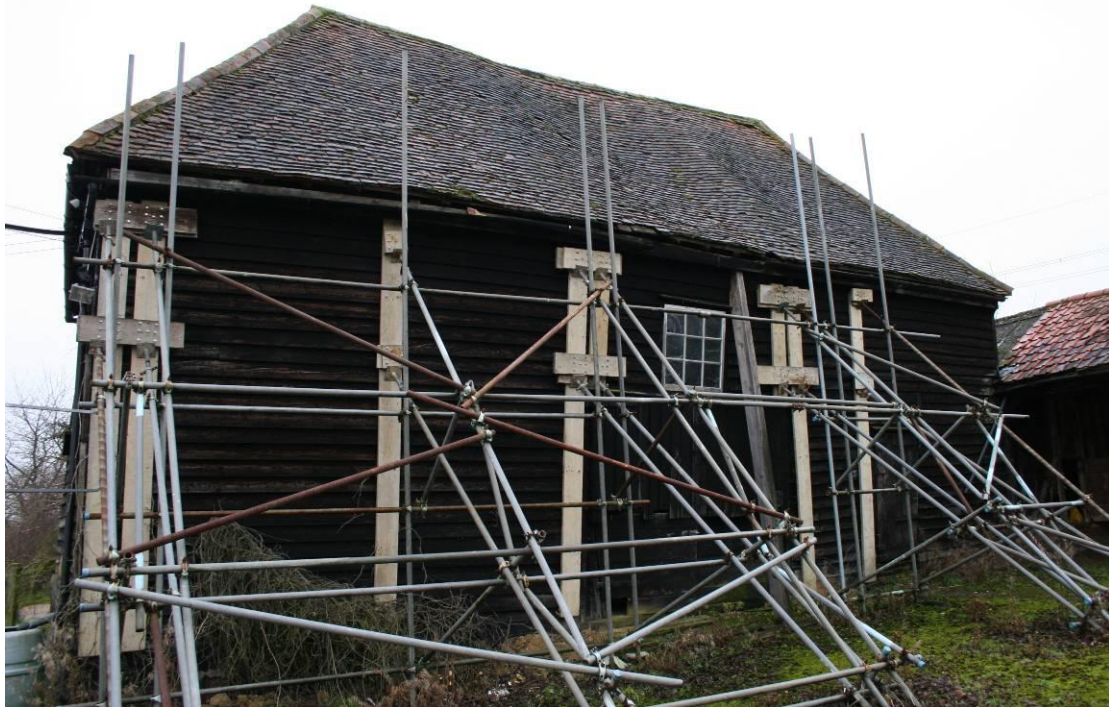
The eastern elevation has central doors and a window above.

The eastern elevation is largely obscured by shoring constructed of scaffolding poles and planks. This was erected in the year 2000 after the wind damage. The elevation is clad in mostly original hot-tarred boards but there are several with circular saw marks near the small entrance door denoting replacement.

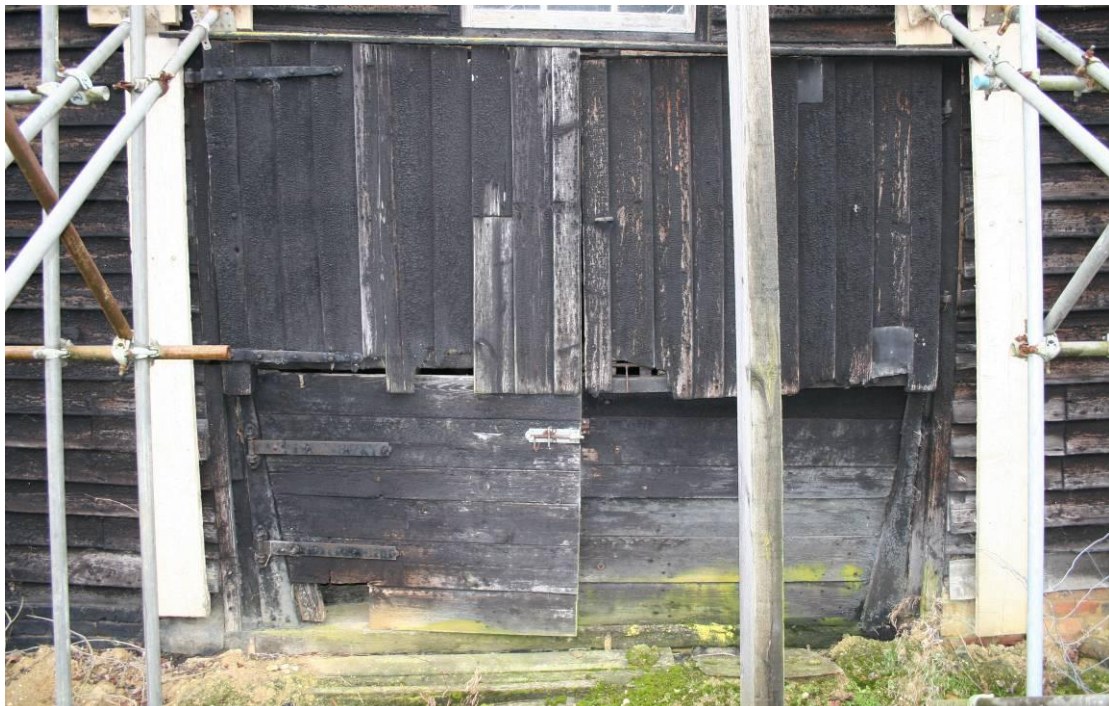
The central midstre doors are partly constructed from the thresh-hold boards.

The doors are suspended on wrought iron pintles of which the southernmost set have been reforged to be fixed to the outside of the doors rather than the inside. This has been done to accommodate a single leaf gate below which has been created by cutting the leap or thresh-hold boards in half. The gate is hung on mild steel straps with cast iron hinges to the same pattern as the lower porch doors. Today these are known as reversible hinges and are popular for stable doors because they cannot be lifted off the hinge.

Set in the jambs of the doorway are two triangular slotted sockets to accommodate horizontal edge-moulded boards for the thresh-hold. The boards are still in-situ but have been cut in half to form the gate. The other half has been crudely nailed together with horizontal oddments of timber to create a solid panel which could be lifted out. To strengthen the construction a piece of C20th machined softwood has been placed centrally and nailed to the mid-rail forming the lintel.

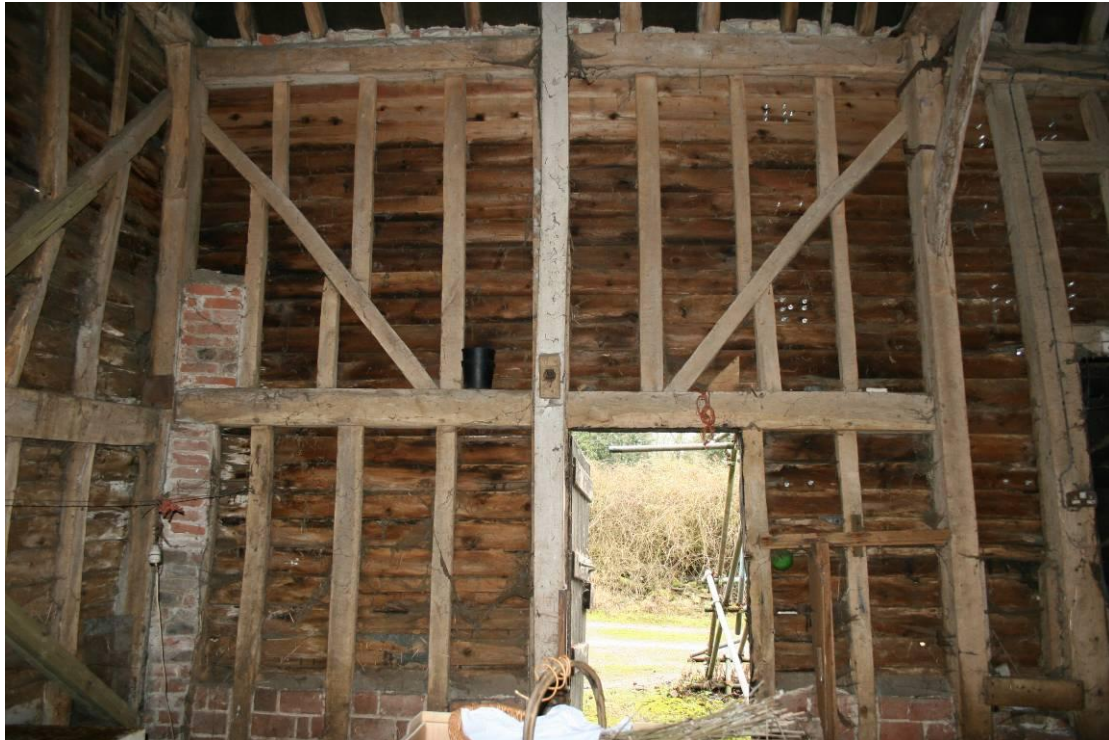
The door has been inserted by removing a stud next to the storey post and this may have led to a weakening of the frame. It is significant that the inserted timber is a match for one used to construct the superstructure for the grain platform at the other end of the Barn.

NE interior wall showing the offset studs and inserted pedestrian door.

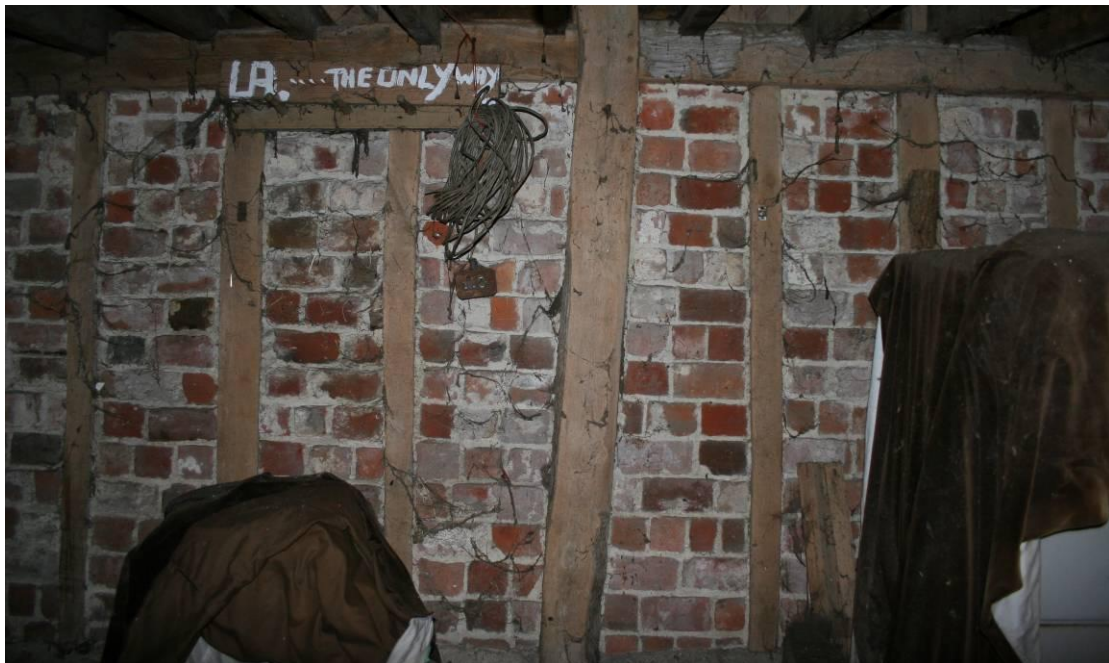
Brick noggin still in-situ in the SE wall.

The SW corner of the barn is still fully brick nogged up to the mid-rails and there are small remnants all the way round the barn on top of the sole plate most likely to prevent the rats from gnawing through into the granary store. The brickwork exerts a great weight on the frame and it may be partially responsible for the historic failure seen in the eastern wall and the truss and why it has been removed from here.

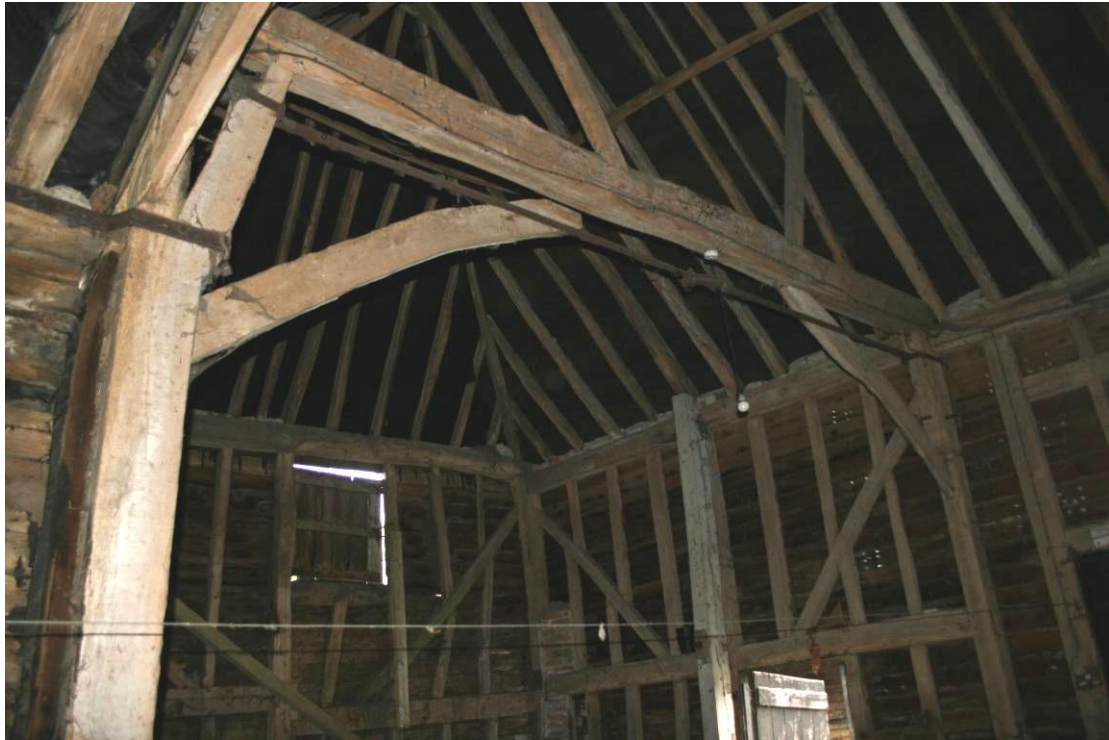
The northernmost truss has failed at both jowls and been reinforced with steel tie-rod.

The two main trusses have narrow section elm posts with clumsy jowls. The northernmost truss has failed at both jowls and badly split out. The movement has been arrested by a homemade mild steel tie-rod assembly. This has been inserted to stabilise rather than reverse the movement. The flat bars are of mild steel secured with hex head bolts and the turnscrew assembly is welded together. Another mild steel strap has been applied connecting to the midstre top-plate. One spandrel has fallen out of its mortice.

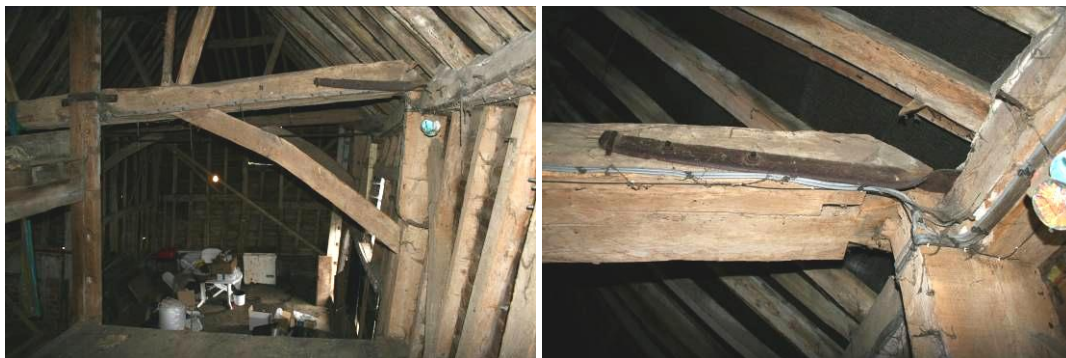
Eastern side of the southernmost truss. Underside shows misplaced teasel mortice.

At the eastern side of the southernmost truss the mismatch of timber can be clearly seen. The tie-beam is much larger than the post head, the dovetail hangs in space and the mortice for the teasel tenon is completely redundant. (The teasel tenon is the tenon on top of the upstand of the original post). The tie-beam is held in place with a nailed and stapled wrought iron L-tie made of twisted wrought iron which stylistically dates to the LC18th onwards. Earlier iron ties are upset to achieve their form.

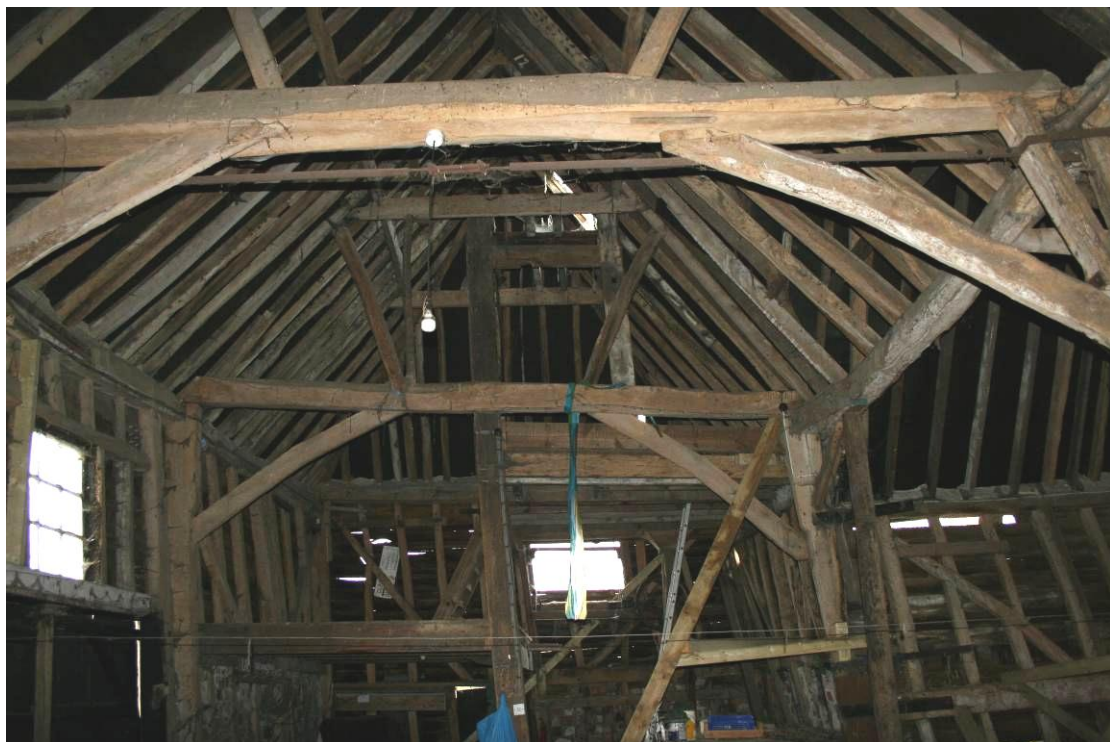
The grain platform occupies most of the southern bay. The barn really is this crooked.

The installation of the machinery undoubtedly contributed to the failure of the frame in the high winds of AD2000. It is significant that the main vertical strut supporting the platforms is a pair for the repair timber on the NE wall as this indicates a failure very close to the installation time of the machinery. Also the frame of the south wall has been considerably altered by cutting through the diagonal brace to insert the sack rolling machine and the door on the ground floor.

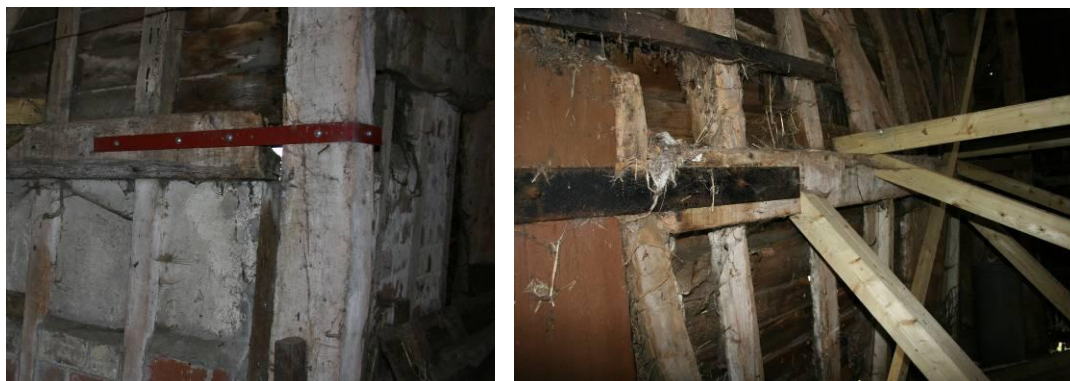
C21st repairs to the midstreys. North side (left) and south side (right).

Apart from the ironwork repairs already detailed there are a number of post AD2000 straps that have been applied to the junction of the midstreys with the principal posts.

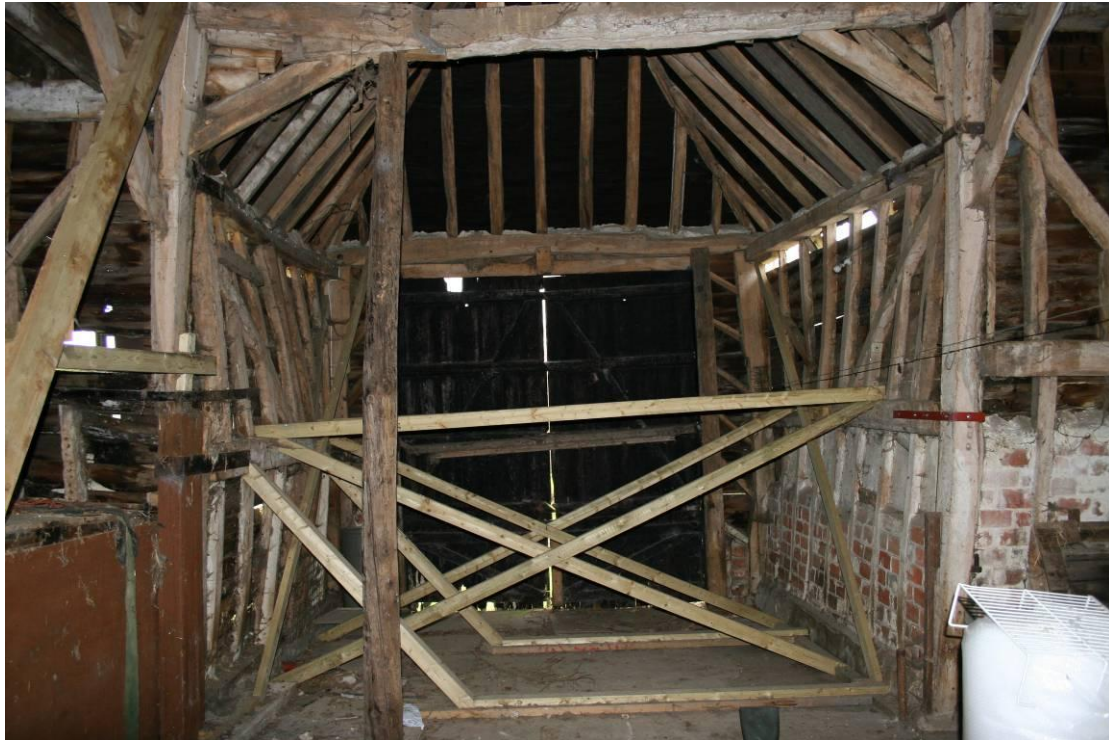
Internal struts and props to stabilise the raked midstrey.

These repairs are part of the stabilisation of the Barn after it was damaged in AD2000. There are a large number of inserted timber struts in green tanalised timber that can be seen in nearly every photograph.
