The Old Rectory, Bell Lane, Lt Bardfield, Essex.  
Description and analysis of a timber-framed stables at the Old Rectory.  
Surveyed 24 01 2011.

Barry Hillman-Crouch  
Design & Recording Services

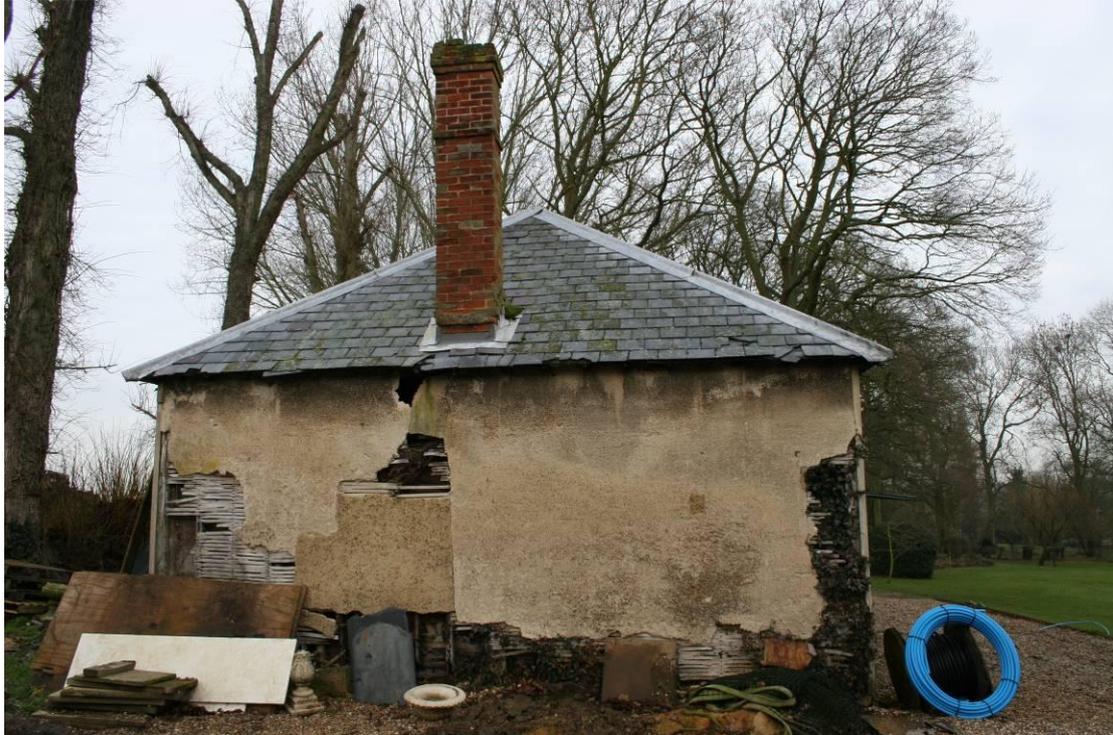
Southern elevation of the Stables.

The southern elevation presents a plain rendered wall beneath the full hipped grey 12x24in slate roof. The exterior wall is in poor condition with much of the render fallen off exposing the riven laths fastened with wrought iron nails. The larger part of the render remaining is of hairless lime mortar. There is a patch of much later cementitious render that has also been pebble-dashed. Here the laths are machine sawn. This is the pattern for the rest of the walls.

Where the frame is visible it appears to be made from machine cut softwood with a single diagonal brace and interrupted studwork. The frame is also boarded on the inside and gains much of its strength from this. The frame stands on a brick plinth but it is buried on this elevation. Described in the eastern elevation section.

The chimney is made of 65x110x225mm hard reds and overfired purples set in a beige sandy mortar. The brickwork has been repointed in grey cement with several blown bricks cemented over.

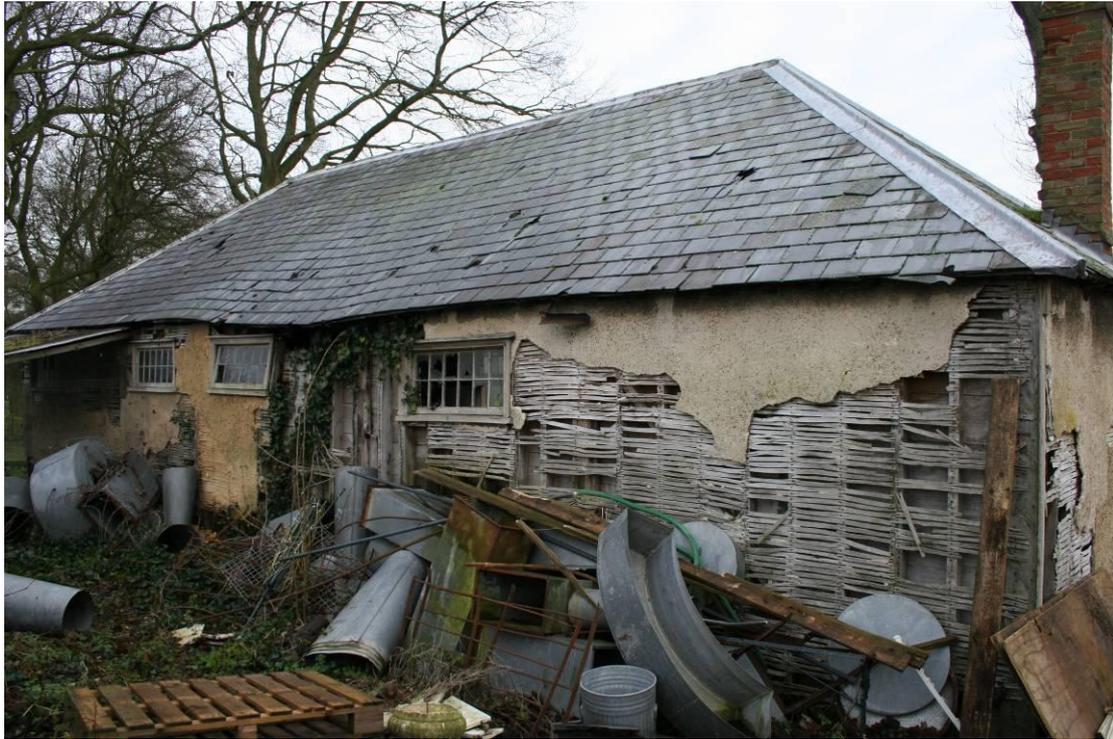
Western elevation is the rear elevation and shielded by trees. Looking NE.

The western elevation faces the field boundary and is the rear of the building. The render has fallen off most of the southern half of the wall and the central section has lost most of its laths. The timber frame is more clearly visible. There are only 3 diagonal braces and the vertical studs are machine sawn on a module of 2.5x5in. The principal posts are 5in deep but vary between 4 and 7in wide.

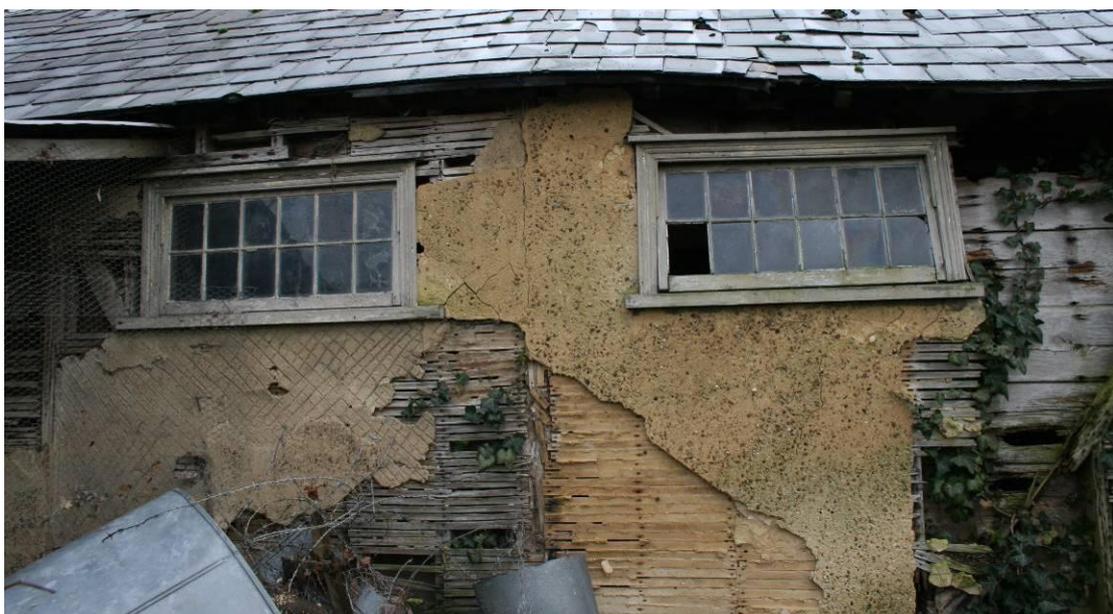
There are four identical rear windows. Note modern plaster and laths.

There are at least three episodes of rendering; lime mortar on original laths, cementitious mortar on sawn softwood lath and a modern unfinished scratch coat on the original laths.

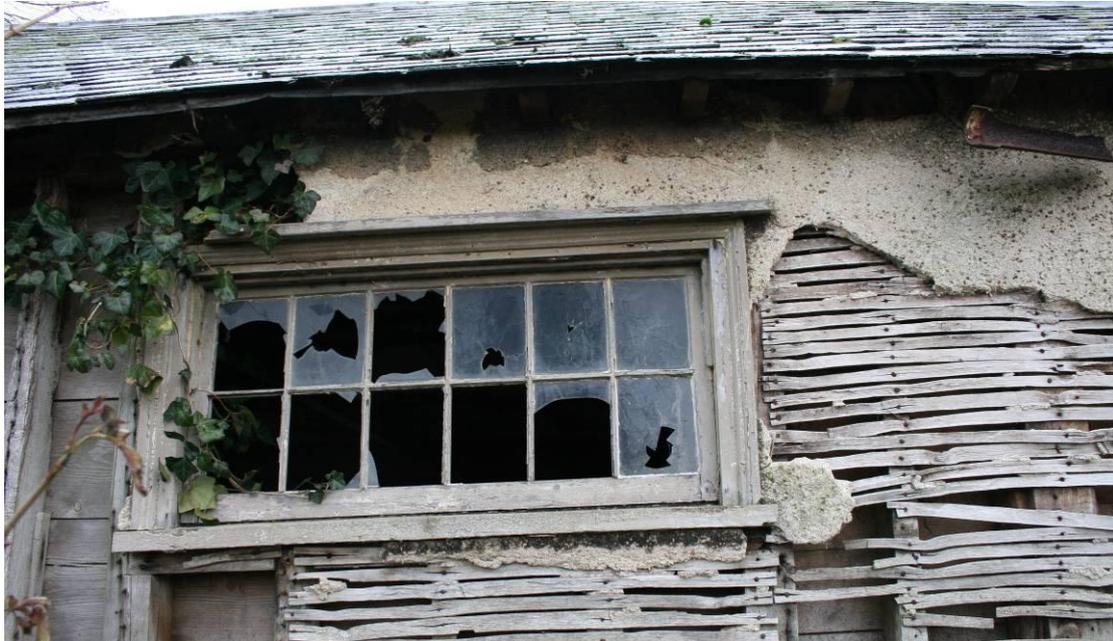
Basculating window. Remains of guttering.

The roof is sunken in the middle near the eaves and there is the remnant of a cast iron rainwater gutter hanging from its bracket.

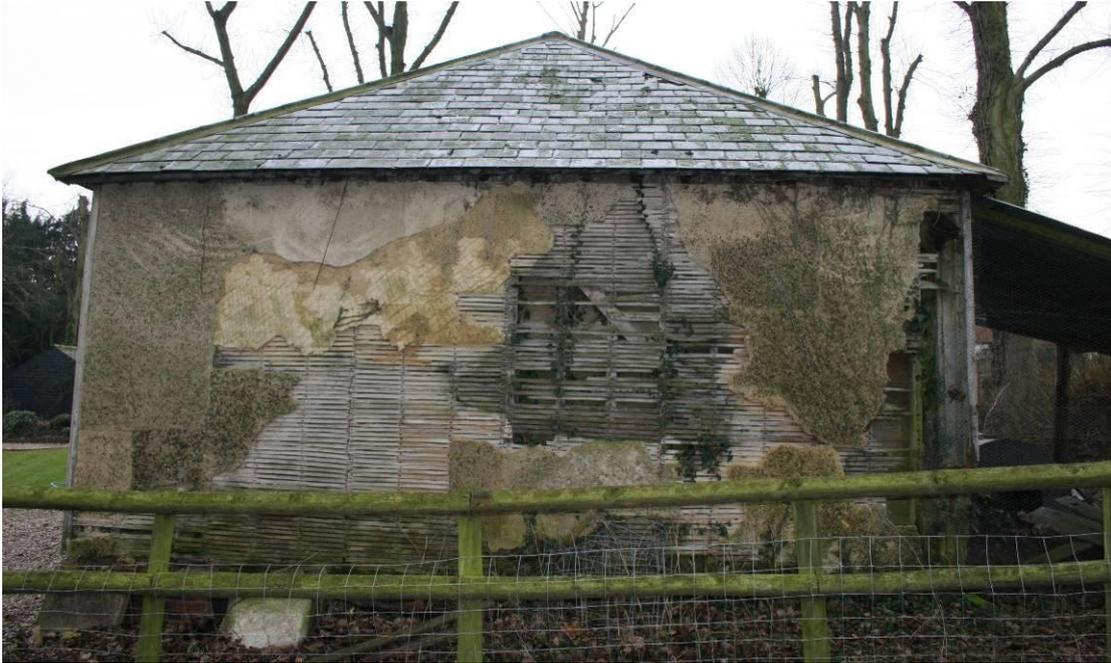
Northern elevation is a reflection of the southern one.

The timber-framed wall and roof structure is a reflection of the southern elevation with the exception of the lack of a chimney. Here it can be seen that there is a central principal post with diagonal braces of similar section and vertical interrupted studwork. Again the render is in several episodes with much of it being pebble dashed.

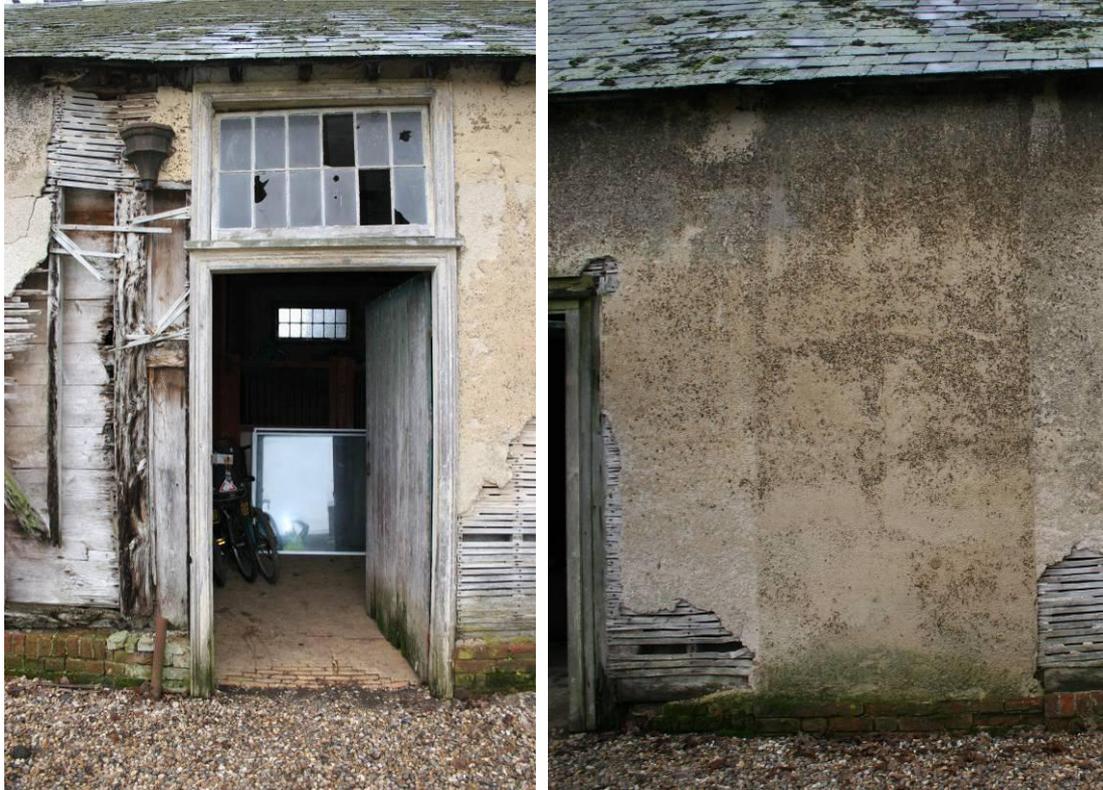
Main entrance into Bay 4 and blocked doorway into Bay 2.

The western elevation is the front of the building and originally had at entrance doors into Bays 2 and 4. That into Bay 4 is still in-situ while the other has been lath and plastered over and clad on the inside.

The blocked in doorway corresponds with the dimensions of the other and the render is beige sandy lime. The new render is well defined by the application of a fine gravel pebble dash. The brick plinth below has also been inserted and is laid in a Flemish bond without a soldier course.

The central section (Bays 3 and 4) have larger red bricks, 65x110x225mm laid in Flemish bond with a soldier course. They are set in a fine white mortar. The blocked door has similar bricks and there is a damp course of roofing slate inserted one brick below the sole plate. Elsewhere fragments of grey slate can be seen directly under the plate.

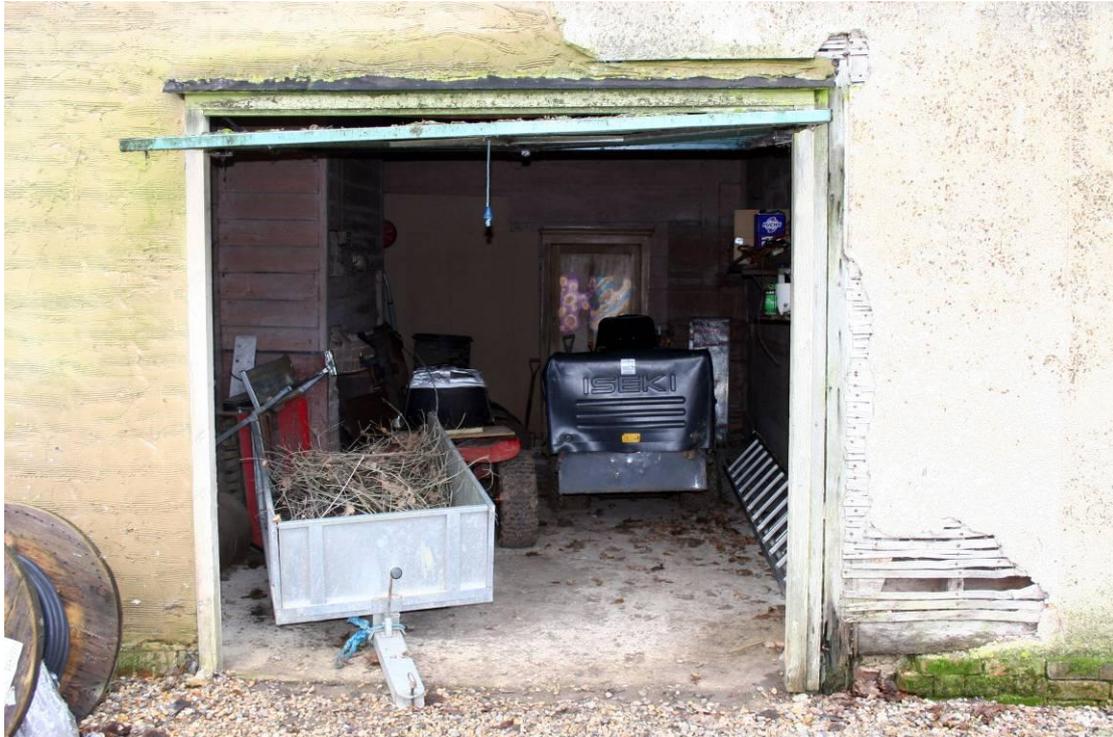
LC20th garage door inserted into Bay 1.

The insertion has been done very amateurishly and the section to the south of the door is clad with a membrane and EML. The scratch coat was applied and the job never finished. It has to be assumed there was a doorway and perhaps also a window into Room 2 as there are no indications of any others.

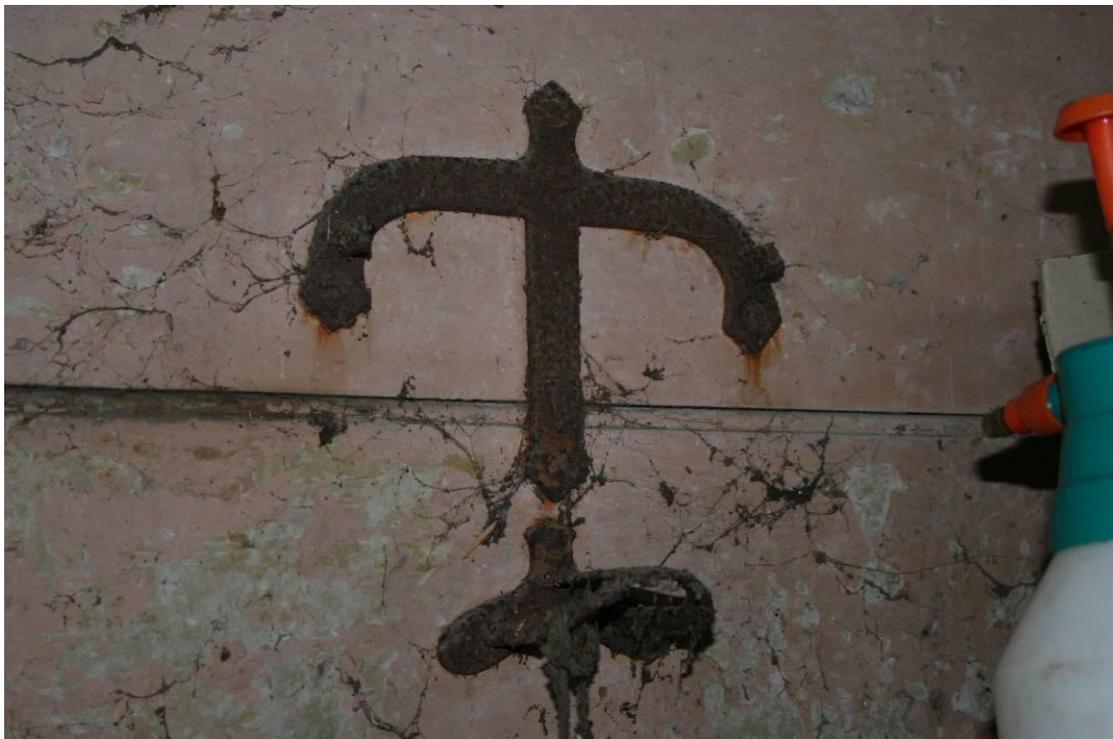
Remains of a saddle hanger and harness hanger below. Very corroded.

Being a working building that is little changed from when it was being used for its primary purpose there are still several of the original fittings. Each stall has lashing rings for the horses. They are very rusty and it is likely they are all mild steel. This is important for dating as mild steel was not invented until 1856 when Henry Bessemer perfected his 'Convertor' which he patented the year before.

There are a number of very corroded harness hangers, hooks and the remains of a saddle hanger (high up on the wall next to the entrance door). On the other side of the door there is a profiled wooden shelf to receive long objects like broom-handles and below there are battens for triangular shelves.

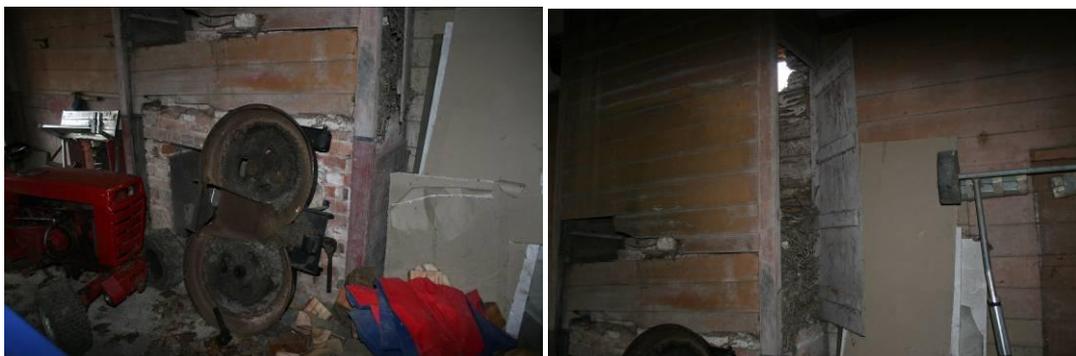
Fireplace obscured by grass cutter too heavy to move. Door into firebreast (right).

The fireplace itself is 38in wide by 36in high internally and is lined with steel sheets. There is a thick mild steel strap supporting the brickwork above the opening. The bricks are 65x110x225mm oranges with creased faces, sharp arrises, horizontal pressure lines and frogged. They are set in a white mortar. There are wrought iron fixings for a timber fire surround but it has been removed.

The chimney is quite unusual. The base and visible chimney are quite square but the section hidden in the firebreast is built in an S shape which may have been done to promote the draught. There is a hinged door in the west side of the fire breast to give access to the chimney and possibly there were shelves inside but presently there is a huge birds nest within.

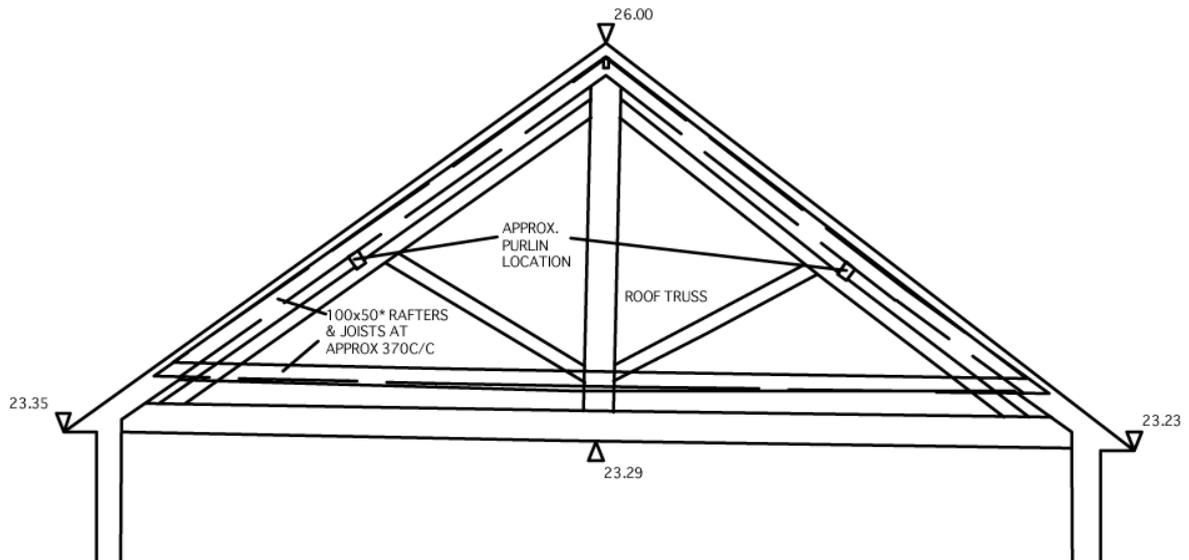
**Architects section through the roof. Snell David Architects. 2009.**

The central truss is supported on an inserted machined post next to the entrance door and examination of the frame shows the main post has rotted away.
