Birds Farm Henham

A report on the barn

David Andrews
2012

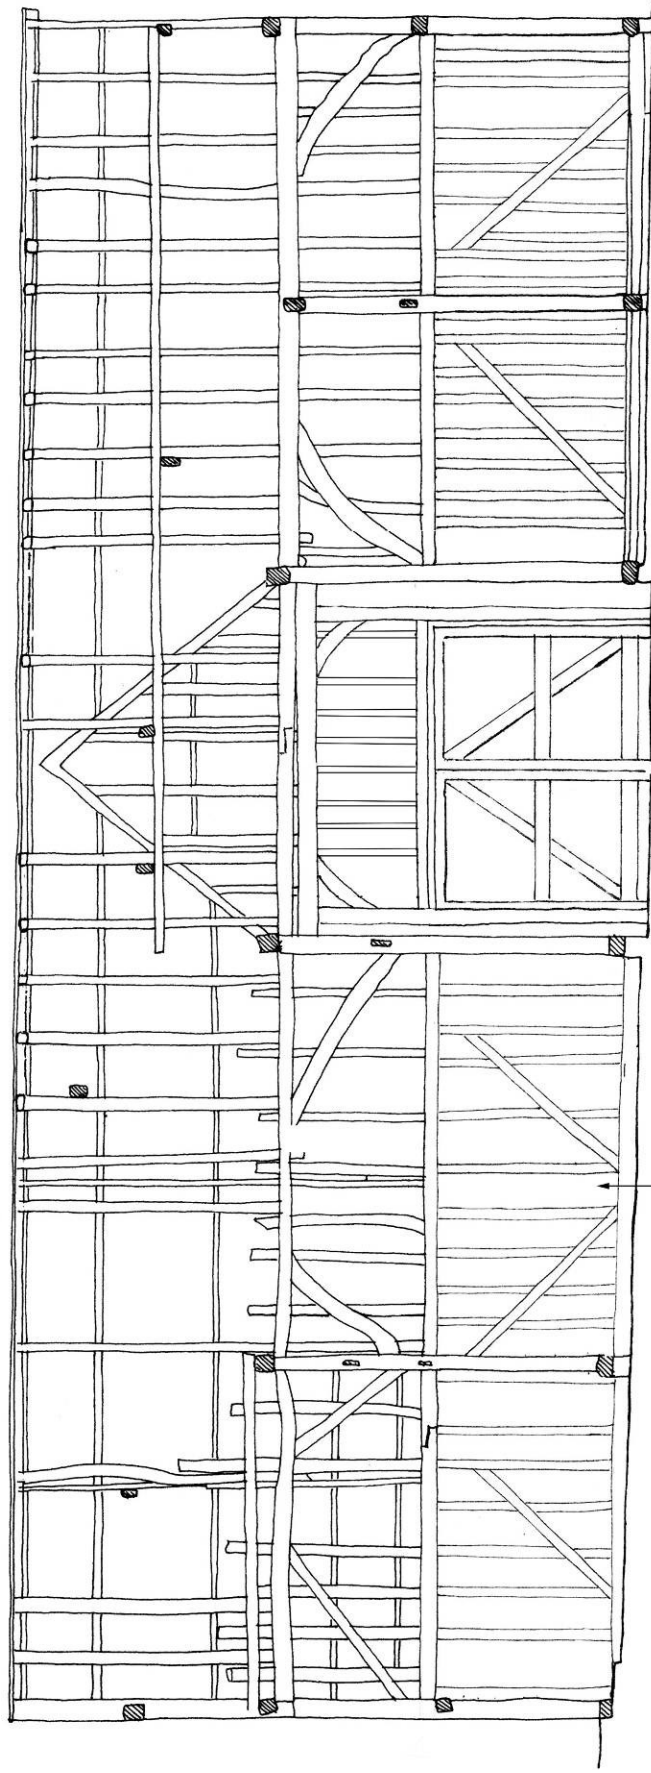
WEST ELEVATION

Wall rebuilt and realigned

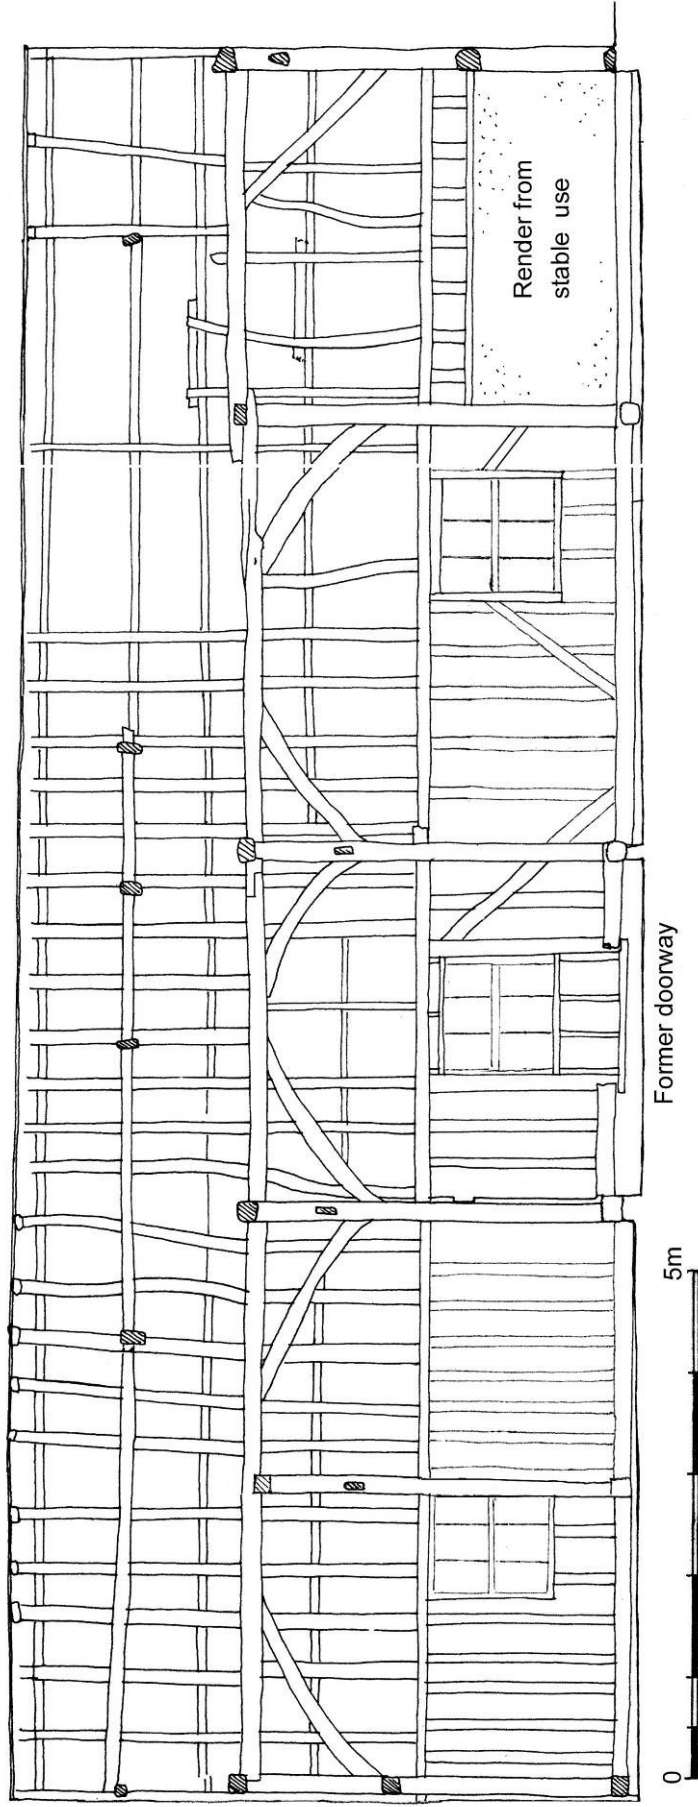
EAST ELEVATION

Render from
stable use

Former doorway

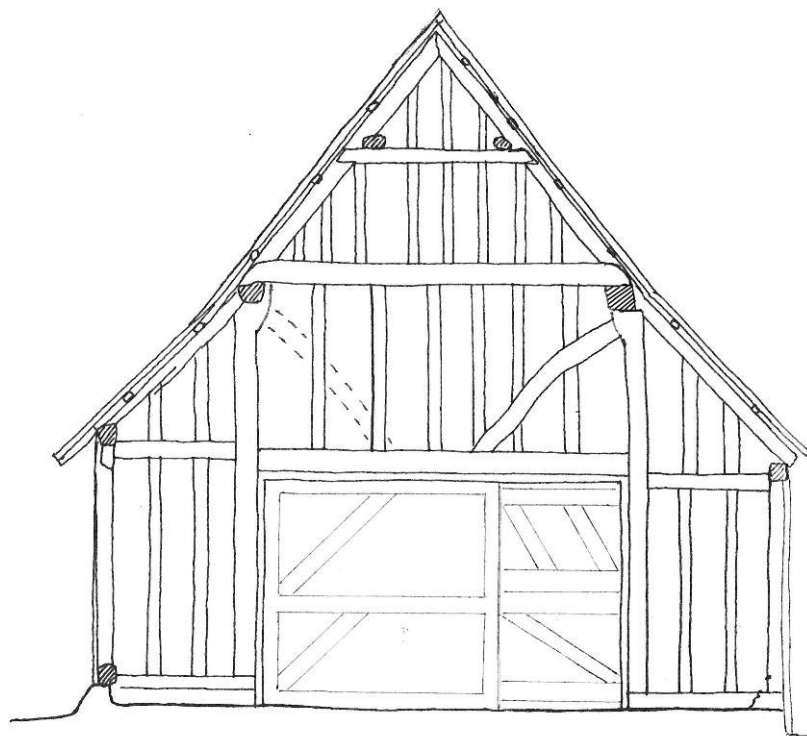
North gable

The north wall includes some reused timber. The east arcade post in this truss has had the top of the jowl (which would have connected to the tie-beam) removed, and the top plate sits at the edge of the top of the post, in a way that suggests these members have been re-assembled and misaligned.

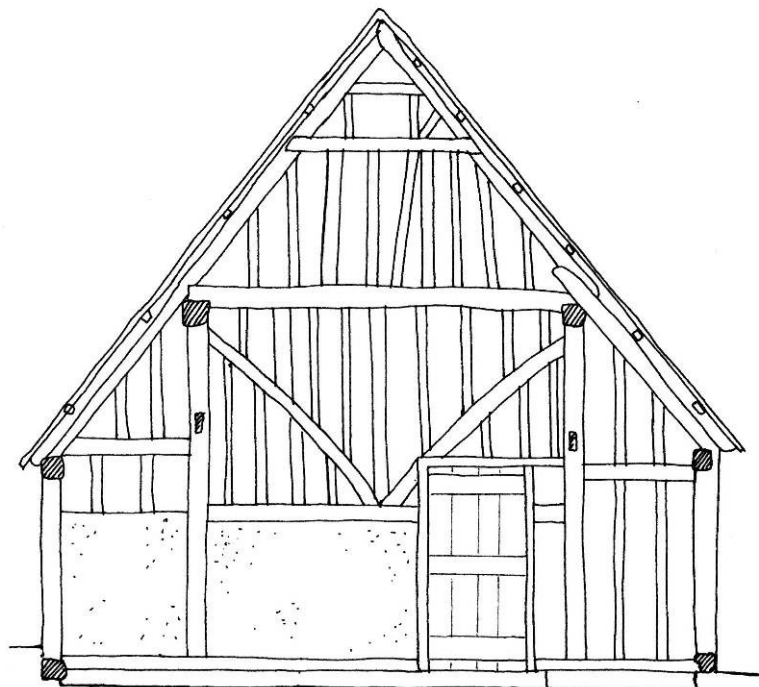
South gable

The south bay is an extension. Its top plates have been added to those to the north. On the west side in this bay, there has been subsidence and the top plate has dropped dramatically. The posts in the south wall do not have jowls and there are large primary braces, features characteristic of later timber framing. South of the midstrey, the west aisle has been rebuilt and widened. The aisles at about 900mm wide are narrow. Here it is now 1.4m, though whether this was done to increase capacity or because this part of the barn was in need of repair is uncertain. The original position of the aisle top plate can be seen where there is an empty housing for it in the mid rail of the midstrey. The aisle top plate continues into the southern bay and so this was done when, or after, the barn was extended. These alterations probably occurred in the late 18th or early 19th century.

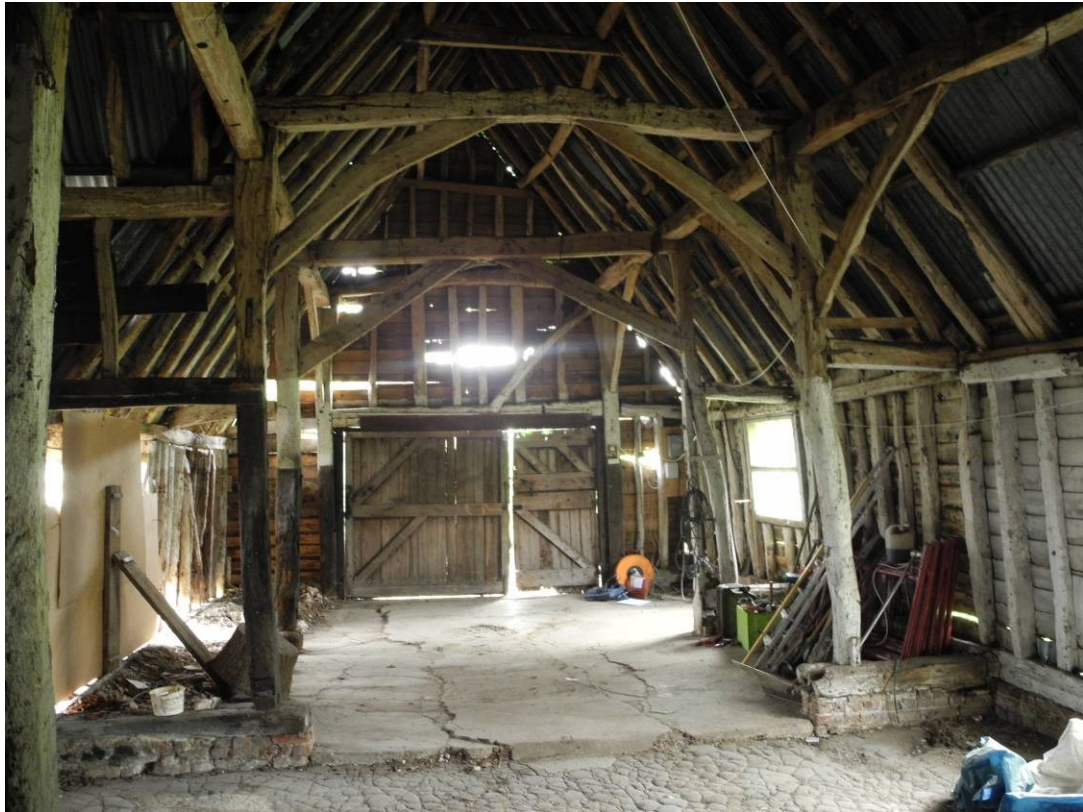
Interior of the barn, looking north

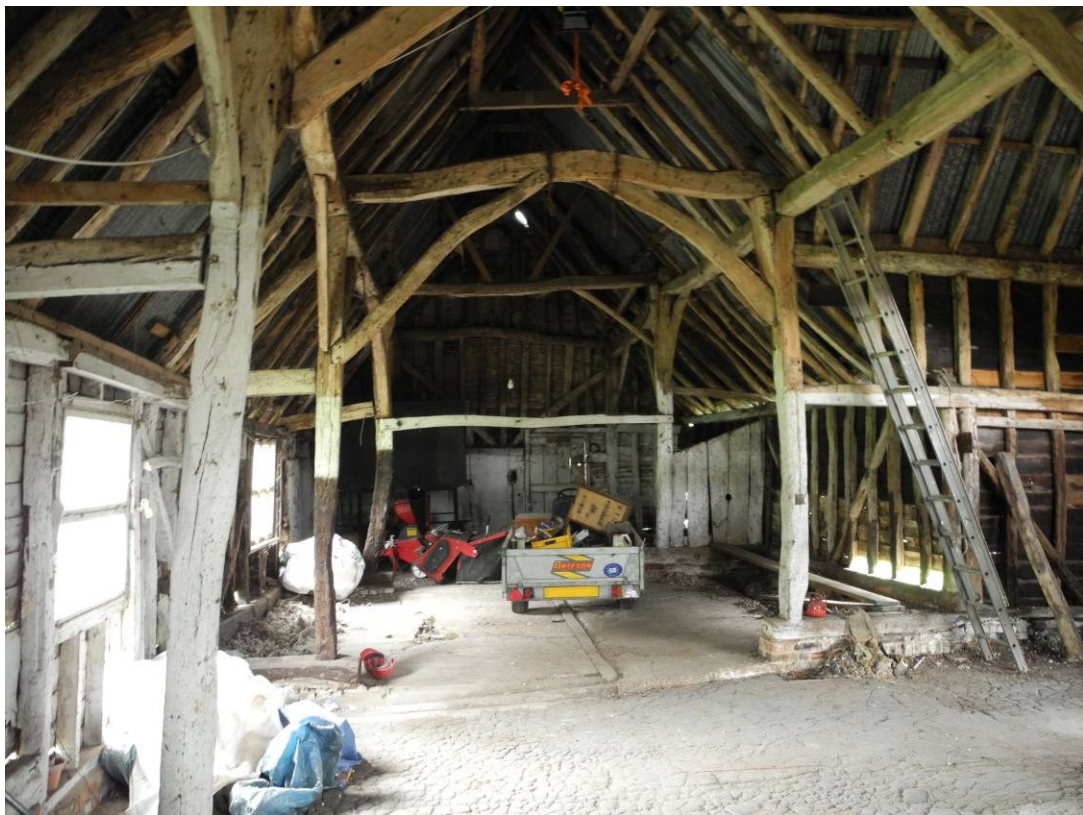
Interior of the barn, looking south

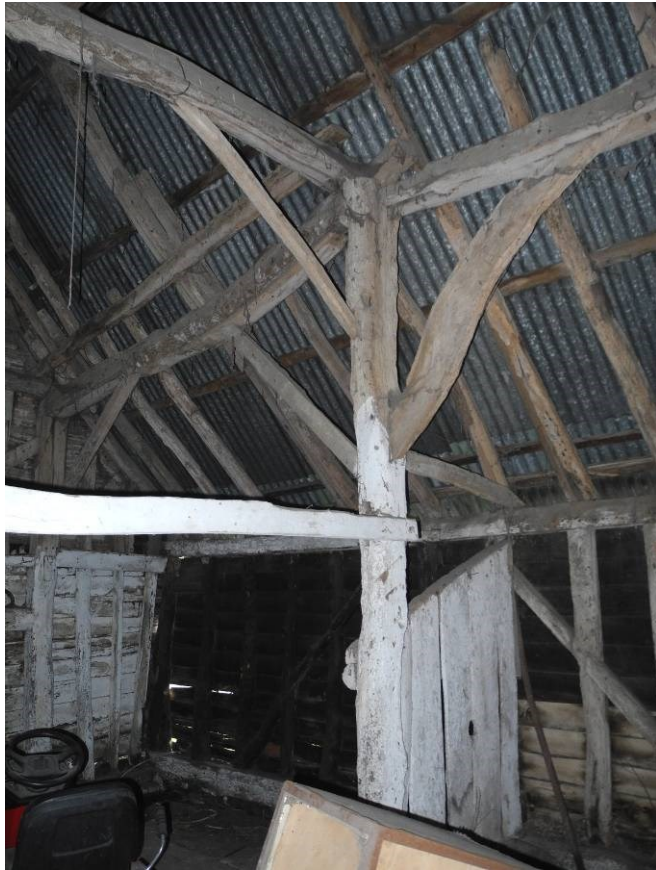
South-east corner of the barn, with surviving wooden stable partition

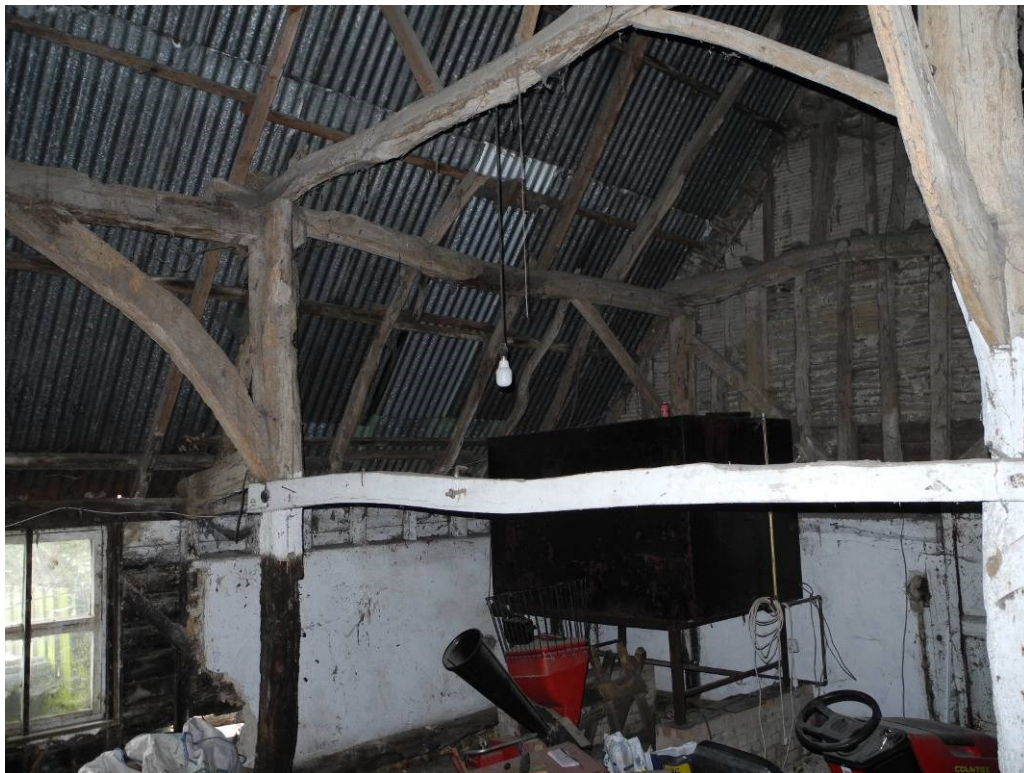
South-east corner of the barn, with rendered walls for stable use
