Ancient Monuments Laboratory
Report 64/97

WALL PAINTING CONDITION AUDIT,
KEMPLEY, ST MARY'S CHURCH,
GLOUCESTERSHIRE

J Davies
T Manning

Kempley, St Mary's Church Gloucestershire

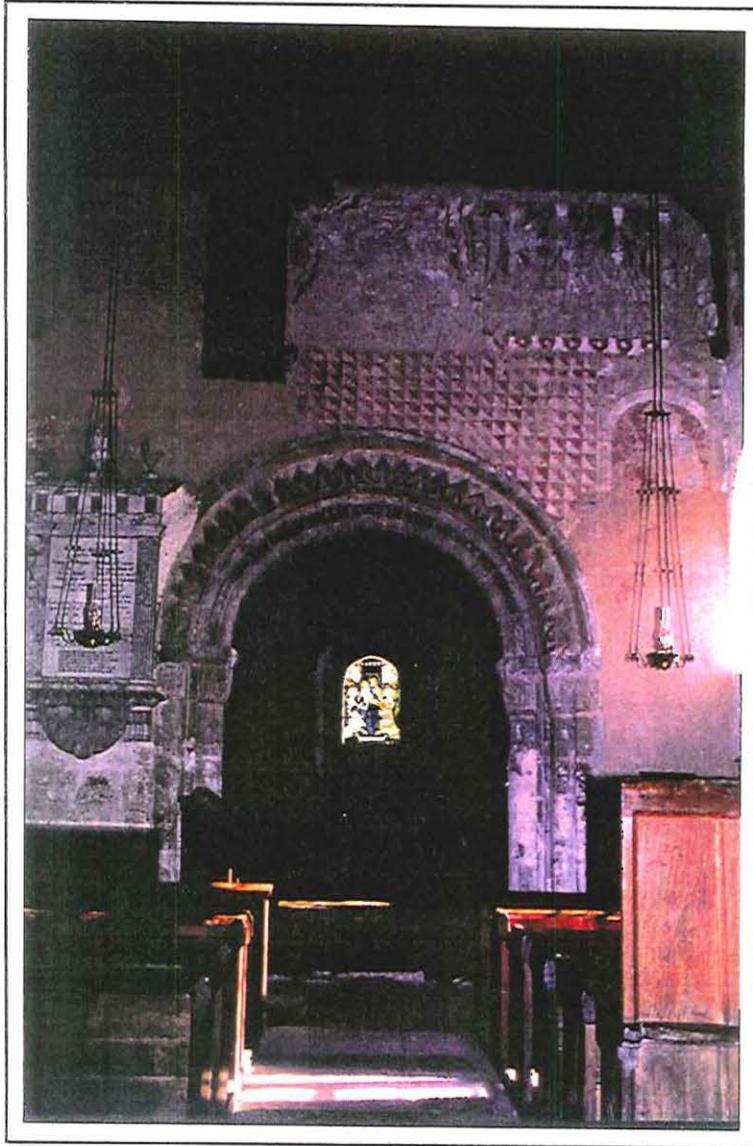
Nave, general view to east showing 12th-century decoration over the chancel arch

Overall condition score **3**

This contraction and micro-flaking of the paint layer is still visible over the chancel arch, especially in the centre (within the chevron pattern) and near the figure on the south side and it is not clear whether this deterioration is active. A programme of treatment to attempt to continue fixing of the paint layer would therefore be desirable. [Timescale: 2 conservators, 1 week].

Comments Appears to be related to ongoing structural movement. This is visible within a repair (probably dating from 1979) on the south side, which has cracked along the lines of a previous fissure.

Routine visual inspection should also be carried out of the cracking on the south side in order to detect any further structural movement.

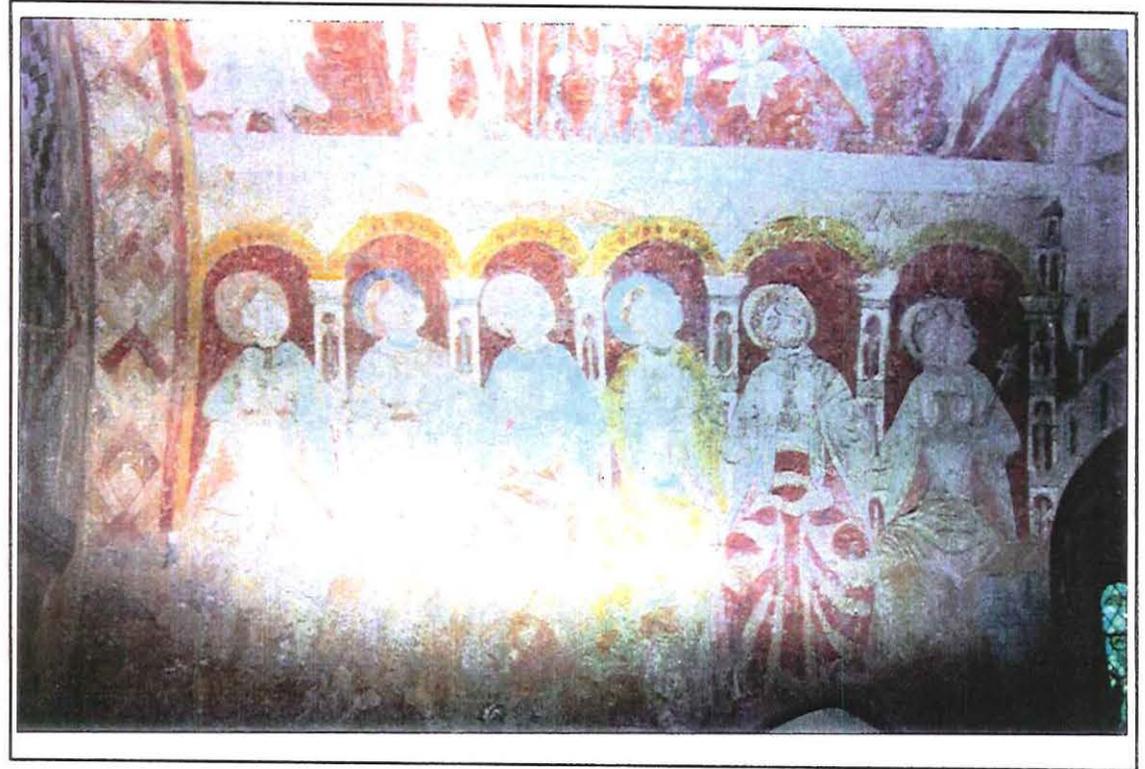
Chancel, south side, 12th-century scheme including seated apostles

Overall condition score **2**

Comments Cracking appears to be associated with structural movement and possibly delamination of the render.

Comments The lower walls have twice been replastered since 1954 (1955, 1983). Salt efflorescence noted in north-west corner, crystallised in pattern of ashlar blocks. Damp appears to be an on-going problem in the chancel, as green MBG is present to the north corner of the chancel step. The drain to the exterior of the north wall requires clearing. The drain to the corner of the north walls of the nave and chancel appears to be blocked solid and requires clearing.

As these paintings are of great historical and artistic importance, routine inspection of the paintings and fabric should be undertaken to ensure their stability. Regular inspection of drains, guttering, etc., is also necessary. There have been severe problems related to damp (salt crystallisation, algal growth) in the past, and therefore the situation should be monitored. It should be noted that at the time of inspection, there was some green microbiological growth at the base of the chancel arch (north side). At the base of the walls, a white efflorescence is also visible within the Baker repairs (north wall of the chancel), forming a pattern which follows the pointing in the support. These large repairs to the dado level are the second ones applied by the Bakers (as a similar pattern of deterioration took place twenty years after their initial work here), and it is probable that within the next 10-20 years these repairs will have to be replaced.

The room above chancel vault should be inspected. It was noted during this audit that a strong breeze came through it. The roof and window should be checked and made secure if necessary.

Some minor flaking on the north side of the east wall, caused by the contraction of remaining preservative on the surface could be consolidated. However, as was found during the 1990 treatment of the flaking on the chancel arch paintings, it may be impossible to reduce the preservative without the loss of original material.

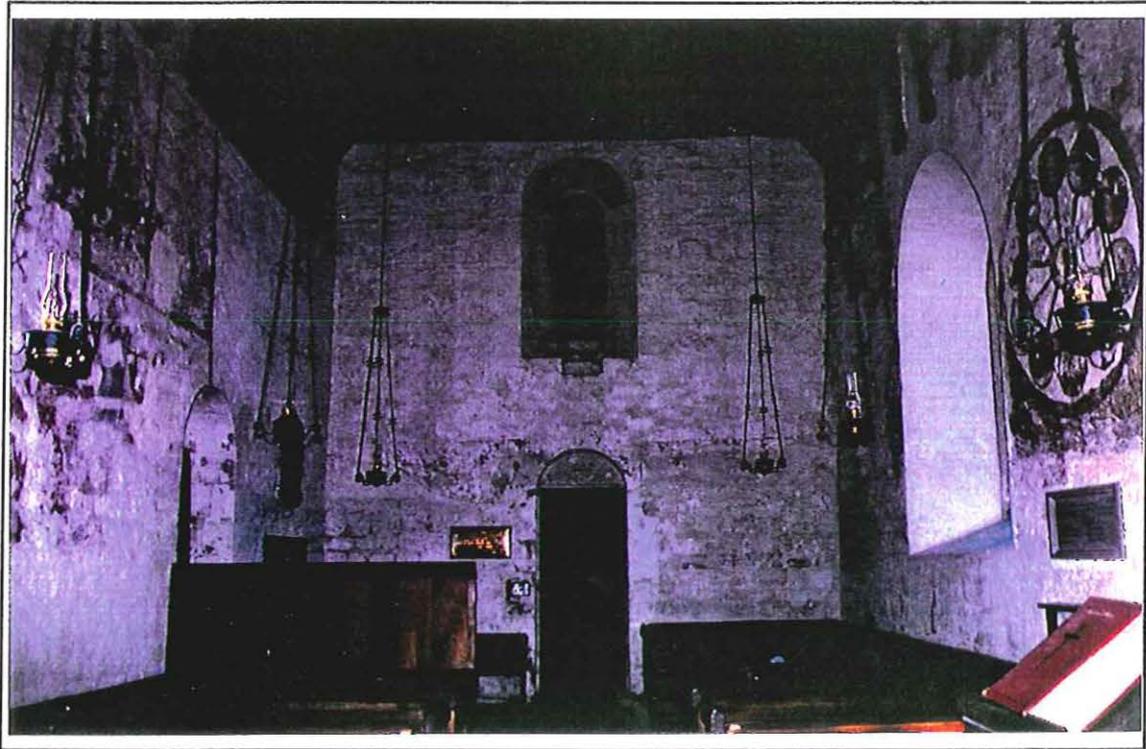
Nave, general view to west, showing the various schemes of medieval decoration on the north and south walls

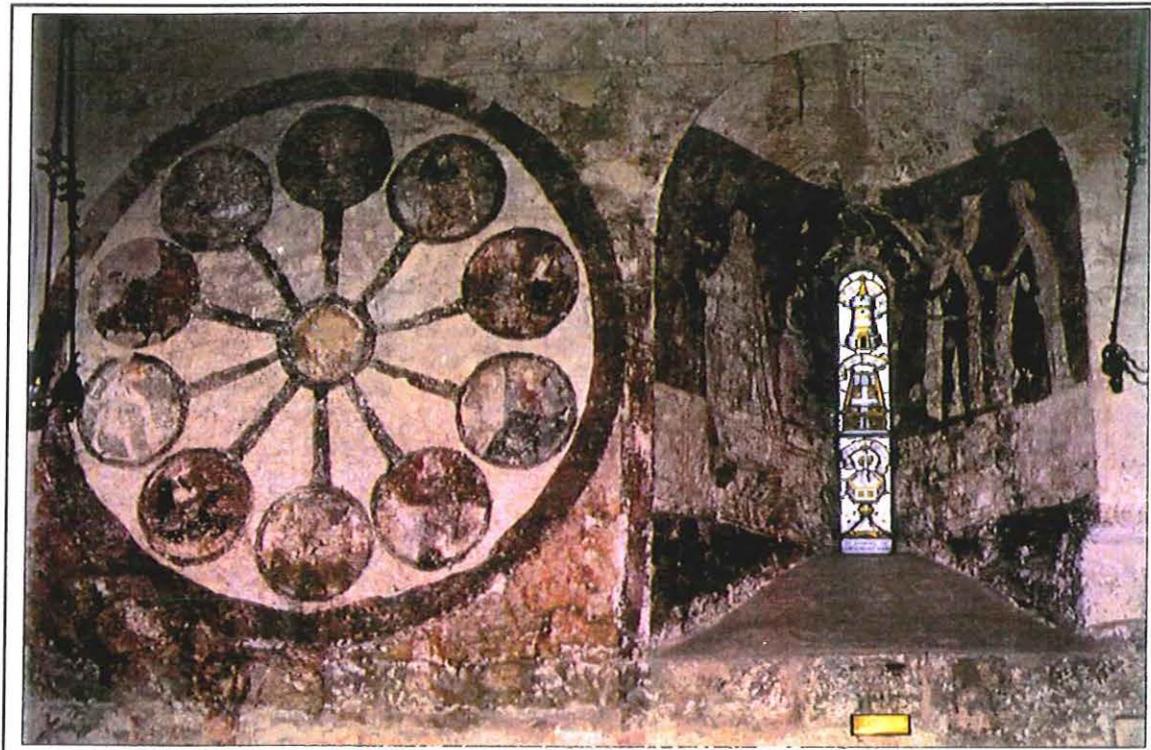
Nave, north wall, detail Wheel of Life and east window

Overall condition score **3**

Type cracking
Location general
Comments Ground layer has old cracks, probably now relatively stable.

The delamination of the paint layer requires stabilising. However, further treatment proposals including cleaning are problematic as areas of preservative, overpaint and numerous repairs, as well as dirt and dust, confuse the original appearance of the scheme. Further decisions could be made after a programme of light surface cleaning and flake fixing. [Time scale: two conservators, 1-2 weeks].
