St Paul's Cathedral

Cleaning and refurbishment projects 2003–5

John Schofield
Cathedral Archaeologist

2005, revised 2014

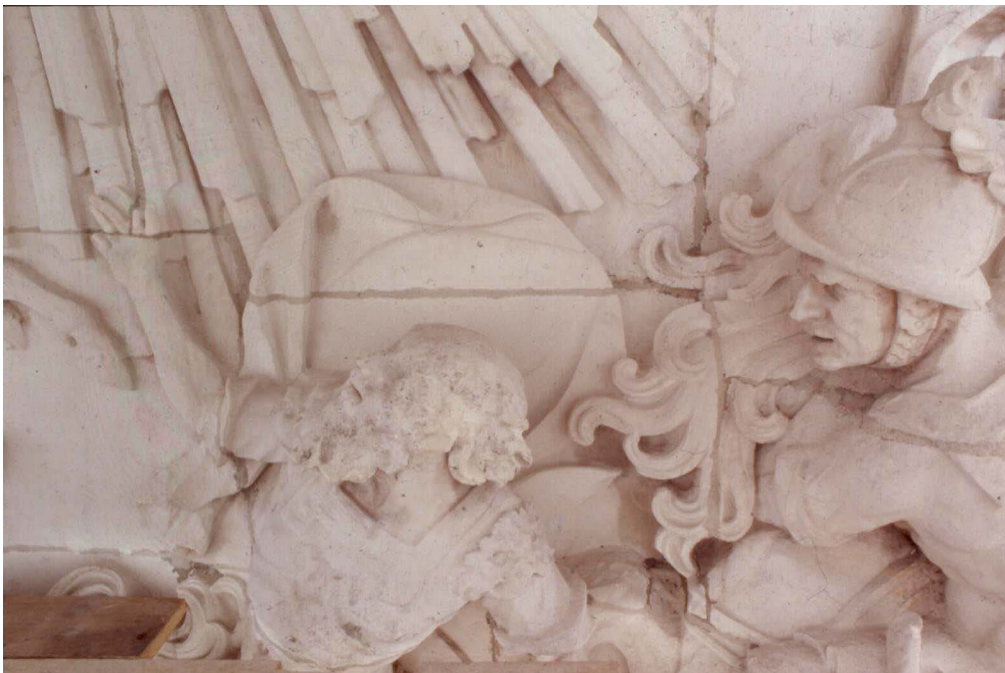
Fig 5 The pediment at the west end: St Paul (left centre, weathered)

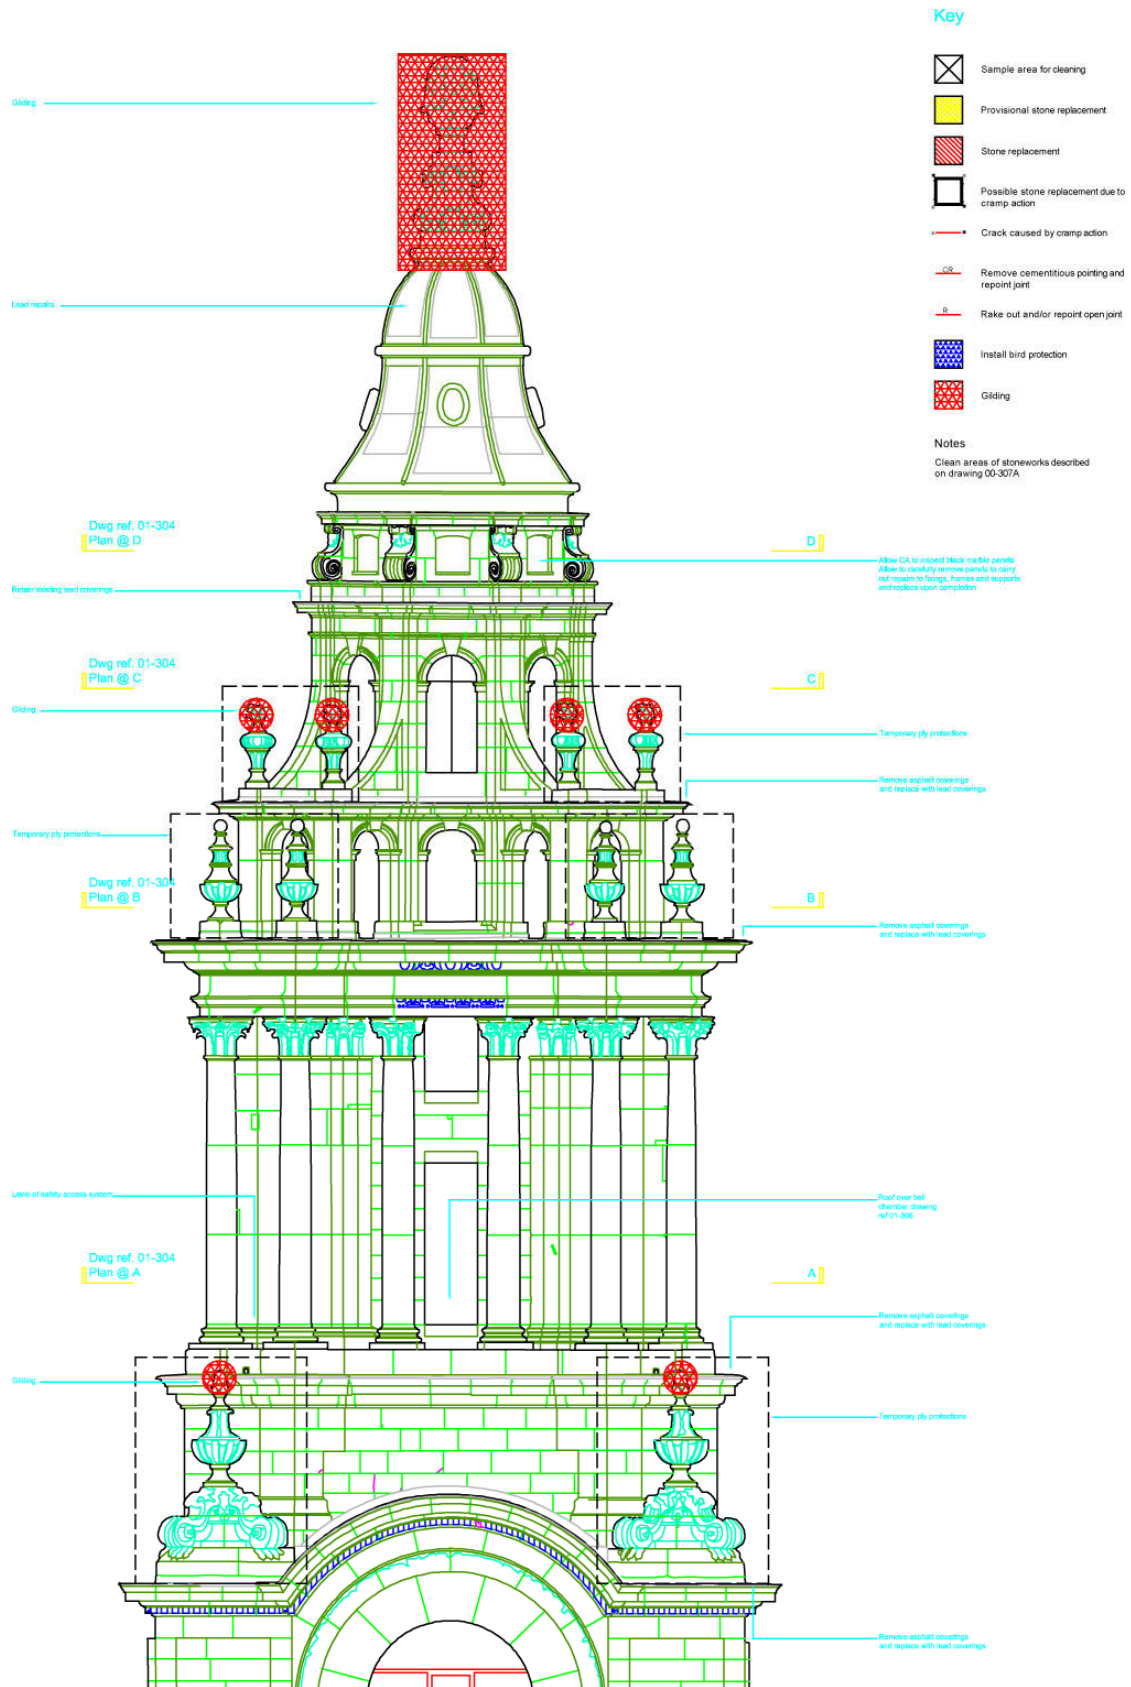
Fig 13 Tender drawing 01-300A by Purcell Miller Tritton, showing repairs proposed on the north elevation of the north-west tower

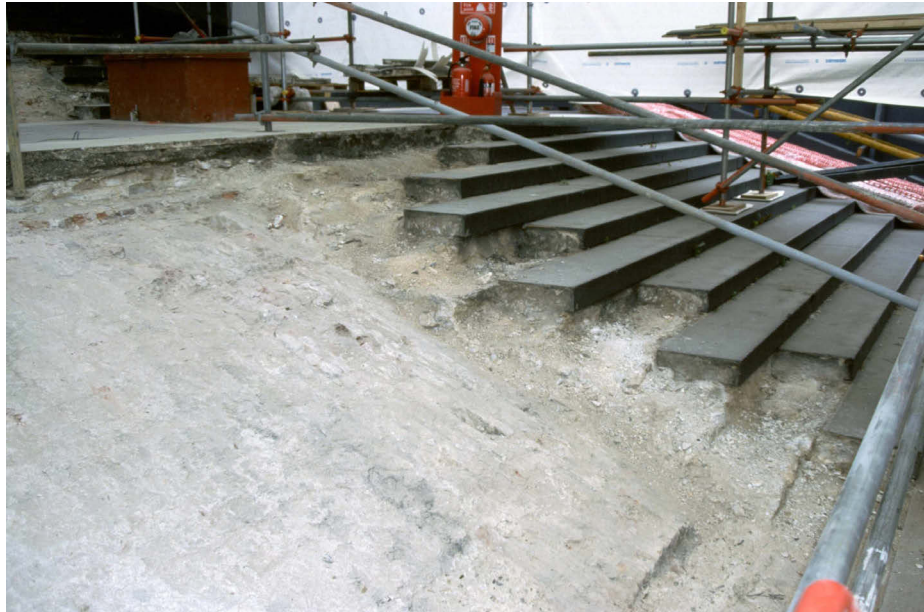
Fig 67 The substructure of the Wren steps, looking south, with the pre-restoration steps of the south part still in place

The substructure of the Wren steps was exposed, but not investigated (Fig 67), as it was not to be disturbed. It comprised a rough concrete screed probably laid down or amended by Penrose. This screed layer lay on top of the vaulting of the Wren stairs, which could only be roughly surveyed as it was greatly obscured by the screed. The sides incorporated one and possibly more low arches of brick to form tubes which ran into the vaulted area (Fig 70), but these were not investigated further.

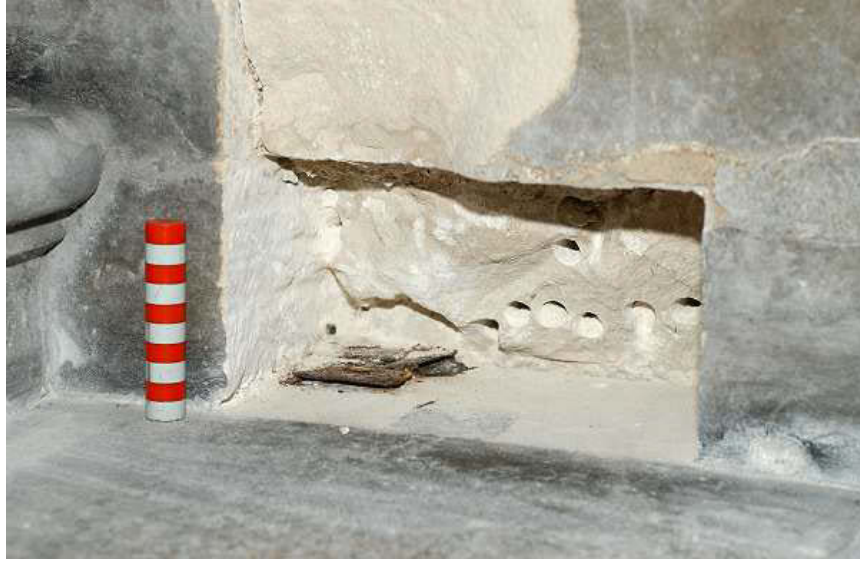
Fig 74 Detail of the investigation into the side wall of the stair. This shows the exposed iron shim which was inserted by Kempster to tighten the joint between the tread and the surrounding wall; each tread has its end inserted into the wall. Scale is 10 x 10mm units

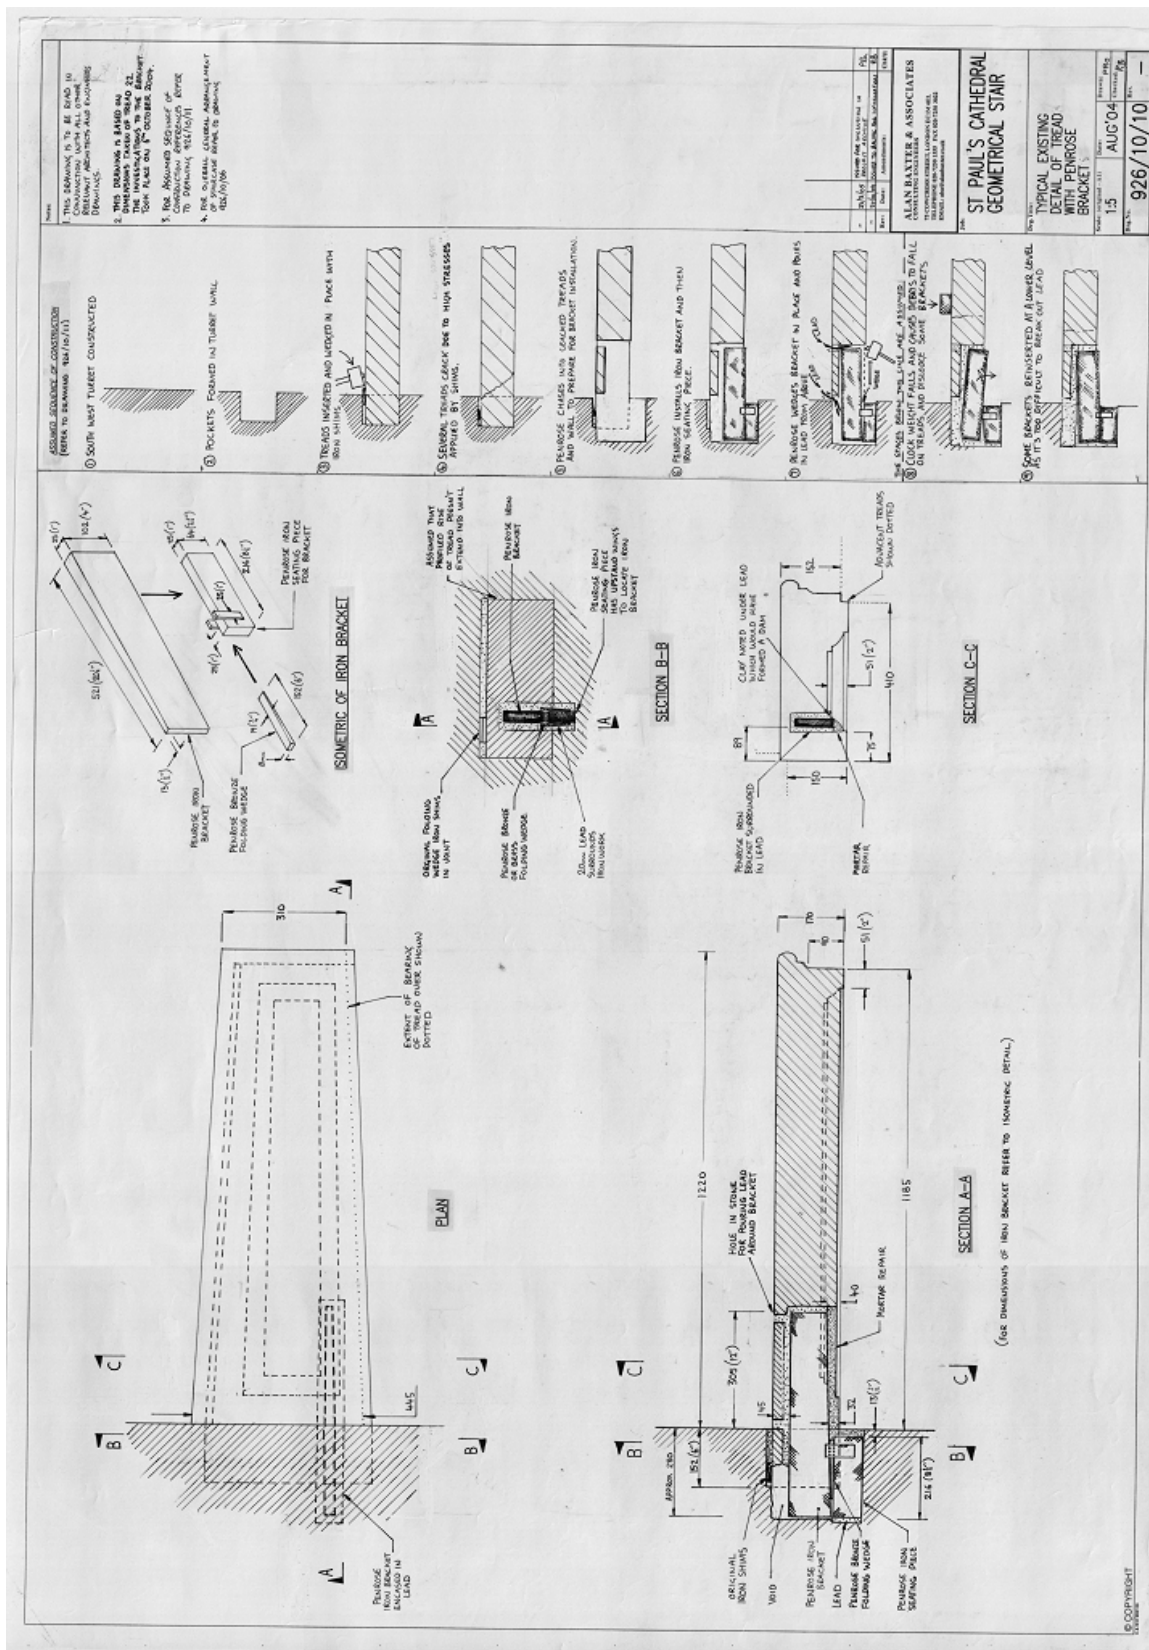
Fig 75 Analysis of a step in the Geometric Stair by Alan Baxter and Associates, 2004 (drawing 926/10/10)

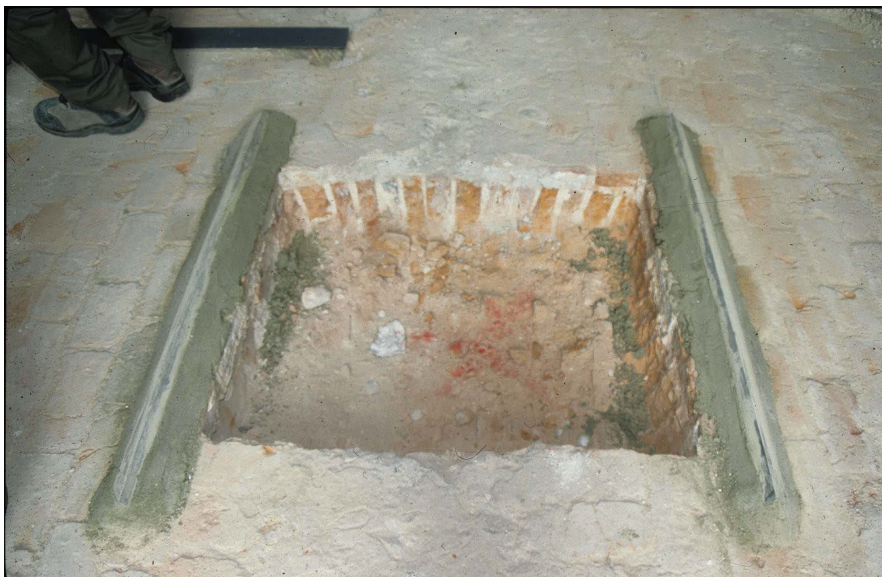
Fig 78 The area of the crypt vaulting, within the NW doorway, which had to be removed to install the new revolving door, looking E; the crown of the crypt vault is shown. This is the site of the sampled bricks [2]

The two bricks from context [1] are in MoL fabric 3032, although one of them has fewer organic/burned inclusions and rather more calcium carbonate than usual. Dimensions are given in Table 2. Both bricks have blackish surfaces, probably the result of slight overfiring. In that respect, they may be regarded as ‘seconds’. But they were used in a utilitarian structure within the cathedral, the substructure of the west steps: for such an application they were entirely serviceable products.
