LANGLEY GATEHOUSE, SHROPSHIRE

A Structural Survey

Birmingham University Field Archaeology Unit

December 1987

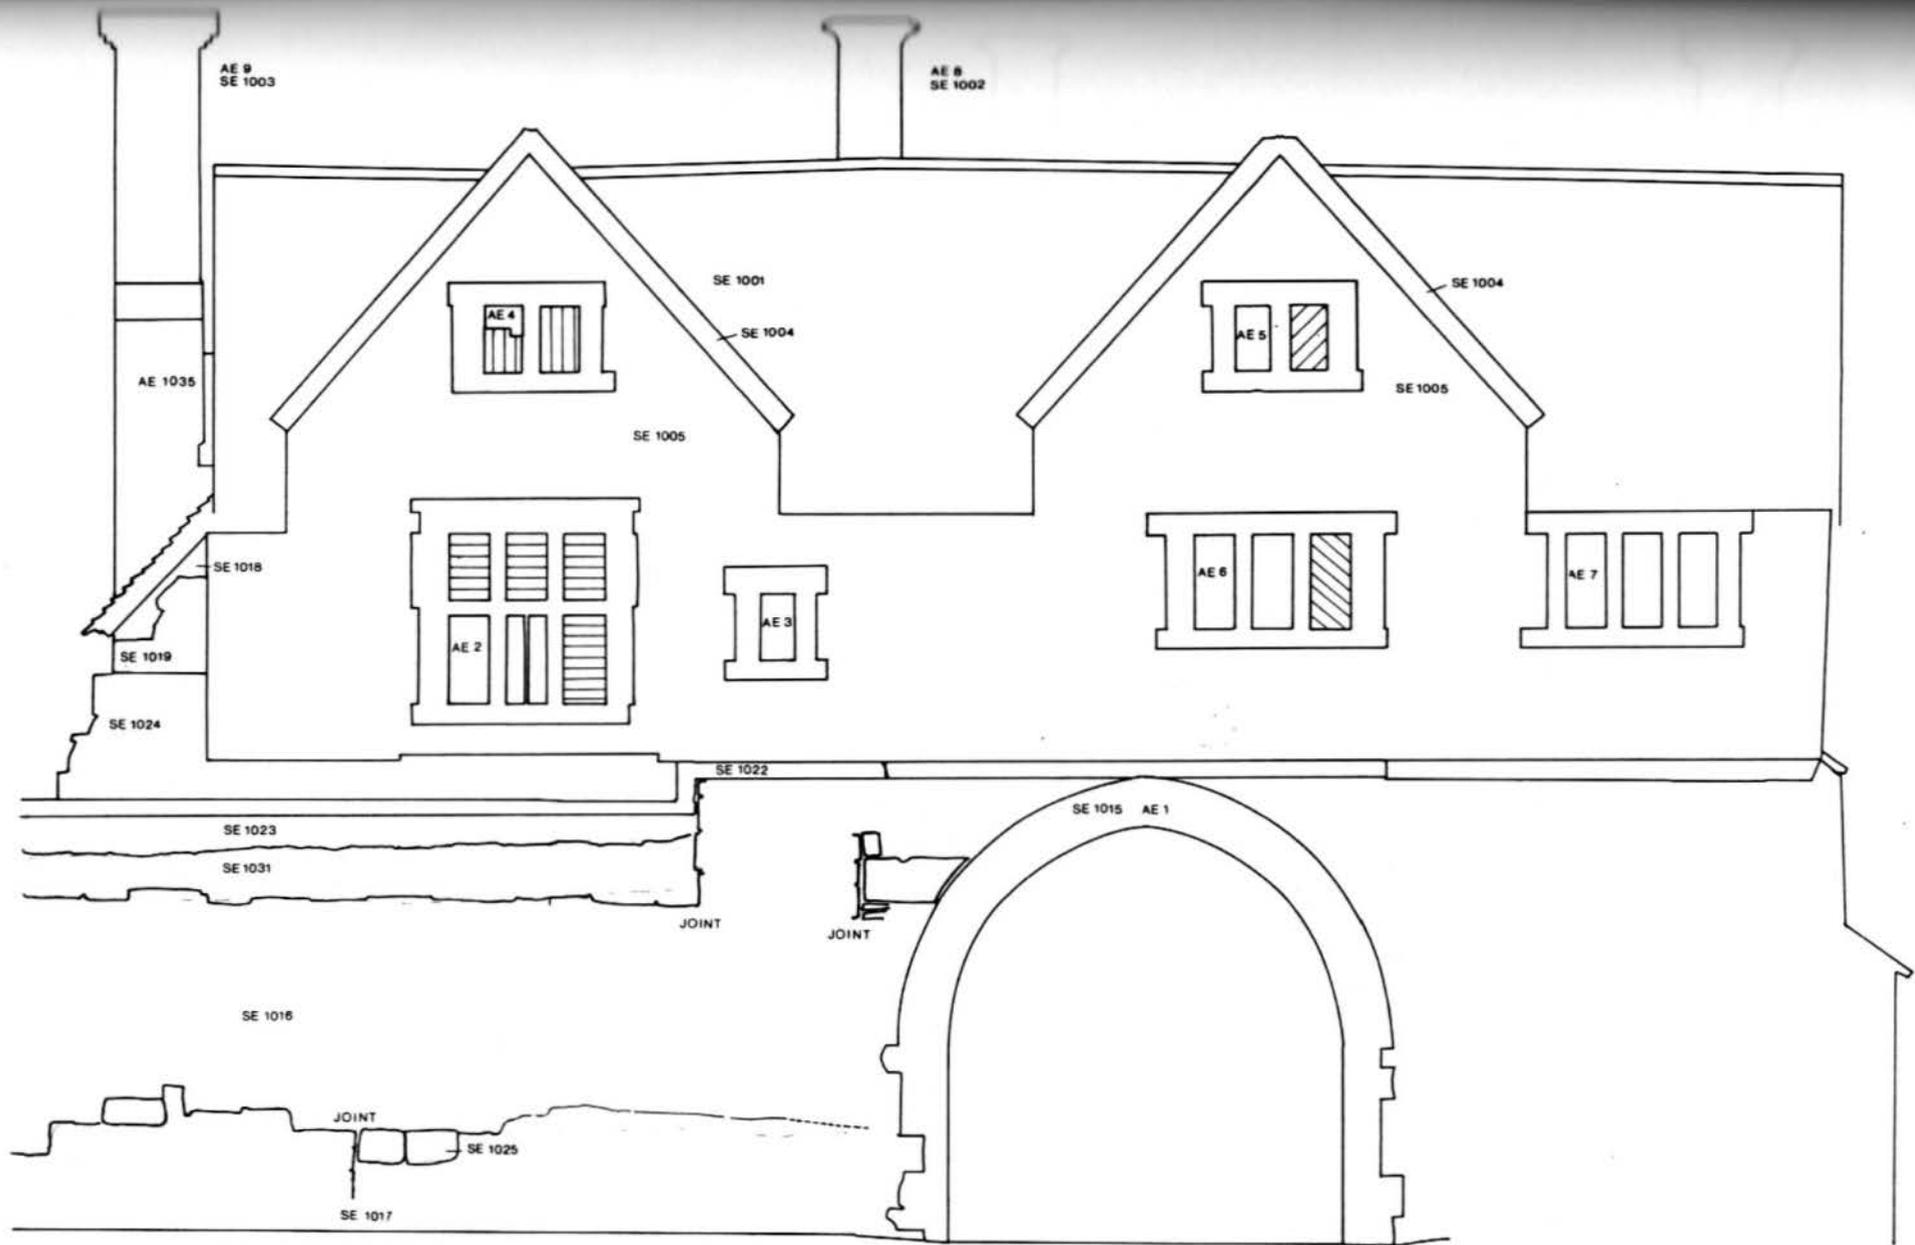
Fig. 4 West Elevation

An examination of the internal arrangements suggests a composite structure and this is borne out by a study of the individual elevations (Figs. 4-7). The west or front elevation retains its power to impress and consists of two storeys, built and faced in stone, pierced at ground level towards the southern end of the building by a double-chamfered stone archway (AE1). The roof, of tilestones, is of uniform pitch and is here viewed side-on, though this elevation does present two gables whose position in relation to the arch below spurns the beauty of symmetry. The rooves of the gables, again of tilestones, are pitched at 45 degrees. The lower part of this elevation is constructed, with the exception of the fabric of the arch, of irregular, unfaced sandstone blocks, the upper of well-cut faced and finished ashlar sandstone blocks; the two builds being separated by a chamfered stringcourse (SE1022) that is stepped beneath the northern gable and itself consists of two distinct builds. At the northern end of the elevation the rough stonework is bonded into the breezeblocks of a byre while the wall face to the south side of the arch is obscured by a modern shed or garage whose back wall, the face of the gatehouse, is whitewashed and upon which hangs, high up, a bicycle suspended like a piece of Daliesque furniture, these elements conspiring to prevent an examination of the stonework here in detail. The upper, finer, stonework is pierced by a number of windows. At first-floor level the northern chamber is lit by a large

window (AE2) with chamfered surround, divided into six lights by a chamfered mullion and transoms (four of the lights now being bricked up), and a small single-light window (AE3), again with a chamfered surround. The central and southern chambers at this level are each lit by similar windows (AE6, AE7) of three lights, with mullions and chamfering, one light of window AE6 being bricked-up. The roof or attic space is lit by two windows (AE4, AE5), positioned one towards the centre of each gable. Each has two lights, now either wholly or partially bricked-up, and in the same style and finish as the other openings below.

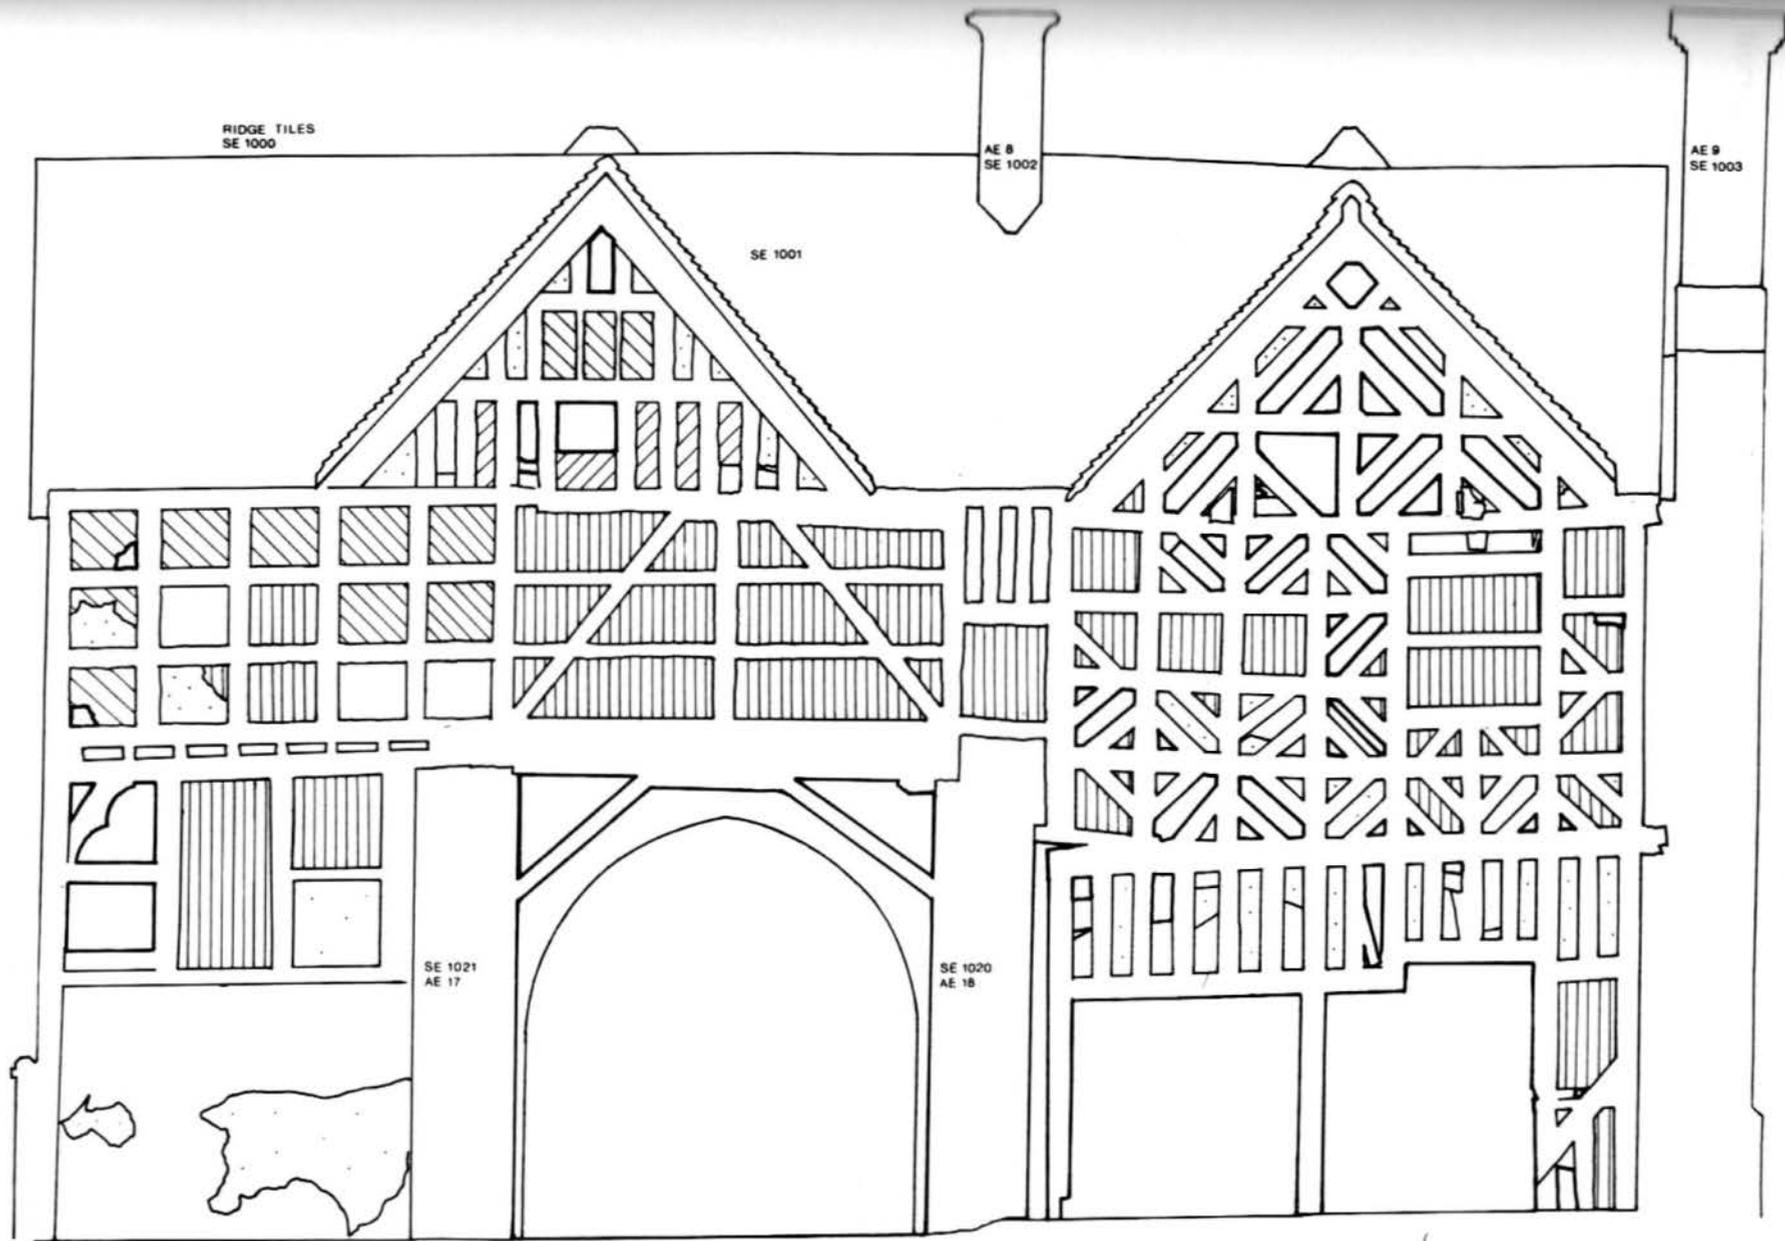
Fig. 5 East Elevation

The back or east elevation presents a complete contrast to the front in terms of both appearance and construction. Here the entrance passage is not framed by an elaborate arch; rather the opening is rectangular with a horizontal wooden lintel supported by two angled struts. To either side of the opening is a stone buttress built to first-floor level, that to the south (AE17) being different in style to its northern counterpart (AE18) though each is bonded into the stonework that forms the side walls of the entranceway. This elevation, presenting two gables as does the front, is built of timber framing, studding and strutting, the panels between the timbers being infilled with lathes, daub and plasterwork or, in places, with brick nogging. There is a predominance of diagonal strutting to the north end of the building, in contrast to the vertical struts employed in the south; this difference may be more than simply a case of aesthetics. A certain amount of timber and panneling can be assumed to have been removed to the north of the entranceway at ground-floor level for the face here is now largely open; it can be presumed that evidence for a doorway here, as there must once have been, was at the same time destroyed.

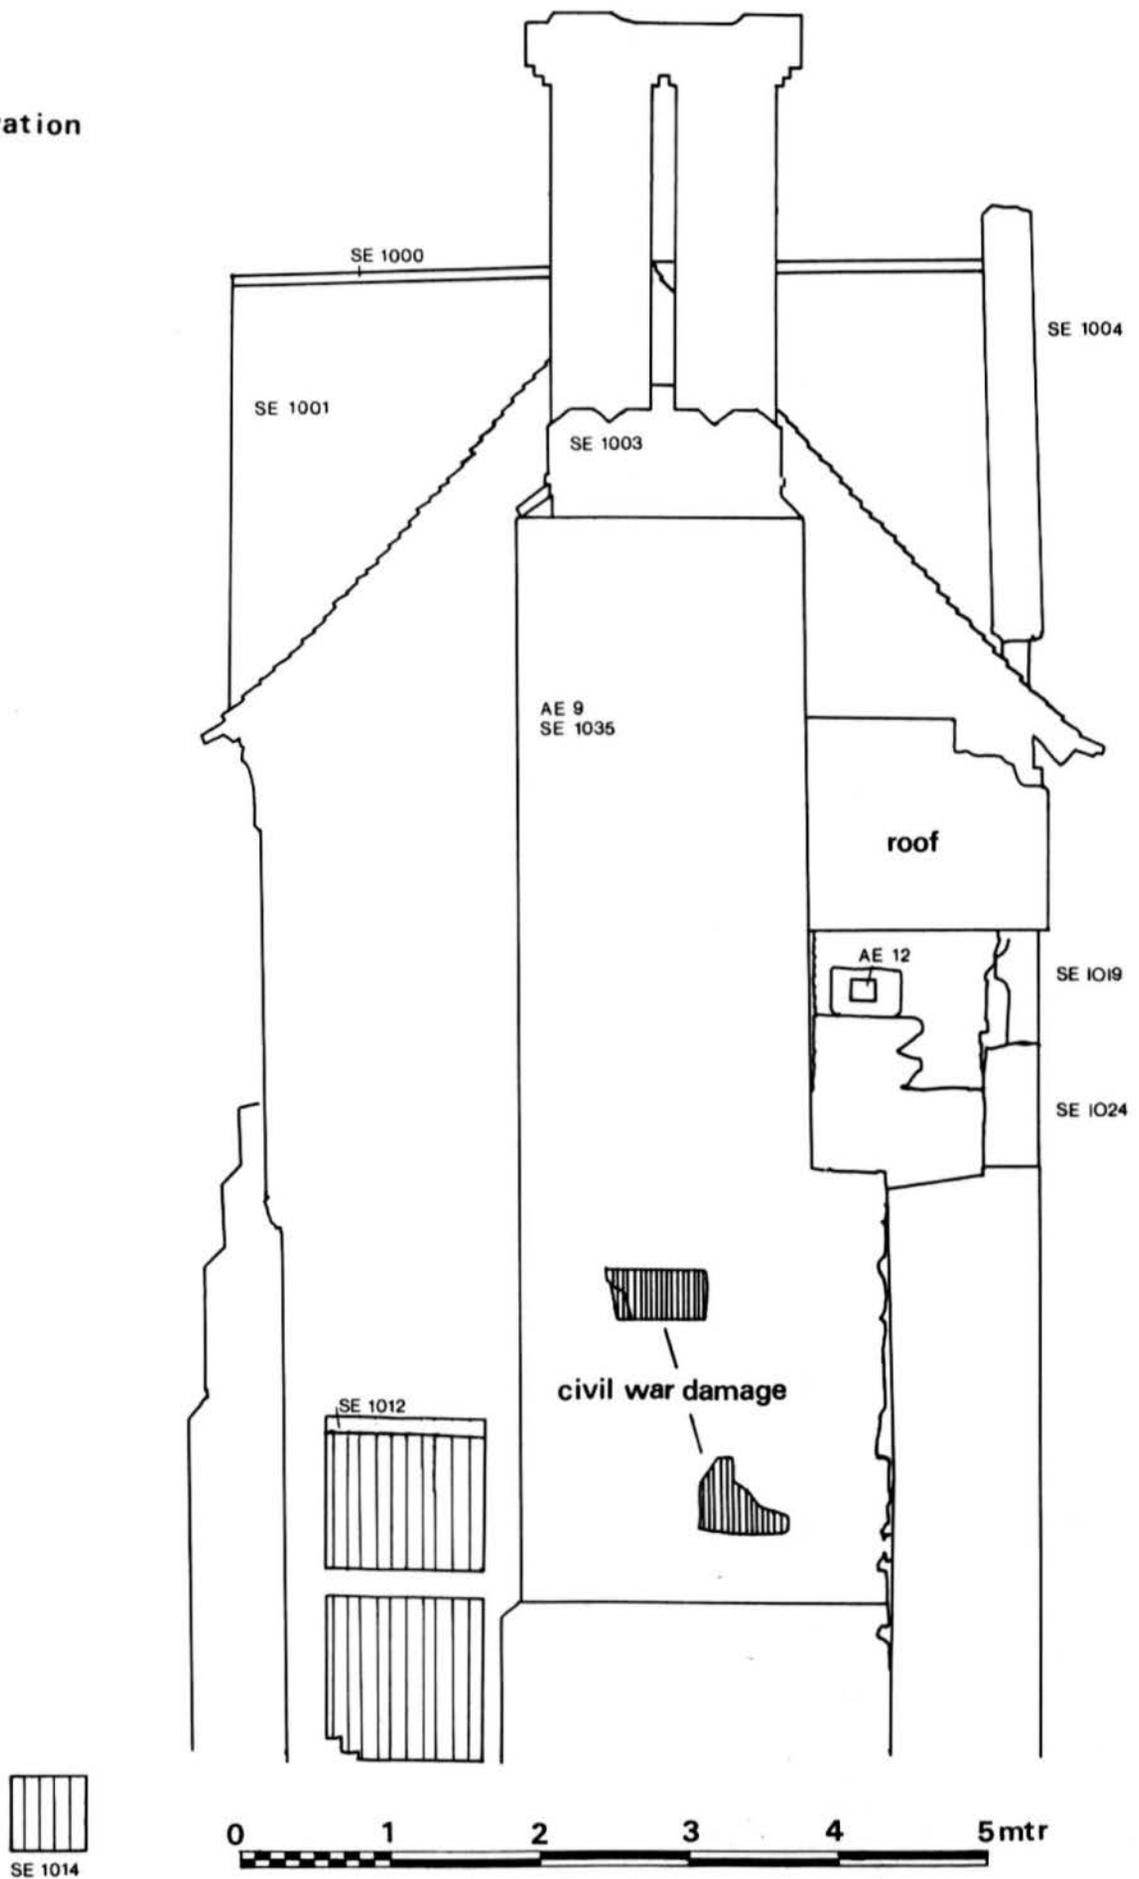
Fig. 6 North Elevation

The northern side elevation is dominated by a large external chimney stack (AE9) that projects out 1 metre from the main wall face at its base, the stack being built of well-cut and faced sandstone (SE1035), the chimneys, arranged in twin shafts with a star-shaped plan, of moulded brick (SE1003). To the east of the stack the main wall face is again timber framed with diagonal strutting, with much of the lower panneling infilled with brick nogging. At first-floor level is the projecting garderobe chamber, with a straight joint where it and the stack construction meet, built of sandstone with some brickwork and a tilestone roof. A number of the stones in the stack bear signs of damage that would be consistent with the effect of cannon shot but it is not known if any Civil War action took place here, though Sir Richard Lee, the owner of the house at the time, was a staunch Royalist.

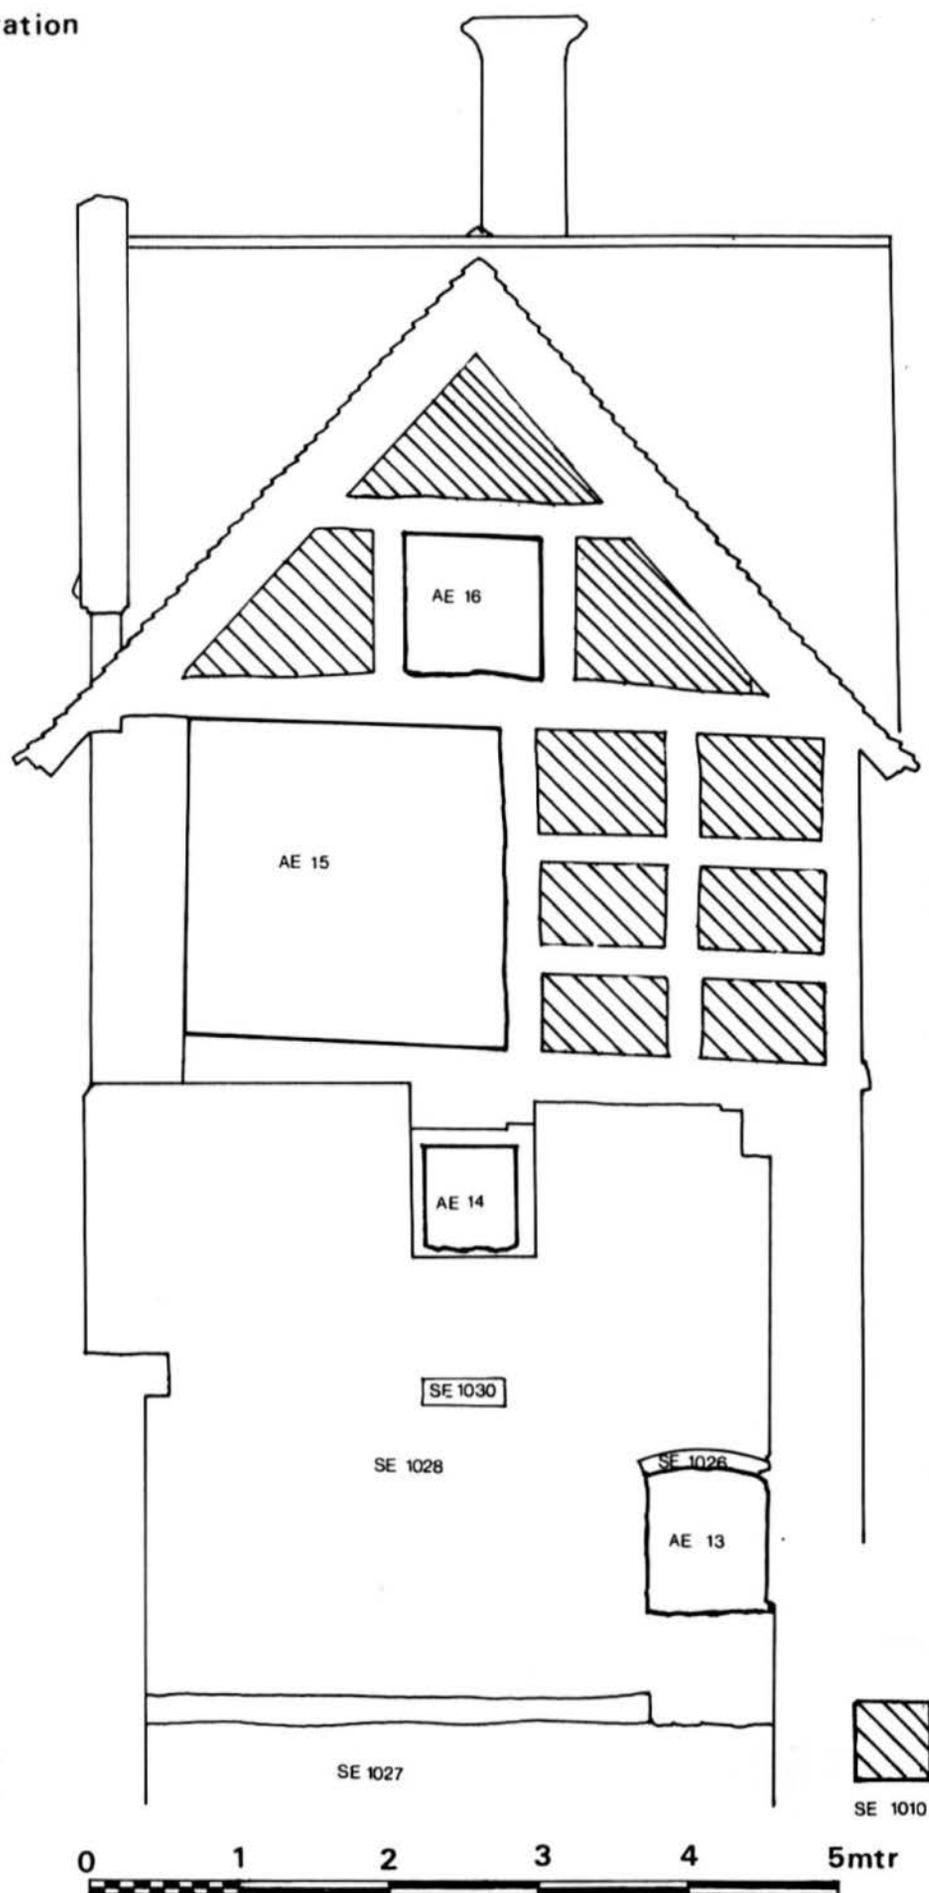
Fig. 7 South Elevation

The side elevation to the south is largely uninteresting, consisting as it does of a lower build of sandstone in rough blocks up to first-floor level, and mostly of obviously recent work, topped by a timber framing whose panels are now largely infilled with brick. The stonework is pierced at ground-floor level by a small, square window (AE13) with a brick-arched head, again relatively recent. Further up the face are three, variously sized openings (AE14, AE15, AE16), the largest of these (AE 15) perhaps marking the position of a former doorway giving access into the now-demolished cross-wing (see below).

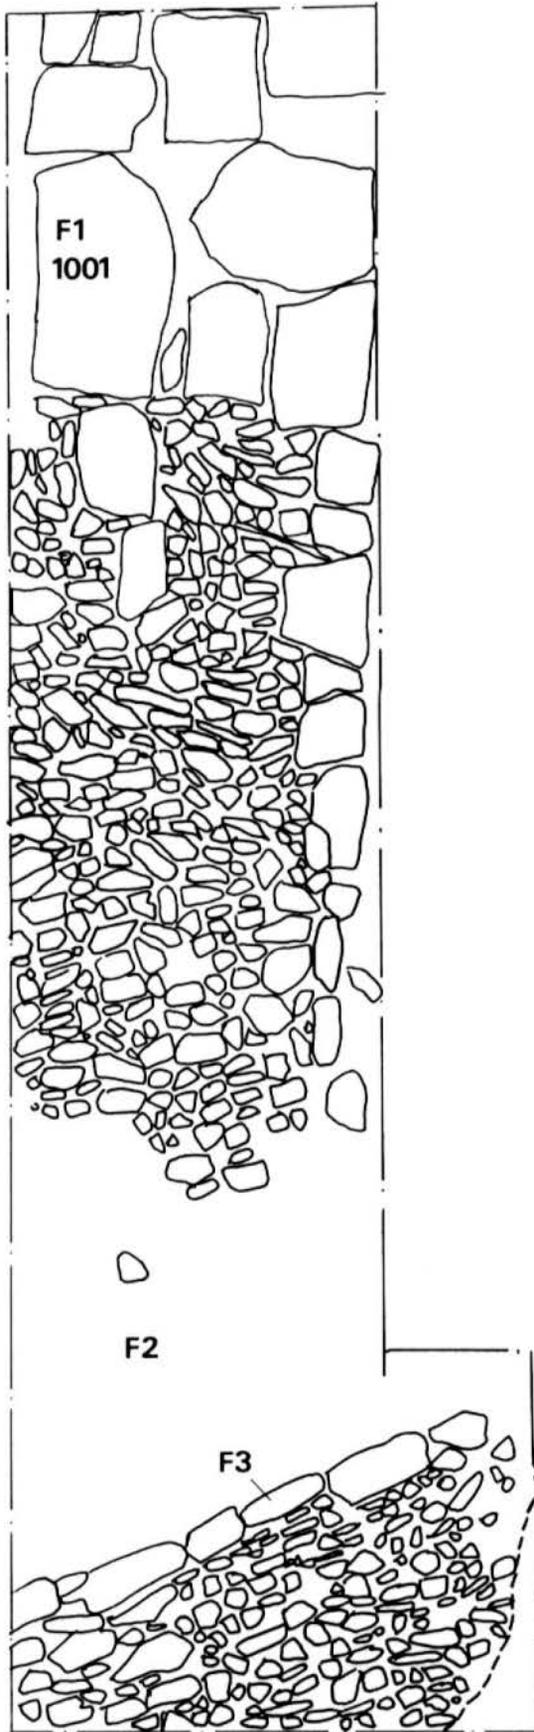
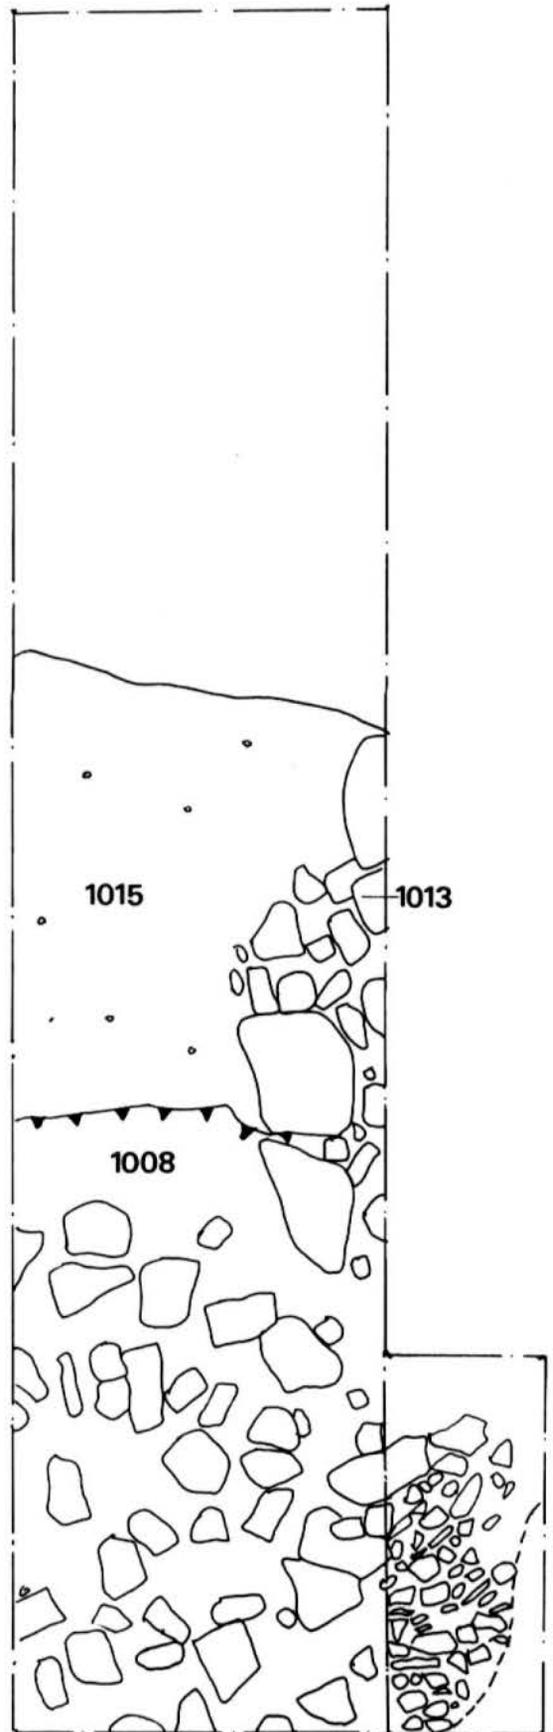
Fig. 12 Plan of Trench A

These trenches, after the removal of the topsoil (1000), revealed the considerable extent of the laid cobble surface (F1) that is best seen beneath the archway in Trench E. The cobbles, 4-10 centimetres in diameter, were bedded in a layer of fine sand and, in a number of places, sandstone blocks set flush with the cobbles and showing considerable signs of wear, formed an integrated part of the surfacing especially along the west edge of Trench E where they formed a kerb-like threshold. There is no reason to question the broad contemporaneity of the three isolated areas of flooring/surfacing

encountered in the three trenches, though they have each been assigned a separate context number (1001/f1 Trenches A and E, 1004/F4 Trench B). On removing the cobbles in Trench A two spreads of rubble or hardcore make-up were revealed, the uppermost (1002) containing brick, tile, mortar, charcoal and occasional pebbles in a sandy mortar matrix, the lower (1008) including coarser rubble and quantities of limestone tilestones like those employed in the roofing of the gatehouse. This trench was bottomed at 80 centimetres below the present ground surface, the full depth of 1008 not having been determined. After their exposure the cobbles in Trench E were cleaned, photographed and drawn but left in situ. In Trench B the cobbles covered only the west end of the trench, having been presumably cut away by a trench (F5) backfilled with brick rubble (1005), a layer of red brown sand (1016) exposed in the side of F5 appearing to run under the cobbling to the west. This trench was excavated at its east end to a depth of 40 centimetres, with the cobbles left in situ to the west, with context 1005 only partially removed.

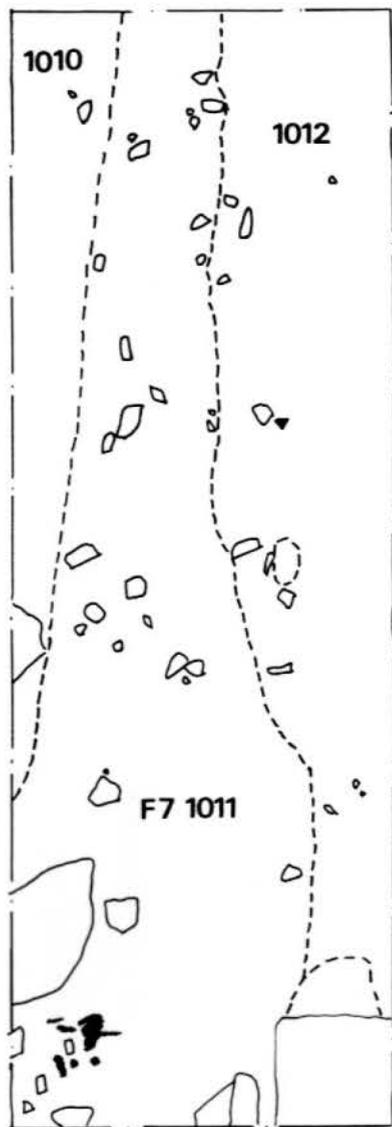
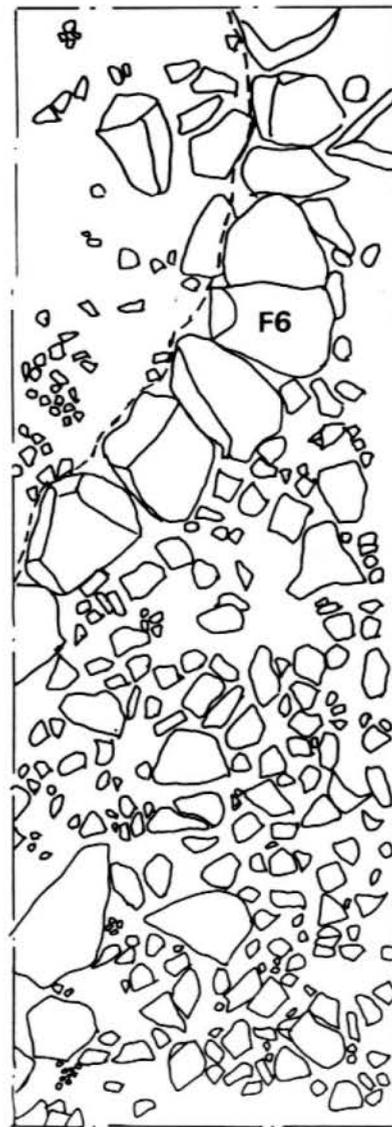
Fig. 14 Plan of Trench C

Under the topsoil (1000) was a compact, probably modern, deposit of hardcore (1006) containing much stone rubble and brick, post-medieval pottery, the skeleton of a dog and quantities of cattle bones, perhaps suggesting that there is a huge backfilled shallow pit here. Some 35 centimetres deep, its removal revealed a surface of sandy clay (1010, 1012) cut by a possible robber trench (F7) whose backfill was a mixed dirty silt clay with much sandstone flecking. No further earth was removed in this trench.
