Mottisfont Tythe Barn, Mottisfont Hampshire (SU 325 268)

Historic Building Record 2009-2010

November 2010

Souterrains Project No. SOU10/059

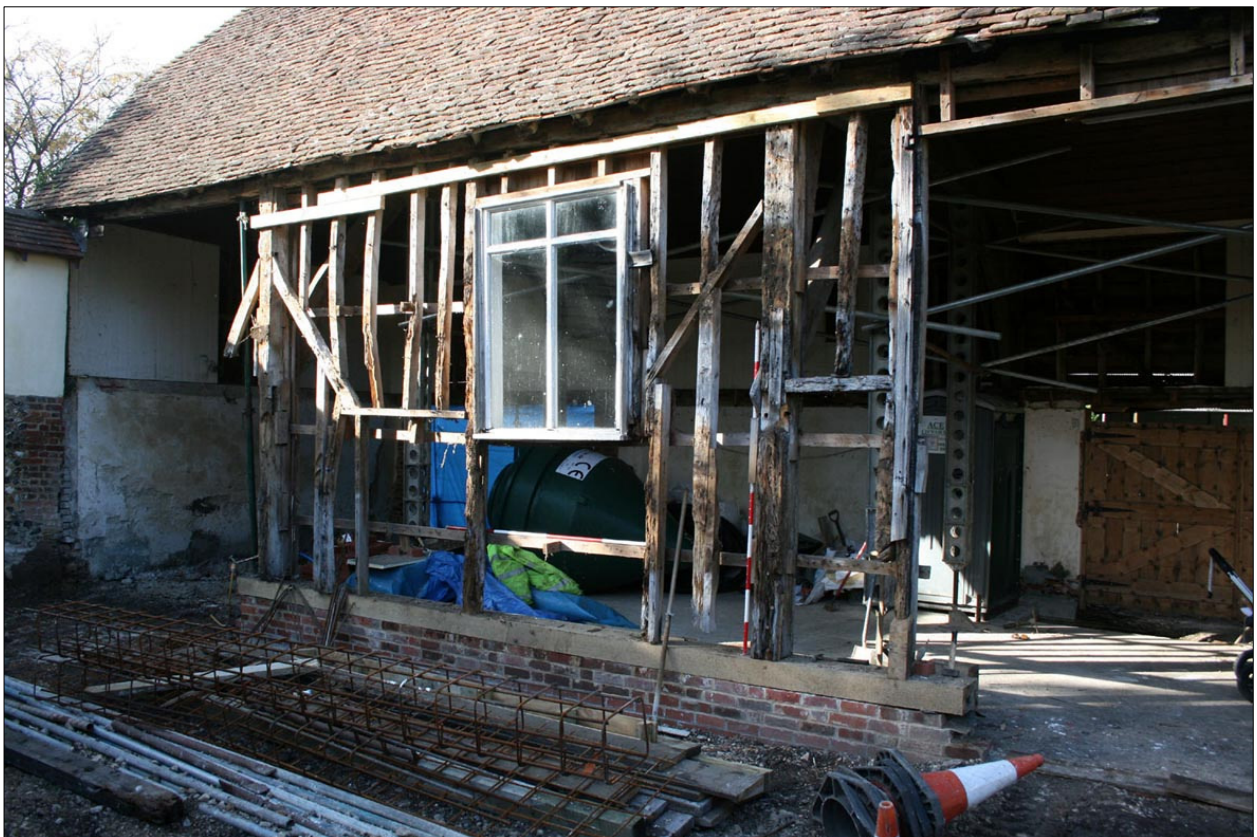
- 4.3 Removal of the weatherboarding from the south elevation revealed that many of the structural elements had either seriously decayed or were completely missing; sills were absent and most main posts, rotten at the base, were scarfed with new oak timber during the restoration (Fig.11). Other than the principal post of cross-frame 2, there was apparently no Phase 1 or Phase 2 timber work present after the removal of the 20th century cladding⁹; a possible open access to an adjacent building in the 19th century (*ante*. 3.1) might account for this. The priority to secure the structural stability of the south frame determined the course of the restoration programme, during which the roof was supported by a purpose-built steel scaffold.

Fig. 11. Bay 1 and 2. Remains of medieval and post-medieval timber framework in the south elevation. Facing north-west.

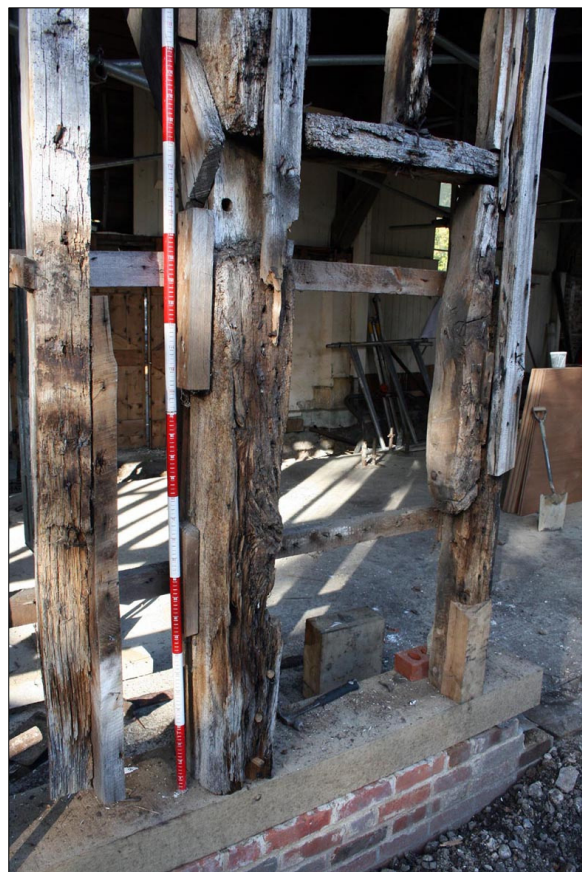
- 4.6 The north and south elevations retain their original principal posts. In the preliminary analysis (Roberts, 2007) it was suggested that this bay may have contained the Phase 1 wagon entrance, on account of bays 4 and 5 having evidence for loft floors, and given that wagon entrances were usually in the centre of a barn in order to minimise labour. In this respect; therefore Bay 2 would have functioned as a 'central' bay. In support of this theory there are no mortises present in posts 2 or 3 for down-swinging curved tension braces (Figs.18 and 20), as seen elsewhere along the north elevation. The timber framework of the north elevation, including wall plate, belongs to Phase 2; the lower beam of the framework consists of a re-used mid rail turned onto its side (Fig.20). The lower part of the south elevation was not seen by the archaeologist during the development, although he was informed that there were no remains of sill beams or the original ashlar plinth. Few storey posts (i.e. those which rise between and wall plate) survive in the south elevation, their lower portions rotted away, were scarfed to new timber during the restoration (Fig.19).

Fig.19. Cross-frame 3,(S). Principal post (centre) and Phase 2 storey posts, set upon new sill. Facing north-east.

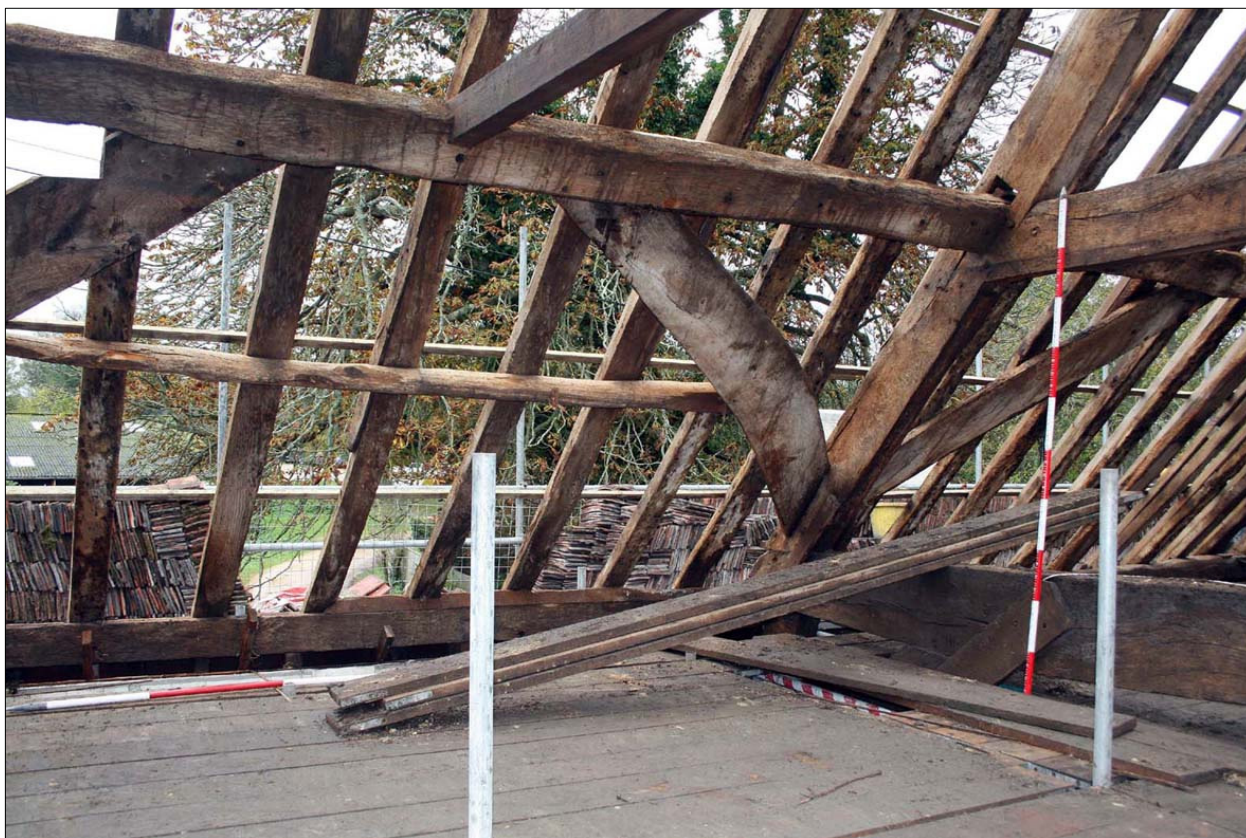
- 4.7 Most of the roof frame (i.e. with the possible exception of the common rafters) belongs to Phase 1. Truss 3 (Fig.5) is faced up to the west. Medieval carpenter's numerals are present, as are a series of numerals of probable 18th / early 19th century date (Fig.21). 'Daisy wheels' are also present (Figs.21 to 23). The original wind braces are intact. Notches, at right-angles, have been cut out at a later date, the reason for this is uncertain (Fig.24).

Fig.24. Bay 2. the roof structure. Facing north-east.

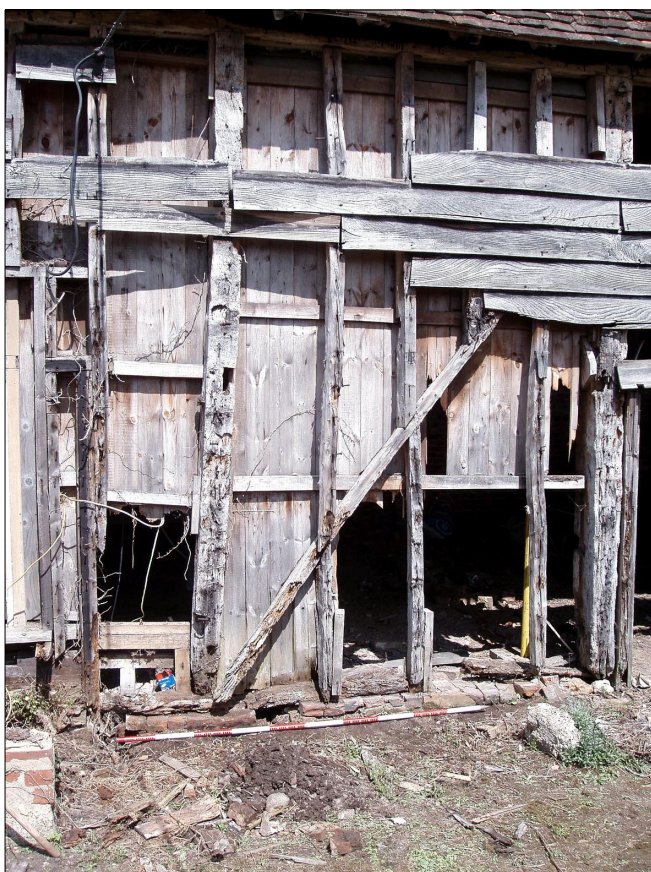
Fig.27. Bay 4. Condition of Phase 1 and Phase 2 timbers in the south elevation. Facing north.

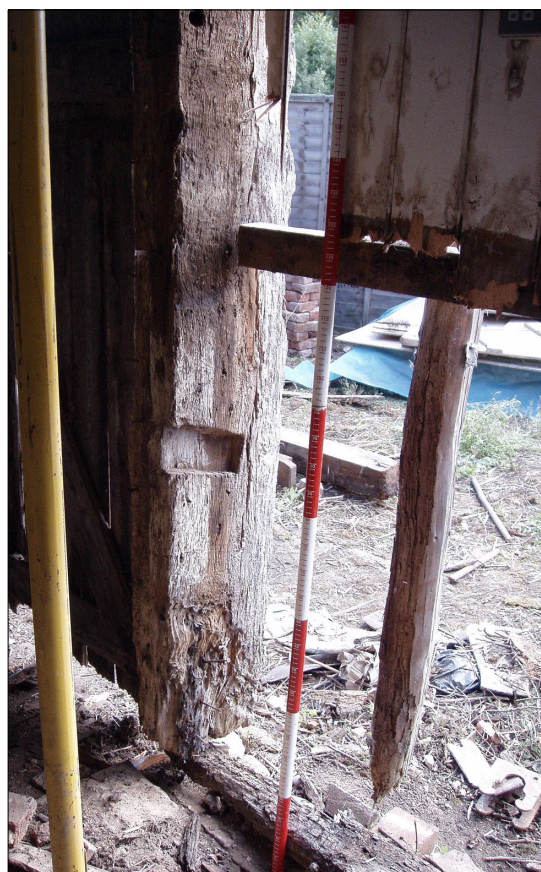
- 4.10 The lower half of the north elevation consists of a brick wall, to a height of c.2m, upon a foundation of re-used limestone blocks. The wall extends throughout Bay 5. On top of the wall, mid rails have been laid, turned through 90 degrees, to form a sill for the timber framework of the upper half of the elevation. Due to the constraints of visibility, it was not possible to ascertain whether there was evidence for a down-swinging tension brace in post 4.
- 4.11 In the south elevation, there was no trace of a sill beam; the lower parts of principal posts and storey had rotted away (Fig.27). Symmetrically, opposed mortises cut diagonally into inward sides of the 2nd and 3rd principal posts indicate the probable position of a manger; a Phase 2 feature (Fig.28).

Fig.28. Bay 4. South elevation. Mortise for Phase 2 manger; principal post 4 Facing south-east.

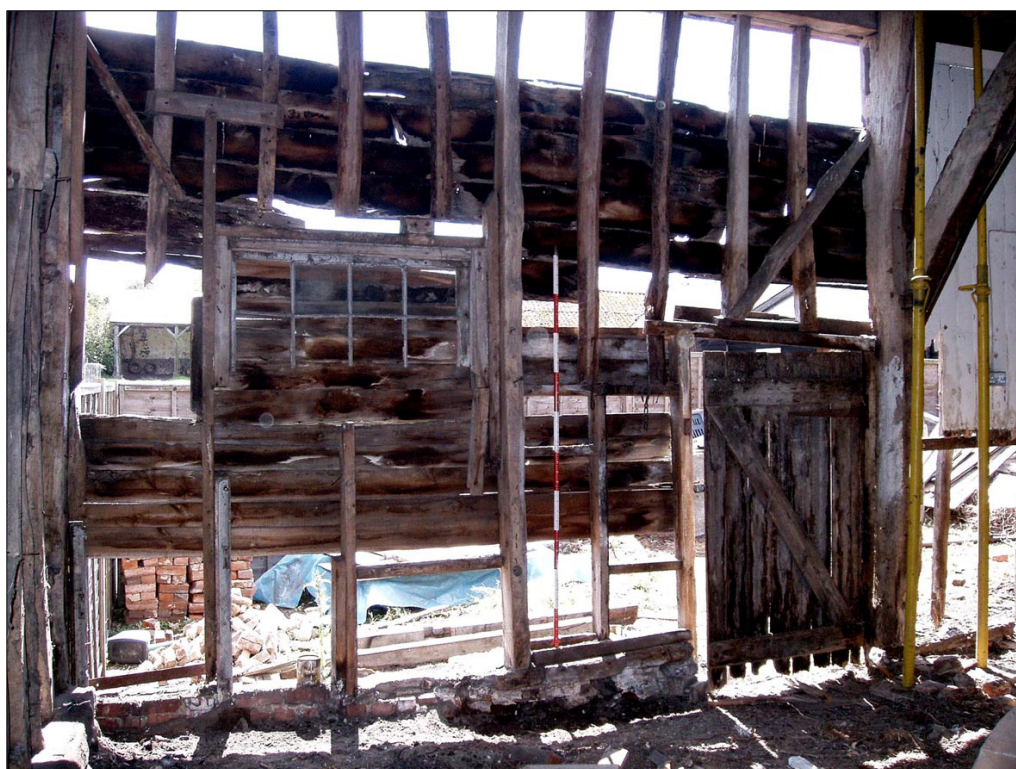
- 4.14 The sill of the southern elevation comprised the remains of rotten timber fragments upon a plinth of assorted bricks. There was a lack of diagnostic carpentry cast doubt on any these fragments being Phase 1 material (Fig.36).

Fig.36. Bay 5. Remains of Phase 2 and modern timbers in the south elevation. Facing south

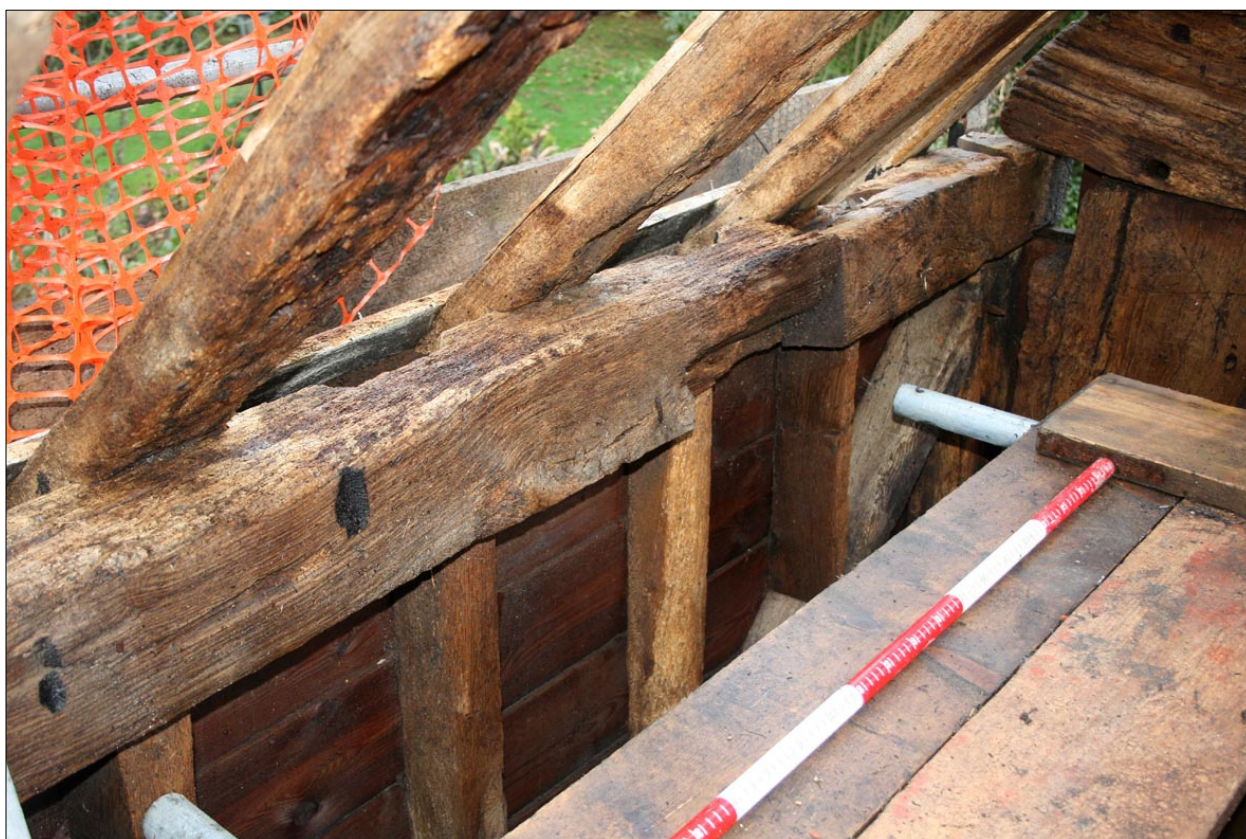
- 4.15 The principal post of cross-frame 5 on the north side has been severed at approximately mid height and stands upon an 18th century brick wall the upper part of the post shows signs of repair work. The timberwork of the north elevation in Bay 5 (Fig.37) is entirely replacement, its reconstruction probably dates from the 18th or even, 19th century. Timbers, such as the segments of wall plate (Fig.38), are likely to have been derived from at least one other medieval structure.

Fig.38. Bay 5. North elevation. Wall plate and post-truss (6) joint. Facing north.

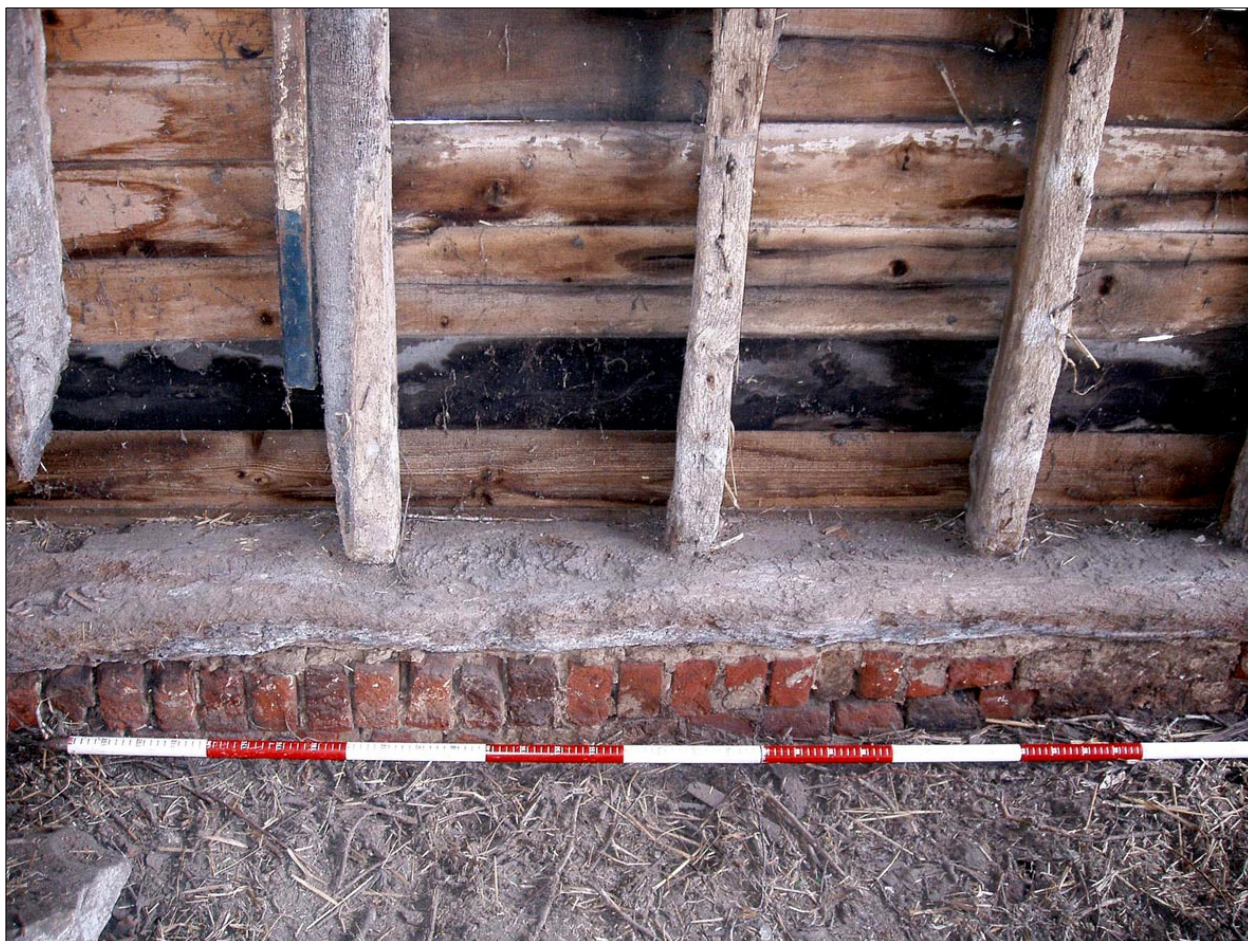
- 4.16 The principal post on the south side remains intact, although was dislodged from the sill beam. The sill beam may be timber from Phase I although the brick plinth is more likely to be Phase 2 (Fig.39).

Fig.39. Bay 5, cross-frame 6. Phase 1 sill on Phase 2 brick plinth.

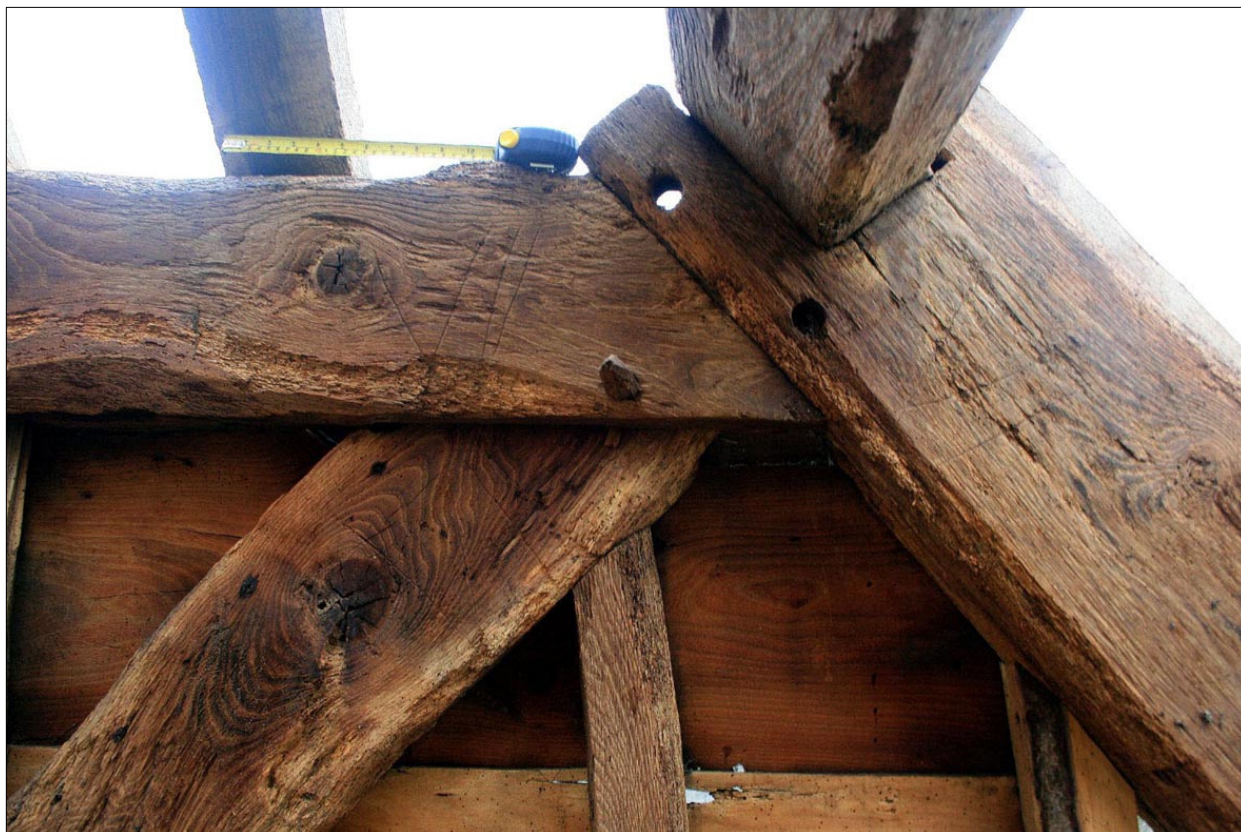
- 4.18 Truss 6 is a 'fan truss', the king strut flanked by out-curving braces (Figs.8 and 40). The truss has been severed just above the purlins (Fig 41). There is a stave groove above the collar, indicating a gable. Medieval carpenter's numerals show that this was indeed the original end frame; these flanked by 18th century numerals as observed on cross-frames 2 to 5 (Figs.41 and 42). Notably, the principal rafter on the north side of cross-frame 5 has no wind brace mortise and has clearly suffered weathering on its east side, indicating that it is a replacement timber that was formerly an end frame (Fig.43).

Fig.41. Bay 6, truss 6. Principal rafter-collar beam joint, with medieval carpenter's numerals. Facing east.

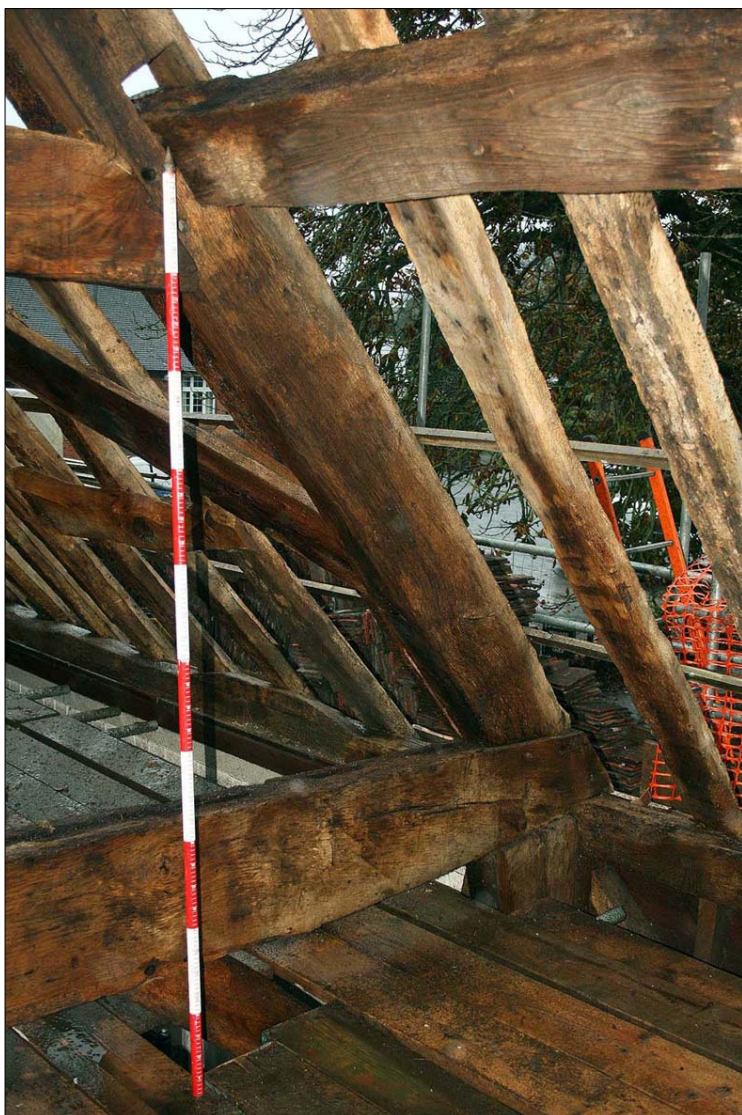
Fig.43. Bay 5. Replacement principal rafter on the north side of cross-frame 5.

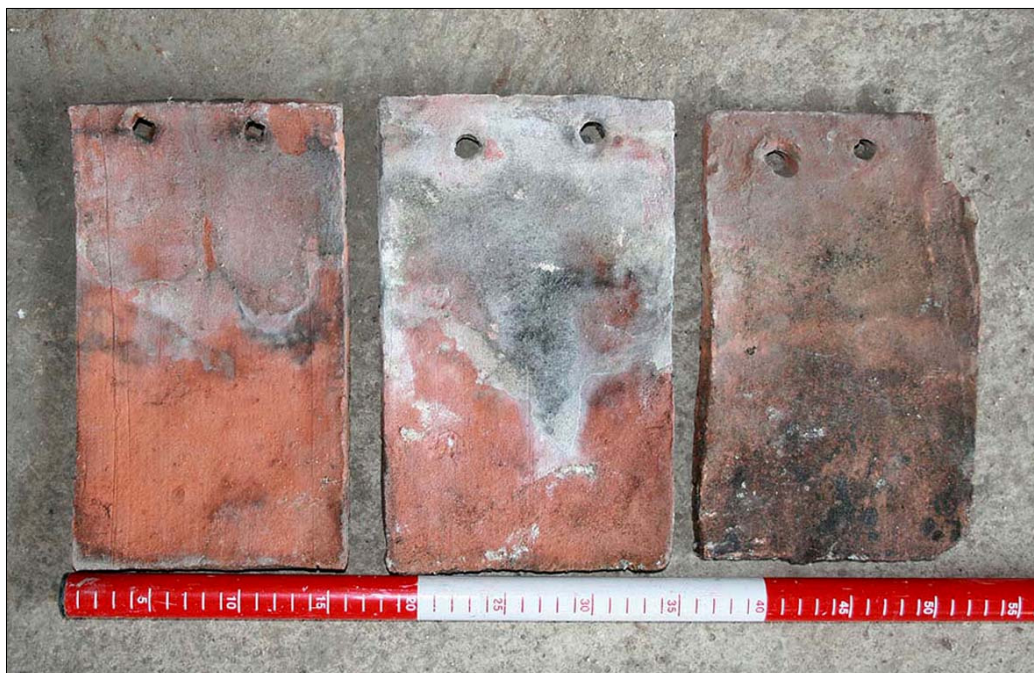
- 4.20 There were two main types of roof tile (Fig.45), the earlier of these having the rounded peg hole, some with rotted wood inside. The tiles each measure approximately 10 ¾ " x 6 ½ " x ½ " (273 x 165 x 13mm). Tiles were fastened by either a gob of mortar or metal pins; many were placed upside down. The type of makeshift wooden batons that these were attached to seems to indicate that the roof had been re-tiled in the late 19th or early 20th century (Fig.46), perhaps at the time of the building's conversion to a village hall. During the development, the structure was re-tiled utilising a predominant quantity of the original tiles (Fig.47).

Fig.45. Roof tiles.
