# Happy Valley Stenness Orkney

## Archaeological Building Survey

November 2011

**Project No: 300**

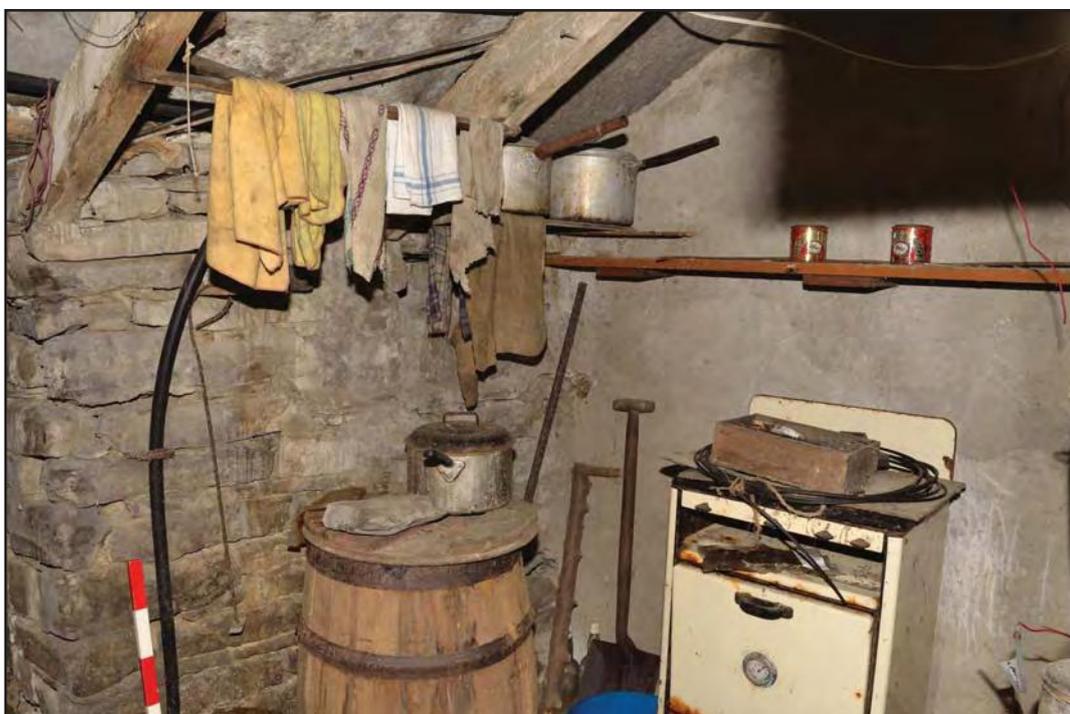
Plate 16: Room 3, looking southwest.

The south elevation contains the main external stone wall (**3.3.001**) and an external door. The rafters (**3.3.004/005**) are bedded into the wall head (Plate 16). The external tongue and groove door (**3.3.007**) has an iron latch and bolt (**3.3.008/009**). A hidden alcove (0.4 x 0.24 x 0.34m, **3.3.002**) is located in the upper west part of the wall (Plates 17 and 18). This has a slab cemented in the front with a broken corner which can be refitted loose to obscure the hole. A collection of eight old coins (4x shillings (1948-1961), 1x 2 shilling (1955), 1x six pence (1929), 1x half crown (1936), 1x old penny (1914)) was found in the base of the alcove suggesting it was used by Mr. Harrold, and perhaps previous residents, as a safe. The blocking stone was already removed when it discovered during the survey. The alcove was also hidden by the towel rail (**3.6.006**). The wall around the alcove has recently been rendered with cement. The elevation also contains a wooden peg hook holding a fire rake (**3.3.010**), the end of a shelf (**3.3.012**) and black plastic

Generally, the fabric and wooden fittings in Room 3 all consist of reused timber which is in moderate to very poor condition, especially the wooden panels. The concrete block wall and southern stone wall are in good condition, however the east stone wall and rafters are suffering from damp from the roof.

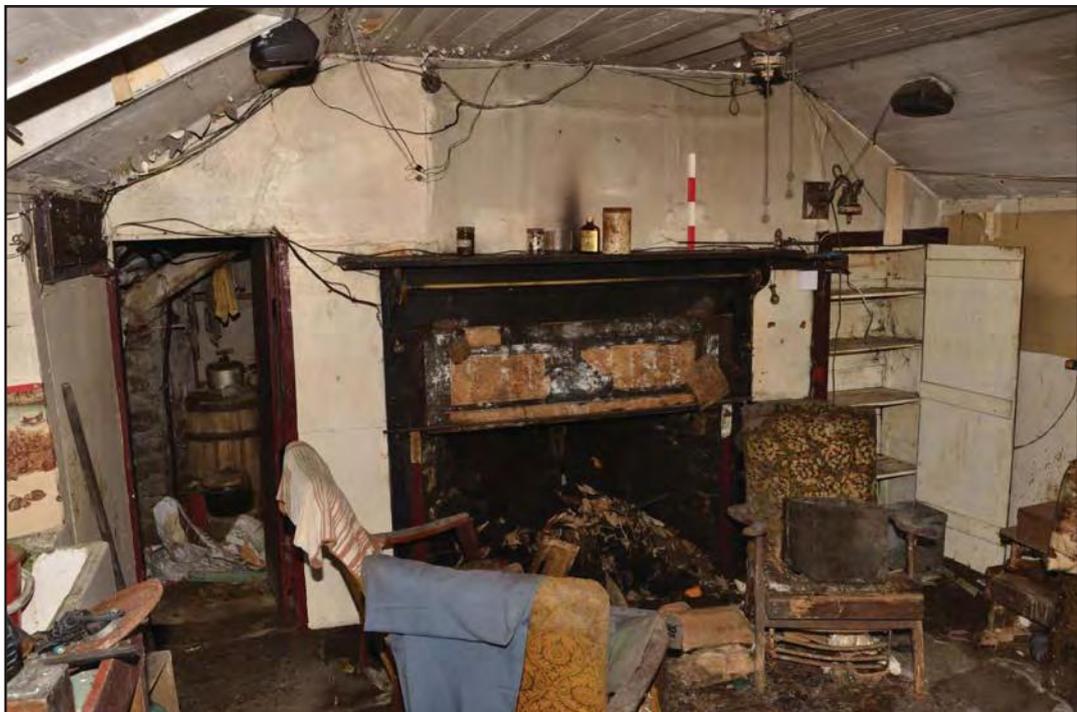
Plate 22: Elevation 4.4, looking northwest.

The west elevation in Room 4 is perhaps the most iconic in the house in terms of Mr Harrold as this contains the main fireplace and mantle piece, two 12V bulbs and a homemade shelf for his car stereos (Plate 22). The wall fabric consists of replacement plasterboard (**4.4.001**) but this appears to have been fitted around the original features, however the gas lamp (**4.4.020**) is fitted above. The southern tongue and groove door (0.55 x 1.56m, **4.4.004**) has an iron latch (**4.4.005**) and leads to Room 3. This is matched on the north side by a tongue and groove door (**4.4.023**) that leads to an alcove (0.55 x 0.35 x 1.65m, **4.4.027**) containing a series of wooden shelves (**4.4.024**). There is a batten of wood attached to the top of the door frame (**4.4.025**) that supports a washing line. The central fireplace recess is tapered and set back into the wall (**4.4.029**). It is surrounded by a late 19<sup>th</sup> century wooden mantle piece and fire surround (1.6 x 0.19 x 1.48m, **4.4.006**) that is probably original to Phase 1. There is a hinged veneered wooden panel (now peeling) forming an upper guard that is said to have been put there by Mr. Harrold was from a piano. For this reason Mr. Harrold apparently called it his 'musical mantle piece' (Neil Leask pers. Comm.).

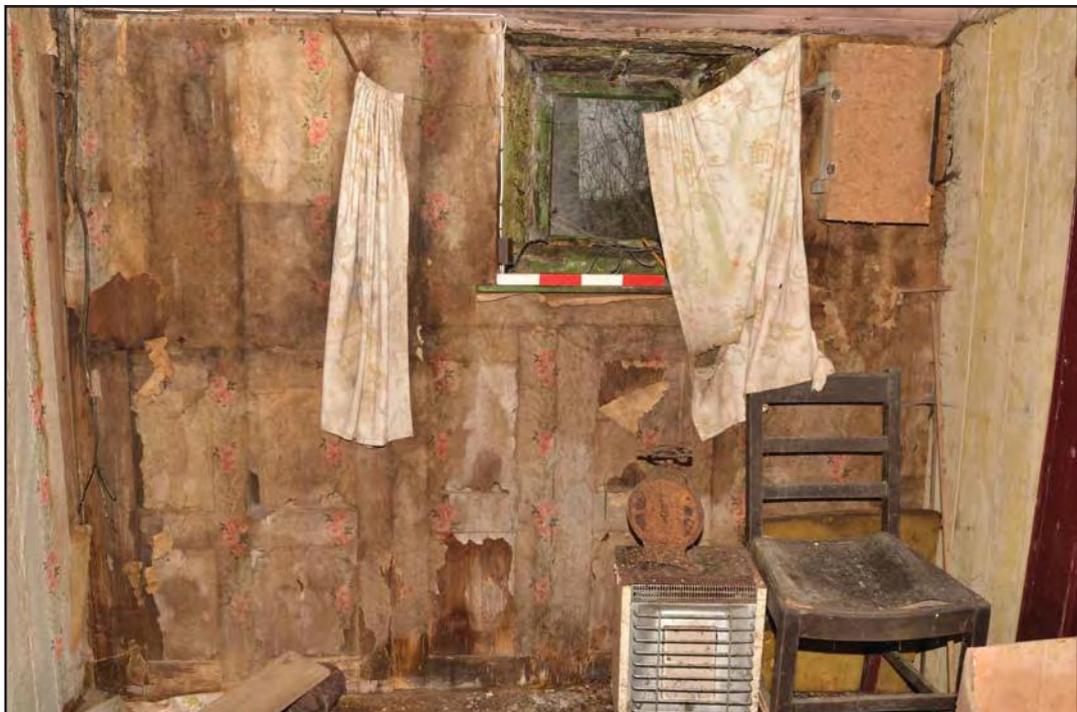
Plate 27: Elevation 5.1, looking north.

The north elevation is clad in wooden panels (**5.1.002**) that cover the stone wall (**5.1.001**, Plate 27). The panels are the same as those reused in the north elevation in Room 3 (**3.1.004**), and are in a very poor condition with rot and woodworm. The small window aperture is tapered towards the outside (**5.1.004**) and contains a replacement timber framed window (**5.1.005**) with a wire curtain rail and curtains above (**5.1.007**). There is a small handmade wall mounted wooden cupboard to the east of the window (0.27 x 0.09 x 0.41m, **5.1.006**).

Generally, the fabric in Room 5 is in moderate condition, apart from the rotten and woodworm ridden panelling in the north elevation (**5.1.002**) that is in very poor condition. The area of tongue and groove above the box bed in the southern elevation (**5.3.002**) is in poor condition due to the weight of the coats in the corridor (Room 8). The box bed sides are in good condition. The room contains an iron bed with fibre mattress and bedclothes, suit tops hanging above the bed, two chairs, a gas heater and a set of scales.

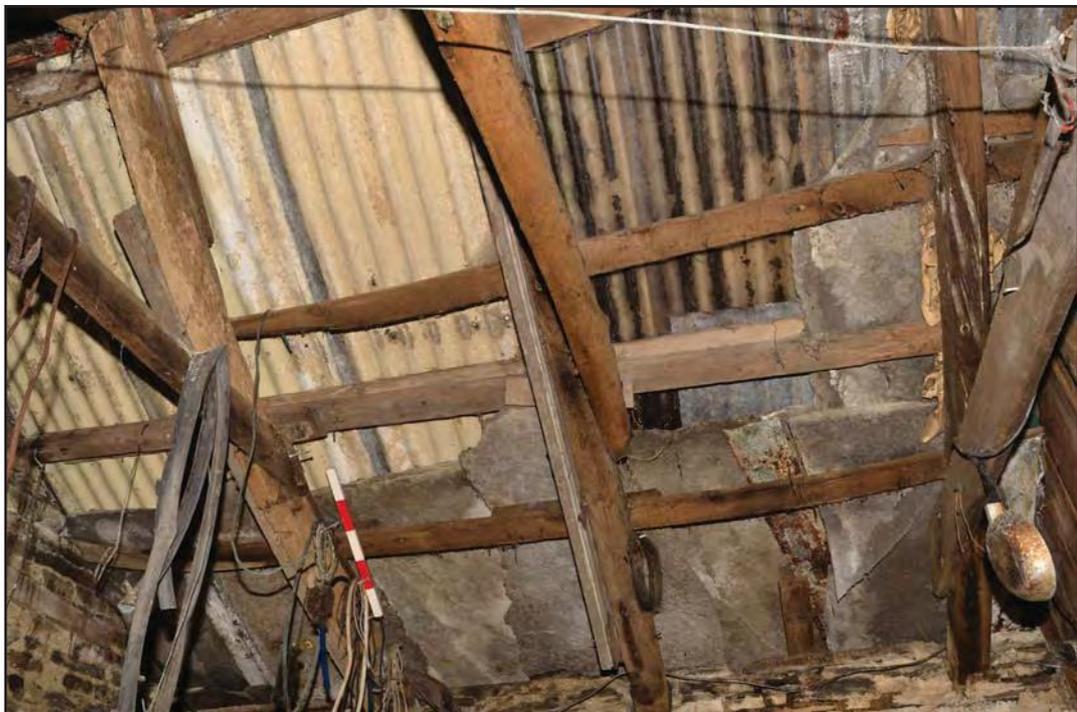
Plate 41: Ceiling/roof 9.6, south side, looking south-southeast.

The original flagstone floor (9.5.001) continues to the west below the stud walls and box bed. The ceiling extends up into the roof (Plate 41). Three original 'A' frames are visible (9.6.001/003/005) all of which have been repaired with bracing or additional cross pieces (9.6.002/004/006). The western 'A' frame contained moulded timber similar to that forming the northeast alcove lintel (9.2.003), and may indicate that the roof timbers (Phase 1) are reused. There is a wooden shelf between the central and east rafters (9.6.007), several battens (9.6.010) and various hooks and nails for suspending items (9.6.011). The surviving roof slabs are visible in a row above the south wall head and partly extending up to the apex at the west side (9.6.008). Corrugated iron sheeting makes up the remainder of the roof (9.6.009).

The main wall fabric in Room 9 is in fair condition however the rafters are in poor condition and require urgent attention. It is likely that the stone roof slabs were replaced (Phase 4) with lighter corrugated iron in an attempt to

It is recommended that the layout of the building should be maintained during renovations. Most of the stud walls are attached to the rafters by areas of tongue and groove that could be removed and then replaced. The roof timbers could be reused ships timbers and older than the house. The box beds are in reasonable condition and should be left in position. The house contents could be boxed or bagged according to the numbering system used during the survey for replacement.

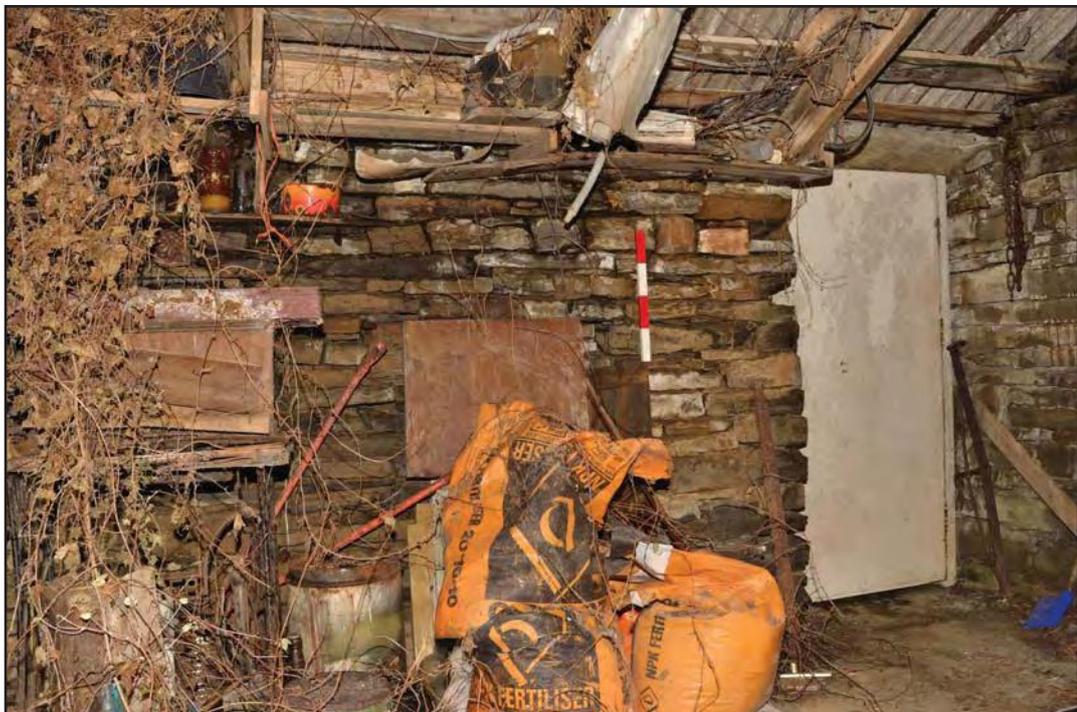
Plate 43: Elevation 10.3, looking southwest.

The south stone wall (**10.3.001**) supports four rafters (**10.3.002-005**) below which are several shelves and homemade shelf units constructed from reused timber (**10.3.009-011**, Plate 43). The doorway contains a replacement flush door (**10.3.008**). There is a 12V wire (**10.3.013**) which leads to the ceiling bench light and a Bakelite light switch (**10.3.012**). The west elevation contains two shelves with metal and wooden peg brackets (**10.4.004/005**) and numerous nails, pegs and hooks (**10.4.006**). The rafters are keyed into the gable end wall of the main house (**10.4.001/002**).

The fabric in Room 10 is in moderate condition, however water is leaking down the west wall and there is considerable damp. Ivy from the roof has encroached inside and had to be cut back. The room contains a multitude of tools, spare parts and useful things. There are two old sewing machines, a home made cart, metal and wooden sheeting, spare wire, cogs, chains, wheels and tools. Many of the items in the workshop may directly relate to the construction, modification and maintenance of the hydro electric generator system in Building 2.

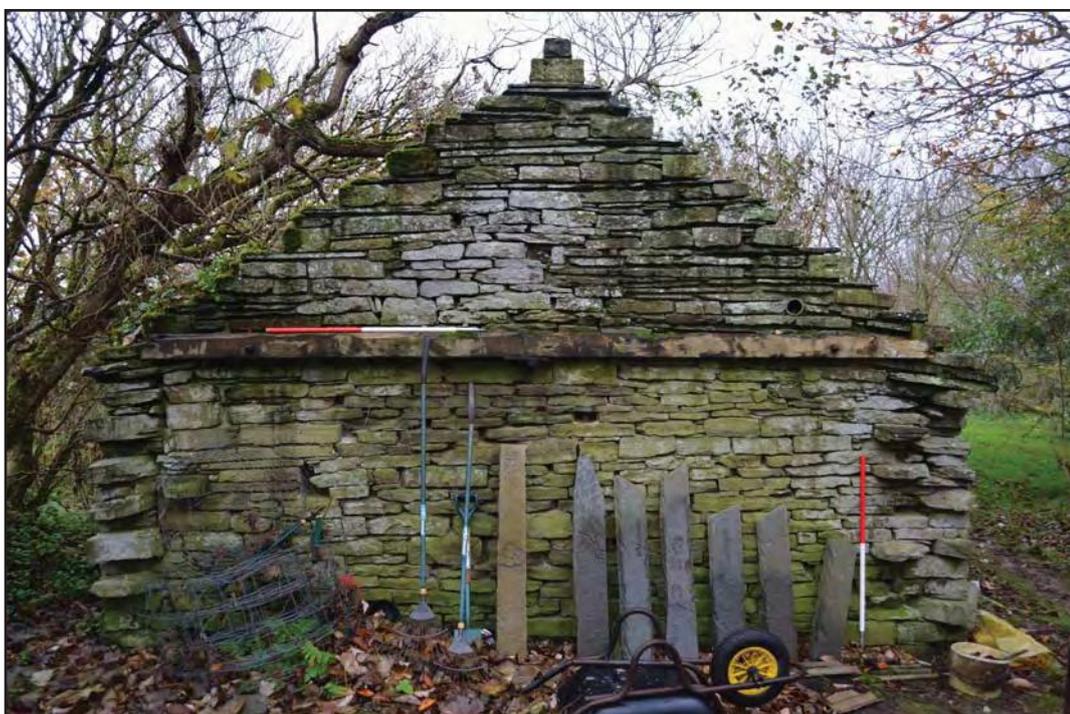
Plate 52: B1.4, looking east.

The gable end of the west extension (3.48m high) has a scar in the masonry on the north and south sides where a former building or walls were keyed in (**B1.4.002/003**, Plate 52). A timber beam (**B1.4.008**) fixed to the wall level with the top of the wall heads would have supported a lean-to roof (now missing). The blocked aperture on the north side (0.85 x 1.10m, **B1.4.006/007**) is also visible on the inside (**1.6.003**) and may have been an animal trough built into the wall. The upper part of the wall has been rebuilt with crow stepped reused free stone and neater coursing (**B1.4.004**). The freestone matches that used in the border edging along the south side of the house and there is a pile in the garden c.20m to the northeast. Mr. Harrold is likely to have salvaged the stone. The crow steps are finished with a neat pinnacle of free stone (**B1.4.005**). This gable end was constructed in the late 19<sup>th</sup> century (Phase 1B) and was renovated by Mr. Harrold (Phase 4). The demolition of the walls to the east and the lean-to roof also occurred around this time.

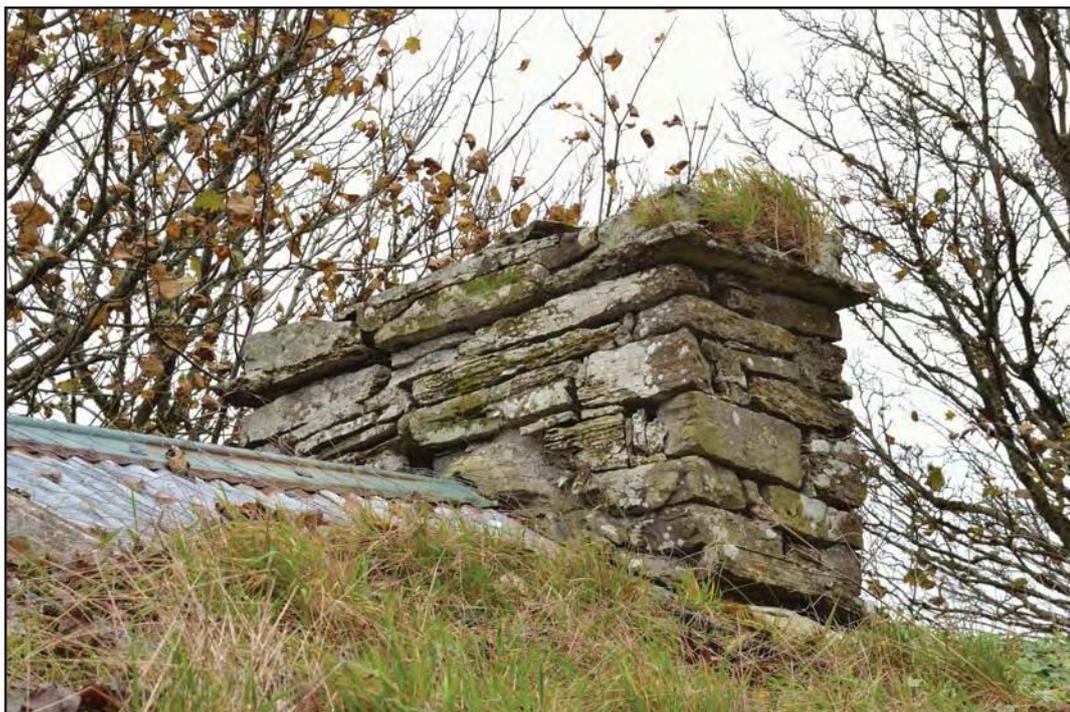
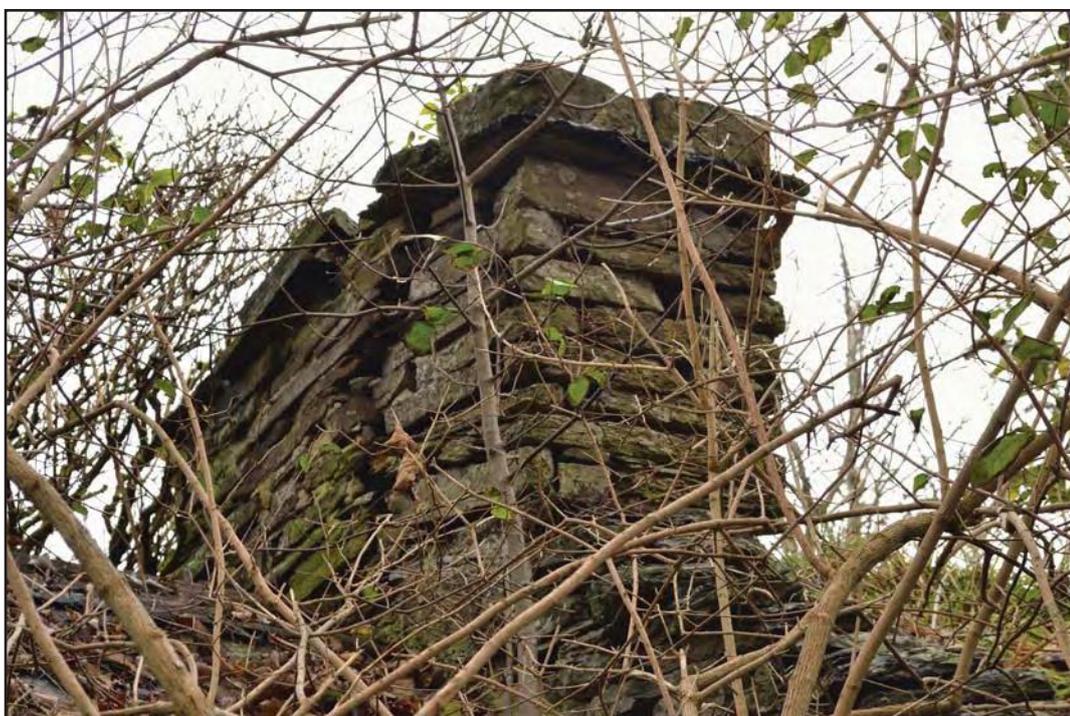
All the external walls are stone constructed with the remains of lime plaster evident in some places. The walls are generally in good condition apart from the chimney stacks which are starting to collapse, especially the western example. The original slab roof and rafters are present at the western end of the main central house, although most of the slabs have been replaced with corrugated iron sheeting above Room 9 at the eastern end. The rafters appear to have been replaced above the western extension (Rooms 1-3) and the original slabs repositioned. The original rafters have been retained above the eastern extension (Room 10) along with some of the slabs although most of these have been replaced with corrugated iron sheeting. An original 19<sup>th</sup>-century flagstone floor is present in the main house and extensions. This continues below the internal stud walls and has only been removed in the sunken area in the toilet (Room 2).

The roof is divided into three sections corresponding to the original house and two extensions. The main central roof has a stone built chimney stack at either end (**B1.6.001/002**, Plates 56-57). These have an upper lip of stone and no chimney pots. Both are in need of urgent repair, especially the west stack which is collapsing outwards. There are original stone roof slabs in the central and west parts (**B1.6.003**) with replacement corrugated iron sheeting above Room 9 at the east end (**B1.6.004**). The top is capped with sheet iron ridge tiles (**B1.6.005**). The roof is partly covered with turf and vegetation

Plate 56: Chimney B1.6.001, looking northeast.

Plate 57: Chimney B1.6.002, looking northeast.

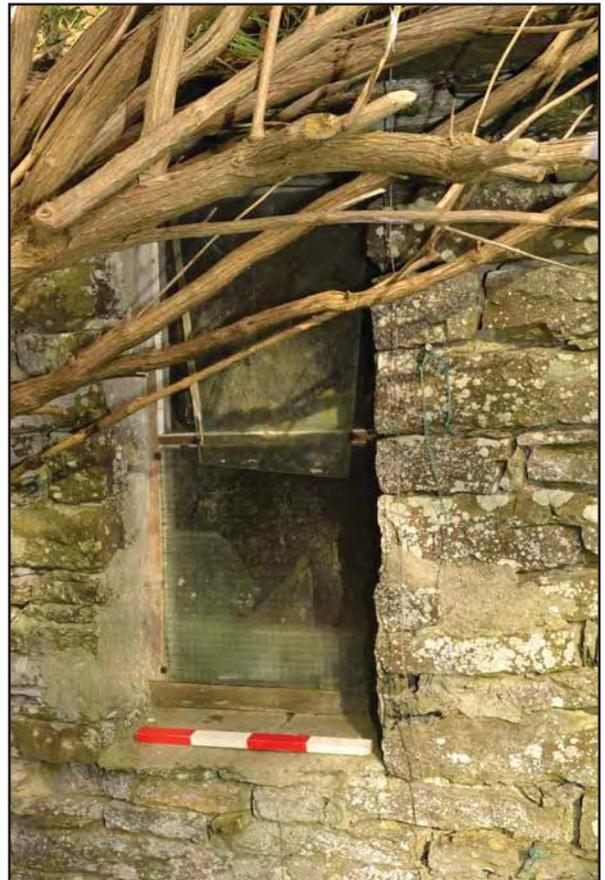
The original house (Phase 1A) is clearly visible in the south elevation with a central door and two small windows equidistant either side (Plate 53). There are two doors where east and west extensions abut the gable ends. The main central door (**B1.3.006**) has a sturdy external tongue and groove door (**B1.3.008**) with a wooden letterbox flap (**B1.3.009**, formerly weighted shut from the inside) a replacement brass door latch and escutcheon plate (**B1.3.010**, Plate 58). There is an iron drip gutter above the door (**B1.3.011**) that used to feed into a wooden barrel (now in Room 3) on a stone plinth. The two plastic buckets by the door were for growing neaps (Chris Gee pers comm.). The east window (**B1.3.004**, 0.48 x 0.66m) is the original size however the wooden framed two paned window is a replacement (**B1.3.005**). The west window aperture is higher, having been altered (**B1.3.002**, 0.47 x 0.94m) and also has a replacement wooden framed window with repaired panes (**B1.3.003**, Plate 60). There is a cable for a

Plate 60: Window B1.3.003, looking north-northwest.

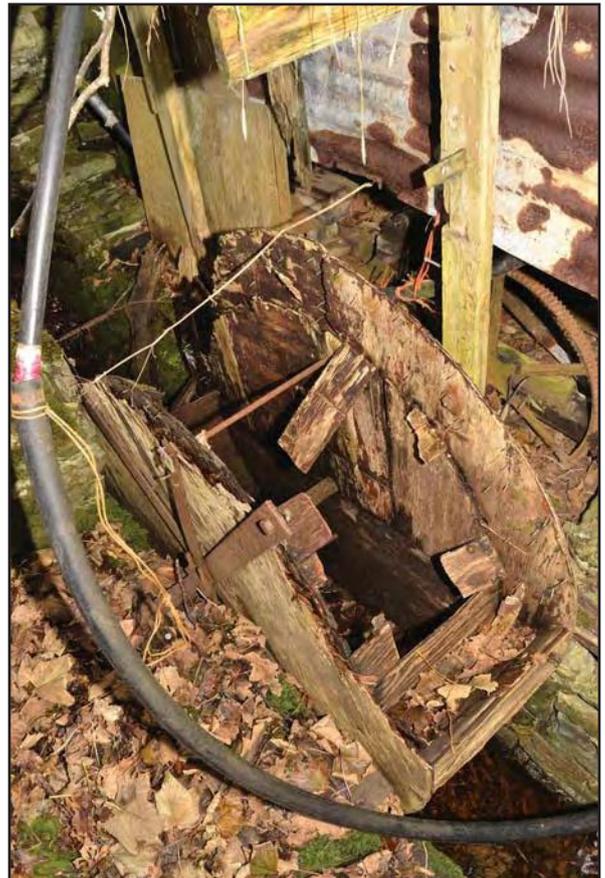
Although the waterwheel is in a poor state of repair, it can still be rotated and the mechanism in the south compartment still turns. The roof is partly collapsed, and it is assumed that there must have been some form of protective wall at the south side of the east wall, although only the timber frame remains.

Plate 65: B2 interior, showing waterwheel, looking southeast.
