**Milton Glen Hydro Scheme,
Callander,
Perthshire
Archaeological Monitoring
Data Structure Report**

July 2016

Client: Baby Hydro Ltd
Project: Milton Glen, Callander - Hydro Scheme Job No: 225
Document Title: Archaeological Monitoring DSR

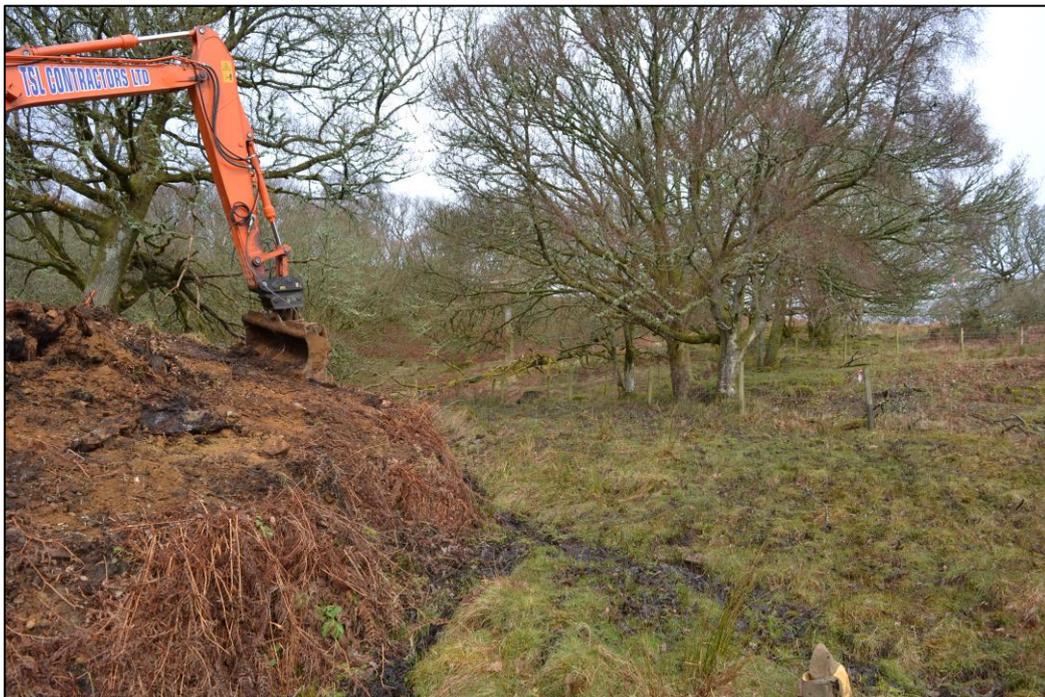
Plate 1: Looking north across lade **3b** (edge of excavations) and **3c** (below treeline) (Photograph 057)

- 4.2.2 Where the penstock cut lade **3b**, this was c.0.50 wide with a depth of >0.50m. The overall depth of the cut lade wasn't clear as the channel had made use of the natural topography to curve around the high ground to the west. Excavation showed this to be a simple excavated channel, with no indication of shoring or stone lining.

4.2.3 At the point of excavation, the second lade channel **3c** was only really visible on its eastern side where the ground dipped slightly from the treeline. Had it not been for the better preserved sections of this feature to the north and south, **3c** would not have merited the description of a lade or channel. The drop from the treeline on the eastern side of the 'lade' was c.0.10m. No features related to the construction of lade **3c** were noted and it must be assumed it was formed by a simple channel excavated through the subsoil in a similar manner to lade **3b**.

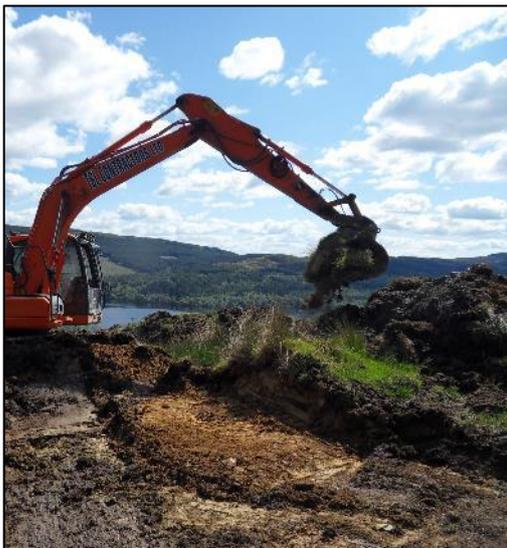
- 4.3.5 The excavations (Plate 2) showed the head dyke (**007**) to be constructed almost entirely from banked, re-deposited natural subsoil. This comprised very clean, firmly compact orange brown gritty clay with a height of c.0.50-1.30m and a width of >1.50m, with gradually sloping sides (Plate 3). There was no evidence of a ditch alongside from which this material had been collated, although the ground to the north was noticeably boggy.

Plate 2: Working shot showing excavations through (007) (Photograph 102)

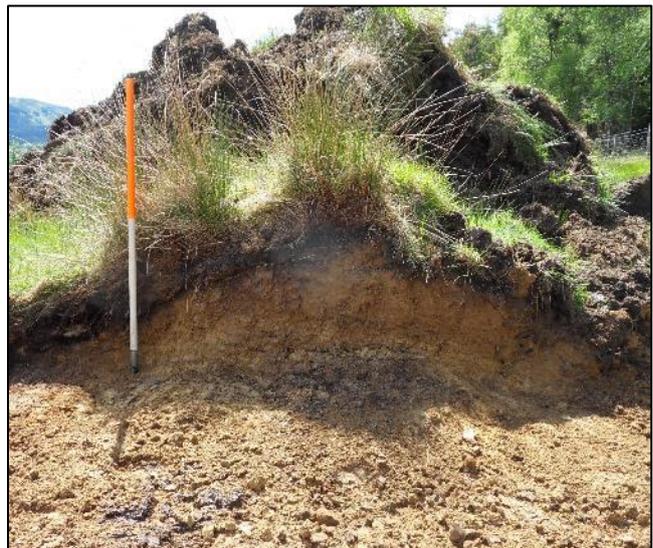
Plate 3: East facing section of (007) (Photograph 104)

- 4.3.6 A relatively small number of medium to large stones and boulders were recovered from the base of (007). These certainly did not form the core of the head dyke which had clearly been constructed of mounded natural subsoil. It is likely that field stones were perhaps collected from the immediate vicinity where these could be found and placed to help form the base of the bank.

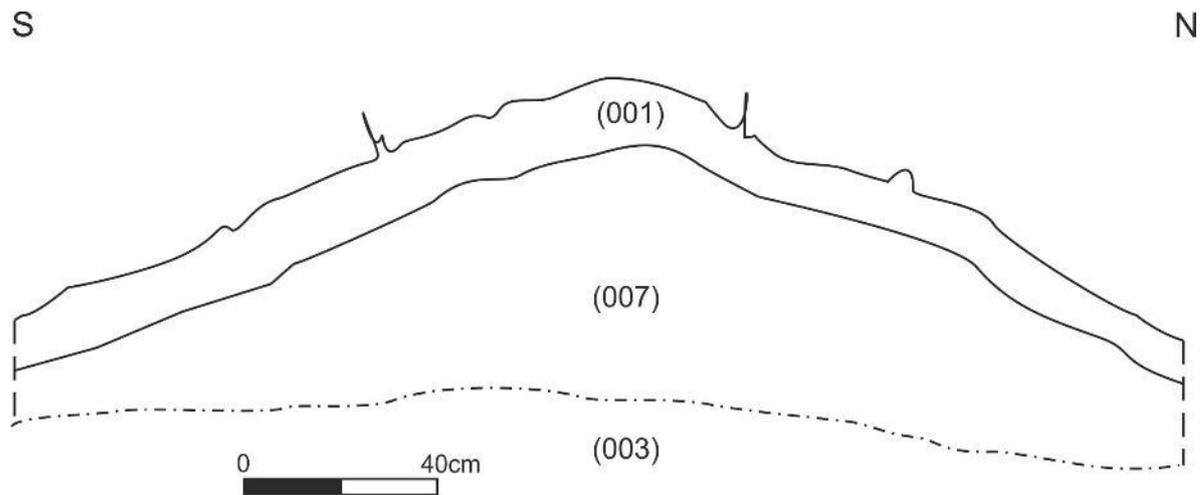
Figure 3: East facing section of Head Dyke (007)

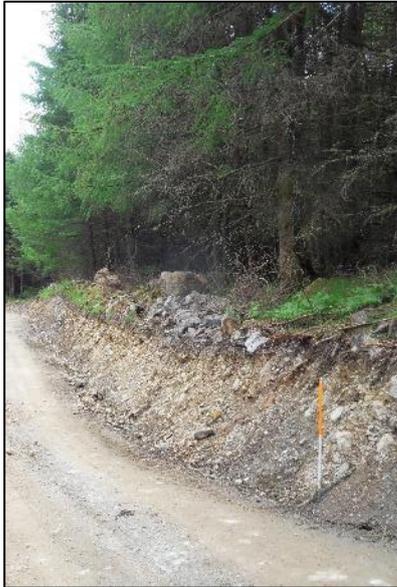
- 4.3.10 While (008) was only actually cut in one location, the placement of the access track along the edge of the trees meant that this often skirted the edge of (008) (Plate 4 and Plate 5).

Plate 4: Looking SW along route of access track. Note DSW (008) along the edge of the road (Photograph 099)

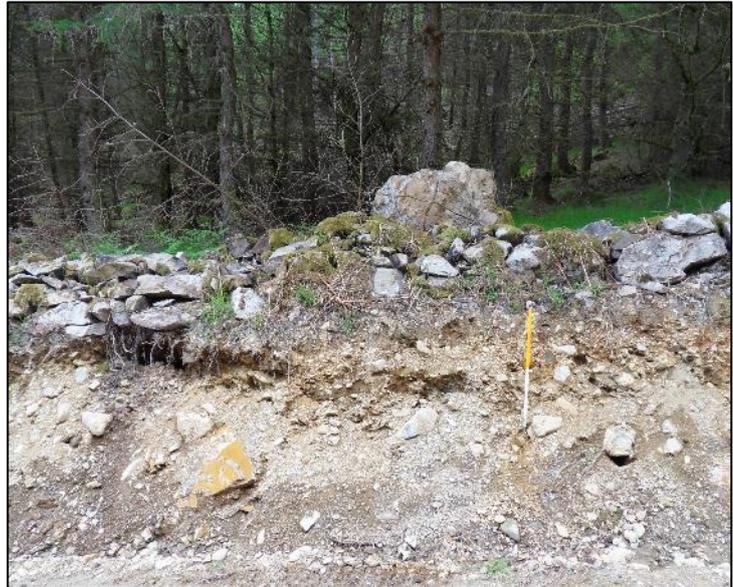
- 4.3.8 (008) was a much denuded and collapsed drystone wall or field boundary, recorded in 2014 as a head dyke. Like (007), (008) would have been a visible demarcation between the improved and more intensively farmed land, and the unimproved rough grazing or common. The presence of the trees today mask the character of the land, but it would be reasonable to assume that (008) is later than the more rudimentary (007), with the boundary of the farmed infield perhaps pushed northwards as improved farming techniques allowed better exploitation of the land.

Plate 5: SW facing elevation of (008) (Photograph 100)

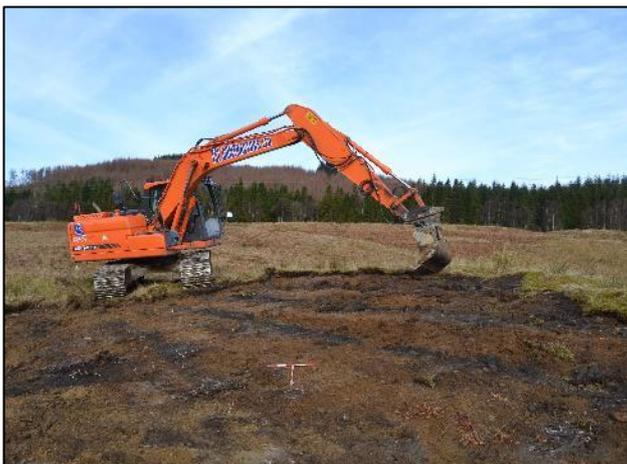
Plate 6: Looking north over an area of rig and furrow visible across Borrow Pit 1 (Photograph 032)

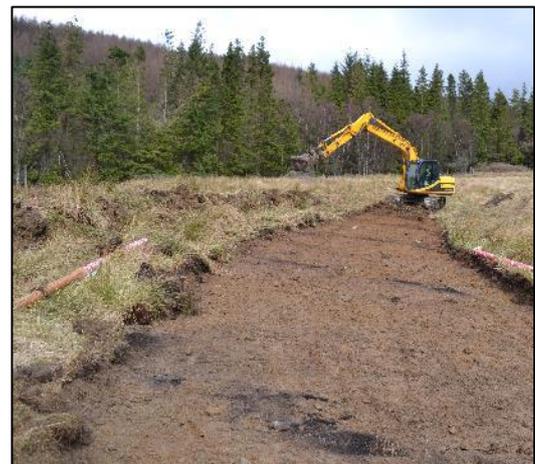
Plate 7: A series of furrows lining the hillside on the access track in the north of the monitored area (Photograph 071)

- 4.4.3 Although this was variable across the site, the linear features tended to be between 1.20 - 2m apart, <0.40m wide and with a shallow depth of 0.05m. The evidence for rig and furrow was recorded as (005) and essentially comprised shallow trenches filled by dark brown topsoil. No dating evidence was recovered from the slots excavated through these.

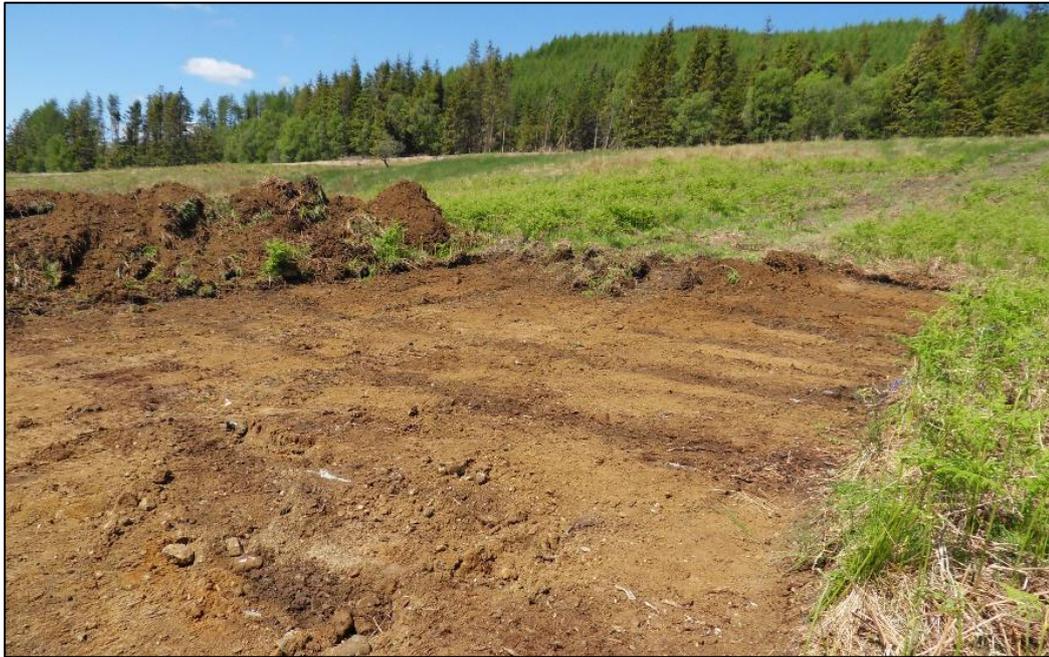
Plate 8: Evidence of agricultural activity on the penstock in the north of the site (Photograph 089)

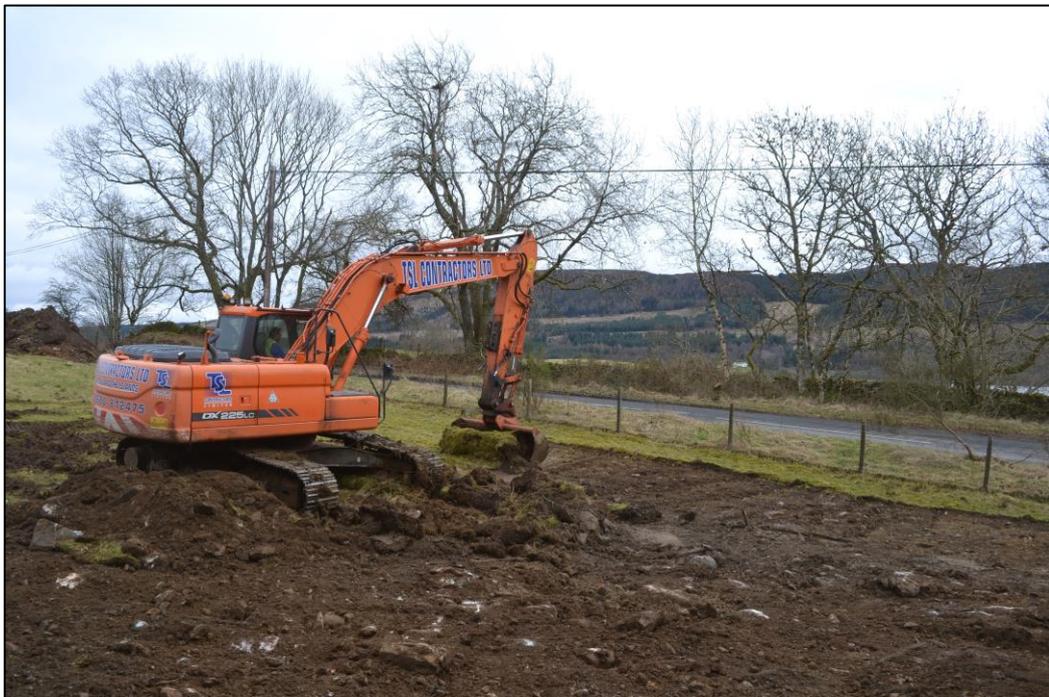
- 4.5.1 In the extreme south west of the proposed development area, in the footprint of the Pump House, an area of made ground (**004**) measuring c.20m² was recorded during excavation. This material contained an abundance of medium sized stones and building material (roughly dressed stones with fragments of bonding material, angular stones, occasional modern lumps of concrete and metallic road signs) (Plate 9). Excavation showed (**004**) to be <0.20m deep.

Plate 9: Excavating made ground (004) (Photograph 019)
