THE ALLIANCE AND LION SALT WORKS, MARSTON, NORTHWICH

THE FINAL REPORT:

VOLUME IV – HISTORIC BUILDING RECORDING

REPORT NO 2015-01

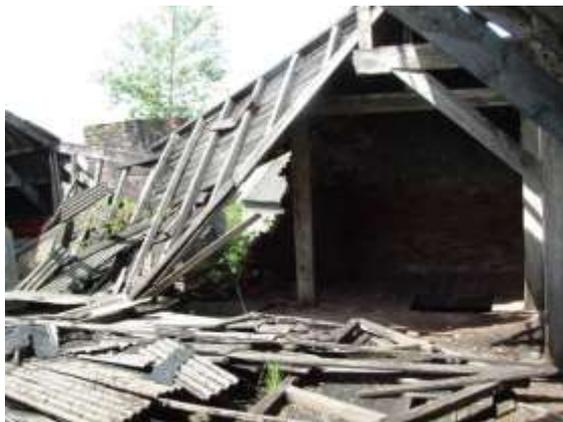
2.2: Collapse of Stove House 1, 1990s, west facing

Stove House 1 appears to have become structurally unsound in the 1990s and in the early 2000s the roof connected to Stove House 3 collapsed (2.1, 2.2). The collapse was almost certainly the result of the poor condition of the roof structure and the subsequent collapse of the southern wall which was shared with Stove House

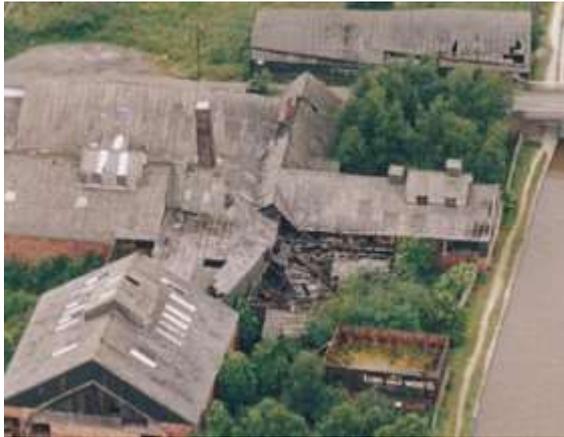
2.51: c. 2000 Aerial Photograph, Pan House 2 has entirely collapsed, east facing

Remedial work in 2009 involved the clearance of the debris in the pan and removal of loose timbers from the front (eastern) side of the pan. In October-December 2012 further clearance of the southern and northern sides of the pan was undertaken in order to make the area safe for access and allow scaffolding to be erected to access the eastern side of Stove House 2.

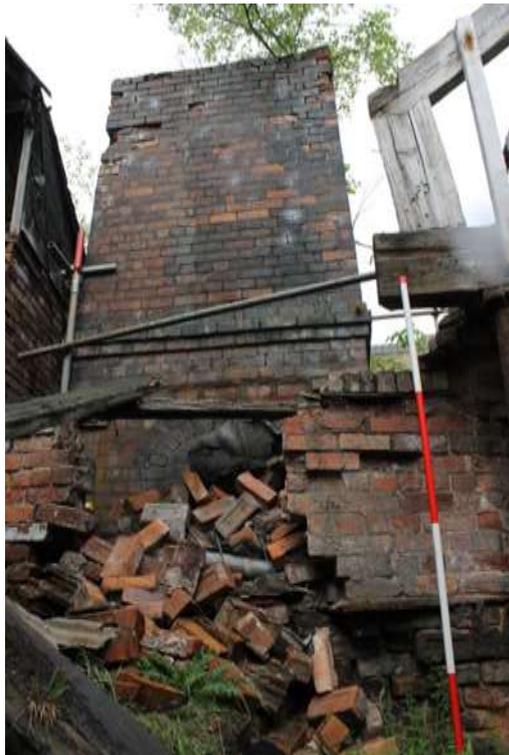
2.138: Chimney 1 in 2012, west facing

This was eventually replaced by flue (6510) that ran from the northern side of Stove House 3, into the eastern side of Chimney 1. It was constructed in poorly made machine-pressed red brick in English bond with ferrous metal plates on top but had almost entirely collapsed.

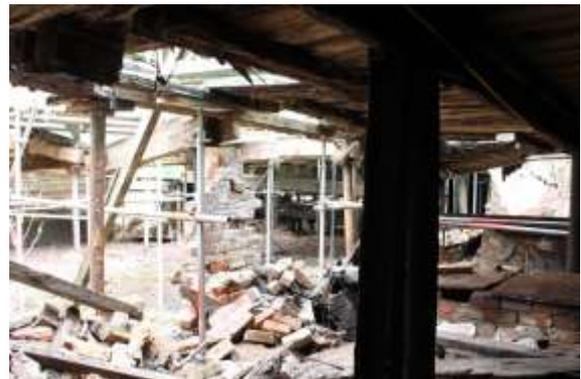
2.176: Stove House 3, northern wall collapsed, north-east facing

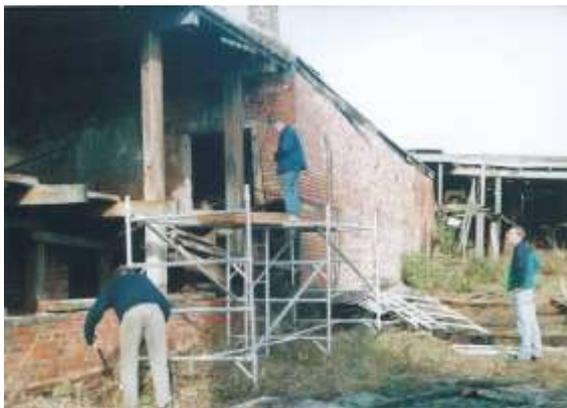
2.191: Pan House 4, during repair in 1990, north-west facing

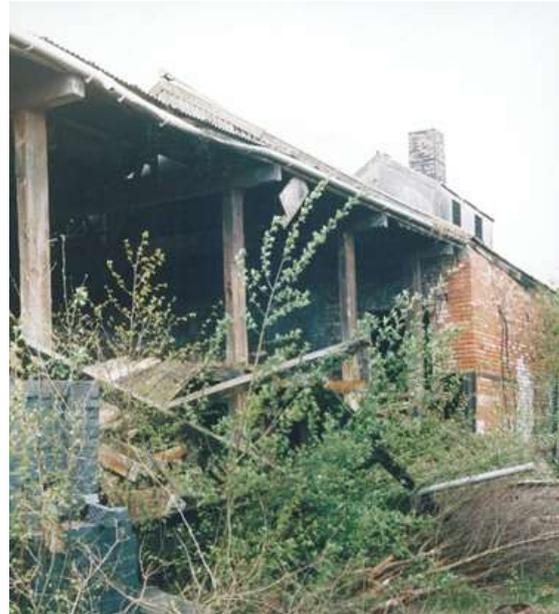
2.193: Pan House 4, during repair in 1990, north-west facing

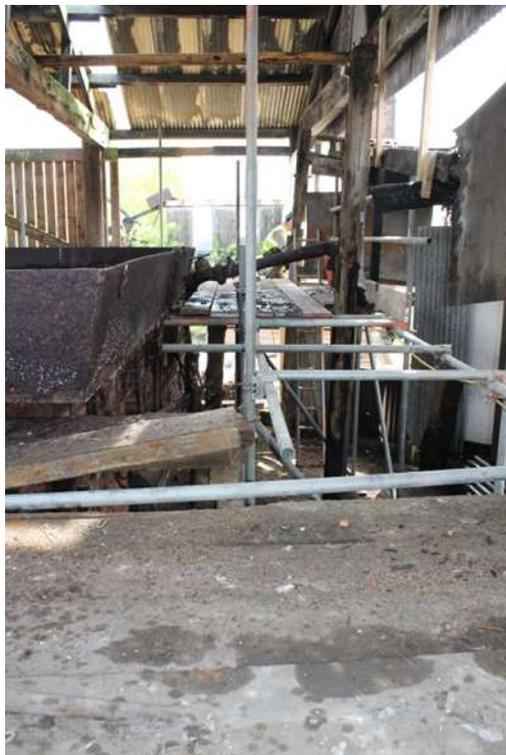
2.216: Pan House 4, southern end of pan and brine pipe, east facing

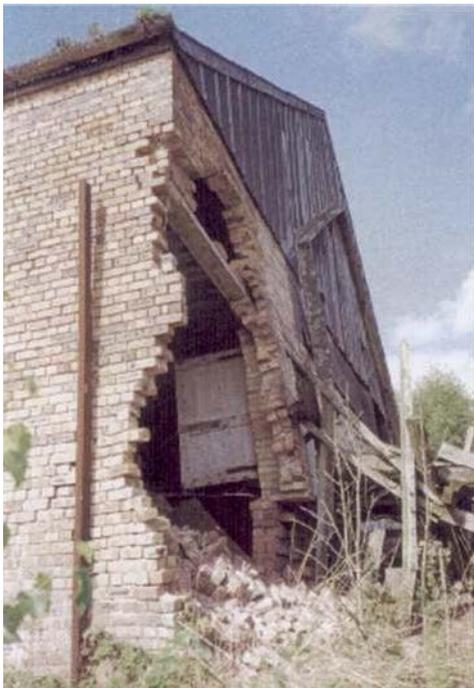
3.49: Stove House 5, collapse in wall, 1997, north-west facing

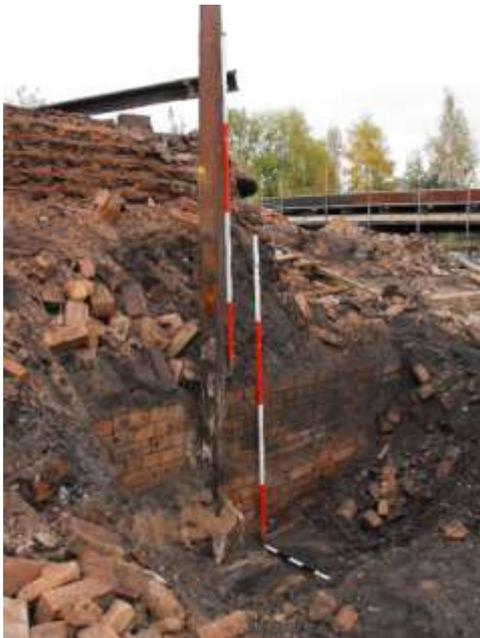
3.62: Stove House 5, remains of southern wall with ferrous metal I-beam support, north-east facing

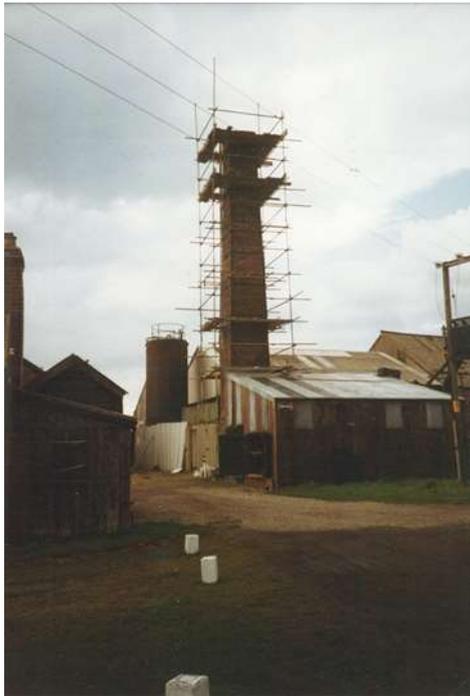
4.47: Pump House Chimney repairs, west facing, during 1990s
