**22A Milton Street, Edinburgh**

**Historic Building Recording and Archaeological  
Watching Brief**

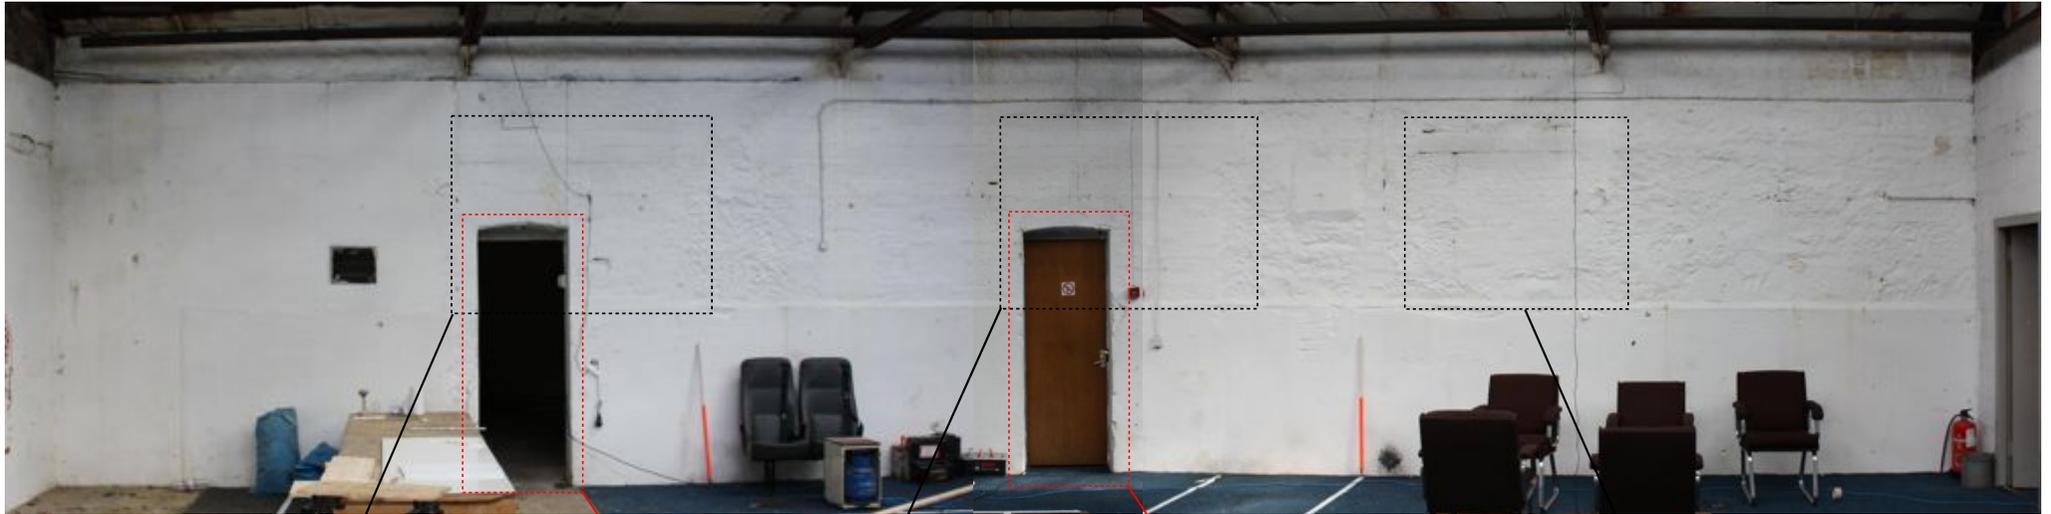
3.3.5 Phase 2 sees the construction of the tenement block adjoining the warehouse complex to the east (Figure 2). Construction of the tenement led to several alterations to the eastern wall of the eastern building. The three original windows were all blocked with bricks (Blocked windows 1-3, Figure 3). Two storerooms were built at the ground level of the tenement with access to them from the eastern building via two newly constructed doors, there was no access available from the tenement itself.

Blocked window 1

Doorway 1

Blocked window 2

Doorway 2

Blocked window 3

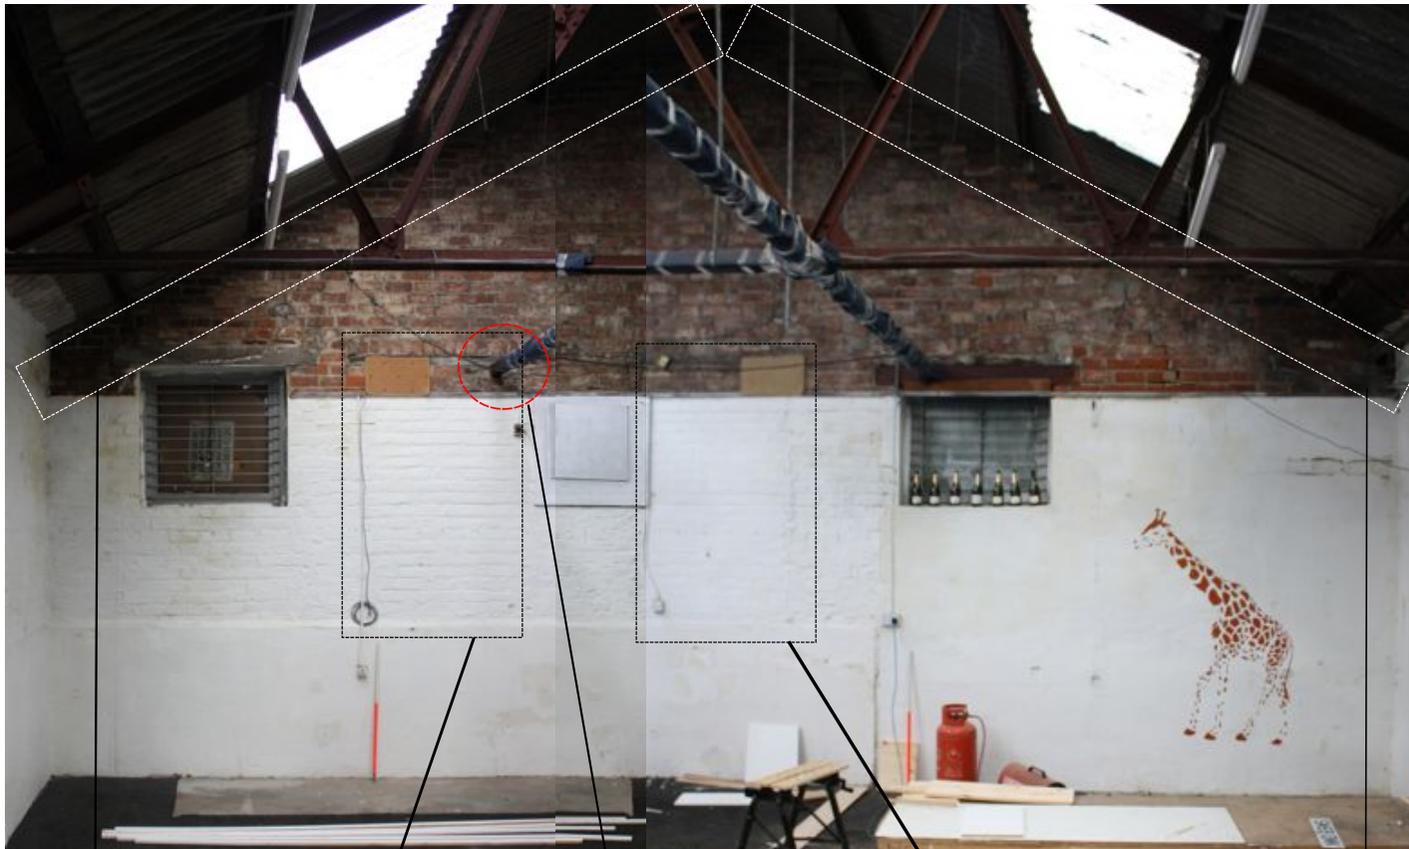
Roof  
Modification

Blocked  
window 4

Steel roof beams  
keyed into bricked-up  
original windows

Blocked  
window 5

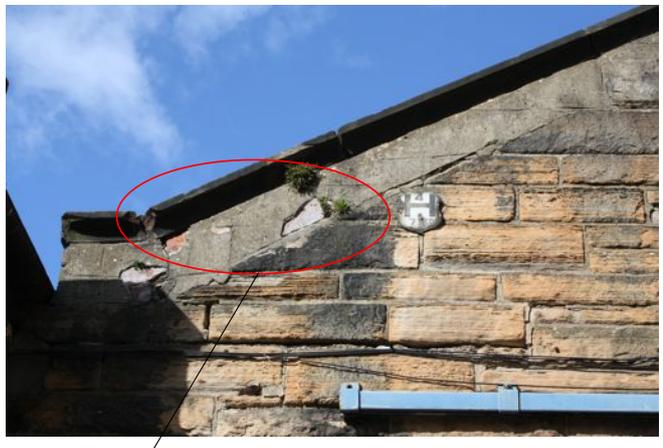
Bricks clad with cement and scored to look like sandstone blocks

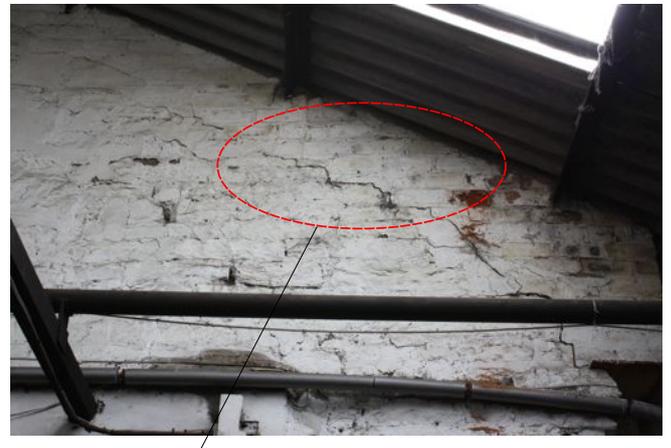
Different brickwork evident from when roof was raised

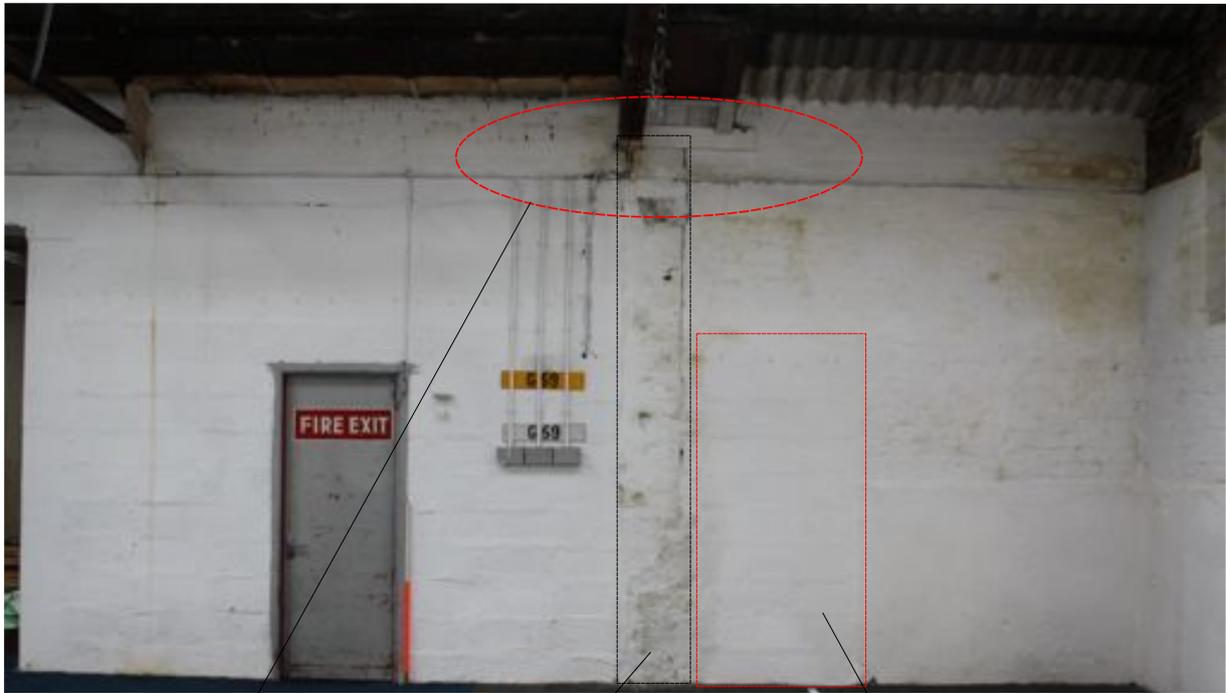
North Wall of Western Warehouse

3.3.6 Phase 3 involves the alteration and/or construction of a new western building (Figure 32). The construction technique and bricks used in the construction of the western building are different to that of the eastern building with better-defined pointing on the brickwork. The northern wall of the western building has also not been keyed in to the western wall of the eastern

building suggesting a later construction date than the eastern building (Figure 6).

Different brickwork evident below level of roof, with roof beam an addition to the northern wall of the western warehouse

Blocked Doorway

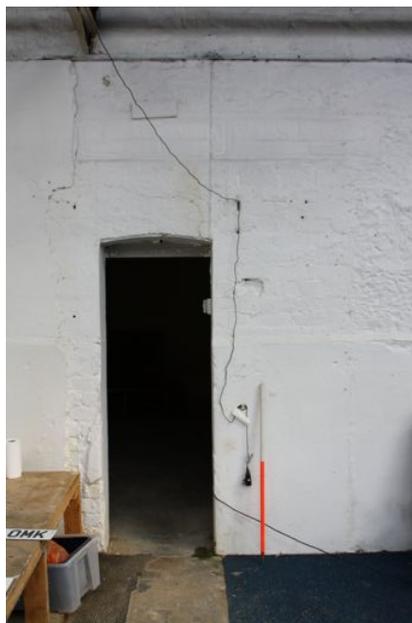
**Fig. 7** - Detail of Doorway 1 in Eastern Wall cut through Blocked Window 1

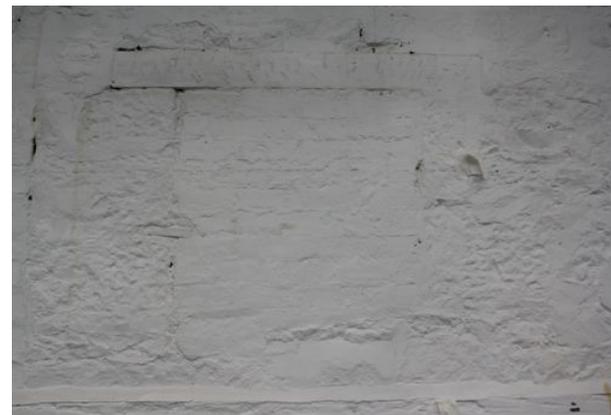
**Fig.8** - Detail of Blocked Window 3

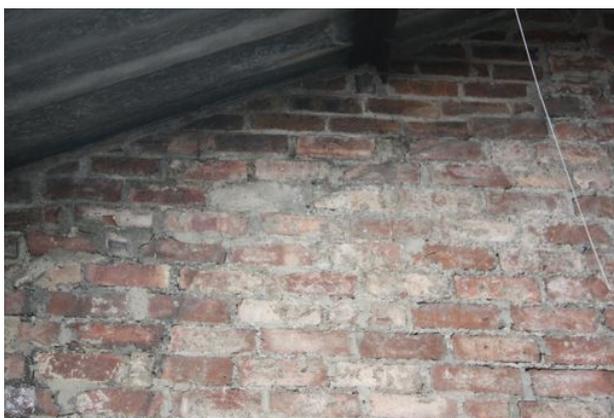
**Fig.9** - Detail of Bricks Added to Northern Wall of Eastern Building to Raise Roof

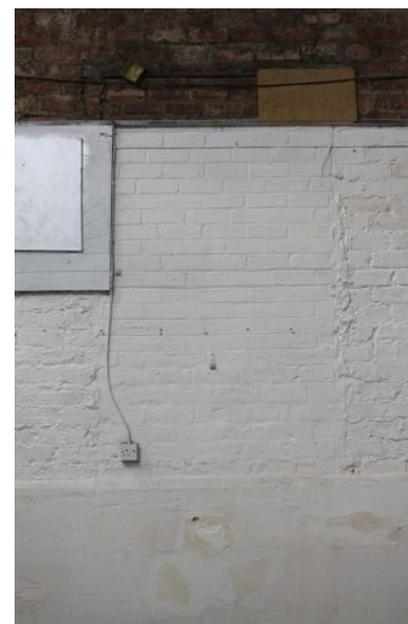
**Fig.10** - Detail of Blocked Window 5

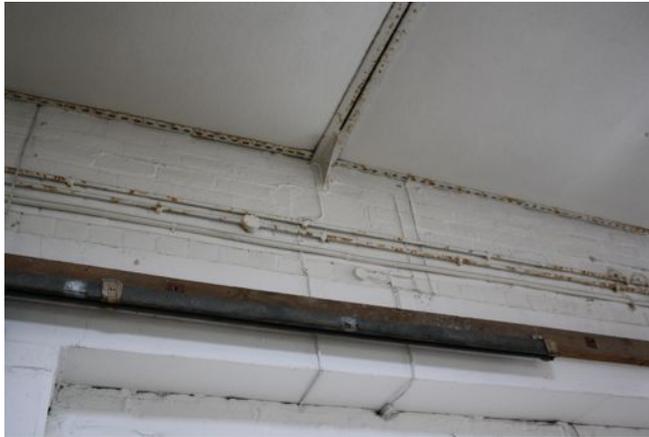
**Fig.11** - Detail of Steel Truss of Roof of Western Building set in Bricks Above Concrete Lintel

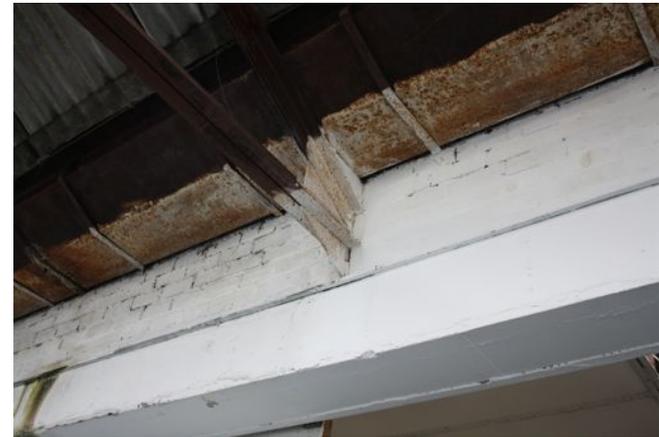
**Fig.12** - Detail of Steel Truss of Roof of Eastern Building Set in Bricks and Resting on Concrete Lintel

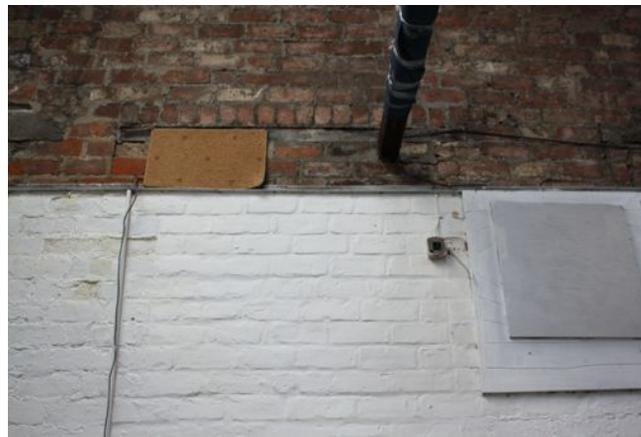
**Fig.13** - Detail of Steel Truss of Roof of Eastern Building Set in Bricked up Window in Northern Wall

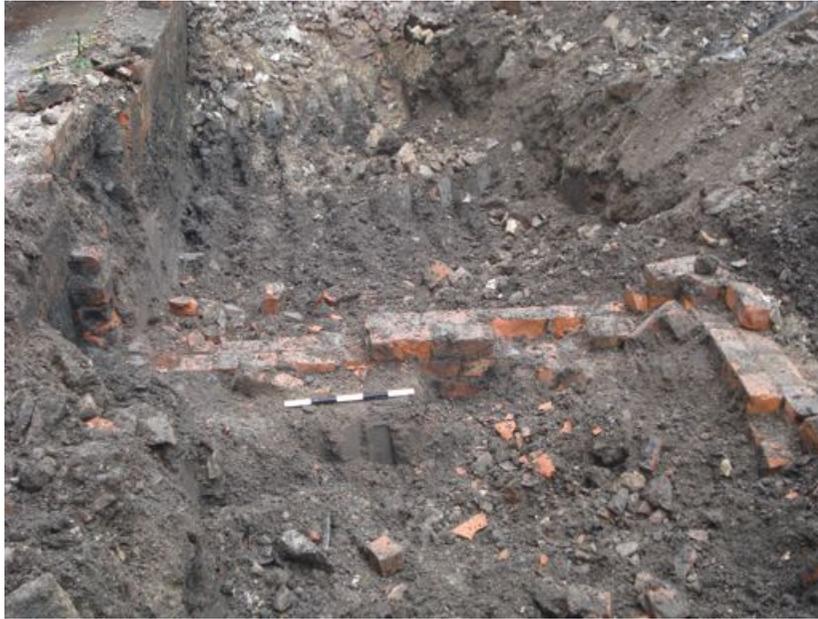
building had been demolished prior to the construction of the western building. The removal of (001) in the western building also revealed the remains of a small brick built room, or tank stand abutting the foundations (005) at the centre of the western wall. The brick built structure (007) was 2.5m long, 2.5m wide and survived to a depth of 0.3m (Figures 14-15). Within the confines of (007) was a made ground deposit (006) consisting of brown clay, ash and rubble.

**Fig.15** - Detail of Tank Stand/Room (007)

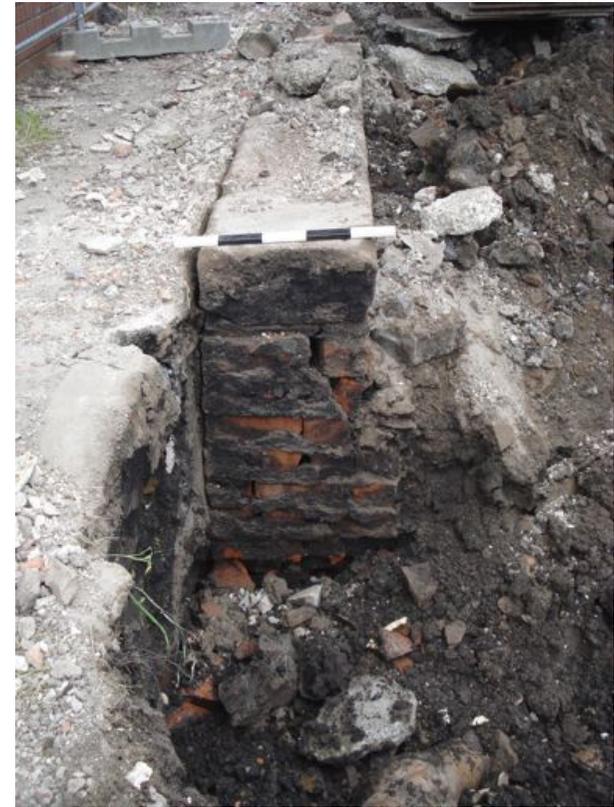
**Fig.16** - Detail of Foundations (005) With Sandstone Capping
