**Archaeological monitoring and recording  
(comprehensive watching brief)  
at the church of St James the Less,  
Halse, Somerset  
NGR ST 139 277**

**12-13 January 2015**

**Project number:  
RGA 2015\_01**

**Prepared by  
Richard Anderson**

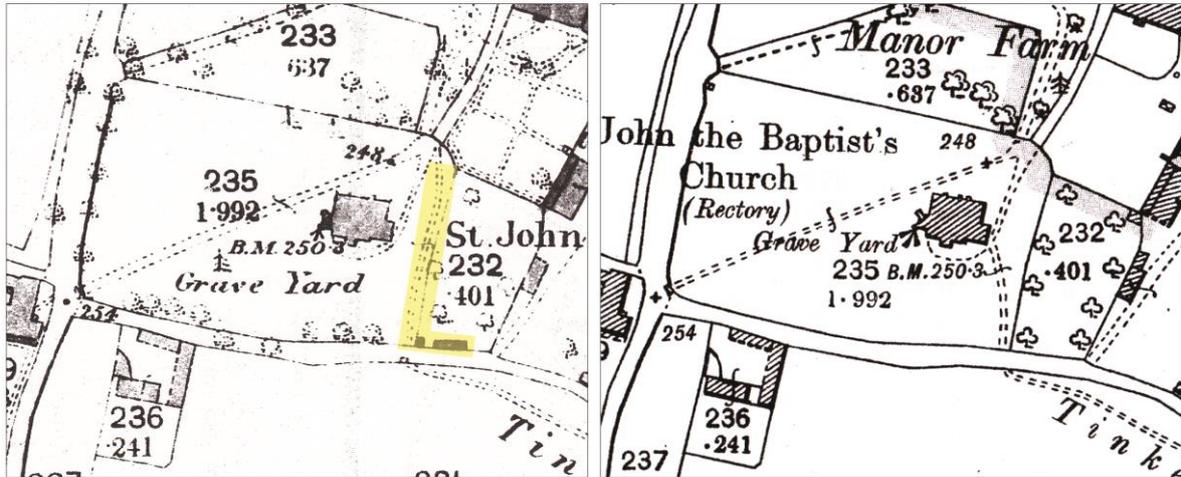
- 7.1 The water pipe trench had been planned in the hope of avoiding the disturbance of any archaeological features or inhumations. In this it has succeeded admirably. The section which runs along the eastern boundary of the churchyard lay directly over a former churchyard footpath, present in 1840 but absent by the Ordnance Survey map of 1904. The remainder of the new pipe trench followed the routes of various modern services and disturbances.

**Fig.2.** (left) Extract from Ordnance Survey first edition map sheet 69:NE of 1888, with churchyard boundary path and adjacent outbuildings in place and highlighted.  
(right) Extract from Ordnance Survey second edition map sheet 69:4 of 1904, showing absence of boundary path and outbuildings.  
The church is shown as 'StJohn the Baptist', and was rededicated to 'St James the Less' at some point in the early C20, exact date unknown but presumably after 1904.  
(Somerset Heritage Centre)

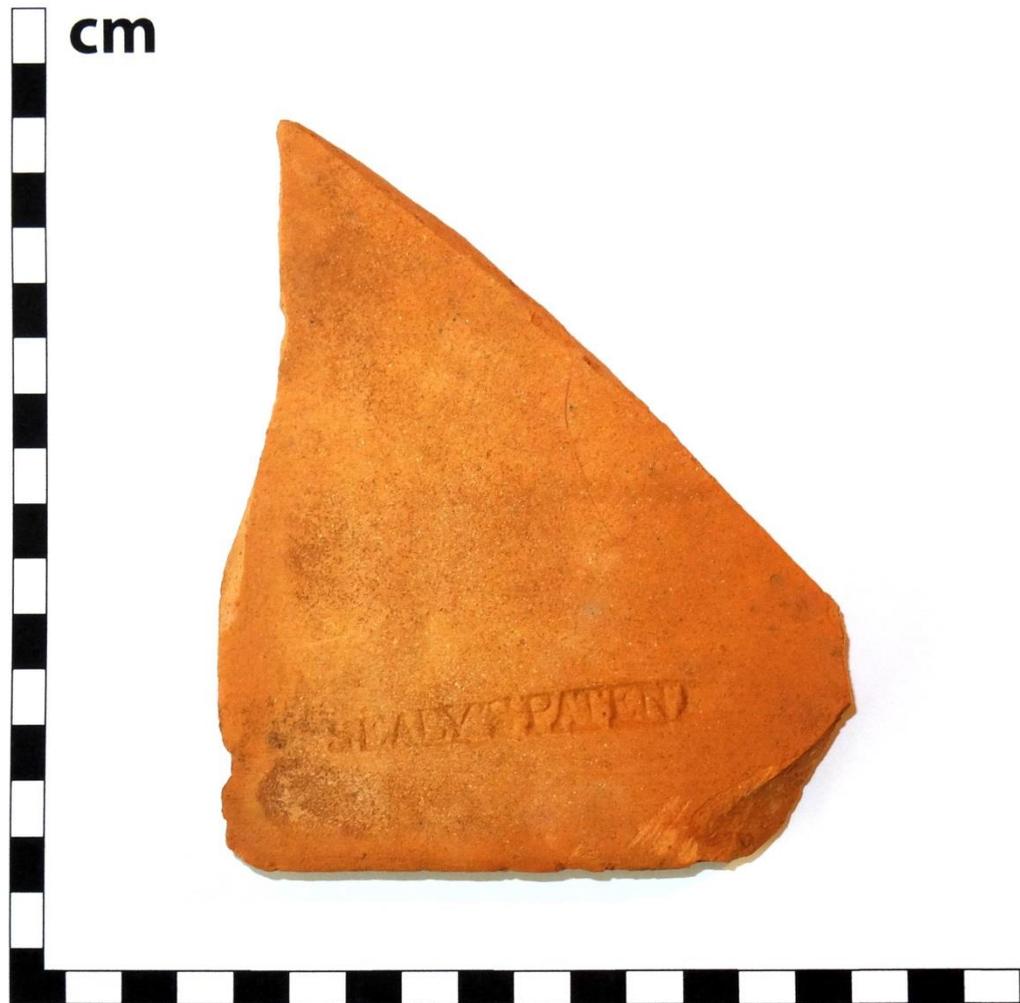
- 6.1 An incomplete fired red clay roof tile, with a stamped makers' mark reading 'SEALY'S PATENT' was recovered from the churchyard boundary section of trench. It is illustrated in figure 3, below. The mark identifies the tile as having been made by John Sealy of Bridgwater, who is known from directories to have operated between 1840 and 1869 under the name John Sealy and Sons (Murless 2000; Crew 2004).

- 7.2 The fragmentary rubble uncovered along the eastern churchyard boundary lay directly below turf level and was mixed with the natural loose red soil. The presence of the Sealy's roof tile presents a date for deposition of no earlier than 1840. A small outbuilding, seen on the Ordnance Survey of 1888, had been demolished by 1904, and it is possible that this material was used to consolidate the footpath in the later years of its use.

**Fig.3.** Incomplete fired clay roof tile by John Sealy's and Sons of Bridgwater, showing the makers' stamp used between 1840 and 1869. (*Photograph: author*).
